Contribution to the Evaluation of Silicon Carbide Surge Arresters

Arnaldo Gakiya Kanashiro and Milton Zanotti Jr.
*University of São Paulo
 Brazil*

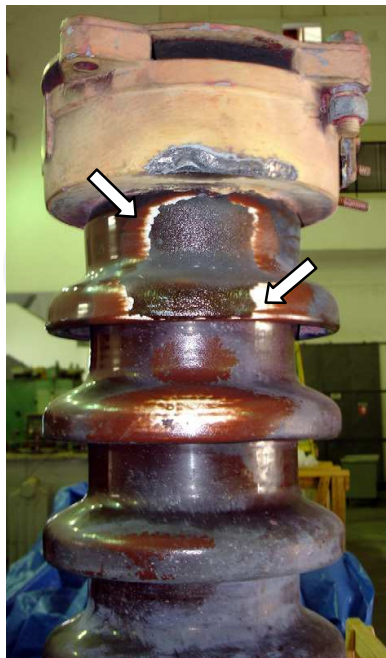
In some of the 88 kV arresters, surface erosion was observed which is a typical sign of electric arc damage on the porcelain, as shown in Fig. 1. Also, most of them had some degree of corrosion in their metallic parts, as shown in Fig. 2. Finally, in order to check the viability of measuring the leakage current in the field, some SiC surge arresters installed at Paraibuna substation were chosen. After this, due to the explosion of one 88 kV SiC surge arrester at Mairiporã substation, leakage current measurements were also performed in this substation.

Fig. 1. Typical sign of electric arc damage on the porcelain of the surge arrester.

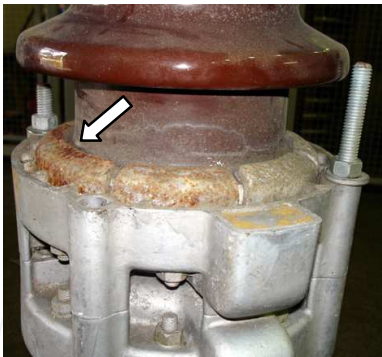
Fig. 2. Corrosion in the metallic parts of the surge arrester.

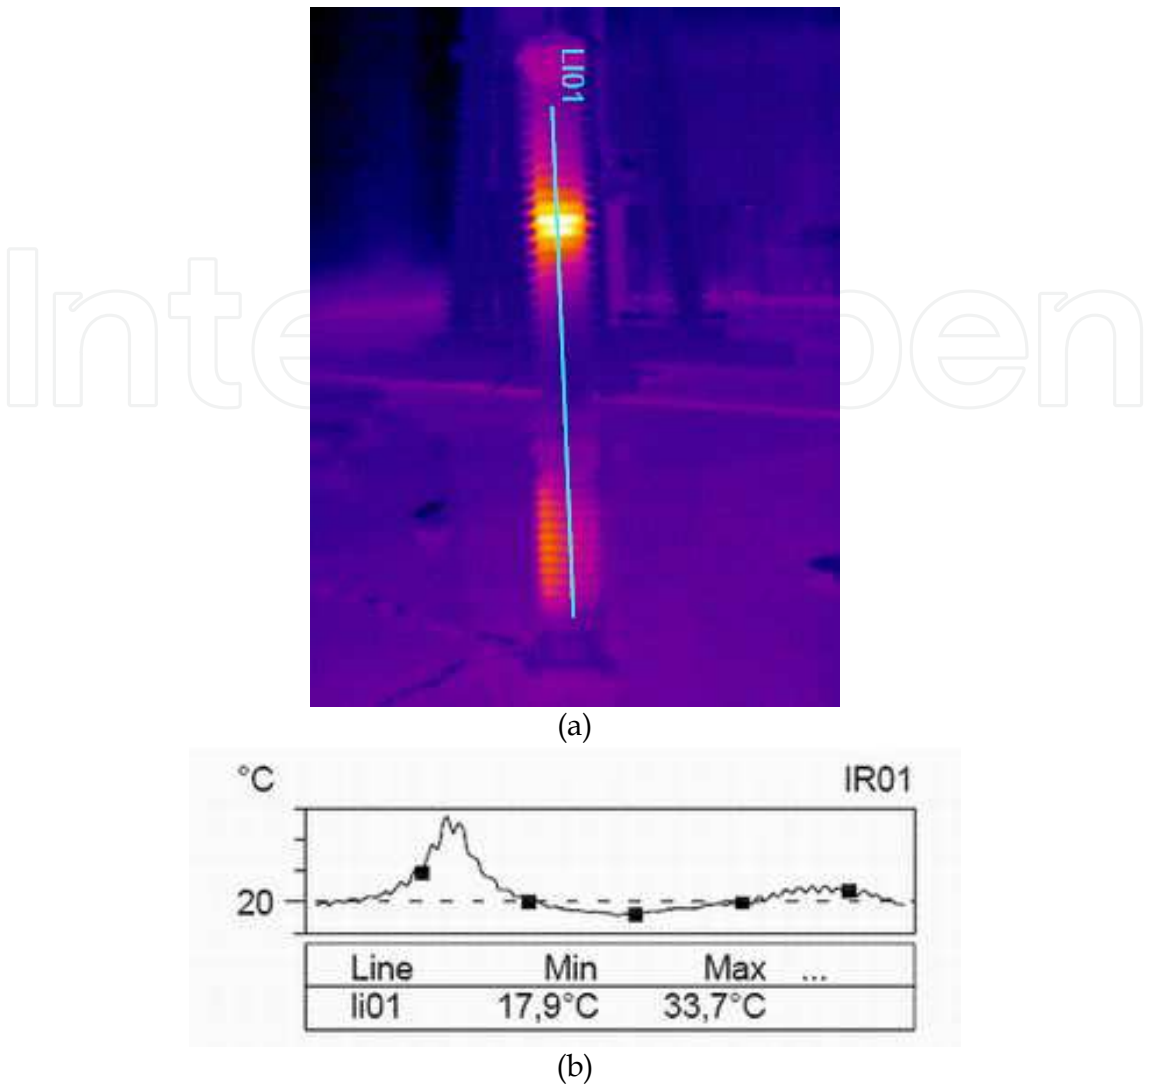
The thermovision were carried out after the samples had been energised for a time period of 5 to 7.5 hours, depending on the manufacturer. One measurement was carried out for each of four different sides of the sample. Each measurement corresponds to the thermal imaging obtained along the sample, from top to bottom. Each of the four sides of the sample had its maximum and minimum temperatures determined, and the difference (Δt) between these temperatures was calculated. The greatest difference value found was named " Δt_{max} ".

Fig. 3. Example of a thermal image measurement, (a) thermal image of the surge arrester and (b) temperature along the surge arrester.

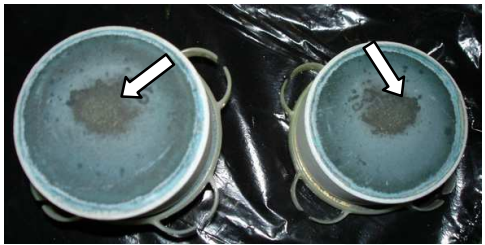
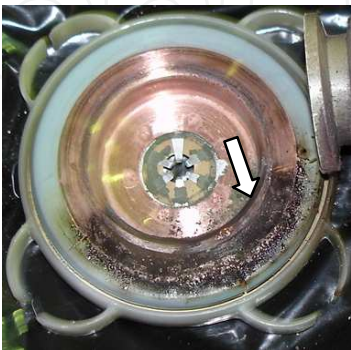
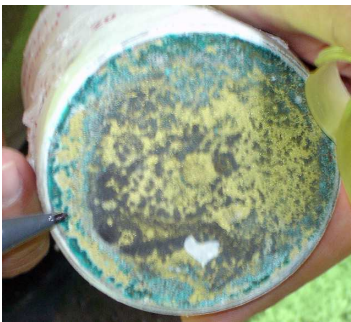
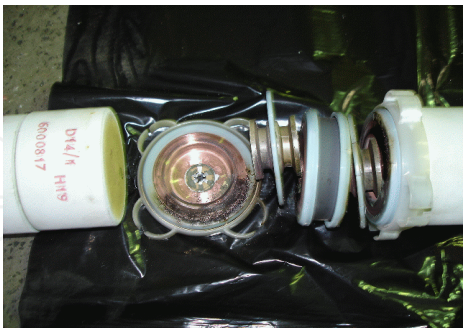
In general, it was noticed that moisture was presented in the internal components of the arresters. Some traces of discharges on the surface of the blocks were also observed. Some of the surge arresters presented signs of discharges in the gap electrodes. During the visual inspection, it was also observed that some nonlinear resistors were damaged.

The surge arrester A6 (manufacturer A) was more degraded in comparison with A2 and A4. The arrester C5 (manufacturer C) was the worst in comparison to the surge arresters C1 and C3.

As a general conclusion, it was observed that the surge arresters of manufacturers A and C presented evidence of ingress of moisture and signs of discharges. Moisture ingress may have deteriorated the SiC material (McDermid, 2002) and (Grzybowski, 1999).

Fig. 7. Surge arresters of manufacturer A, (a) blocks: signs of discharge, (b) gap electrodes: signs of discharge, (c) block: presence of moisture and (d) gap electrode: signs of discharge.

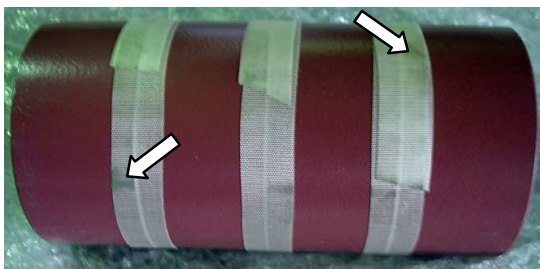
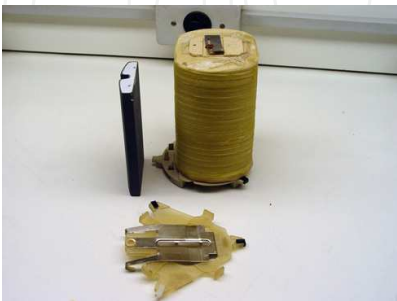
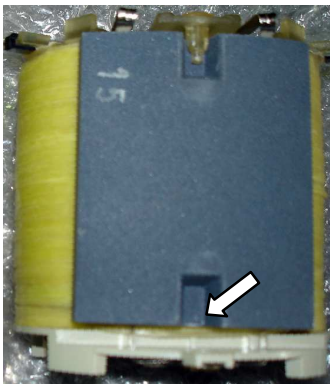
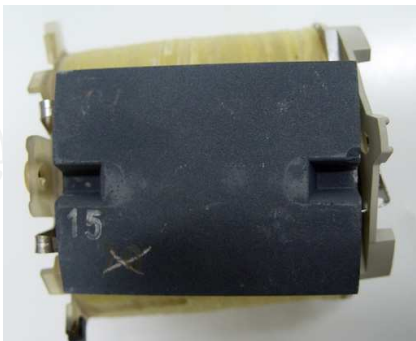
The surge arrester C5 presented some damaged nonlinear resistors and, probably, this was the reason for the high level of RIV ($4,518 \mu\text{V}$), shown in Table 4. This surge arrester also failed the power frequency spark-over voltage test. In Fig. 7 and Fig. 8 it is possible to visualize the condition of the components of the surge arresters, considering manufacturers A and C, respectively.

Fig. 8. Surge arresters of manufacturer C, (a) block surface: presence of moisture, (b) group of gap electrodes: damaged, (c) nonlinear resistor: broken and (d) nonlinear resistor: broken.
