# Correlation of Professional Performance to Acceptable IAQ in Critical Care Medical Facilities

H.W. Holder<sup>1</sup>, K.V. Easterwood, Jr.<sup>2</sup>, D.E. Johnson<sup>3</sup>,  
J.W. Sealy<sup>4</sup>, M.D.Larranaga<sup>5</sup> and D.C. Straus<sup>6</sup>

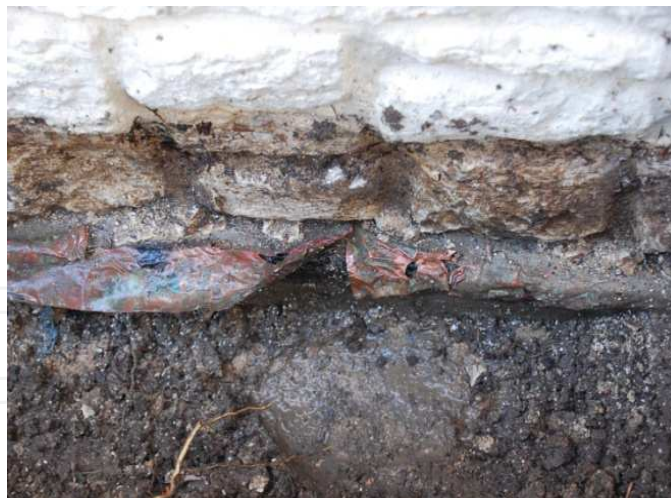
When combined with the fact that water stands against the building, the base flashing not only did not allow water to drain it instead reversed the flow of water such that outside water entered the building. The end result was mold growth along the entire perimeter of the building.

Fig. 2. The copper-coated base flashing at the applied masonry veneer wall terminated below grade and therefore did not allow for the water to drain.

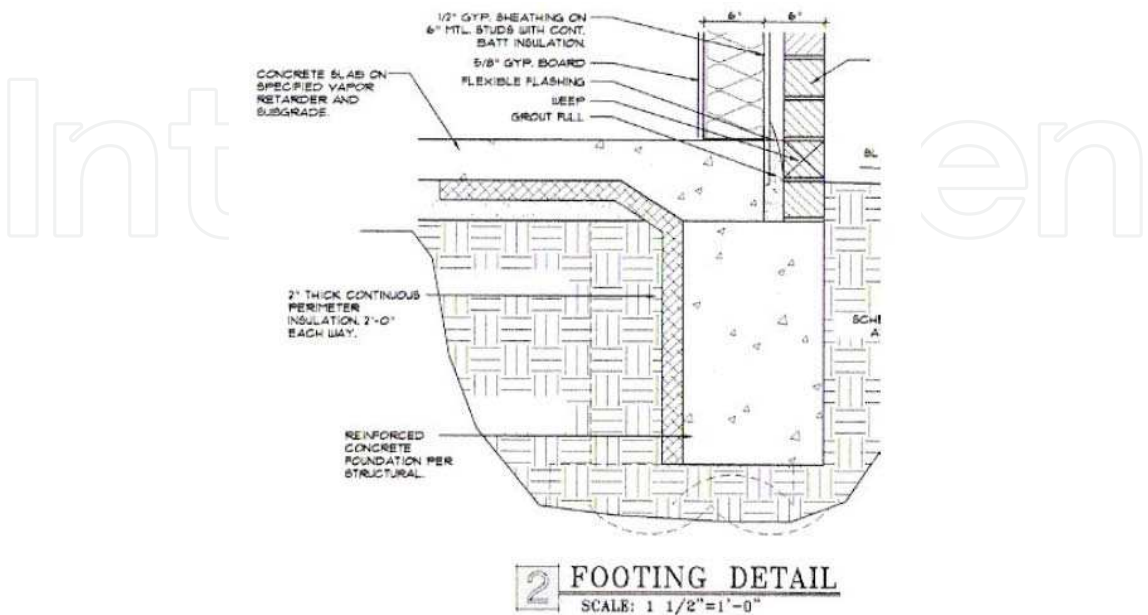
Fig. 8. The architect’s detail correctly shows the acceptable method of installing base flashing when the masonry terminates into grade.

However, he failed to follow manufacturer’s recommendations and buried the exterior sheathing into the grout fill. Inattention to detail by both architect, who failed to refer to the manufacturer’s guidelines, and contractor, who failed to notice the defect, led to the unacceptable condition. As a result of these errors water stands within the wall cavity posing a continuing threat to building materials.

A standard detail that would allow a veneer to terminate below grade calls for a flashing to be installed at a brick or masonry course above grade. The void below the flashing is then filled with grout that, essentially, makes the veneer below grade a part of the foundation.

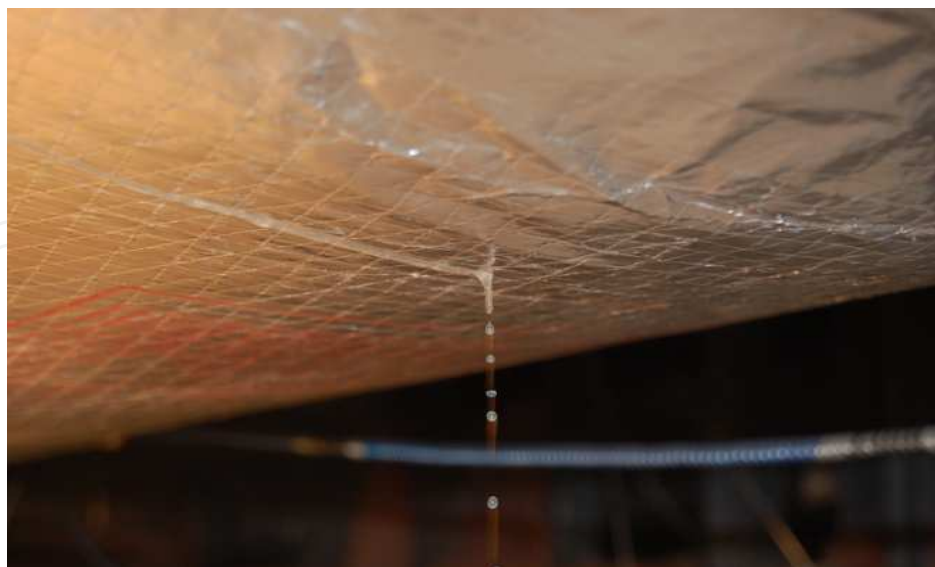
Fig. 10. Water running out of insulation.

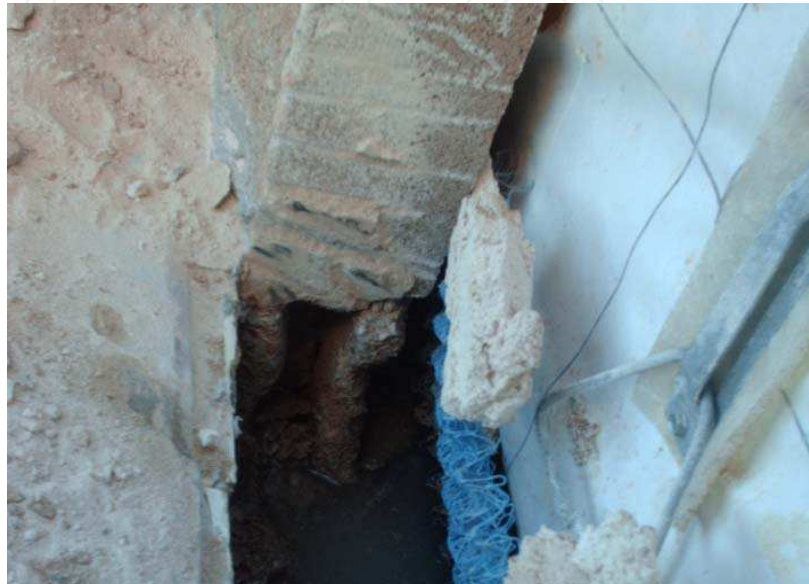
Fig. 12. Water standing inside wall cavity.

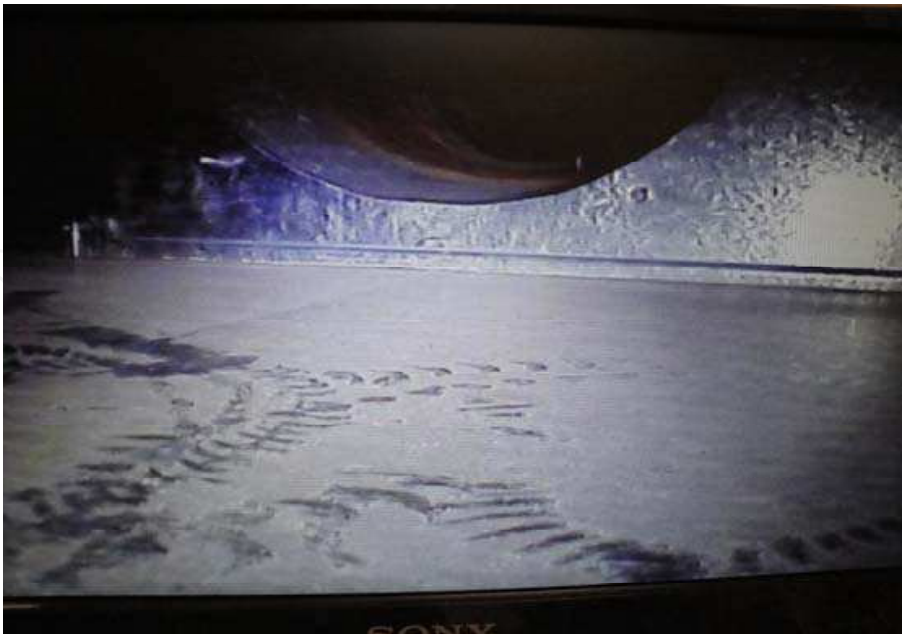
The building was under construction for a long time and the duct work was never protected during construction. The duct work was not cleaned before operating the equipment. Dust in the ductwork was deep enough to leave ruts when a robot was used to photograph the ductwork to an operating room.

Fig. 16. Tracks of robotic camera in the dust of the HVAC ductwork.

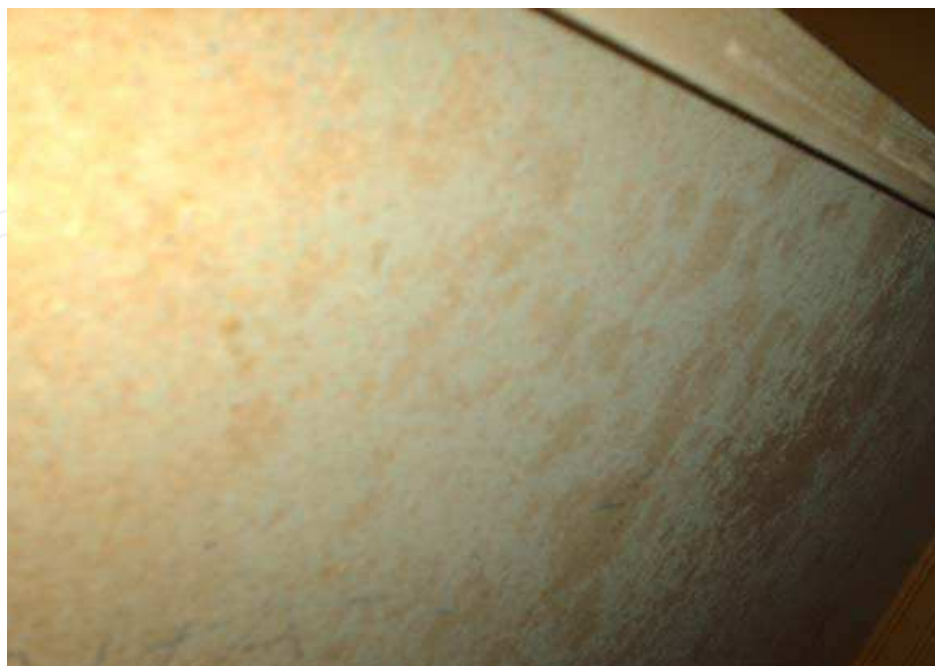
Fig. 17. Mold under a nurses desk.
