Investigation of High Energy Arcing Fault Events in Nuclear Power Plants

Heinz Peter Berg¹ and Marina Röwekamp²

1. Introduction

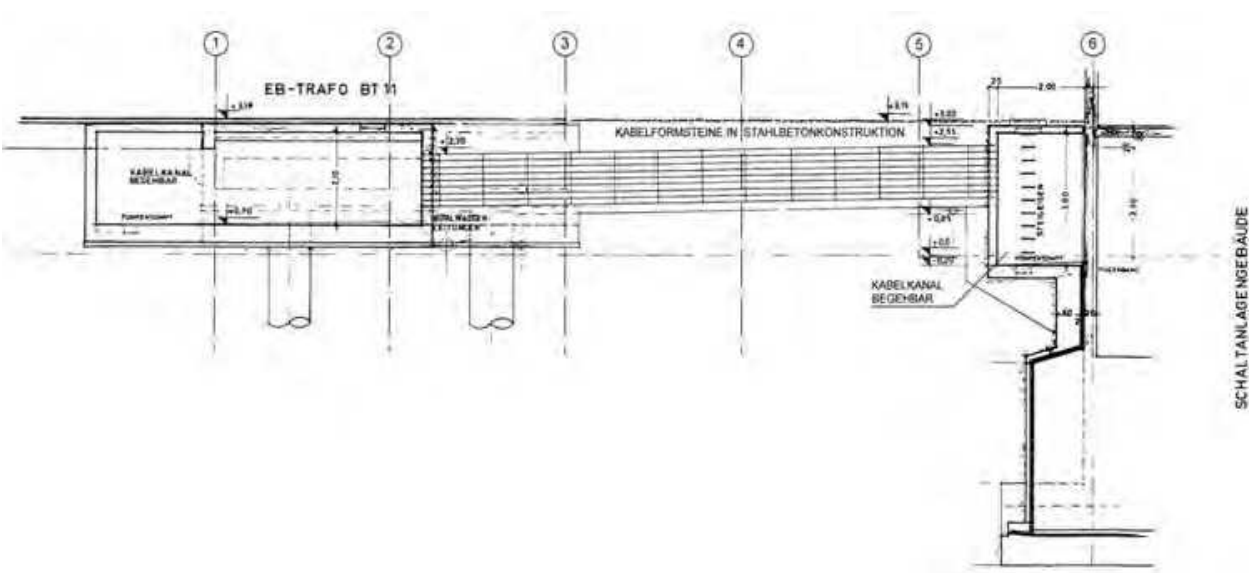
Due to the conditions in the ground, cables were partly imbedded in so-called 'cable cylinder blocks' manufactured from concrete (see Figure 2).

Fig. 2. Cross section of the cable tray inside the cable cylinder blocks inside ground between the buildings

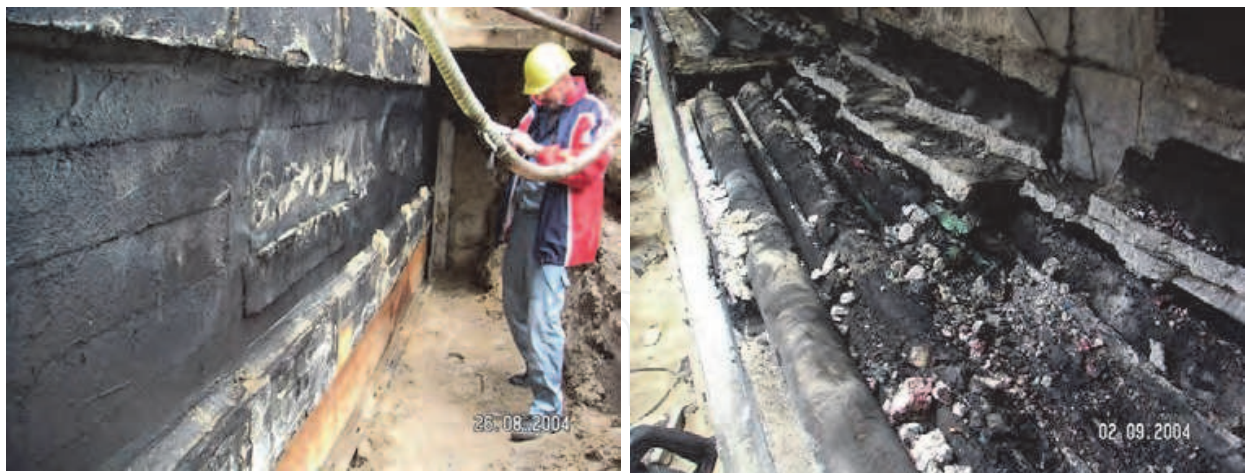
The pyrolysis and/or evaporation of the PVC cable insulations caused a strong smoke release inside the cable channel.

Fig. 3. Photos of the cable damage; left: location of the damaged cable, right: damage by the cable fire/evaporation

The detailed analysis led to the definite result that the event was mainly caused by ageing of the 10 kV cables. The ageing process was accelerated by the insufficient heat release inside the cable cylinder blocks.

As a corrective action, all high voltage (mainly 10 kV) cables with PVC shielding being older than 30 years were replaced by new ones.

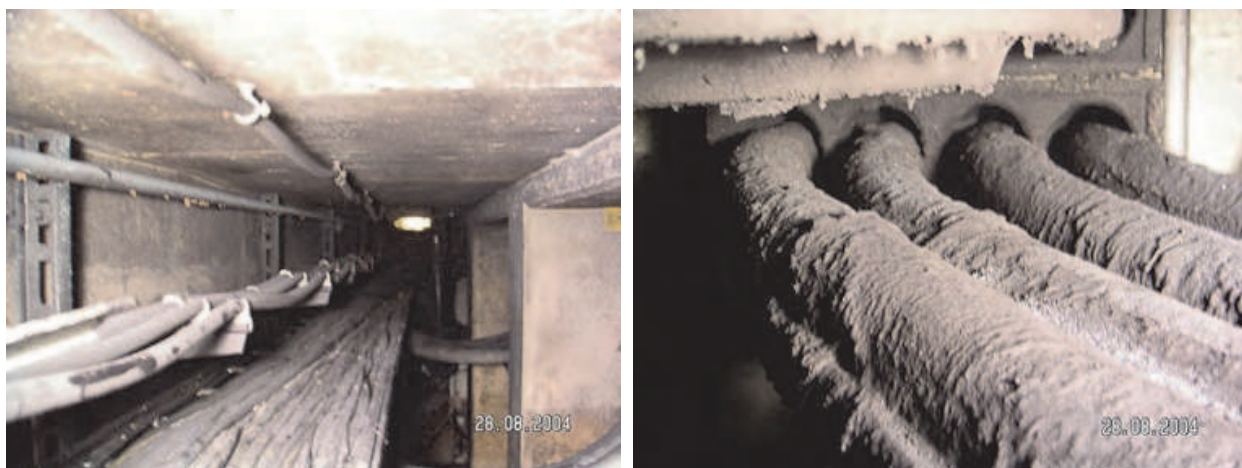
Fig. 4. Cables with protection by intumescent coating; left: photo of the cable channel, right: photo of the coating

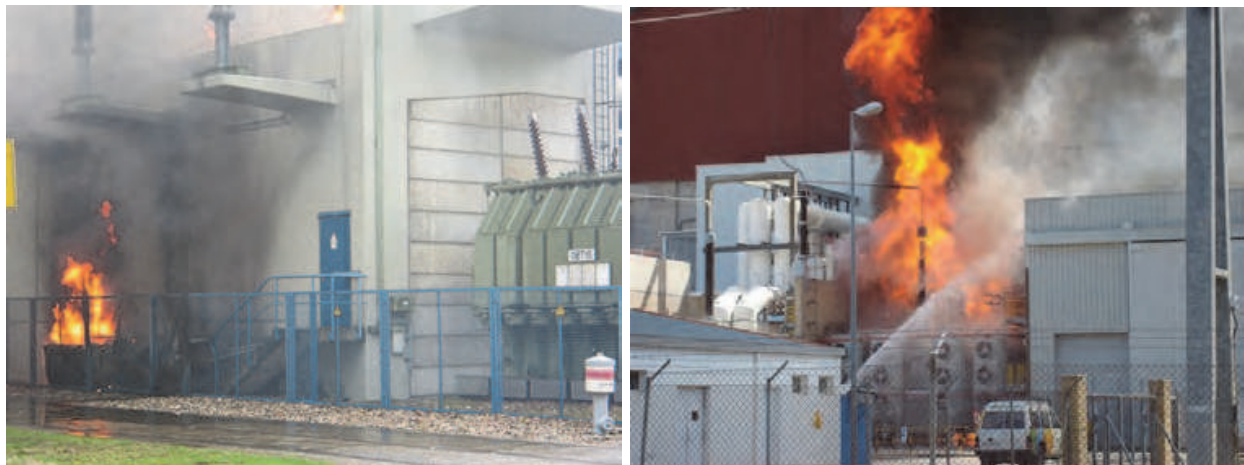
Due to the damage caused by the fire in the transformer, the plant was shut down. The fire of the transformer showed the normal behaviour of a big oil-filled transformer housing, the fire lacks combustion air and produces a large amount of smoke (see Figure 8).

A detailed root cause analysis regarding the different deviations from the expected event sequence was carried out. The cause of the fire was a short circuit in the windings of the generator transformer. Due to the damages to the transformer it was not possible to resolve the failure mechanisms in all details.

Fig. 8. Flame and smoke occurring at the generator transformer; the photo on the right hand shows the fire extinguishing activities

As a consequence of these indications, improvements concerning the fire protection of transformers are intended in Germany (Berg et al., 2010).

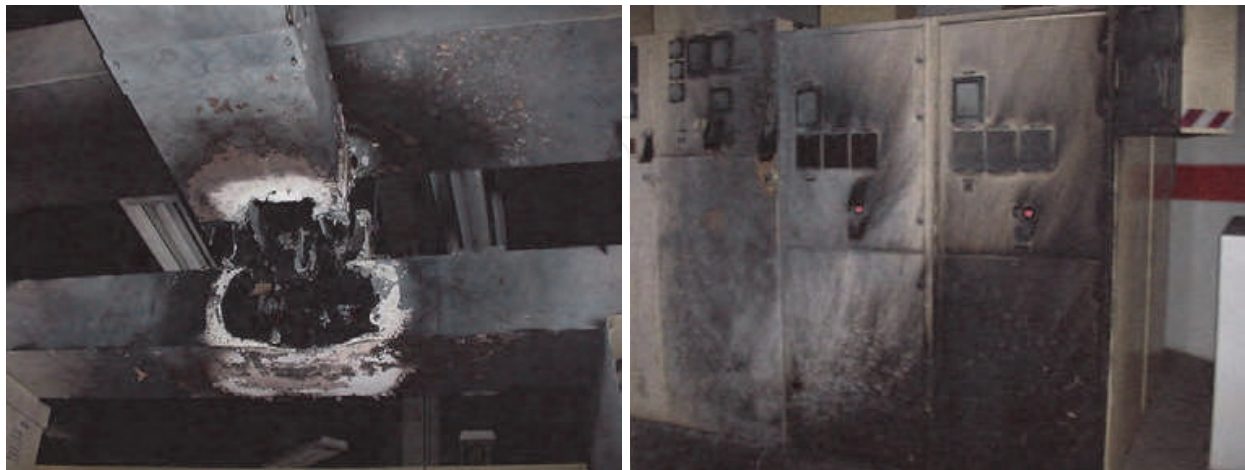
This event was initiated due to the centre bus overheating causing the polyvinyl chloride (PVC) insulation to smoke, which lead to a failure of the adjacent bus insulation. Having only a thin layer of silver plating on the electrodes, noticeably flaking off in areas not directly affected by the arc, contributed to the high-energetic arcing fault event.

Other factors that caused the failure were heavy bus loading and splice joint configurations, torque relaxation, and undetected damage from a 1995 transformer explosion. Two photos of this failure are shown in Figure 9. More photos are provided in (Brown et al, 2009).

Fig. 9. Photographs of the damages at the Diablo Canyon nuclear power plant (from Brown et al., 2009)

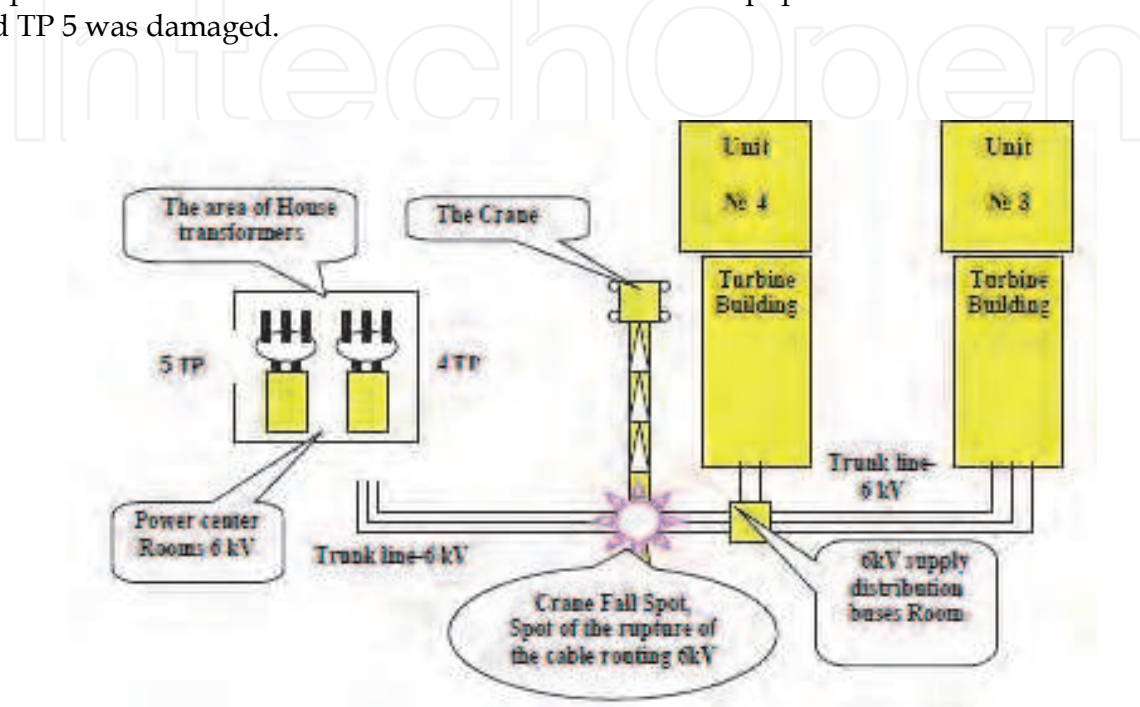
The long-term exposure of this earth fault (1 min and 36 sec.) caused a high earth fault currents which burn the cables. This led to a fire spread to the 6 kV supply distribution buses and 6 kV metal clad switchgear rooms resulting inside these rooms in high temperature and release of the toxic substance. Also the equipment of the transformers TP 4 and TP 5 was damaged.

Fig. 10. Diagram of the situation after the event (from IAEA, 2004)
