Fracture Analysis of Generator Fan Blades

Mahmood Sameezadeh and Hassan Farhangi

This chapter reports the failure investigation of a rotating axial flow fan of the Iran Montazer-Ghaem-VI 123 MW capacity generator unit. The unit was equipped with two rotating fans, one at each end namely at the turbine side and the exciter side of the generator. The failed fan consisting of 11 blades was mounted on the generator-rotor at the

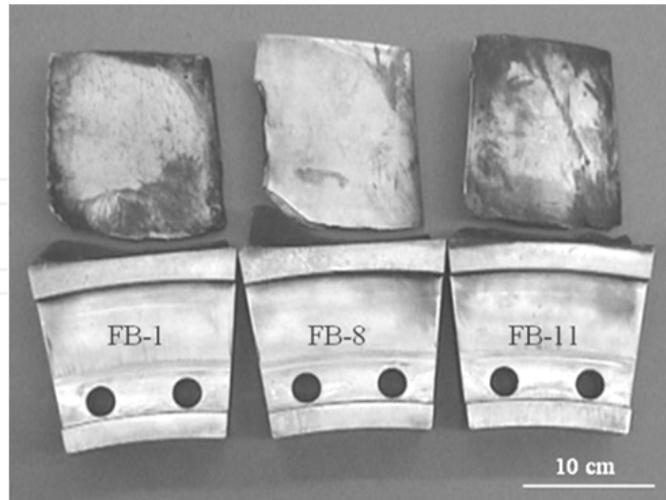
Visual inspections indicated that the accident has led to three different categories for the fan blades of the turbine side (Table 1). Dye penetrant testing revealed the cracked blades which did not completely fracture during the accident. A photograph of the fractured blades, labelled in according with their location on the fan is shown in Fig. 2.

Figure 2. Fractured fan blades

The fracture location of the broken blades can be identified from Fig. 2. It can be seen that the fracture had occurred close to the transition radius between the blade airfoil and the blade root. All the fracture surfaces exhibited very similar macroscopic features. A

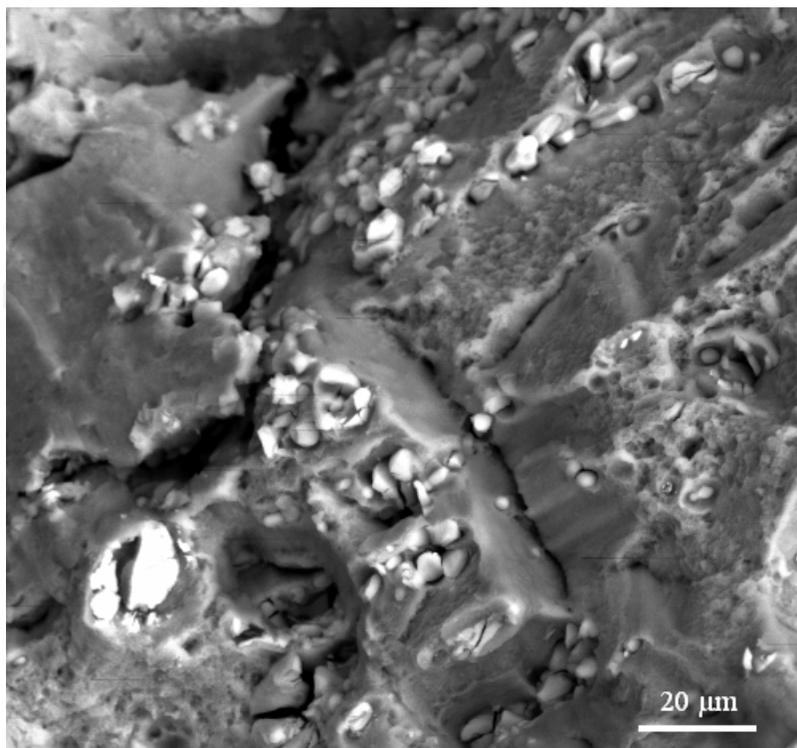
is shown in Fig. 4. Presence of several second phase particles on the surface is obvious. This kind of large particles can accelerate the fatigue crack initiation and affect the fatigue behaviour of the blade material.

Figure 4. Fracture surface of a fatigue test specimen

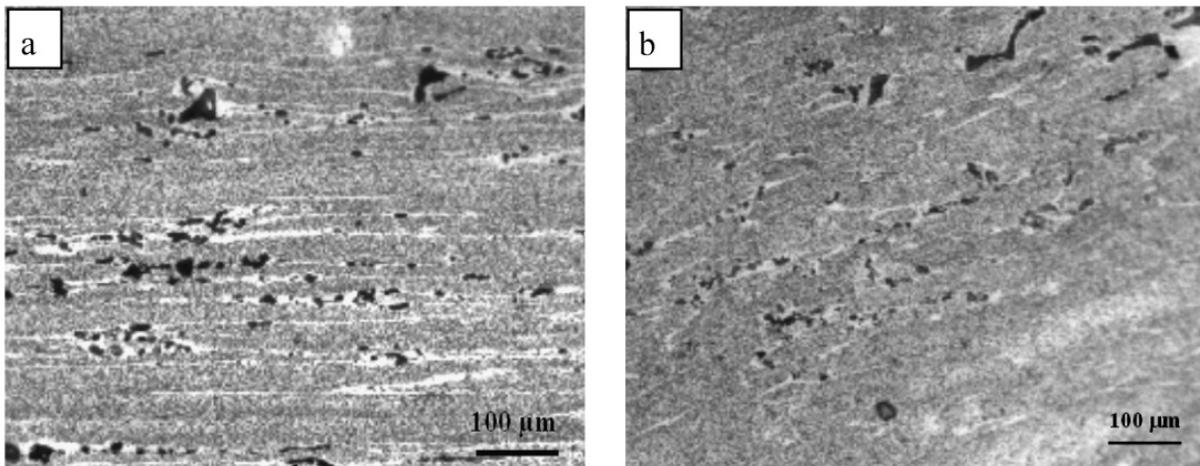
Typical microstructures of the blade material in the longitudinal and transverse sections of a cracked airfoil are shown in Fig. 5. The microstructure consists of elongated grains and second phase particles in the longitudinal direction. Various types of second phase particles can be identified in the SEM micrograph, shown in Fig. 6. The large and elongated particle on the micrograph was subjected to EDS analysis. The composition of the particle contained iron, copper and aluminum which is consistent with the β -phase (Al_7Cu_2Fe) particles common to aluminum alloys (Merati, 2005).

Figure 5. Microstructures of longitudinal (a) and transverse (b) sections of a cracked blade

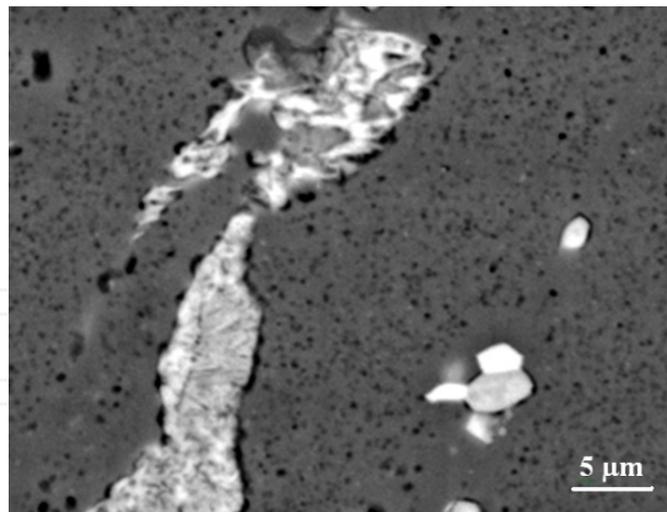
Figure 6. SEM micrograph showing large second phase particles

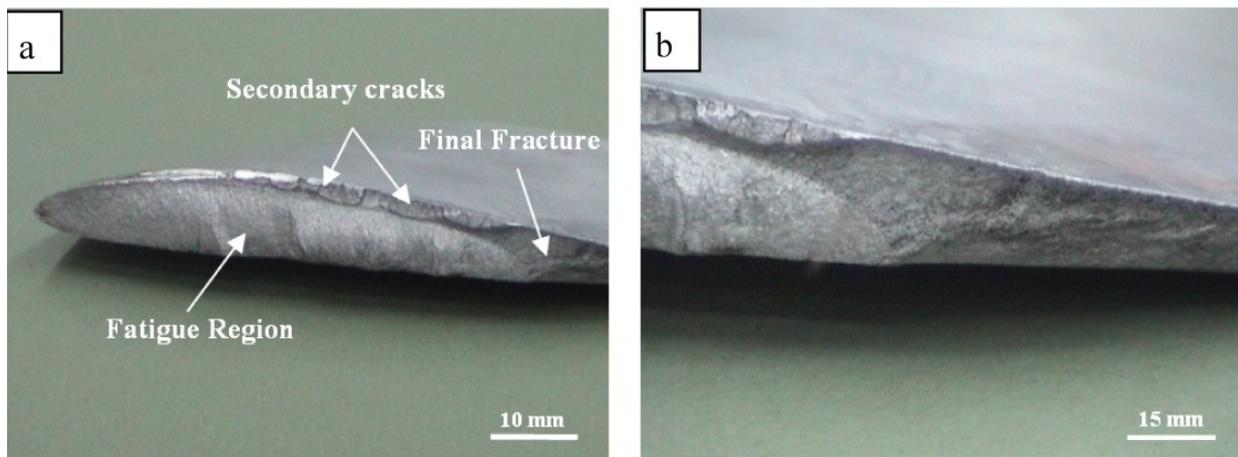
representative fractograph of the fracture surface of blade No. 8 is shown in Fig. 7a. It is observed to consist of two distinct regions at low magnification, a semi-elliptical and smooth region which is oriented normal to the blade axis and exhibits a macroscopically brittle appearance, and an outer region with a rougher and more ductile appearance. The transition from semi-elliptical region to the outer region can be clearly identified in Fig. 7b. In this region the remaining cross section of the blade failed by tensile overload.

Figure 7. (a) Fracture surface of blade No. 8, (b) transition from fatigue to tensile overload fracture

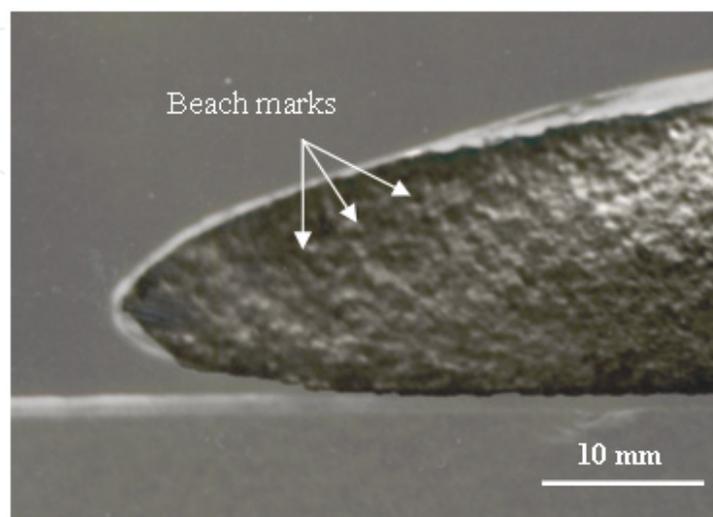
Faint beach marks indicative of the progressive nature of crack growth in the semi-elliptical region can be seen in Fig. 8. Parallel microscopic fracture surface markings can also be observed in this region at higher magnifications in SEM micrograph as shown in Fig. 9. A schematic drawing of the fan with the location of damaged blades is presented in Fig. 10. Visual inspections and fractographic assessments revealed that the sequence of fracture for the broken blades has been blade No. 1, blade No. 8 and blade No. 11 respectively (Sameezadeh, 2005).

Figure 8. Beach marks on the fracture surface near the leading edge of the blade

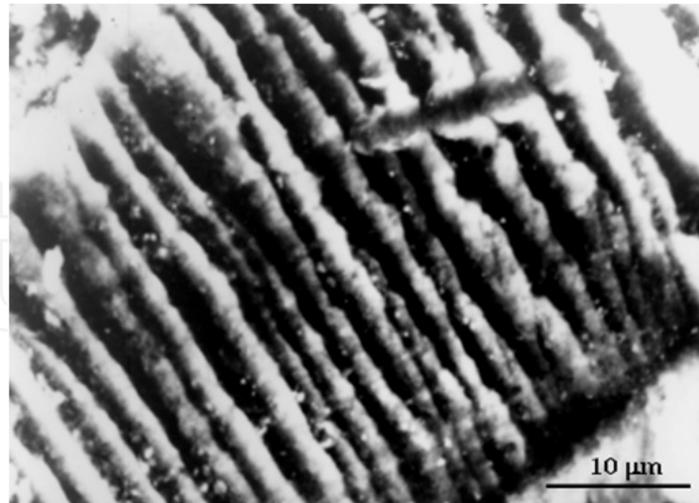
Figure 9. SEM fractograph showing parallel fracture surface markings

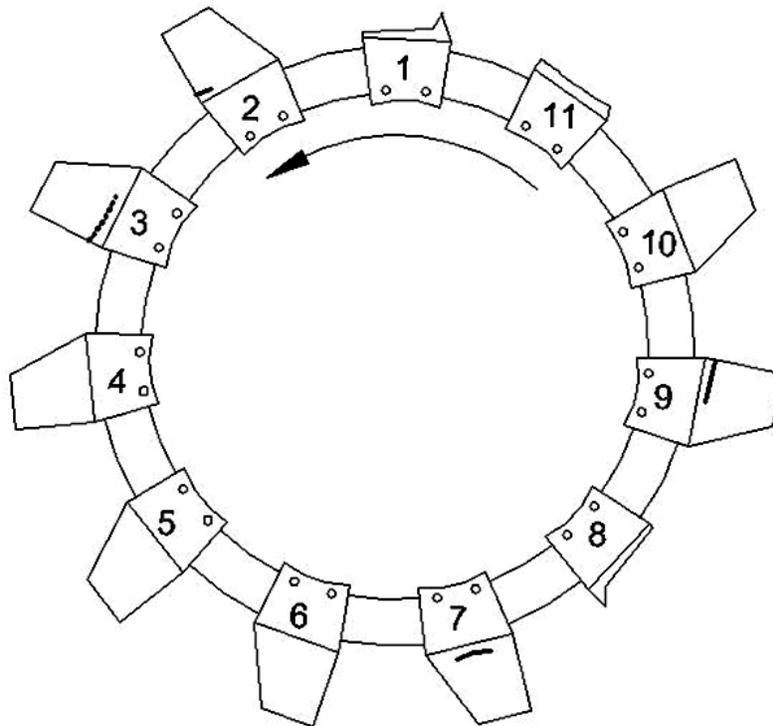
Figure 10. Schematic drawing of the fan with location of damaged blades

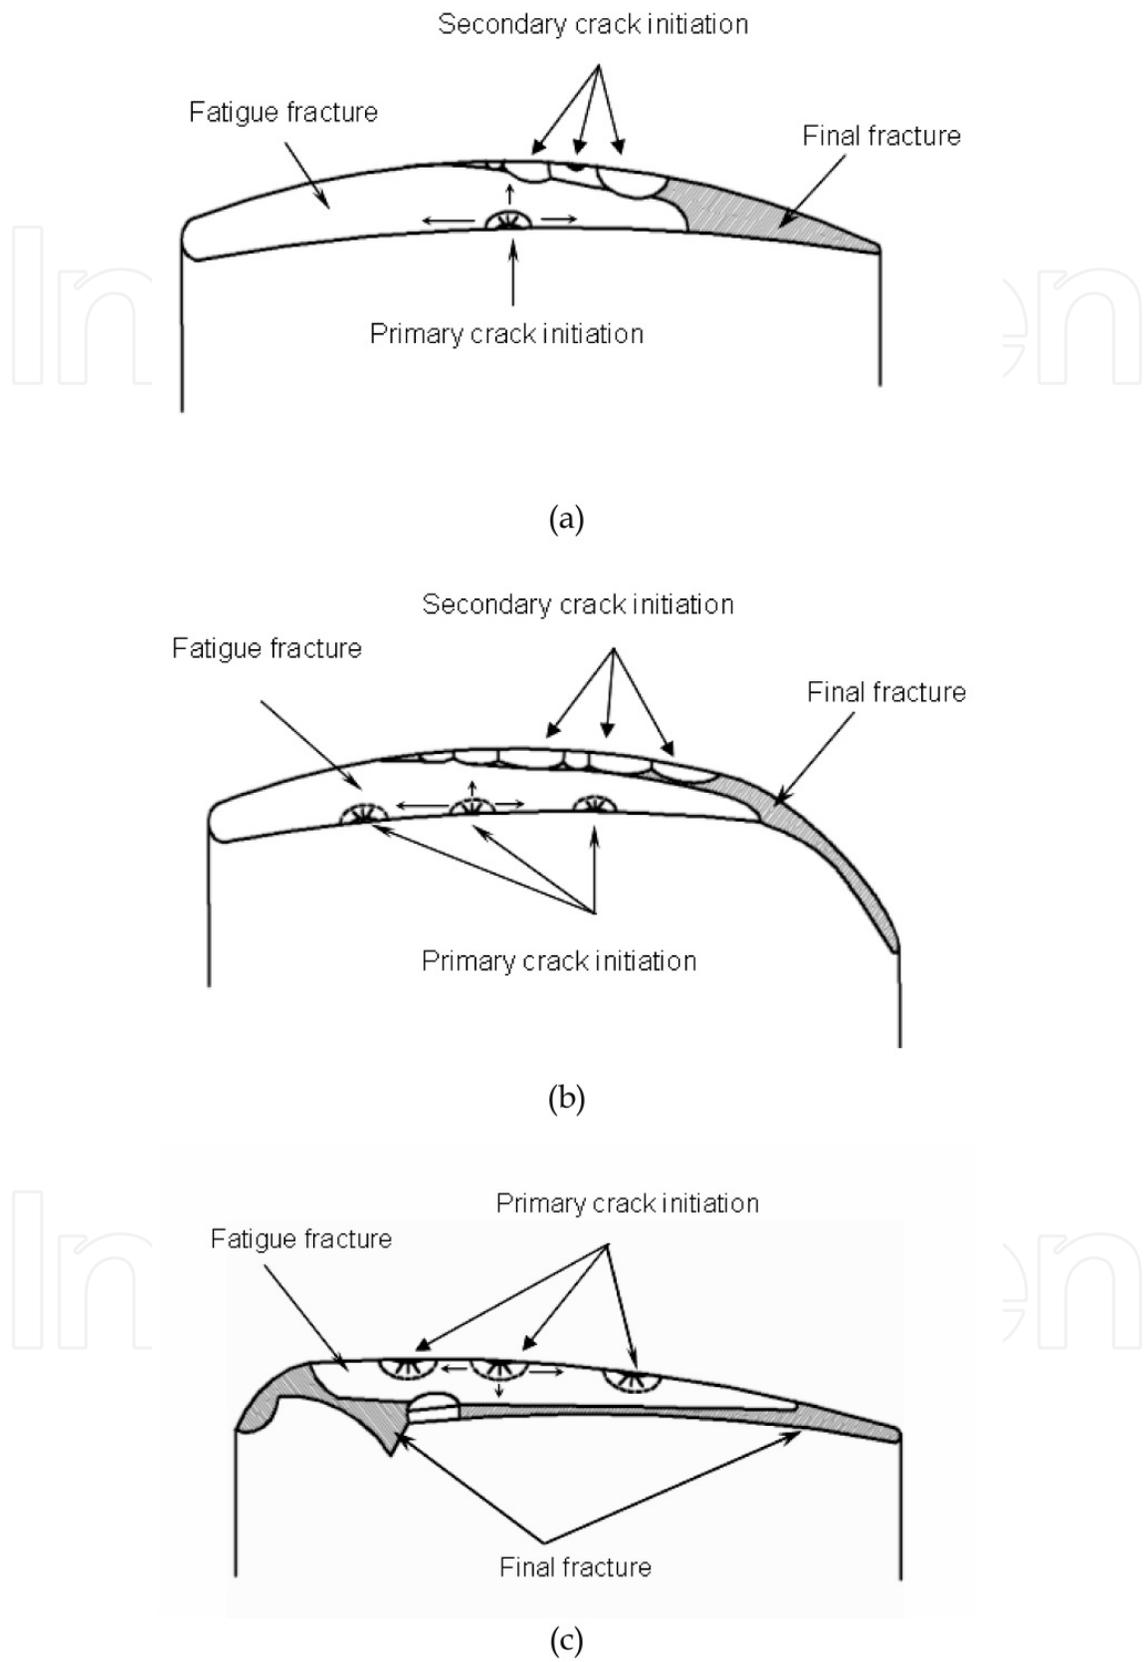
Table 3 shows the crack lengths which are measured on the surface of cracked blades. Schematic drawings of the fracture surfaces of three broken fan blades which show multiple crack initiation sites as well as the macroscopic crack growth paths are presented in Fig. 11. Also, For the first and the second fractured blades (blades No. 1 & No. 8), primary crack initiation sites are located on the concave side of the airfoils near the centre where the cross-sectional area is high. Primary cracks have coalesced during fatigue crack growth to form shallow semi-elliptical crack geometry and have propagated to reach the final cracks. In

According to Fig. 11 the presence of shallow semi-elliptical cracks on both concave and convex sides of the airfoils is indicative of the influences of considerable bending stresses during crack propagation.

Figure 11. Schematic drawings of the fracture surfaces: (a) blade No. 1, (b) blade No. 8 and (c) blade No. 11

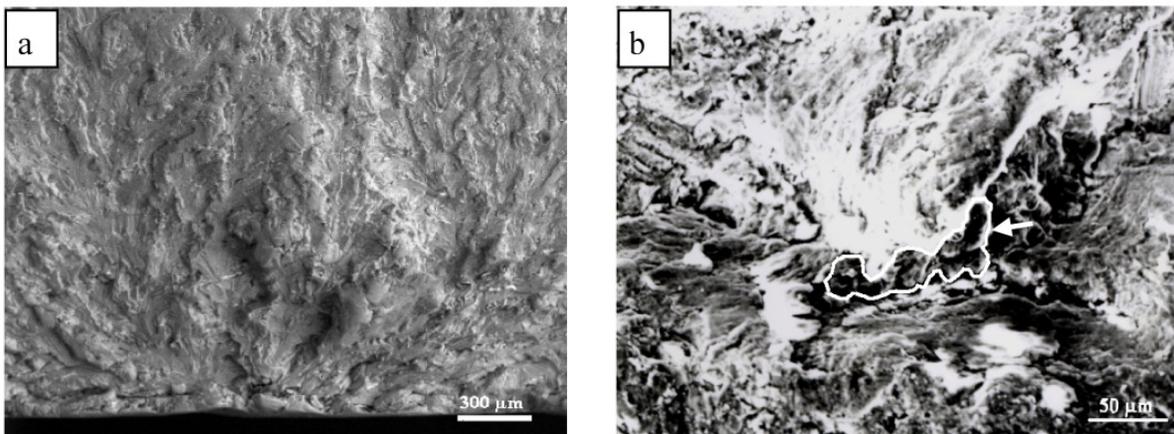
An SEM micrograph showing one of the typical primary crack initiation sites is presented in Fig. 12a. A secondary electron mode micrograph of this region revealed a large second phase particle with a length of about 100 μm at the crack origin as shown in Fig. 12b. The EDS spectrum of this particle identified that its composition is very similar to the intermetallic particle. Presence of the large particles at the origin of the crack have been shown to act as preferred fatigue crack nucleation sites in such alloys, despite the fact that they represent a small fraction of the particle population (Kung, 1979; Merati, 2005).

Figure 12. (a) Typical micrograph showing a primary crack initiation site and (b) a crack nucleating particle at the origin of the crack

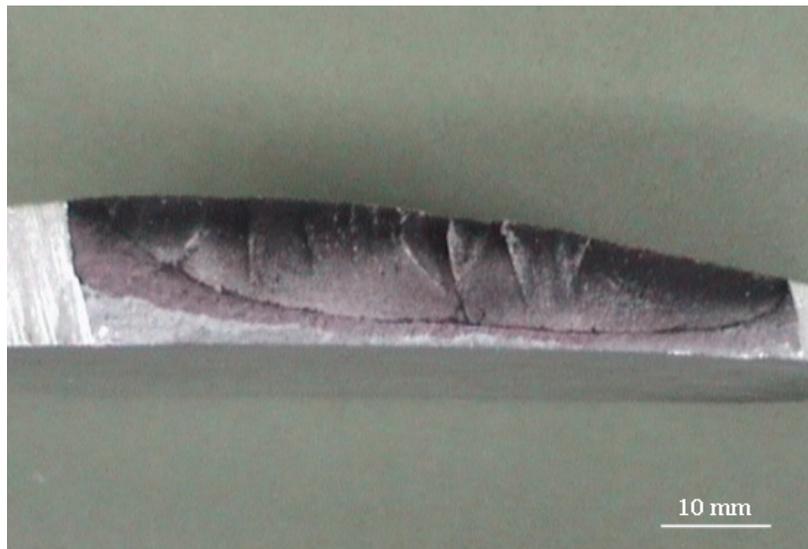
Figure 13. Opened crack surface of blade No. 7

Crack initiation and growth from the convex side and also decrease in the fatigue region in comparison with the fractured blades, prove that the fluctuation of the stresses and the maximum stress had been highly increased during the accident probably due to excessive vibrations.

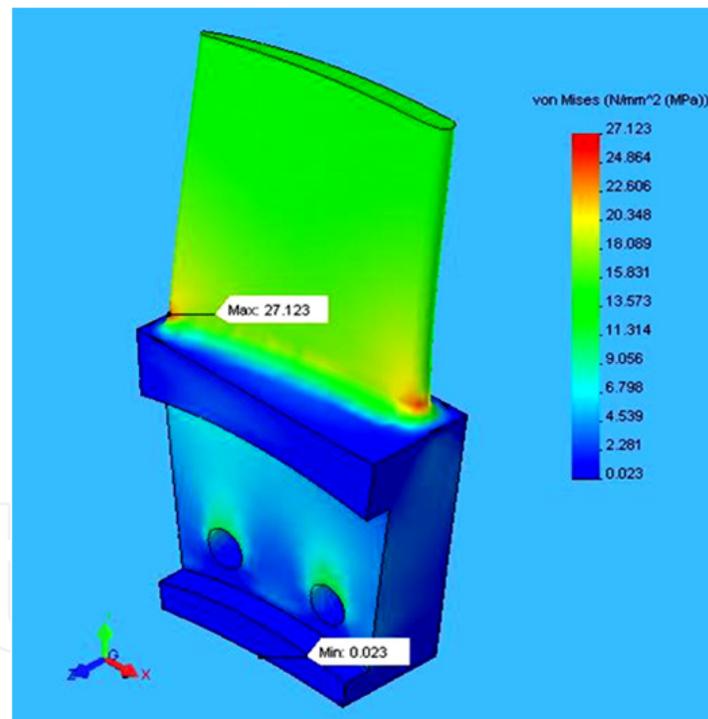
A 3D finite element model was used to simulate the normal operation of the fan blades. The results revealed that the maximum total stress acting on the blade under normal condition was about 27 MPa which occurred close to the transition radius between the airfoil and the root where the cracks initiated in fractured blades (Fig. 14) (Ataei, 2006). The bending stress introduced by the action of the air flow pressure are less important (Cohen, 1987) and was estimated as about 7 MPa. According to the results, the steady state stresses are very low in comparison with the strength of the blade material therefore, it can be concluded that the fracture accident was happened during an abnormal condition.

Figure 14. Finite element simulation of the fan blade, which shows the stress distribution under normal operating condition (Ataei, 2006)

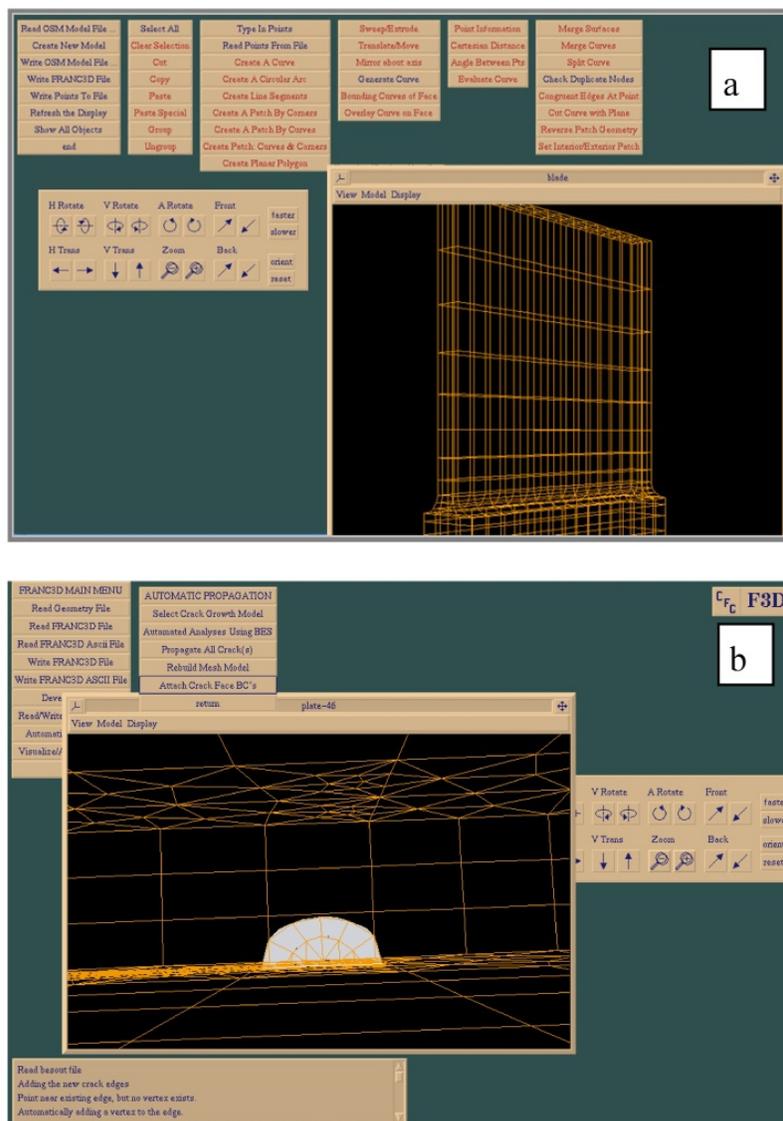
Based on the stresses applied by the model boundary conditions, the initial crack was grown in a series of crack propagation steps. Fig. 15a is a simplified 3D model of the airfoil that was meshed 2D (Boundary elements) in FRANC3D for simulating fatigue crack growth in fractured blades. Fig. 15b shows simulated fatigue crack in blade No. 8 after three steps of propagation.

Figure 15. (a) A 3D model of the airfoil with 2D mesh for simulating fatigue crack growth in FRANC3D software and (b) simulated fatigue crack in blade No. 8 after three steps of propagation

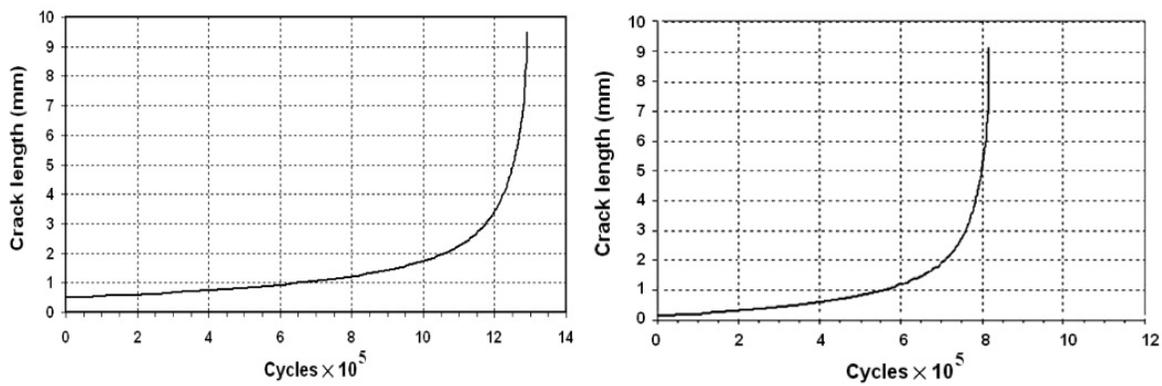
The empirical constants C and n were computed by fitting the near threshold crack growth data for AA 2124 aluminum alloy (Department of Defense, 1998) as $C = 9.5 \times 10^{-13} \text{ m} \cdot (\text{MPa}\sqrt{\text{m}})^{-n}$ and $n = 4.9$ for da/dN expressed in $\text{m}\cdot\text{cycle}^{-1}$ at a load ratio of $R = -0.1$ assumed in this case. The results of crack growth simulations in the first and the second fractured blades, where initial cracks are grown in small steps to their final dimensions are plotted in Fig. 16. These curves show the crack size as a function of the number of applied stress cycles. It can be seen that the number of cycles required to propagate initial cracks to their final dimensions for the first and the second fractured blades are just about 1.3×10^6 and 8×10^5 cycles respectively.

Figure 16. Crack length as a function of number of cycles in: (a) the first fractured blade (blade No. 1) and (b) the second fractured blade (blade No. 8)
