Assessment of Safety Standards of Magnetic Resonance Imaging at the Korle Bu Teaching Hospital (KBTH) in Accra, Ghana

Samuel Opoku, William Antwi and
Stephanie Ruby Sarblah

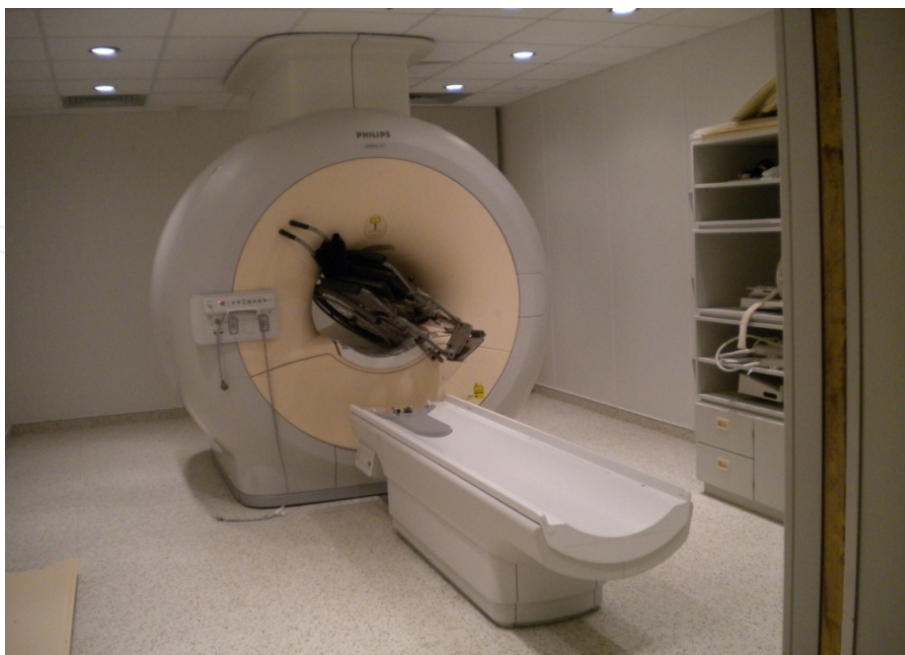
Figure 2.

In recent times, Magnetic Resonance Imaging (MRI) unit of the Korle - Bu Teaching Hospital (KBTH) in Accra, Ghana has witnessed various degrees of accidents. In particular, there was a fire outbreak in 2007 which brought the operation of the MRI facility down for a whole year. Again in 2010, a wheelchair was pulled into the gantry of the MRI scanner by the missile effect when a patient was lifted off the wheelchair onto the MRI table as shown in appendix I on page 28. This incident resulted in three weeks down time of the facility. A second incident in the same year occurred where a Radiographer Intern at the MRI unit wrongly switched off the safety button, resulting in three weeks shut-down of the entire unit. These incidences have been documented in the Incidence Reporting Book at the MRI Unit and are reproduced here with the permission from the Radiology Department of the hospital. These incidences at MRI Unit at the Korle Bu Teaching Hospital are very worrying, suggesting that the safety aspects might have been compromised. Thus it is imperative that the existence of policy guidelines and manuals regarding the operational safety of the MRI in the hospital and their compliance and adherence by staff needed to be evaluated. Similar incidences occurring in other hospitals around the world are documented in the literature and some of which are reproduced in Appendix II on page 29.

A photograph of the wheelchair that got trapped in the gantry of the MRI Scanner on the 12th of May, 2010 at the Korle Bu Teaching Hospital, Accra. Ghana
