## **Case-Based Reasoning of Man-Made Geohazards Induced by Rainfall on Transportation Systems**

Kuan-Tsung Chang, Edward Wang, Chih-Ping Kuo,  
Min-Cheng Teng and James Jin-King Liu

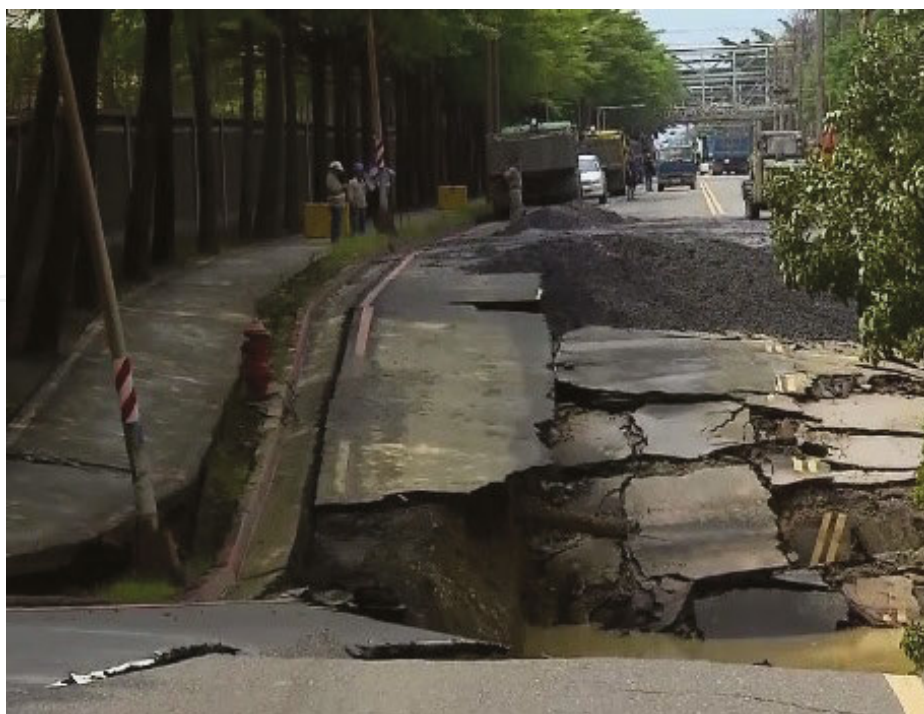
**Figure 2.** Destruction of roadway.

The accident occurred during the underground cable tunneling project of Taiwan Power Company. Due to the failure of the shield tunneling engineering machinery occurring 30 m underground, groundwater flooded into the excavation and caused the road pavement to collapse. In addition to the underground drinking water pipe failures, trees, and utility poles around the road tilted as well. Although the accident occurred at about 2 a.m. on the 18<sup>th</sup> of September, the construction personnel did not formally close the road and notify the impacted pipeline and business units until past 6 a.m. In addition, since the underground pipelines were already damaged, secondary damage occurred during the emergency repair, including oil and water leakage with the resulting environmental pollution. The collapse area continued to expand after the initial accident.

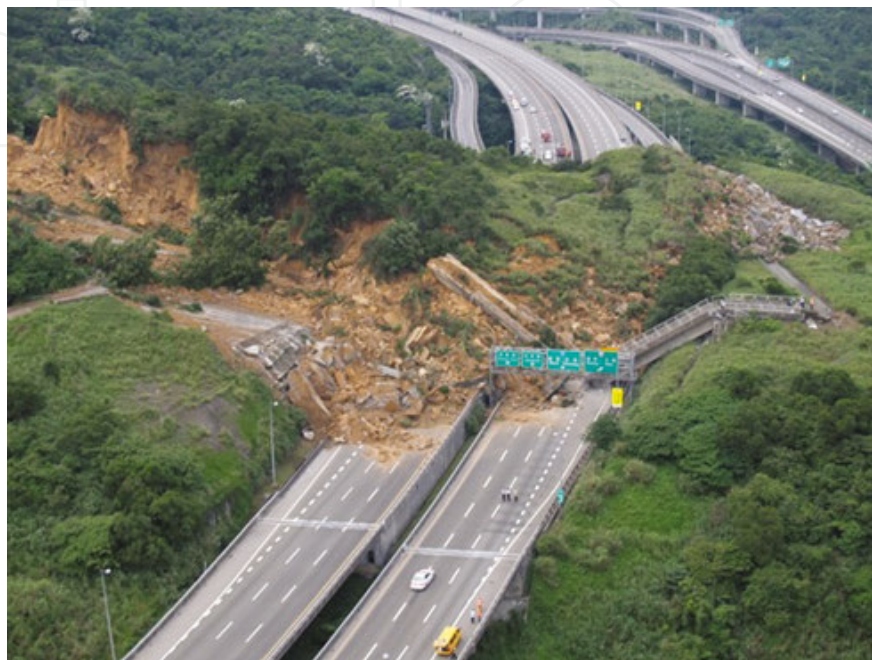
The landslide accident occurred in Madong Village, Qidu District, Keelung City. During the slide, the Dabu Bridge crossing Freeway No. 3 also collapsed onto the freeway mainline, thus blocking traffic (**Figure 3**).

**Figure 3.** Photograph of the landslide at Freeway No.3 (Source: [http://www.nasc.gov.tw/files/duty\\_news\\_files/\\_4251883.JPG](http://www.nasc.gov.tw/files/duty_news_files/_4251883.JPG)).

The site is a mostly oblique ridge with a steep slope in the northwest and gentle slope in the southeast in this region, and it is dip slope in terrain, that is, the stratum tendency and slope direction are close, and in the southeast direction. There are many similar dip slopes along the alignment of the freeway in northern Taiwan. According to the field investigation results, the landslide causes are preliminarily summarized as follows.

1. The disaster was caused by dip-slope sliding.
2. The dip slope at the location is formed through mutual stacking of sandstone and shale, and a slide is likely to occur at the interface of rock layers.
3. The sandstone in the upper layer is seriously weathered, rich in vertical joints, and permeable. The shale in the lower layer has poor water permeability; therefore, a higher water content and water pressure was caused in the interface between the two rock layers, reducing the friction between the rock layers and resulting in a slide.
4. The sliding rock is huge, and it is likely to exceed the original rock anchor capacity, causing the breakage of the sliding rock's connection to the base material.

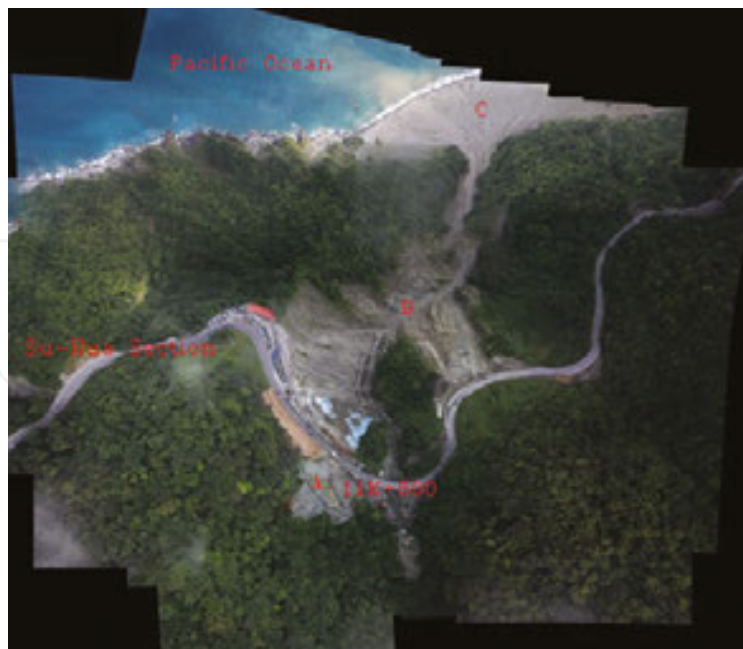
Due to the combined effects of Northeast seasonal winds and Typhoon Nalgae, heavy rainfall induced in the I-Lan area resulted in serious landslides. The Suao Landslide at the coastal Su-Hua Section of Highway Route 9 was located at the 11.8K-km mark. At this site, the entrainment effect of debris flow and toe erosion on the downslope induced a regressive sliding failure at the adjacent road causing the downslope collapse and roadside barrier failure. The rockfall barriers at the upper stream of the nearby Daken bridge were destroyed as well. The incident took place at 05:00 on 9th October 2011. The heavy rainfall lasted 12 h, with an average rainfall at the nearby rain station of 30.5 mm/h with a total rainfall of 418.9 mm. The affected landslide area along the road was 150 m<sup>2</sup>. **Figures 4** and **5** show the photographs captured by the UAV camera. **Figure 4** shows the orthorectified image of the landslide. **Figure 5** shows some selected views of the landslide.

**Figure 4.** The ortho-rectified UAV image of the Suao Landslides (Source: GangYu Corporation).

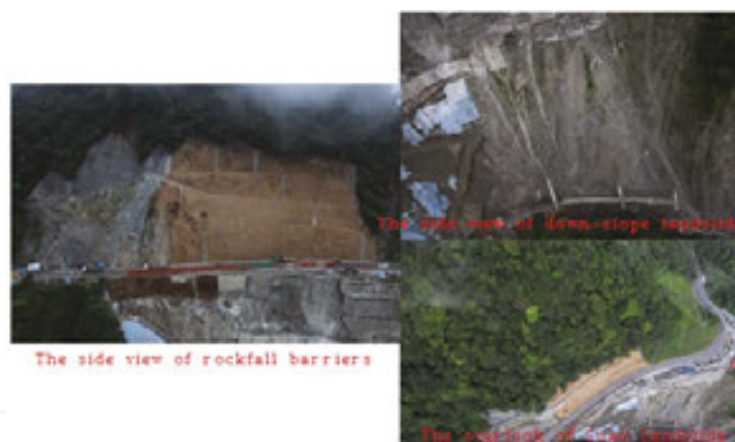
**Figure 5.** Some selected views of UAV images of the Suao Landslides (Source: GangYu Corporation).

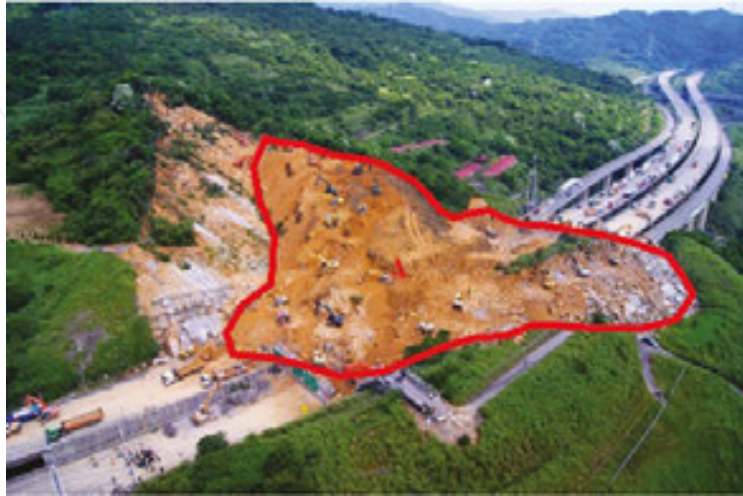
**Figure 6.** UAV side-view of the landslide taken by a rotary wing UAV owned by Flying Tiger Helicopter and Skyline Dynamics Co., Ltd.

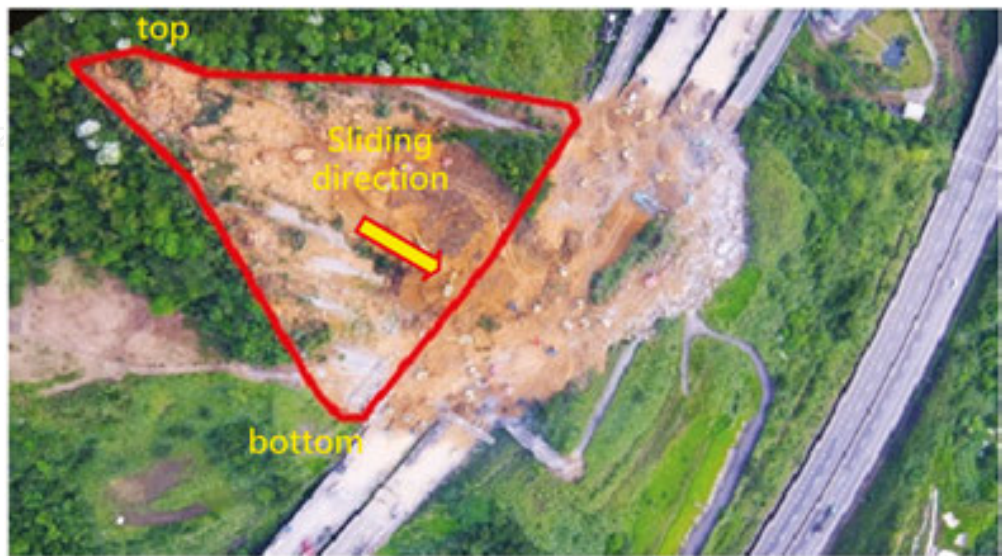
After the establishment of stereo-pairs, digital elevation models and orthophotomosaics were created. **Figure 9** shows the side boundary of the landslide and the limit of the freeway where the landslide overtopped it. The landslide area is estimated as 11,475 m<sup>2</sup> and the volume 137,571 m<sup>3</sup>, with an estimated material weight of 300,000 tons. These estimates were useful for managing the trucks used for debris disposal.

**Figure 9.** Side boundaries of the landslide and the freeway limits [23].

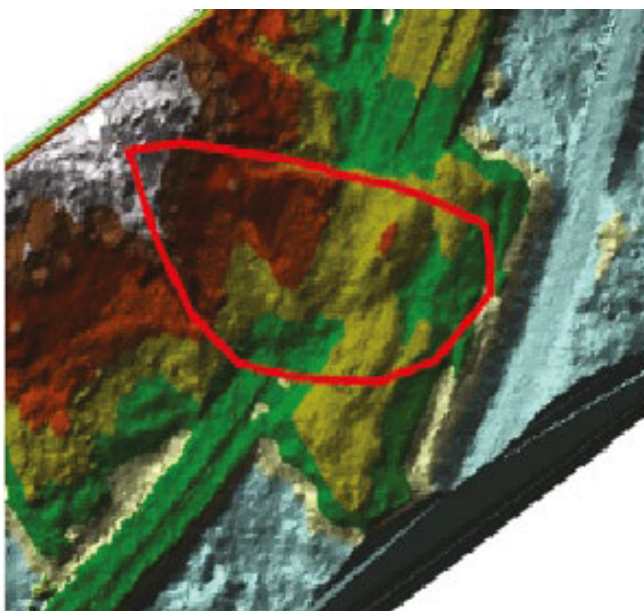
**Figure 11.** 3-D models following the event [23].

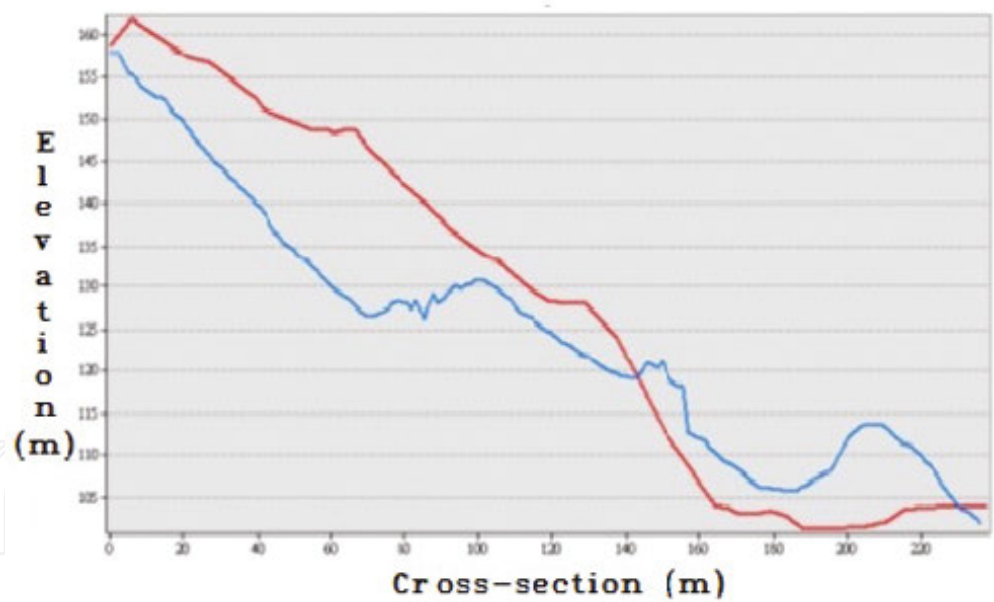
Figure 13. Cross sections for both prior to and following the event.
