Earthquakes and Structural Damages

Burak Yön, Erkut Sayın and Onur Onat

Abstract

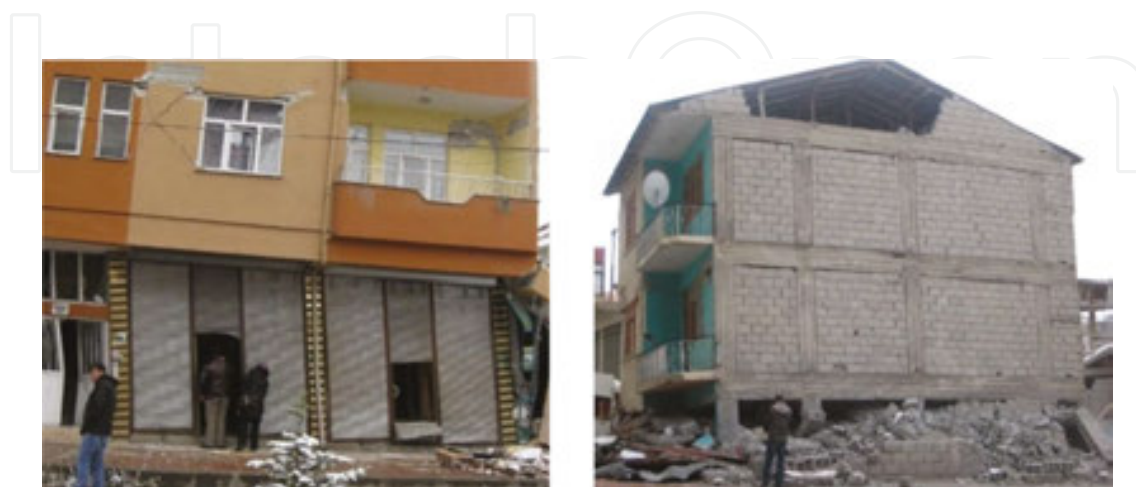
In some R/C buildings, especially at the ground floor, walls may not be continuous along to height of building for architectural, functional, and commercial reasons. While ground floor generally encloses with glass window instead of brick infill walls, partition walls are constructed above from this storey for separating rooms for the residential usage. This situation causes brittle failures at the end of the columns. In mid-rise reinforced concrete buildings, the most common failure mode is soft-storey mechanism, particularly at the first storey. Failures can be concentrated at any story called as weak storey in which the lateral strength changes suddenly between adjacent stories due to lack of or removing of partition walls or decreasing of cross section of columns. Thus, during an earthquake, partial and total collapses occur in these storeys. These types of damages can be seen in **Figures 10 and 11**.

Figure 10. Unexpected inter-storey drift due to soft storey during the Van earthquake.

- The reason of soft storey collapse is occurred due to low rigidity of reinforced concrete structural members at ground floor. In case of the absence of the infill wall, the rigidity of

the ground floor is lower than the upper storeys. Thus, this failure mechanism is triggered by earthquake. This type of failure is prevented during design phase by designing with more detail.

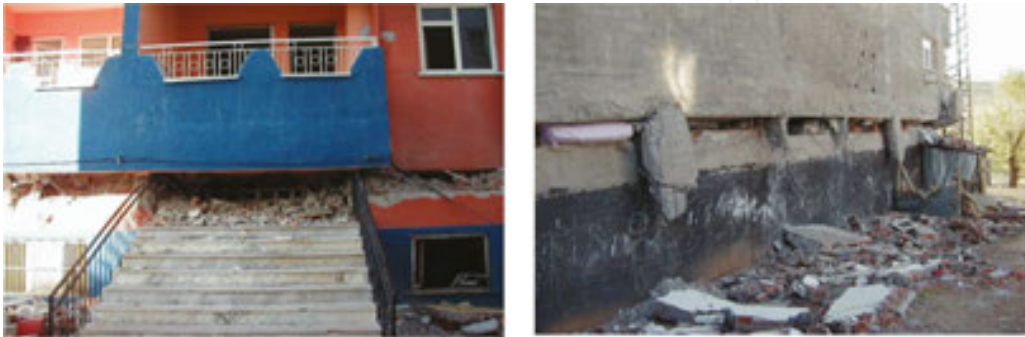
Figure 11. Weak storey mechanism during the Bingöl earthquake.

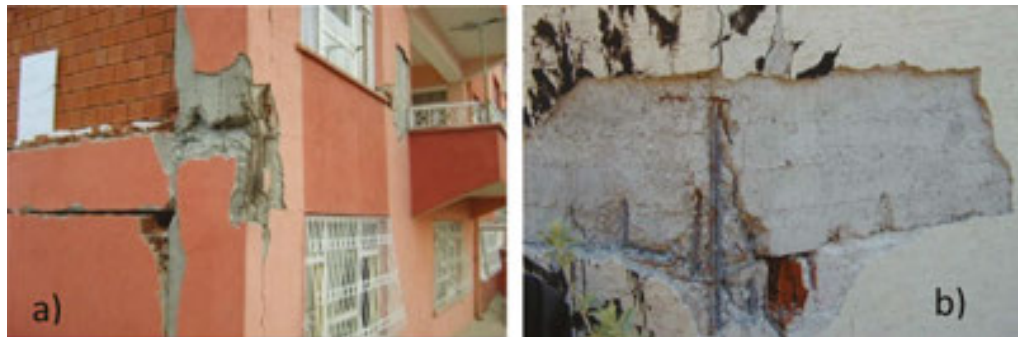
Shear forces increase during an earthquake especially at columns and beam–column joints. Consequently, special attention should be paid to construction and design of beam–column joints and columns. Seismic design requires increasing of ductility of structures for performance-based design approach. In particular, columns of buildings can be having insufficient transverse reinforcement in the plastic hinge region. Therefore, structural elements which have such details show low performance against to dynamic loads and lost their shear and axial load carrying capacity. **Figure 12** shows this failure below.

Figure 12. Damaged structure due to inadequate spacing between shear reinforcements during (a) Van earthquake and (b) Bingöl earthquake.

- Inadequate transverse reinforcement and no bending of hooks of ties in structural elements cause damages. This problem can be solved by using close-spaced stirrups and 135° bent hooks to increase shear resistance of structural elements.

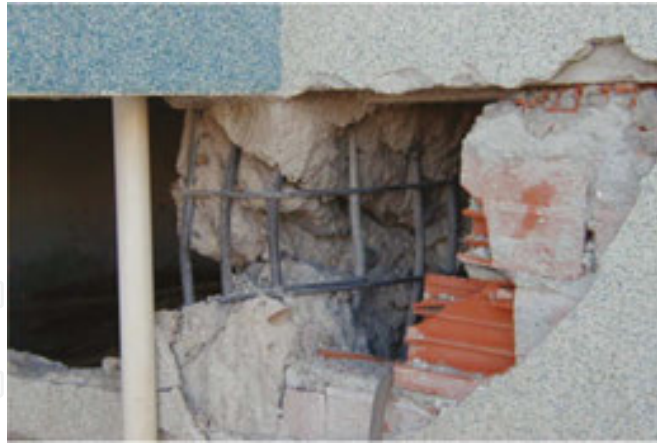
This type of mechanism can be developed due to structural adjustments and/or to continuous openings at the top of infill walls between columns. Lateral forces that occurred by an earthquake are carried by columns and shear walls. Length of column is an important factor for dissipation of these loads. When the length of column decreases, the column becomes stiffer and brittle than the other columns and this column attracts more shear forces. Thus, shear failure which is a critical type of concrete column damage occurs at these columns. Short column failure is given in **Figure 13**.

Figure 13. Short column damages during the 2003 Bingöl earthquake.

- Failures reason of short column is especially occurred due to partially filled infill walls in R/C frame system. These failures can be prevented by increasing of shear strength of this part of the column.

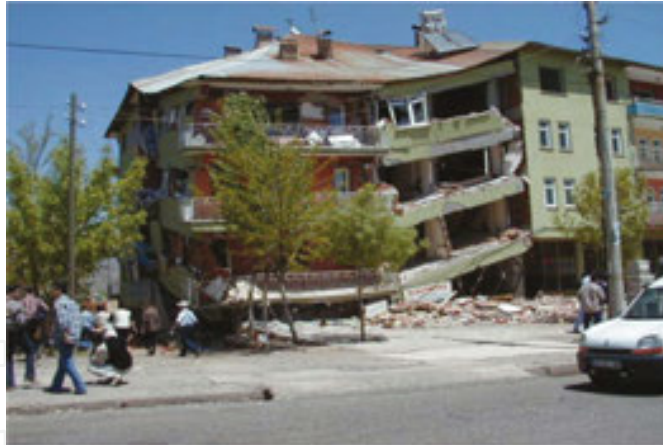
Buildings are sometimes constructed adjacent because of the lack of building lots. In this layout plan, one or two faces of two buildings are in contact to each other. Consequently, the buildings that have not adequate gaps pound to each other during the earthquake. If the floors of the buildings are not at the same level, pounding effect of the buildings becomes more dangerous. **Figure 14** shows this type of damage during the 2003 Bingöl earthquakes.

Figure 14. Collapse of adjacent buildings during the Bingöl earthquake.

- During the earthquake, after first shake, different natural vibration periods cause hammer effect and then result in total collapse. To prevent this problem, adequate gaps according to current codes should be left between the adjacent buildings.

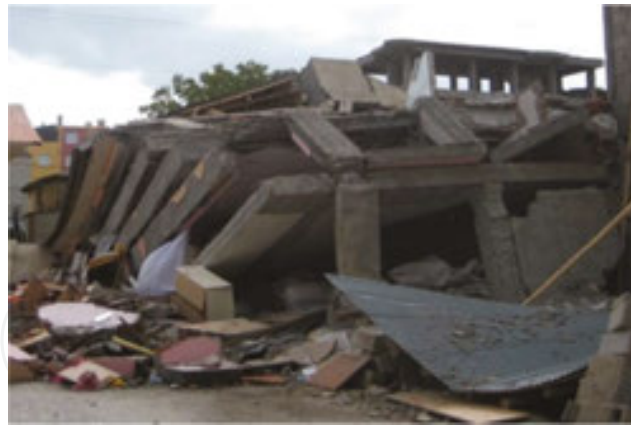
Deep and rigid beams are used with flexible columns in type of buildings. Therefore, these beams resist more moments, occurred by dynamic loads, than weak columns. In such a design during an earthquake while deep and rigid beams show elastic behavior, shear failure or compression crushing causes plastic hinges at flexible columns. Failure mechanism of strong beam–weak column can be seen in **Figure 15**.

Figure 15. Failure of a building due to strong beam–weak column effect during the Van earthquake.

- When deep and rigid beams are used with flexible columns, weak column–strong beam failure mechanism is developed. To refrain this type of problem, sum of moments at column connected to any of joint should be bigger than sum of moments at beam connected to the same joint.

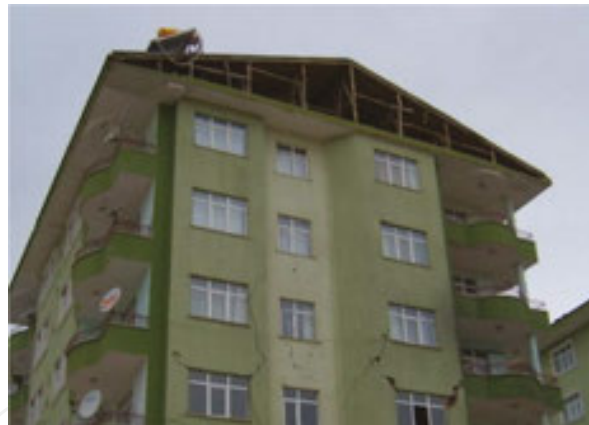
The most common failure mode at gable walls is out-of-plane collapse in the earthquakes. Although failures of gable walls are not structural damages, these damages may cause loss of lives and properties. Stability problems and large unsupported wall lengths cause damages at these walls. Failure of gable wall is presented in **Figure 16**.

Figure 16. Failure of gable walls on top of the building during the Van earthquake.

- The reason of in-plane, out-of-plane, and gable wall failures is lower strength of infill materials than reinforced concrete frame. To prevent this type of failure, adequate connection and high-strength mortar between wall and reinforced concrete frame should be used.

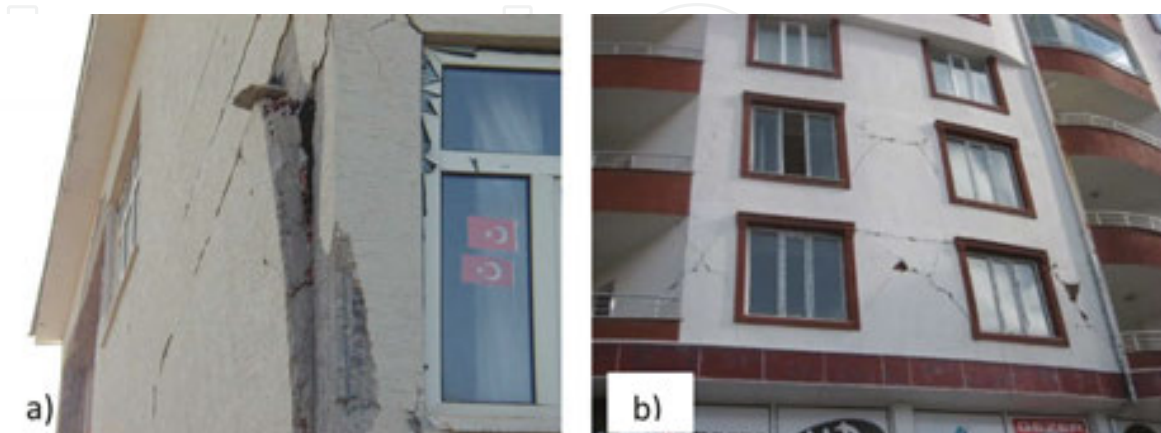
One of the most important reasons of life and economic loss during the earthquake is combined effect of in-plane and out-of-plane movement of the wall. In-plane and out-of-plane interaction is very complicated and should be analyzed well for this phenomena. For low-rise and mid-rise unreinforced masonry (URM) infilled R/C frames, ground story infill walls are expected to be damaged firstly, because they are subjected to the highest in-plane demands. However, under the effect of bidirectional loading, where the two components of a ground motion are equally significant, infill walls of the upper stories may fail under the combination of in-plane and out-of-plane effects. The in-plane demand reduces at the upper stories, while that of out-of-plane forces increases due to the increase of accelerations [40]. To prevent this problem, in-plane carrying capacity of the wall should increase and out-of-plane ductility should increase with possible and applicable developments like bed-joint reinforcements and wire mesh. These listed applications will prevent detachment of infill wall from reinforced concrete elements and will increase the stiffness of the total structural system. **Figure 18** shows out-of-plane and in-plane damages.

Figure 18. (a) Detachment of infill wall during the Bingöl earthquake and (b) In-plane damage of during the Van earthquake.

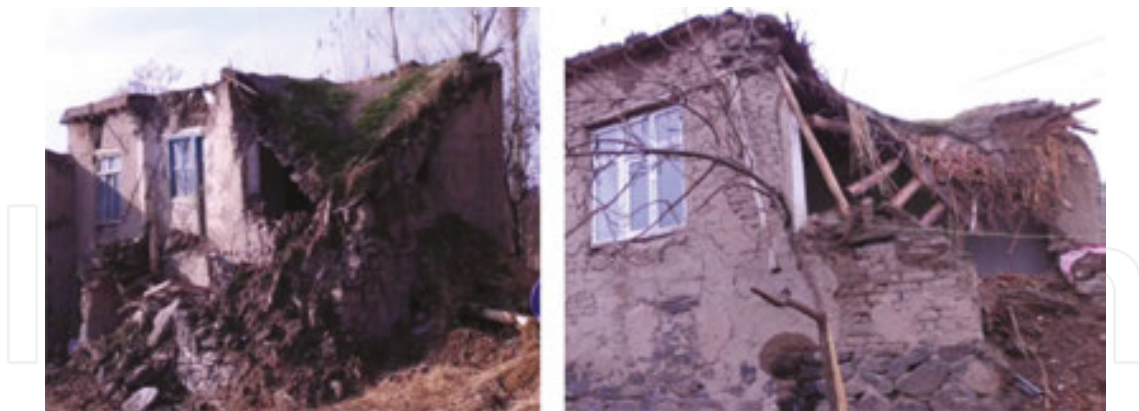
Generally, earthen roofs are constructed over wooden logs supported by two main walls of the buildings to provide thermal and water insulation. Also, heavy earthen roofs are constructed by the residents because a thick roof keeps the house cool or warm according to the seasons. However, these roofs lose their effectiveness because of weather conditions, such as rain and snow. Therefore, the residents place a new earthen cover on top of the existing roof to repair these roofs [16]. Thus, the weight and thickness of the roof increase over time. As a result of these heavy roofs, the structures are subjected to larger inertia forces during the earthquakes [41]. During the horizontal displacements, these heavy roofs are very vulnerable since they can easily slide over the walls [30]. **Figure 19** shows the damaged masonry buildings arising from heavy earthen roof at various earthquakes.

Figure 19. Damage to adobe structures due to heavy earthen roof during the Van earthquake [42].

- Thick and heavy earthen roofs are one of the reasons for the damages. The walls of the buildings could not support heavy mass during an earthquake, and the heavy roof partially or completely collapsed. This type of application should be refrained.

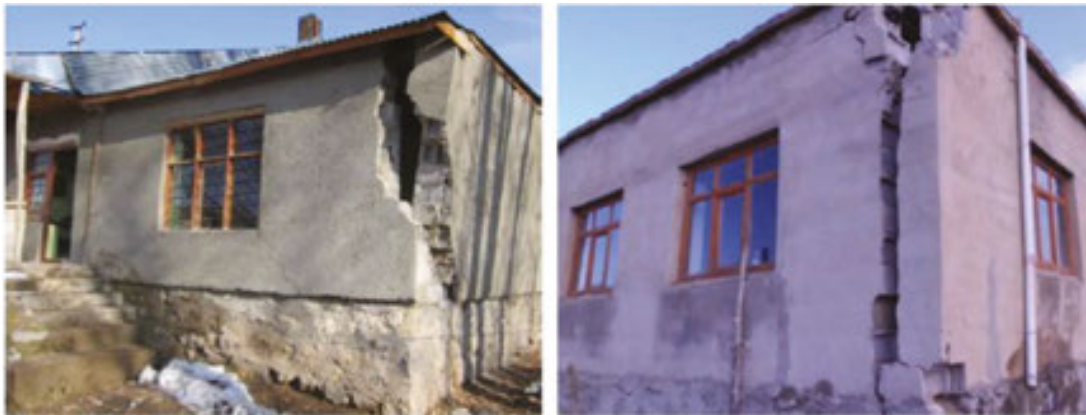
Corner damages are common in the adobe and masonry buildings. This type of mechanism generally occurs at wall-to-wall and wall-to-roof connections when subjected to out-of-plane displacements. During an earthquake, the stress concentrations increase at intersection of the walls. In this way, vertical or inclined cracks appear in the corners of masonry

buildings. If bond beams are not used in the corners or connection, two walls are not properly anchored each other, intensity of the cracks increases and these cracks spread along the height of the wall. Similar cracking may have been observed at adobe buildings [41]. Poor connections between adjacent walls and the absence of bond beams cause serious damages. In addition, there are no appropriate connections at the corner of the walls in damaged buildings. This type of damage for adobe and masonry buildings is shown in **Figure 20** [42]. Due to reduced compression stress and increase seismic acceleration at upper stories, the common failures are seen at the corners of the roof level. When there is no slab with some in-plane rigidity at roof level, top corners are more sensitive to fail because of cantilever-like behavior [43].

Figure 20. Corner damage of briquette masonry buildings [42].

- Corner damages are developed due to insufficient wall-to-wall connections and lack of horizontal and vertical bond beams. This problem can be eliminated by using proper connection defined in current codes. Moreover, bond beams should be used.

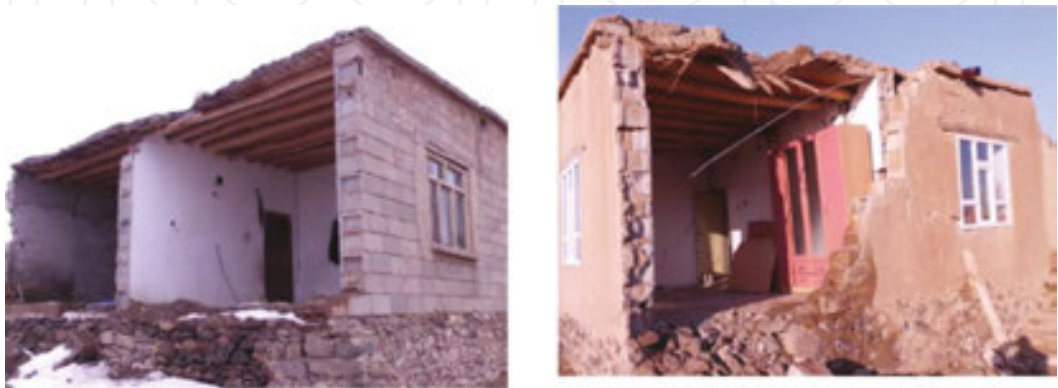
Out-of-plane mechanism may appear from the combination of several deficiencies. A lack of bond beams, poor connections among the walls and the roofs, and large unsupported wall lengths cause the separation of walls and cause damage to occur via the of out-of-plane mechanism. Thus, the whole or the significant parts of the wall fall down during the earthquake. Wooden logs that bear the weight of the floor of the building are generally placed on load-bearing walls in only one direction. Thus, earthquake loads are transferred to perpendicular walls by wooden logs. Therefore, the walls that are not supported by the wooden logs may easily overturn to out-of-plane direction during the earthquake. This failure mechanism can be commonly observed in the earthquake region. **Figure 21** shows the out-of-plane mechanism of the adobe and briquette masonry buildings, respectively.

Figure 21. Out-of-plane mechanism of the briquette buildings [42].

- Another reason for the damages is the out-of-plane mechanism. The main reasons for this mechanism are the lack of bond beams, poor connections among the walls and roofs, and large unsupported wall lengths. Also, the gable walls of some masonry buildings are affected negatively by the out-of-plane mechanism. This problem can be eliminated by using proper connection defined in current codes. Constructing long and unsupported walls should be refrained. In addition to this, vertical and horizontal bond beams should be used.

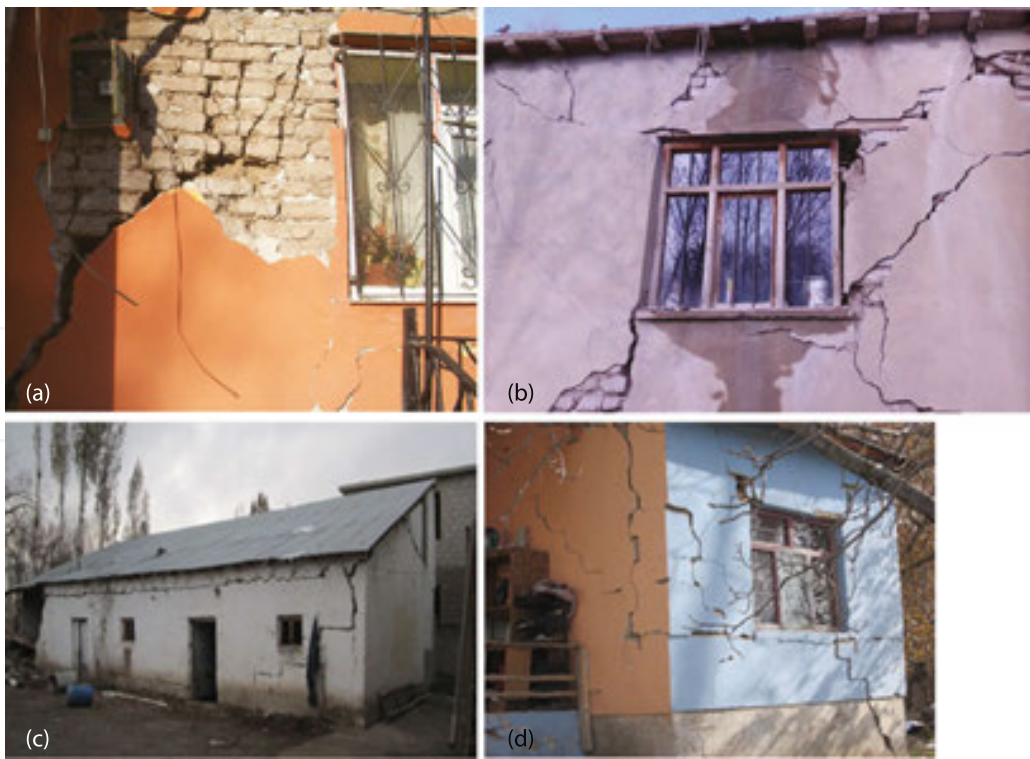
The seismic performance of the masonry buildings relates to the in-plane stiffness of the walls. In-plane mechanism is generally observed in most of the masonry buildings that are affected by shear cracking. Earthquake loads increase the shear force. It can damage walls and their connections. These damages generally occur near openings, because most of the masonry

buildings don't have sufficient and proper bond beams that distribute the lateral forces uniformly and enhance the lateral strength of the walls. During the earthquakes, excessive bending and shear can produce in-plane failures depending on the aspect ratio of the unreinforced masonry elements [41]. In the areas struck by earthquake, three failure modes of the shear damages in masonry buildings are generally observed, namely diagonal shear failures that proceed through masonry units and mortar (**Figure 22a–b**), sliding consisting of straight failure at the horizontal bed joints (**Figure 22c**), and stepped failures from the head to bed or bed to head joints (**Figure 22d**).

Figure 22. Diagonal shear (a-b), horizontal (c) and stepped (d) failures wall [42].

- However, a lack of bond beams and large openings that decrease the stiffness of the walls increase the shear effects and cause in-plane failures, such as diagonal shear failures, sliding consisting of straight cracks, and stepped failures. It should be refrained to construct large

window and door openings. In addition to this measure, vertical bond beams should be constructed near the openings.

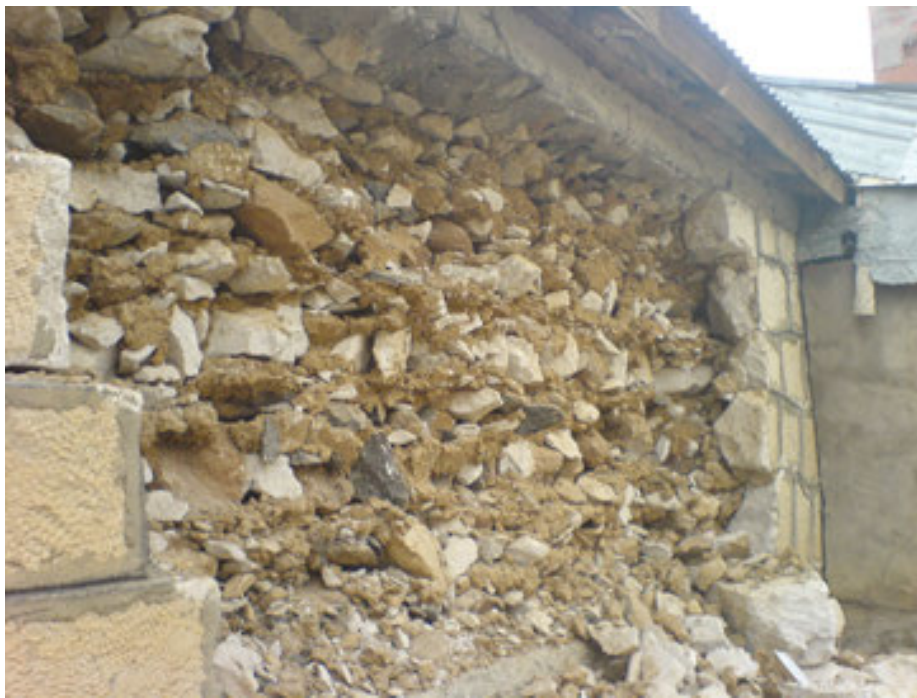
Most of the masonry buildings are constructed with thick stone walls. As the thickness of the walls is relatively large, these stone walls are constructed by using more than one stone along the thickness direction [28]. In these walls, stones are placed in a random order. These walls have two exterior vertical wythes of large coarse stones. However, smaller rubble stones with mud mortar are used between two exterior layers. Using mud mortar instead of cement mortar causes insufficient adherence between the layers. Thus, the interior and exterior layers of the wall behaved independently and separated each other during the earthquake. Some reasons such as the quality of construction, poor workmanship, and the use of improper materials increase the intensity of the disintegration. **Figure 23** presents this failure in stone masonry buildings.

Figure 23. Disintegration in stone masonry buildings [28].

- Construction of multilayer walls with inadequate connections causes the disintegration at stone masonry buildings along the wall thickness. This application should be prevented while constructing stone masonry wall.
