Failure Analysis of High Pressure High Temperature Super-Heater Outlet Header Tube in Heat Recovery Steam Generator

Ainul Akmar Mokhtar and
Muhammad Kamil Kamarul Bahrin

Abstract

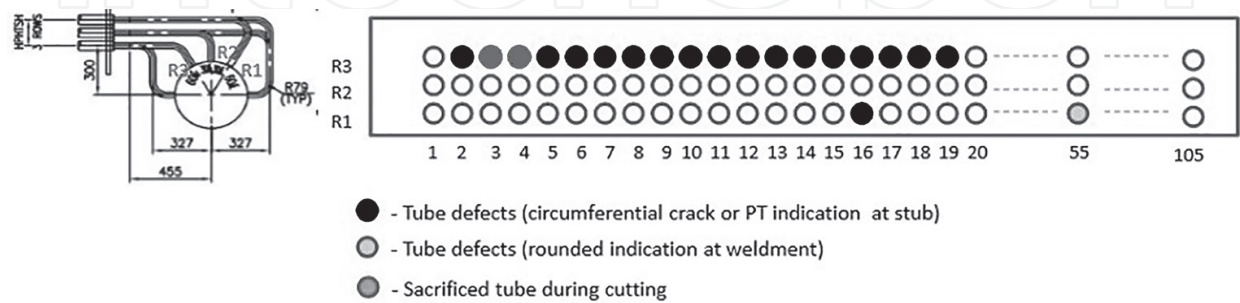
start-up/shutdown. The frequency of tube failures has increased when the plant was having more cyclic operation as compared to 5 years after commissioning. The connecting tubes of the outlet header of HRSG High Pressure High Temperature Superheater (HPHTSH) have suffered leakage, and all the failed tubes were located next to each other in a row (i.e. Row 3) as shown in **Figure 1**.

Figure 1. Tube mapping of recent failure of HPHTSH outlet header tubes.

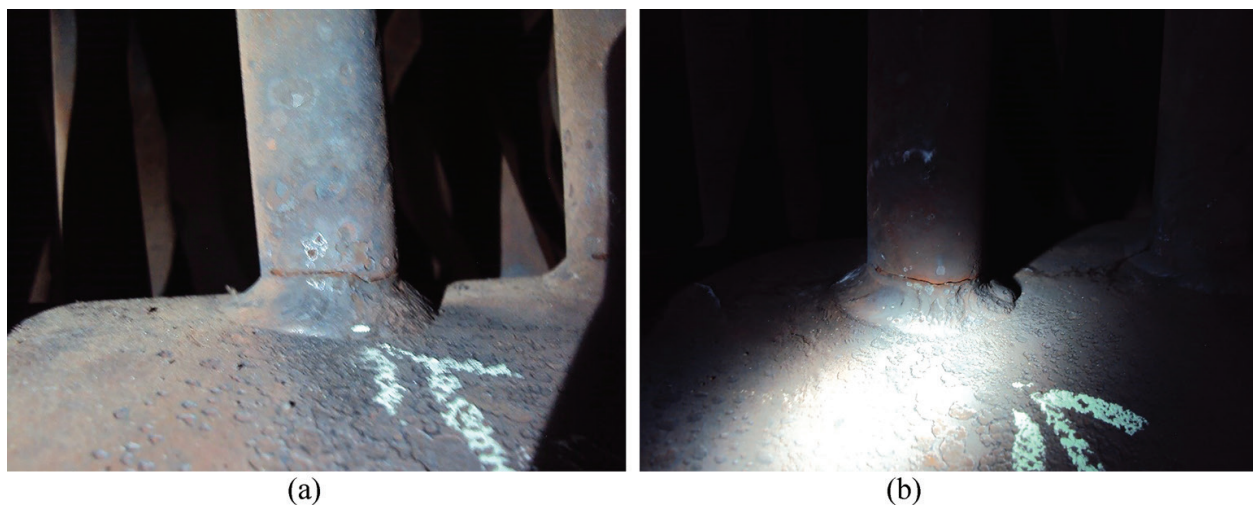
The investigation covered the failure of Tube 8, Tube 9, Tube 10 and Tube 18 of the HPHTSH section. **Figure 2** shows the samples of tube failures. Several analysis methods were carried out to ascertain the potential cause(s) of failure such as visual examination, dimensional

Figure 2. Appearance of Row 3 tube failures, (a) Tube 8 and (b) Tube 9.

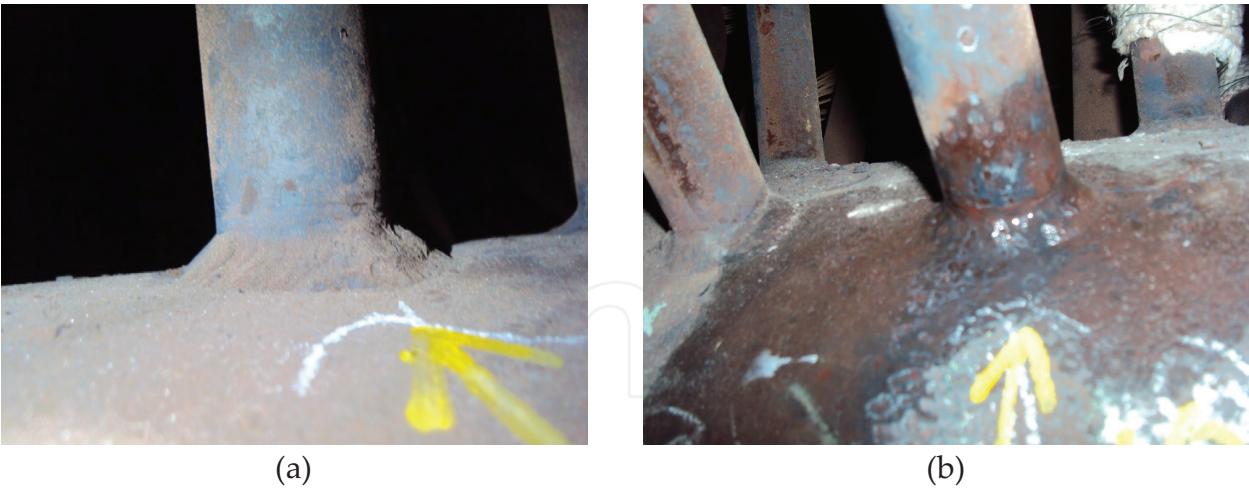
The connecting tubes are welded directly on the header without the presence of stubs. Cracks have developed at the heat-affected zone (HAZ) of the welds on the tube side. All cracks were circumferential in nature with no branching characteristics. The cracks propagated at the outer radius plane of the connecting tubes with an average length of approximately 25 mm as shown in **Figure 4**.

The tube sections have not undergone visible bulging and deformation over the entire length. The external surfaces of all sections appeared to be normal, with no signs of significant corrosion/erosion damage. The magnetite layer on the inner, steam-touched surfaces appeared thick, homogenous, adhesive and continuous, with no signs of serious/apparent exfoliation. The circumferential cracks have penetrated the tube wall.

Figure 4. Appearance of tube failure at Row 3: (a) Tube 8 and (b) Tube 18.

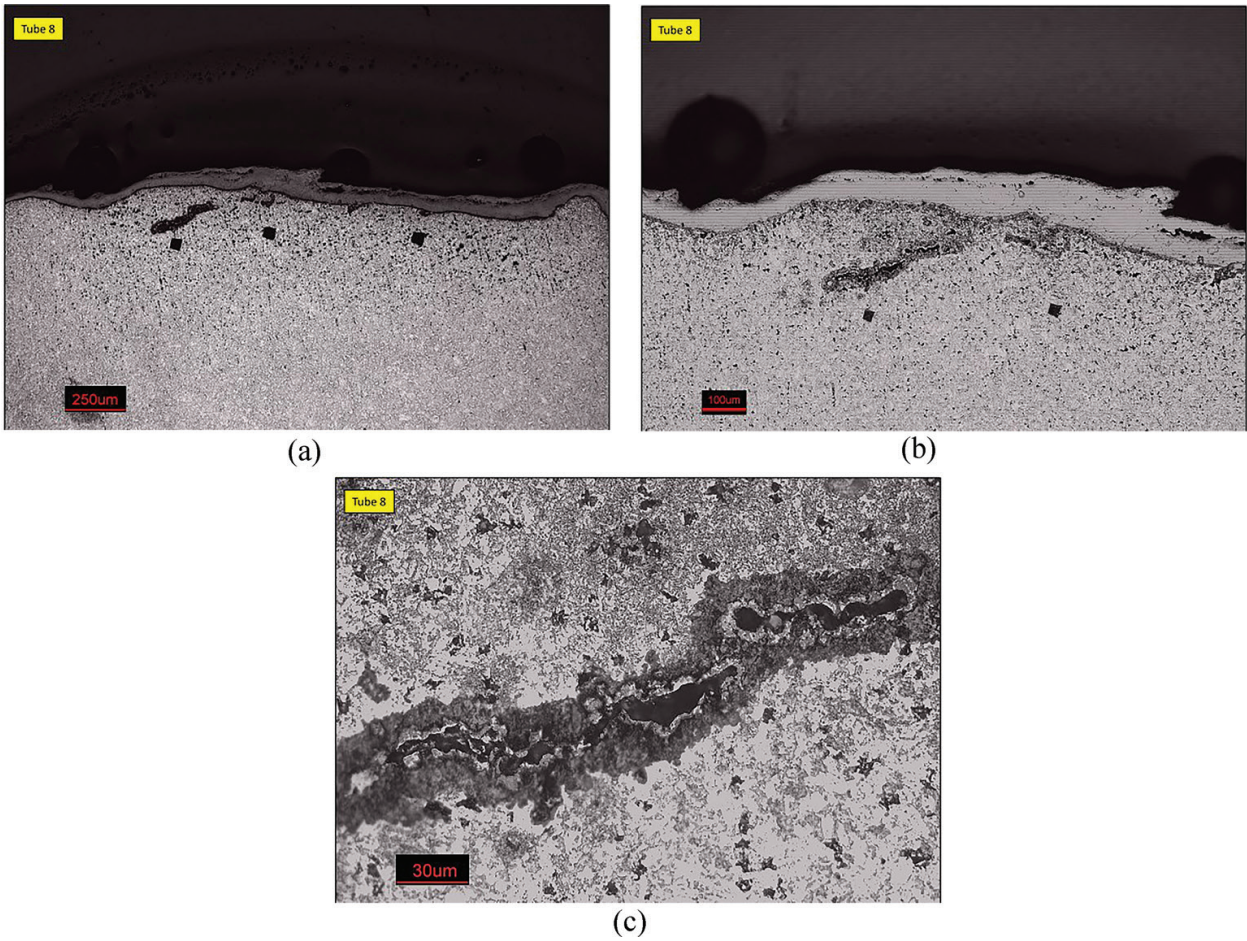
- a. The cracks were fairly straight and had a transgranular appearance, thick oxide filled, without branching characteristics. The cracks propagated in the HAZ.
- b. Isolated, aligned cavities and microcracks were presented in the vicinity of the cracks. The cavities were predominantly aligned in parallel to the cracks, and some were perpendicular to the cracks.

- c. Under high magnifications, the grade 91 microstructure of base metal still appeared normal (martensitic) with no signs of thermal degradation such as phase transformation, grain growth and precipitate coarsening. A small amount of isolated cavities were found in the remote base metal of Tube 8.
- d. The fracture surfaces had oxidized heavily. The oxide layers at the steam touch surfaces (inner surface) were considered thick, in excess of 300 μm .

Figure 8 shows the microstructure of Tube 8 at the fracture area at different magnification. Isolated cavities, aligned cavities, microcrack and thick oxidation layer were observed at that particular location.

Figure 8. The microstructure of Tube 8 shows a crack at different magnification: (a) 250 μm , (b) 100 μm and (c) 30 μm .

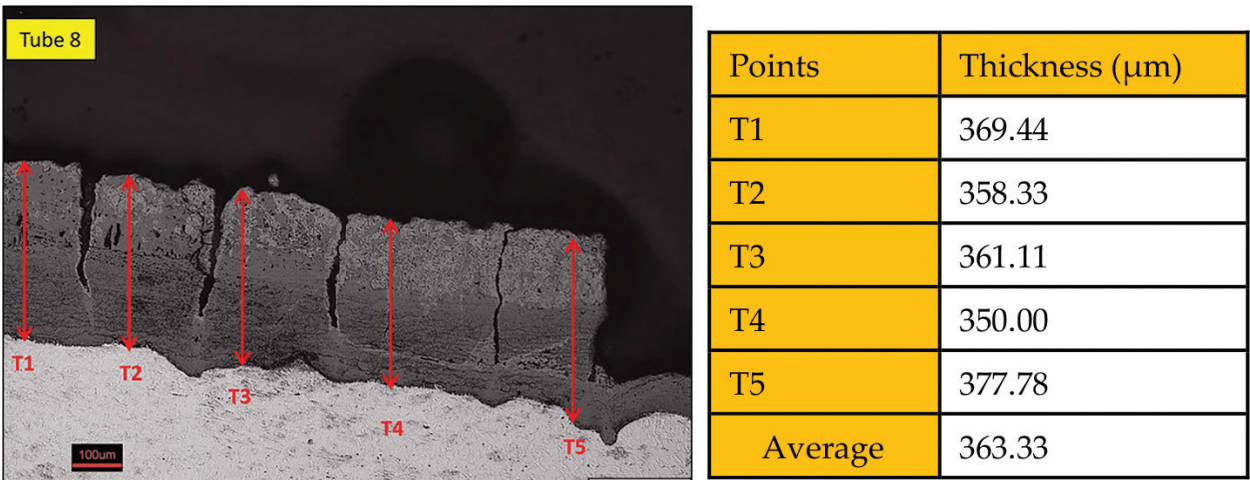
The steam-side oxide scale of micro specimens of Tube 8 and Tube 18 was measured under optical microscope. Both Tube 8 and Tube 18 were found to have undergone excessive steam oxidation. The oxide layer had cracked. The oxide thickness was measured and tabulated in Figures 10 and 11. The maximum thickness of the steam side oxide scale was 363 μm for Tube 8 and 390 μm for Tube 18.

Based from steam oxidation calculation [4], the thick oxide scale suggested that both Tube 8 and Tube 18 had been exposed to temperature in excess of 615°C as compared to material specification of SA 213T91 (design temperature, 602°C). The two tubes had experienced long-term overheating during operation.

Figure 10. Internal oxide thickness at Tube 8 (fracture area).

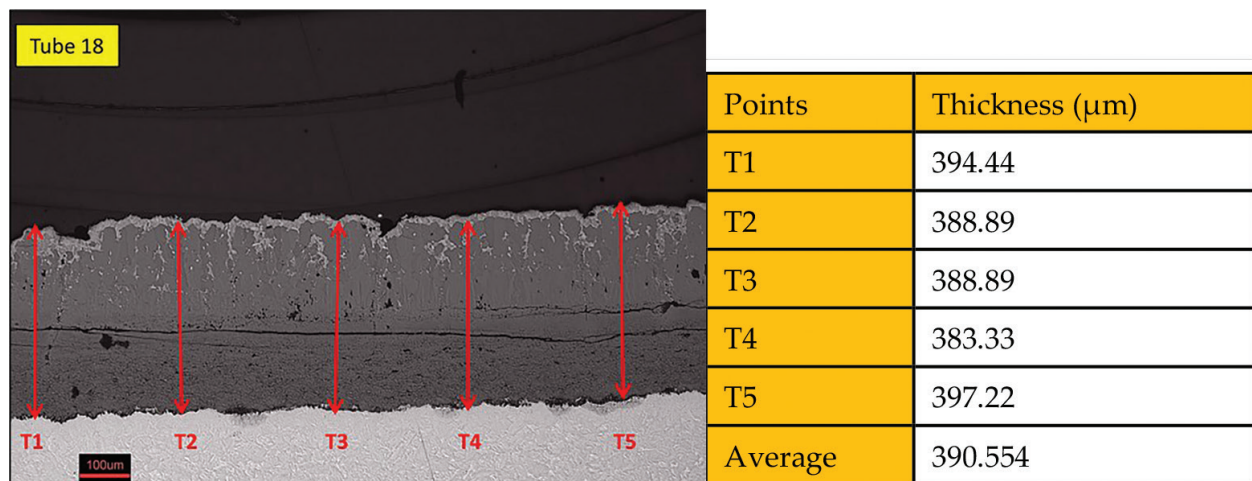
Figure 11. Internal oxide thickness at Tube 18 (remote area).
