# 3D Digital Simulation for Material Damage Mechanism Identification in a Railway Carriage Pressure Vessel

Alessandra Caggiano and Roberto Teti

<http://dx.doi.org/10.5772/intechopen.73233>

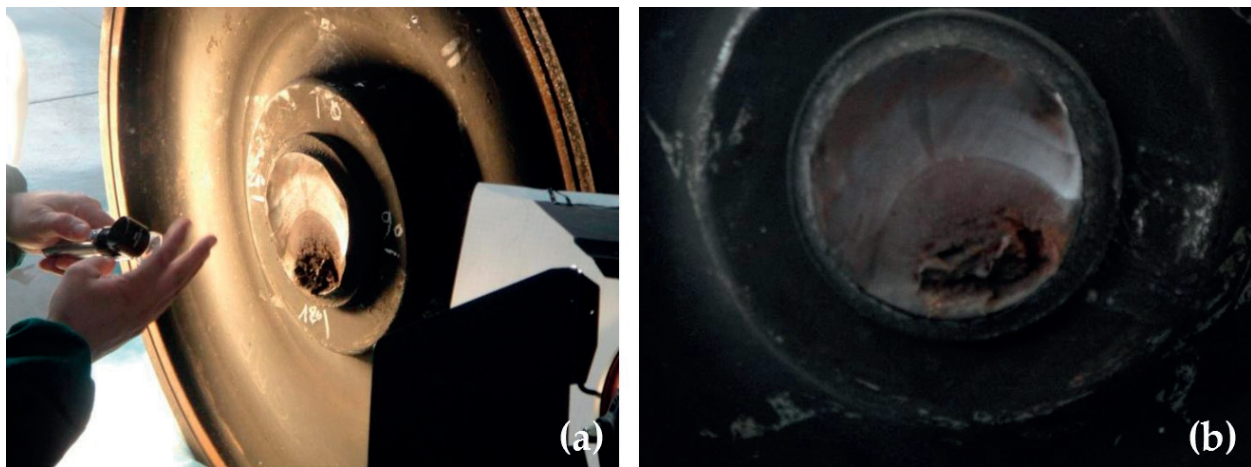
The train derailment was caused by the sudden failure of the second axle of the front bogie of carriage number 1 [5, 6]. The axle breakage was caused by rotating flexural fatigue, determining a fatigue crack extension up to more than 65% of the axle resisting section. **Figure 1** [6] shows that the axle was fractured externally with respect to the left wheel (**Figure 1a**), and this failure was the original cause of the train derailment. **Figure 1b** illustrates the characteristic fatigue failure of the fracture surface of the axle on the wheel side: presence of a smooth area related to the slow propagation of the fatigue crack (upper zone in the image) and of a rough area of rapid failure of the residual axle section (lower zone in the image). The same characteristic fatigue failure is observable on the matching axle fracture surface on the axle box side.

**Figure 1.** (a) Fatigue failure of the fracture surface of the axle on the wheel side. (b) Presence of a smooth area related to the slow propagation of the fatigue crack and of a rougher area of rapid failure of the residual axle section.

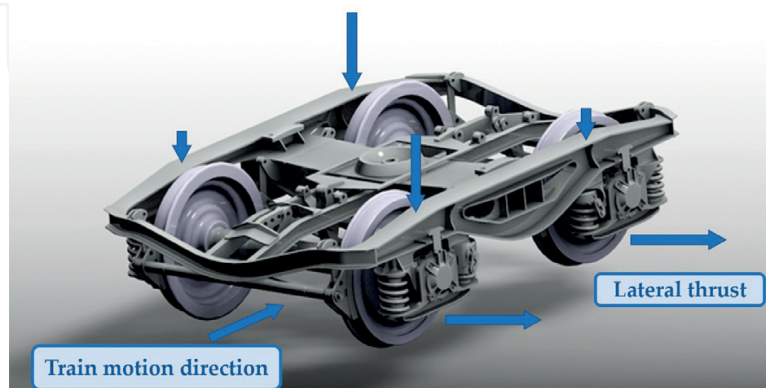
**Figure 2** shows the bogie model Y25 mounted on the pressure vessel carriages composing train no. 50325, with indication of some of its components, including the axle boxes. Due to a fatigue crack in its final development phase transversally with respect to the wheelset axle, the vertical rigidity of the axle box supported by the axel spindle was notably reduced up to reaching a nonequilibrium condition of the vertical forces pressing the wheels on the rails. The surmounting of the rail occurred due to a notable reduction of the vertical force acting on the right front wheel, diagonally opposed to the force acting on the weakened axle spindle (left rear wheel).

**Figure 2.** Forces acting on the first bogie of carriage no. 1 after breakage of the second axle (rear wheelset) due to fatigue failure externally with respect to the left wheel.

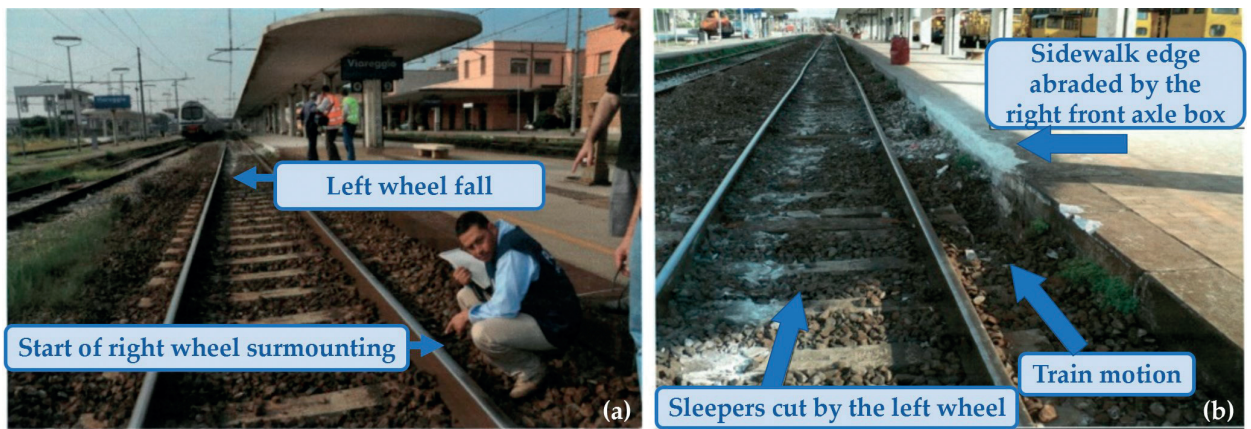
**Figure 3** shows the traces of the initial phase of the derailment and in particular: (a) the start of the surmounting of the rail by the right front wheel of the first bogie of carriage no. 1. (b) The sleepers cut by the left wheel and the sidewalk curb abraded by the right front axle box of the first bogie of carriage no. 1.

**Figure 3.** Traces of the initial phase of the derailment. (a) Start of the surmounting of the rail by the right front wheel of the first bogie of carriage no. 1. (b) Sleepers cut by the left wheel and sidewalk edge abraded by the right front axle box of the first bogie of carriage no. 1.

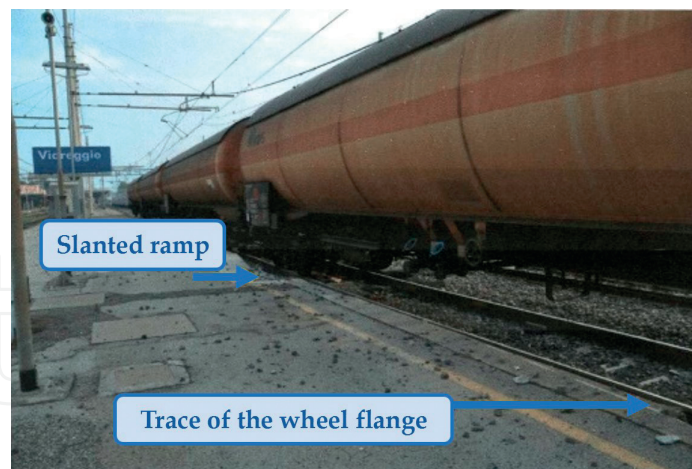
Near the end of the sidewalk, in the southward direction (toward Pisa station), there is a walkway at grade endowed with a slanted ramp (**Figure 5**). Until the walkway at grade, the derailed carriage had been guided by the sidewalk curb that acted on the highly abraded right front axle box just like a grinding wheel on a workpiece in a grinding process.

**Figure 5.** Walkway at grade endowed with a slanted ramp on the sidewalk, near the track of the derailed train, and trace on the granite curb left by the flange of the right wheel of the front wheelset of the first bogie of carriage no. 1.

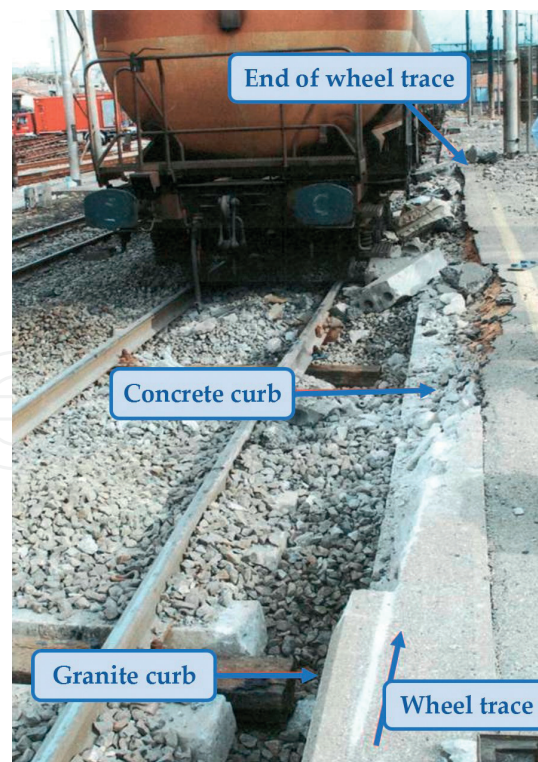
**Figure 6.** Concrete sidewalk damaged by the right wheel of the front wheelset of the first bogie of carriage no. 1 and starting point of the carriage overturning.

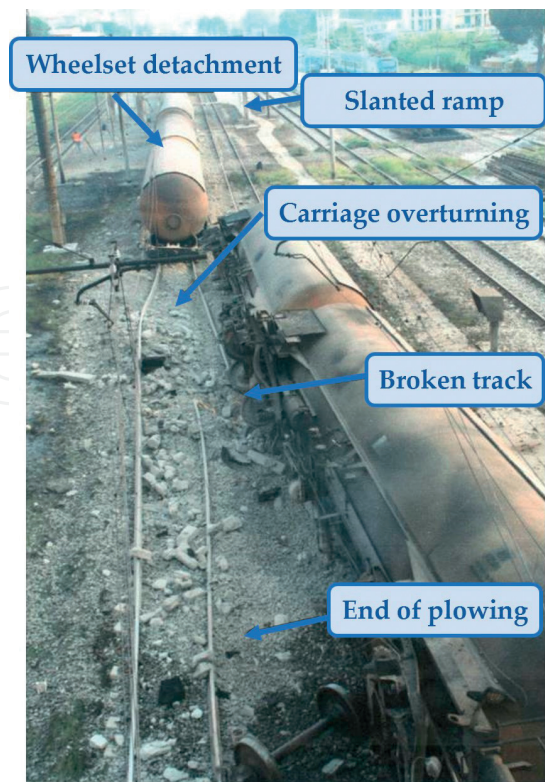
**Figure 7.** Superstructure zone wrecked due to the “plowing” mechanism of the track by the front wheelset of the first bogie.

beginning of the superstructure zone wrecked by the “plowing” mechanism of the track, as shown in **Figure 7**.

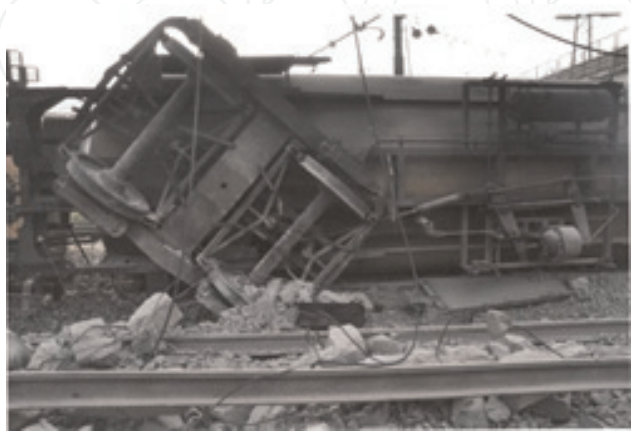
**Figure 8.** Plowing mechanism of the track by the bogie of the overturned carriage.

When, at the end of the overturning phase, carriage no. 1 crashed onto the infrastructure, it presented the remaining wheelset still mounted on its first bogie with its axis slightly slanted forward and the wheel, originally on the left side in the train motion direction, stuck under the sleepers; as the carriage proceeded its course under these conditions, the track was plowed according to the mechanism illustrated in **Figure 8**.

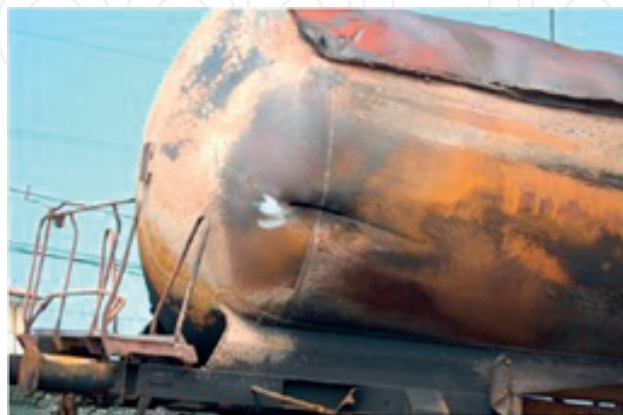
From this cut, the liquefied petroleum gas came out in liquid phase under pressure and started the liquid-gas phase transformation, creating a gaseous cloud that expanded in the environment. After about 190 s, accidental causes determined the ignition of the gaseous cloud and the catastrophic consequences of the accident.

**Figure 9.** Carriage no. 1 with a cut opening on the tank shell.

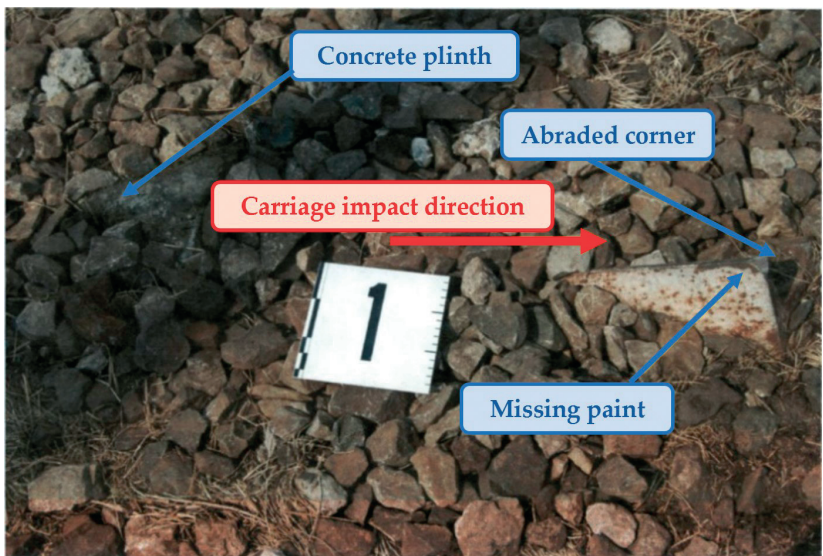
In **Figure 15**, a detail of track reference stake no. 24, found under the tank of carriage no. 1 almost completely buried in the track ballast, is shown. The sharp corner of the lower surface of the rail chunk, making up the track reference stake, appears highly abraded with its abraded metal surface still not subjected to oxidization. This confirms that the abrasion process, due to sliding against the carriage, was very recent during the examinations carried out in the accident scenario.

**Figure 15.** Track reference stake no. 24, photographed during the investigations on the accident site conditions, almost completely buried in the track ballast following its impact against the pressure vessel of carriage no. 1.

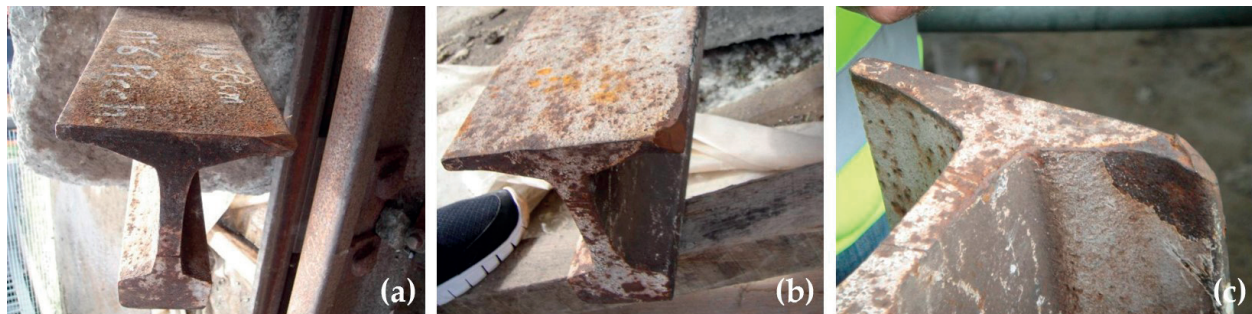
**Figure 16.** Track reference stake no. 24 photographed after its extraction from the track ballast. (a) In the foreground: flange of the track reference stake with damaged edge; in the background: view of the concrete plinth; and (b) and (c) details of the damaged edge.

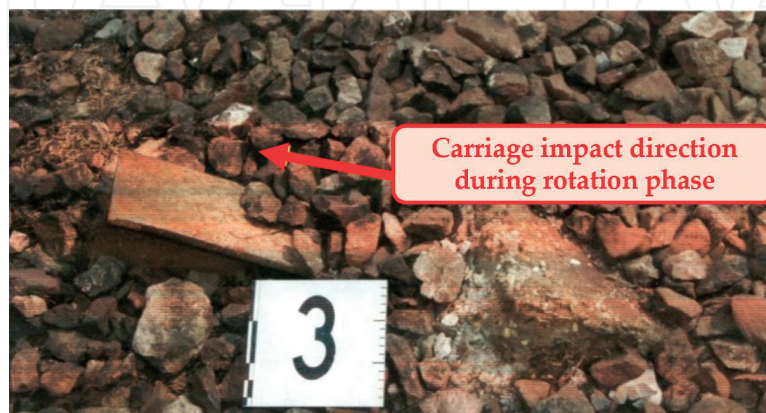
In **Figure 17**, a detail of track reference stake no. 23 knocked down by the pressure vessel of carriage no. 1 about 10 m after track reference stake no. 24 had been hit is shown. The track reference stake no. 23 was found under the tank, and its sharp corners did not show significant traces of abrasion. At the moment of impact against track reference stake no. 23, the carriage was by then almost steady and therefore endowed with a much lower kinetic energy with respect to the moment of impact against track reference stake no. 24.

**Figure 17.** Track reference stake no. 23, photographed during the investigations on the accident site conditions, partially buried in the track ballast following its impact against the pressure vessel of carriage no. 1.

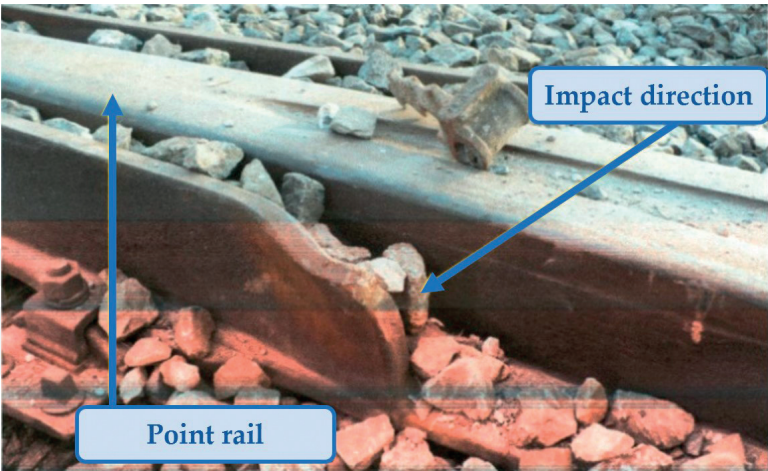
**Figure 18** shows a detail of the deformation of the wing rail. The impact on the wing rail has a component in the transverse direction, oriented toward the left side in the train motion direction, and there are no traces of abrasion due to sliding on the deformed zone of the wing rail.

Figure 18. Wing rail photographed during the investigations at the accident site conditions.

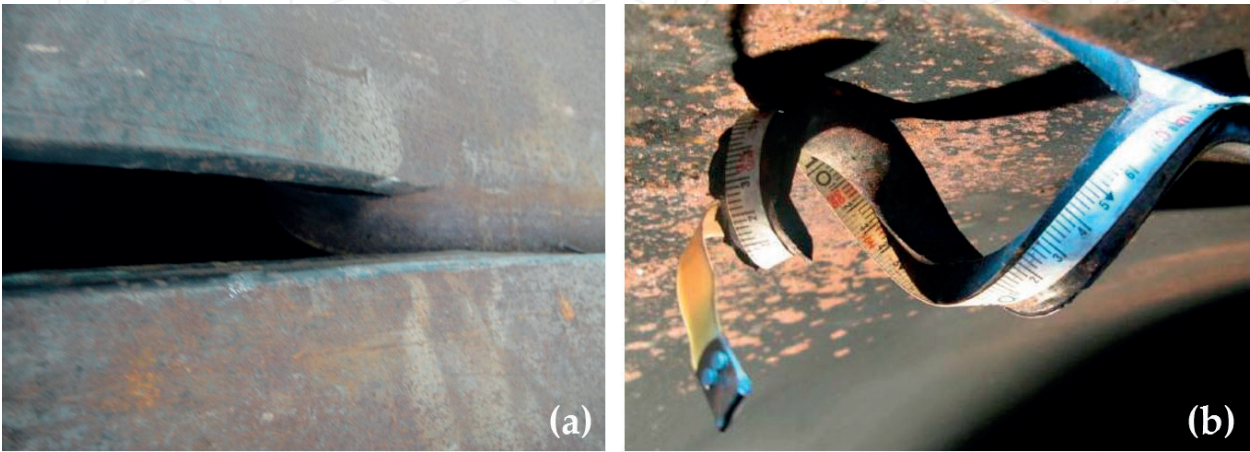
Figure 20. (a) Enlarged external view of the end side of the cut with the attached corresponding chip bent internally inside the tank shell and (b) enlarged internal view of the chip portion still attached to the tank shell.

The final part of the chip remained attached to the tank shell (**Figure 20**), while the initial chip portion was detached from the shell and was found inside the tank. This segmented chip shows the typical morphology of a chip formed during a machining operation that generates a notable chip segmentation (**Figure 21**).

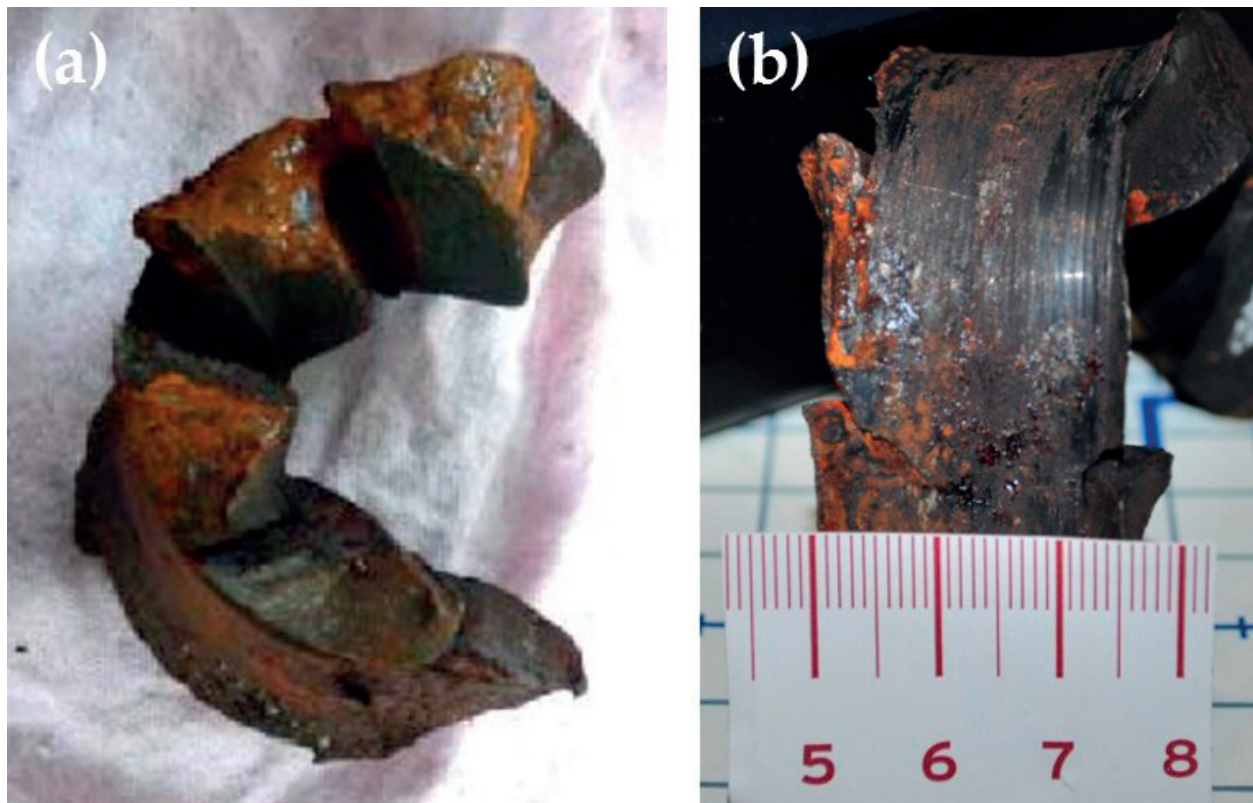
**Figure 21.** Chip portion detached from the tank shell showing the segmented morphology typical of a chip generated during a machining operation.

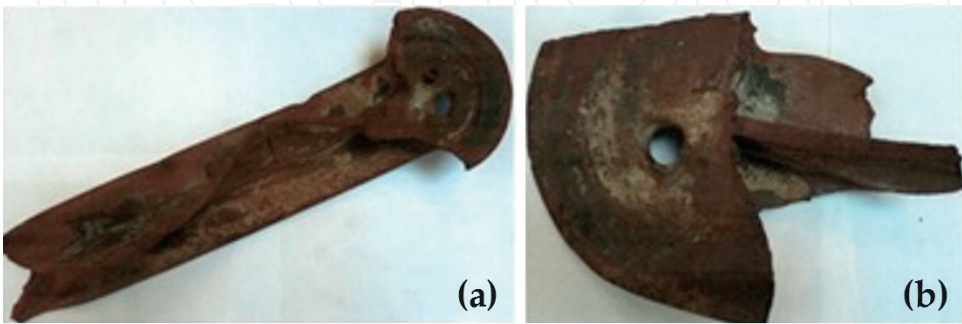
**Figure 26** shows two of the three chunks of the right axle box of the first wheelset of the front bogie of carriage no. 1, whereas **Figure 27** shows the digital model of the fragment of **Figure 26b** obtained by reverse engineering reconstruction based on geometry acquisition with a structured light optical sensor.

**Figure 26.** Two of the three chunks of the right axle box of the front wheel set of the front bogie of carriage no. 1: (a) chunk of the axle box found between the rails near the deformed check rail and (b) chunk of the axle box greatly abraded by the granite sidewalk curb exerting a grinding action on the right axle box, found externally to the track near the right-side rail in the train motion direction.

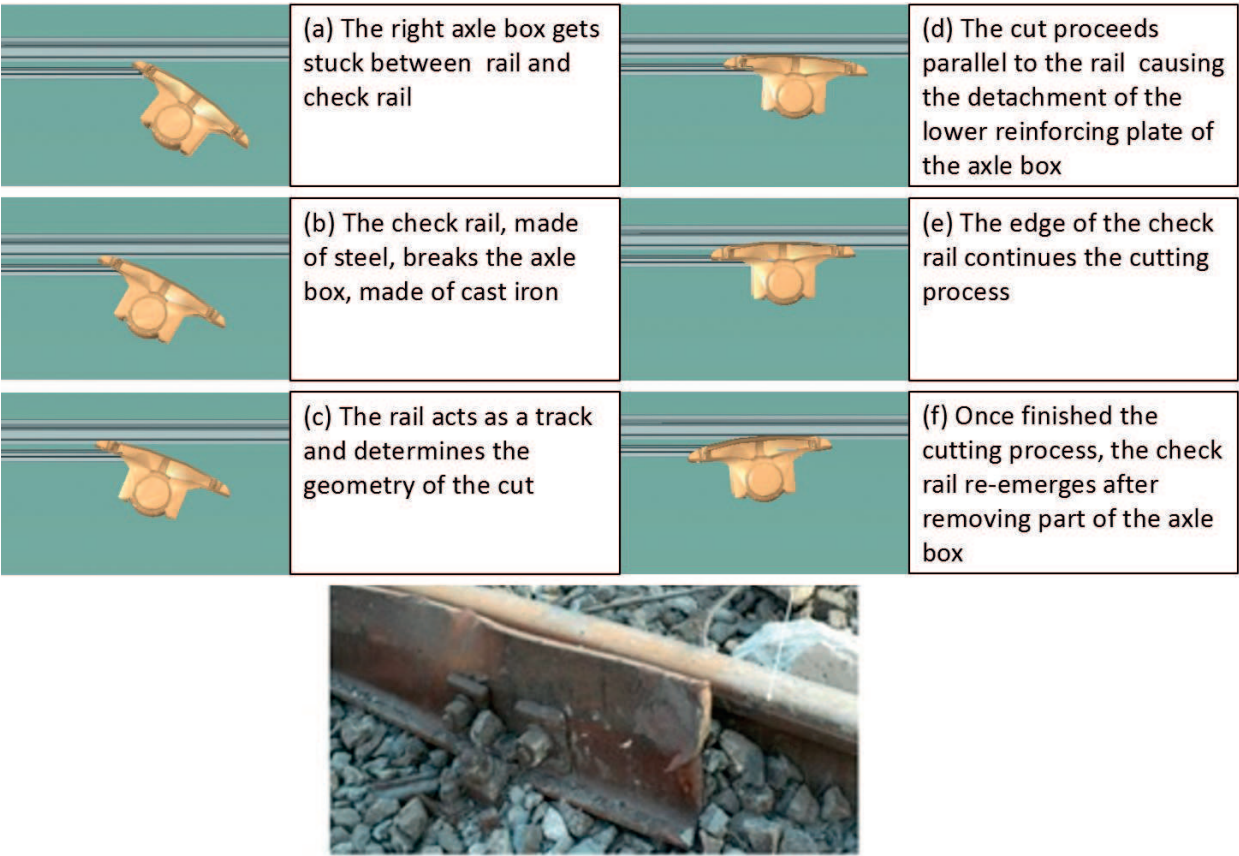
The realization of the digital twins of the check rail and the right axle box of the first wheel set of the front bogie of carriage no. 1, obtained by reverse engineering reconstruction based on geometry acquisition with a structured light optical sensor, allowed to reconstruct under simulation the kinematics of the impact between axle box and check rail, as illustrated in **Figure 28a**. **Figure 28b** shows the traces of damage on the check rail, which confirm the kinematics illustrated in **Figure 28a**.

It is, therefore, evident that the damage on the check rail cannot be related to the opening of the cut on the tank shell of carriage no. 1.

**Figure 28.** (a) Simulation reconstruction of the kinematics of the impact between check rail and right axel box of the first wheel set of the front bogey of carriage no. 1 and (b) traces of damage on the check rail confirming the kinematics described in Figure 28a.

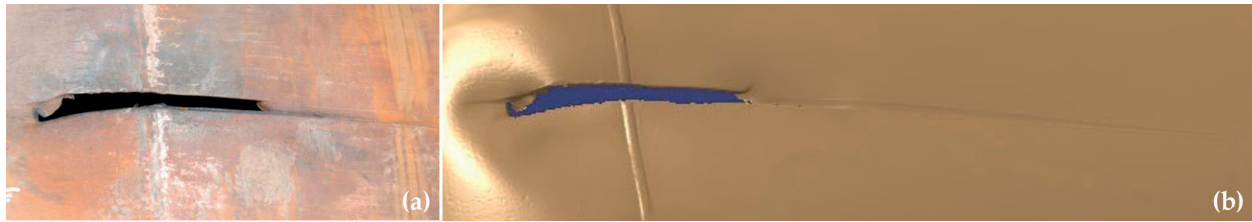
By examining the digital models of **Figures 29** and **30b**, it can be noted that the cut starts with an incidence angle of  $5.1^\circ$  and ends with an incidence angle of  $9.8^\circ$ . Accordingly, the rotation of the tank around a vertical axis, as illustrated in **Figure 12**, was about  $5^\circ$ .

**Figure 30.** (a) Photograph of the cut present on the tank shell of carriage no. 1 and (b) digital model of the cut obtained by reverse engineering reconstruction based on geometry acquisition with a time-of-flight laser sensor.

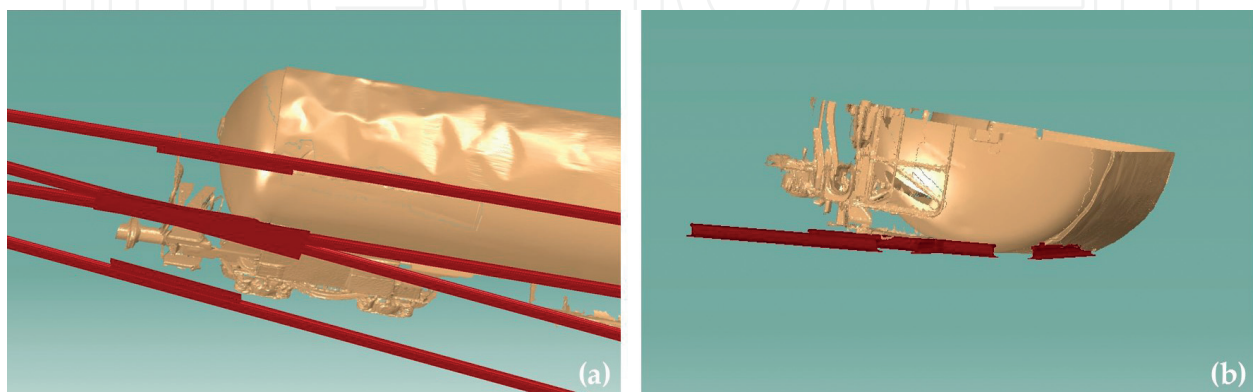
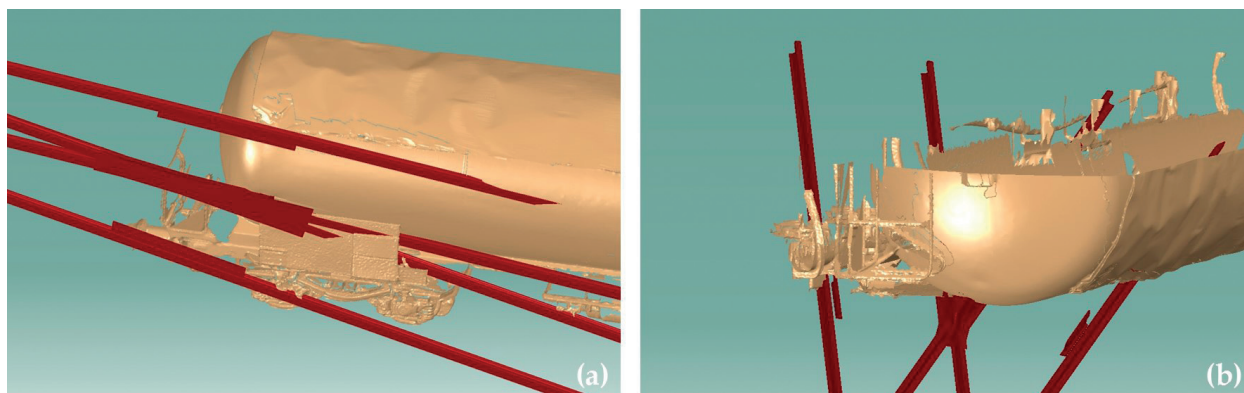
It can thus be stated that the wing rail cannot have been the cause of the cut opening on the tank shell side.

**Figure 39.** Views of the positions assumed by tank carriage no. 1 in the framework of the railway infrastructure under the hypothesis of tank shell cutting by the wing rail during the phase corresponding to **Figure 32c** and **33a**.

**Figure 40.** Views of the positions assumed by tank carriage no. 1 in the framework of the railway infrastructure under the hypothesis of tank shell cutting by the wing rail during the phase corresponding to **Figure 32d** and **33b**.

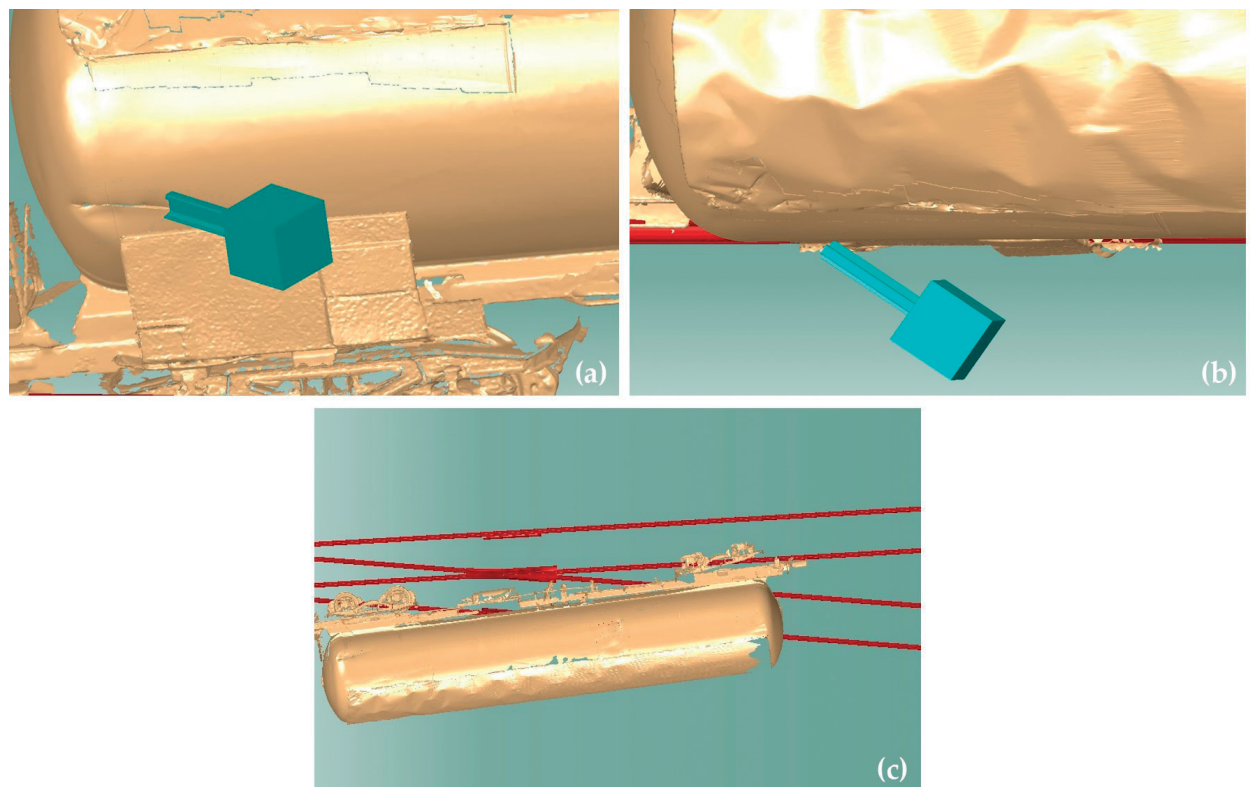
**Figure 46.** Position of track reference stake no. 24 during the sliding phase against the tank shell.

It can thus be stated that the track reference stake has been the actual cause of the cut opening on the tank shell side.

The introduction of alternative track positioning and control systems, capable to provide more advanced solutions for safer conditions in the railway infrastructure and operations, is highly desirable to avoid future disastrous accidents of the kind reported in this work. One such alternative system is represented by the railway surveying system already introduced by the national railways in Germany and Norway [12]. Its operation requires the setting, along the track of interest, of topographic reference points, the position of which is previously determined through a precision polygon. Through traditional topographic methods, these points are subsequently referred to by the points materialized through fastening devices, incorporated in the concrete basis of the poles or portals of the electric power line, for the positioning
