Degradation Monitoring of Photovoltaic Plants: Advanced GIS Applications

Miguel de Simón-Martín, Ana-María Díez-Suárez,
Laura-Álvarez de Prado, Alberto González-Martínez,
Álvaro de la Puente-Gil and Jorge Blanes-Peiró

<http://dx.doi.org/10.5772/intechopen.75650>

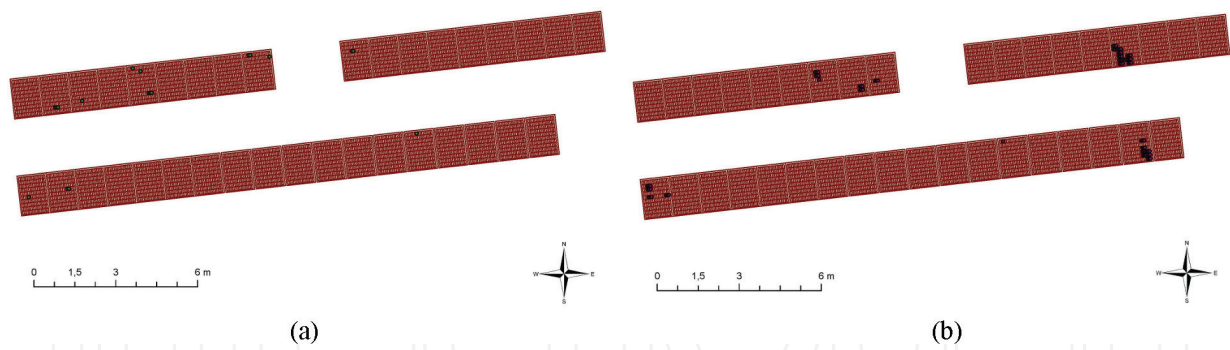
Figure 11. PV faults and defects in the 9 kWp PV plant: (a) snail tracks (b) cell discolorations.

almost no degradation has yet been observed. However, **Figure 11(a)** and **(b)** show some snail tracks and cell discoloration that might lead to the modules needing future maintenance. The distribution of these defects does not appear homogeneous and seems to be concentrated at string series extremes.
