Introductory Chapter: Environmental Characteristics of a Dobrudja Famous Archeological Monument

Daniela Turcanu-Carutiu and Rodica-Mariana Ion

1. Introduction

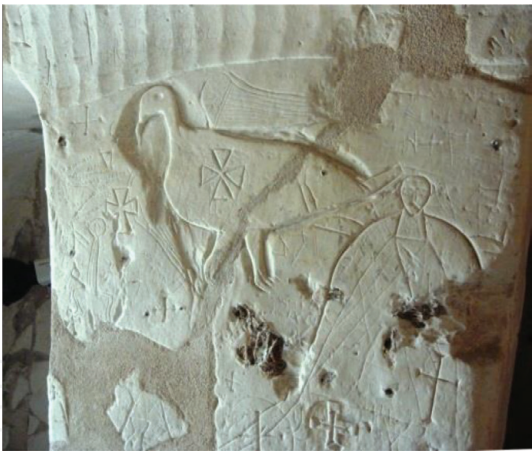
Assembly, dated IX–XI centuries is located in a hill of chalk cliff into a Roman career style, with churches, galleries branched vaults, housing the tombs [1]. Facings are inscribed with symbolic designs and different scenes and a large number of inscriptions. Some of these are palaeoslavonic and Cyrillic and some are written in Glagolitic or in Greek, but mostly in an enigmatic writing that could not be decoded so far [2, 3] (**Figure 1**).

Figure 1.
The interior of the churches and crosses, figures incised in the chalk wall.
