Durability Issue for the Emperor Fasiladas Royal Palace in Gondar (Ethiopia)

Eskinder Desta Shumuye and Gashaw Assefa Bezabih

Abstract

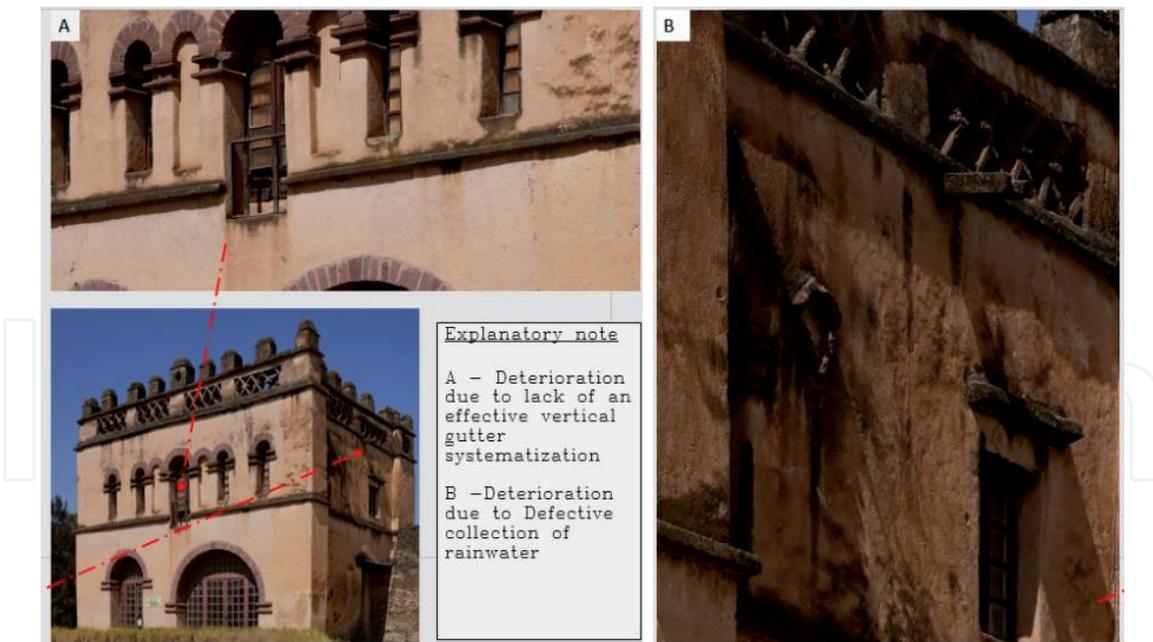
The soil between groundwater level and earth surface holds water by capillarity where this event is called as “surface water” or “capillary water” that cannot be removed by using any drainage system. The humidity rising up the building can cause serious damages on the structure [11]. According [Nigussie] to The groundwater around Gondar city can be found at a depth between 6 and 8 meters [12] consequently the groundwater at this depth cannot affect the durability of the structure (**Figure 2**).

Figure 2.
The effect of improper rainwater removal on the face of the wall [29].

damaging manifestation when this rainwater vaporizes. In case of the Fasil castle, geomembrane was used to solve the effect of rain water dispersion through the wall cracks. However, the application is inadequate for the main palace. Two variables are important from the viewpoint of the damage caused by moisture: dew point and relative humidity of air.

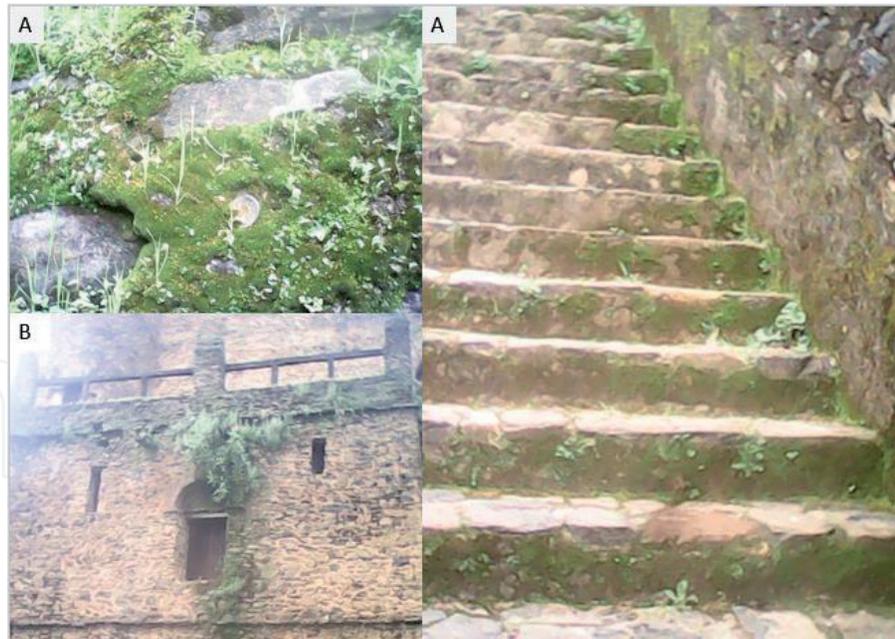
Figure 3.
The progressive biodeterioration processes on the surface of building materials: algae constitute the medium for the growth of fungi that pass through the building material by means of their hyphae. Dense formations of herbaceous plants [A] vascular plants [B] mosses and algae [source; Eskinder Desta].

Bio-deterioration of the binding material occurs due to alive organisms or the products of its metabolism. The process of colonization of a mortar is favored by its characteristics (porosity, mixture and roughness). These properties facilitate the retention of water in the binding material and the consequent growth of algae and cyanobacteria. As shown in **Figure 3**, it is the common durability issue in the royal

palace. For instance, biodeterioration of mortars of the Mosaics of Italica and some other Spanish archeological sites (Baelo Claudia, Medina Azahara) solved by the development of the biocide mortar, the biocide is adsorbed in sepiolite avoiding a quick leaching and increasing the effectiveness [18].

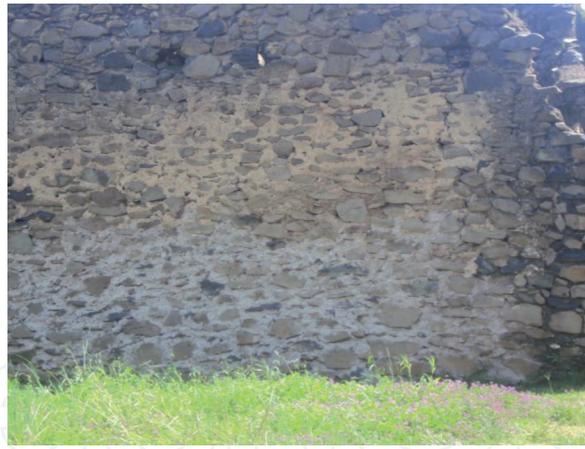
Figure 4.
 A widespread lack of binding mortar in between the stone masonry [source; Eskinder Desta].

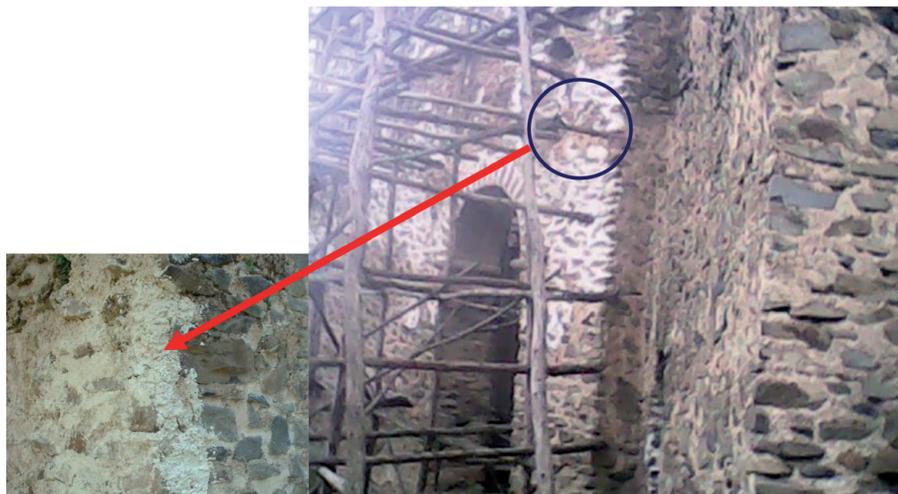
The major raw materials used for restoration works (lime) were transported from the south west part of Ethiopia, which makes it very challenging to perform a frequent restoration work. Some of the maintenance related issues of the Fasil Ghebbi palace are listed underneath [4, 22] (**Figure 5**) (**Table 2**).

Figure 5.
 Mortar repointing used during the restoration of the palace [source; Eskinder Desta].

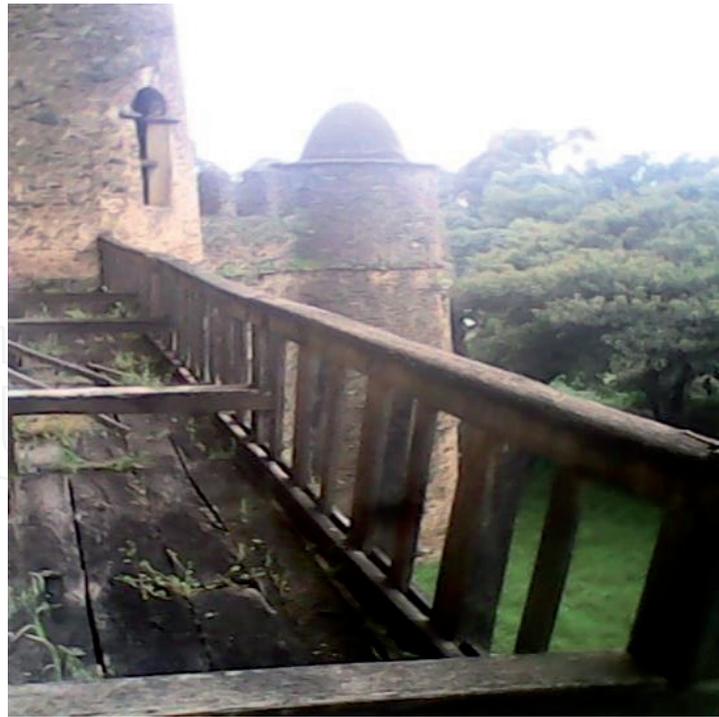
Figure 6.
Active durability issue due to the presence of grass and alga on the wood floor terrace [source; Eskinder Desta].

The investigation commenced with a visual inspection of the internal and external palace wall. As shown in **Figure 6**, the damage appeared to intensify on the outside wall surface and building components compared with that of the internal wall surface. The visual examination was followed by measuring the slope deflection of the masonry wall as shown in **Figure 7c**.

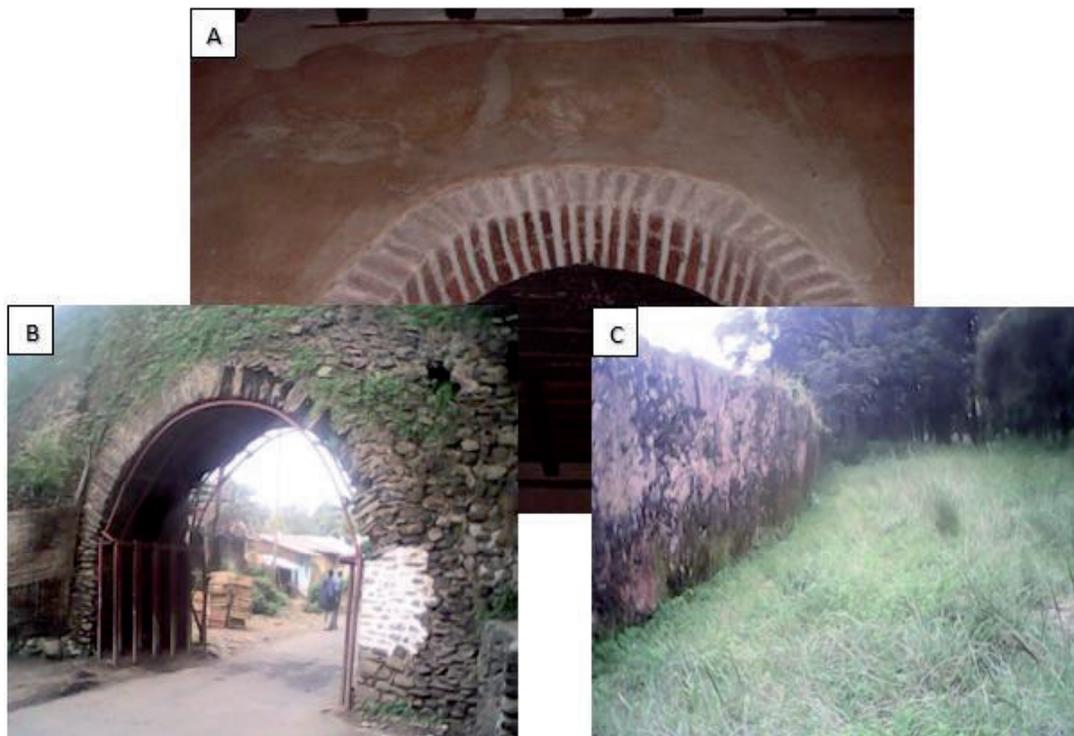
Figure 7.
Active durability issues risking the palace: (a) crack formation inside the palace internal partition wall (repointed surface), (b) steel frame support aimed for the enhancement of stone masonry dome structure, and (c) tilting of the stone masonry wall inside the main palace yard [source; Eskinder Desta].

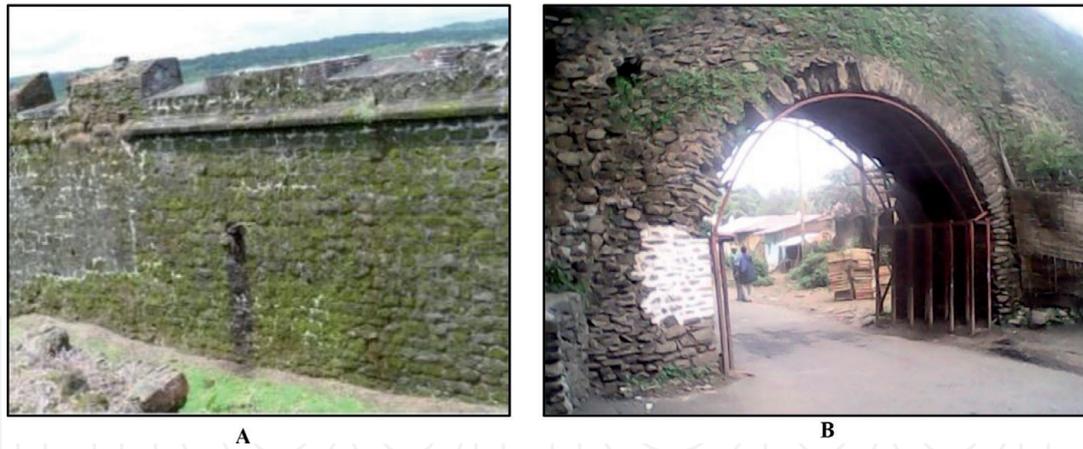
Figure 11. Biological growth at Fort San Lorenzo (Panama); source and Fasil Ghebbi [source; Eskinder Desta].
A. Biological growth at Fort San Lorenzo (Panama). B. Biological growth at Fasil Ghebbi.

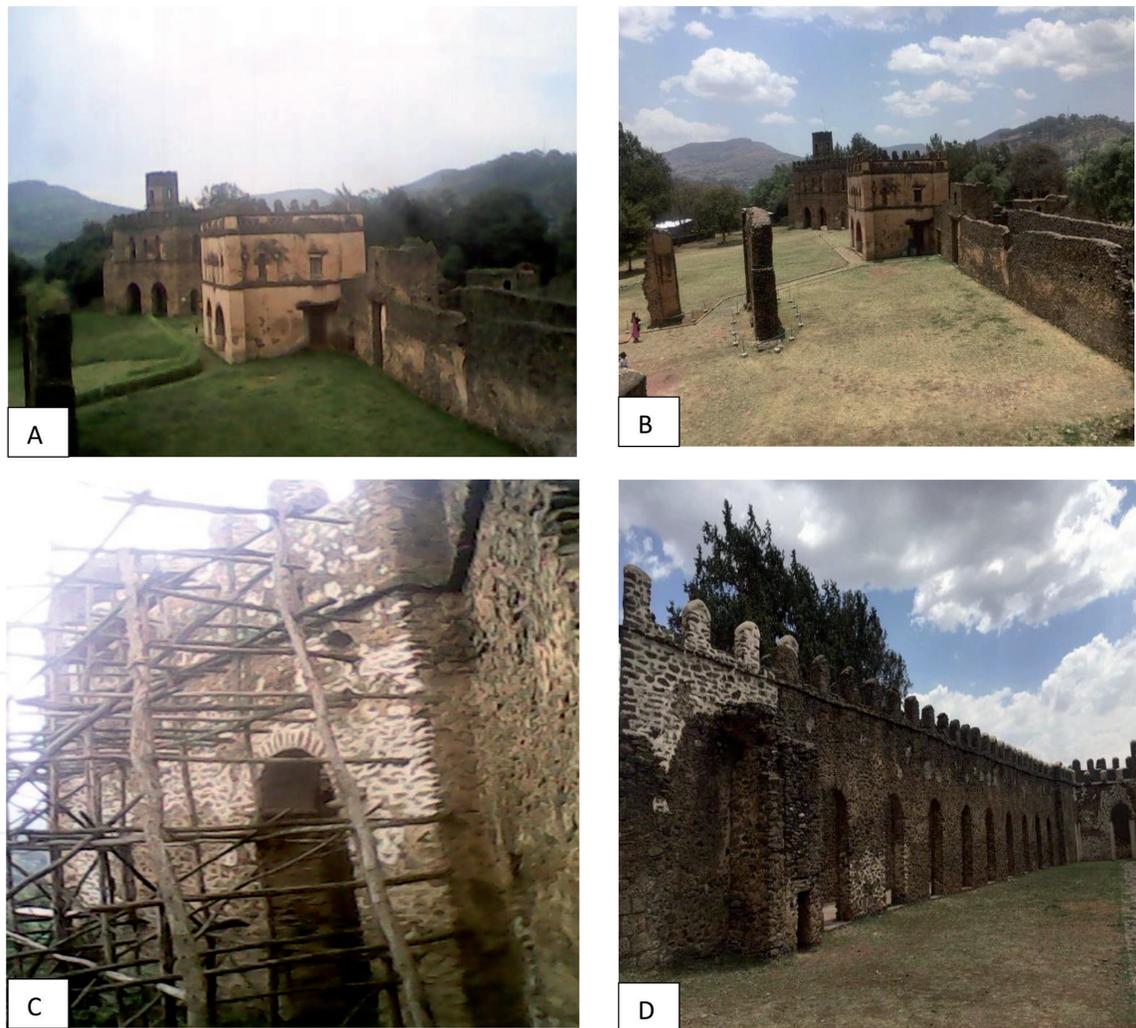
Figure 12. Some selected spots inside the royal palace before and after restoration. (A and C): in 2015; (B and D): in 2019 [source; Eskinder Desta].

Climate and biological effects may include changes to lichen colonies on buildings, spread of existing and new species of insects, increase in mound growth. According to UNESCO climate change and world heritage report [31] these factors may cause changes in appearance and collapse of structural timber and timber finishes. As an example; **Figure 11** shows the biological growth at Fort San Lorenzo [33] and Fasil Ghebbi [4] (**Figure 12**).
