The Position and Function of Macroscopic Analysis in the Failure Analysis of Railway Fasteners

*Guodong Cui, Shuaijiang Yan, Chengsong Zhang,
Dazhi Chen and Chuan Yang*

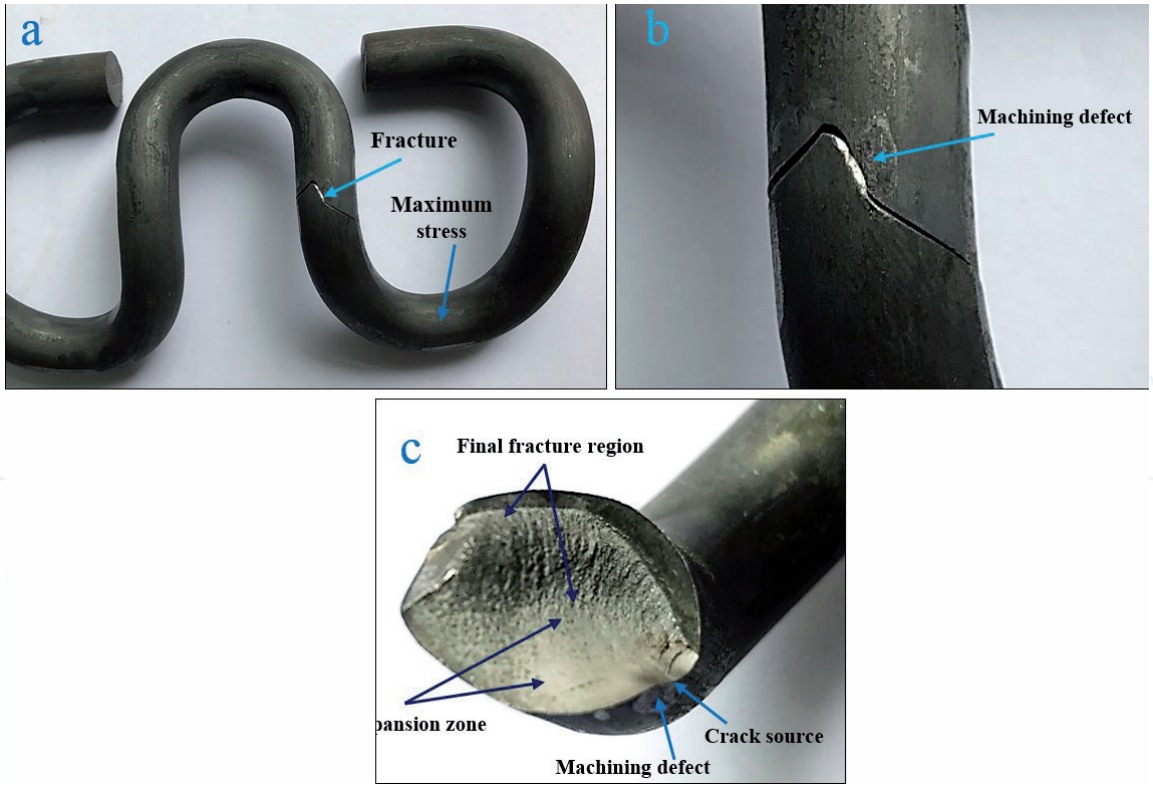
Figure 1 shows the fracture condition of a rail fastening clip after the fatigue test of 4×10^5 cycles. However, according to the TB/T2329-2002 Chinese standard for the fatigue tests of rail fasteners, the samples should not fracture after 5×10^6 cycles. In order to find out the reasons of the premature failure, macroscopic analysis was conducted on the failed sample. As shown in **Figure 1a**, the fracture surface is not located in the position bearing the maximum stress during fatigue tests. The detailed observation reveals that a processing defect exists near the crack initiation region, as is shown in **Figure 1b**. This defect is mainly caused by the excessive extrusion of the hot plastic mold during induction heating, resulting in a local stress concentration at the defect. Subsequent quenching further increased the local stress at defects. During the fatigue tests, crack initiated from the stress concentrated position at the defects leading to the premature failure of the tested sample. As shown in **Figure 1c**, the characteristics of the fracture surface were revealed by the macroscopic analysis. The fracture surface shows the feature of a typical fatigue failure mode. The crack initiation region, crack expansion zone, and the final fracture region can be clearly observed on the fracture surface as marked in **Figure 1c**. Since the crack expansion zone occupies a large area, it indicates that,

Figure 1.
Macroscopic analysis of the premature fatigue fractured rail fastening clip caused by surface processing defects: (a) the overall morphology of the fractured clip, (b) the processing defects near the crack initiation region, and (c) the morphology of the fractured surface.

after the cracks initiated at the surface defect, the sample undergoes a crack expansion period under the cyclic load before the final fracture. According to the theoretical equation reported in the literature [17, 18], the fracture strength of the tested rail fastening clip can be calculated based on the area of the instantaneous fracture zone and the maximum load applied.

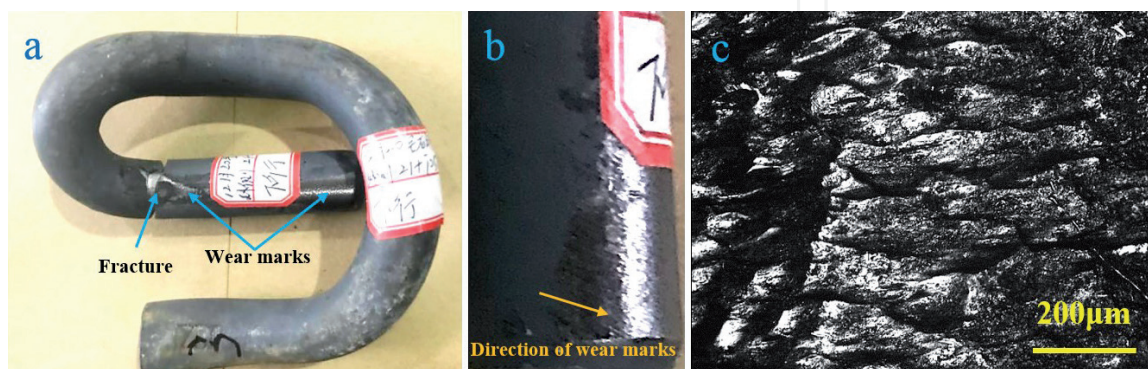
As can be seen from **Figure 4a**, the breaking position located at the root of the straight section of the fastener, and this straight section is installed in the fixed slot. The fracture happened at the boundary between the straight section and the residual curved part, in which the maximum stress is loaded in the broken position in the actual working condition. A detailed observation of the sample surface reveals obvious wear marks. Moreover, the wear marks are in the same direction along the transverse arc of the fastener sample (see **Figure 4b**). As can be observed from the magnified view shown in **Figure 4c**, the wear marks have a certain depth, and their propagation direction is consistent. Based on the direction and depth of the wear scar, it can be preliminarily concluded that the wear scars on the surface of the straight section of the railway fastener were caused by the relative rotation with the spring clip slot it contacted with. However, in the normal circumstances, this type of rotation is not allowed, because the rotation will reduce the pressure between the fastener and the railway track, affecting the train safety. Combined with the relatively deep wear marks, the broken fastener is subjected to a large external force before failure. The reason causing this large external force can only be determined by the on-site investigation with the understanding of the service situation.

According to the investigation of the service scene, the subway operates along a circle line, and the fasteners with premature fatigue failure occurred mostly at or near the curve region of the railway track. This indicates that in addition to the force of caused by the vibration of the track when a train passed, the spring bar is also subjected to the centrifugal force when the train is adjusting directions. Under the combined force of the vibration and the centrifugal force, the fastener rotated relatively in the slot, resulting in a surface with a consistent direction of wear scar. After multiple friction, the wear marks at the position where the fastener is in contact with the edge of the slot became deeper and deeper, and thus fatigue cracks were

The macroscopic morphology and surface wear scars of the fractured metro fastener: (a) the macroscopic morphology of the failed fastener showing the position of the fracture surface and the wear marks, (b) the obvious wear scar that can be observed on the surface of the straight section of the fastener clip, and (c) the enlarged view of wear scar.

The early failure of the railway fasteners caused by the external service environment indicates that in addition to considering the material selection and processing technology and performance of the product, the actual working environments should also be taken into consideration. In order to ensure the operation safety of the equipment, the design and manufacture of the product can be improved based on the actual working condition of the components. Only then can the safety factor in the actual service process be increased.
