A Wear Analysis Carried On Connecting Rod Bearings From Internal Combustion Engines

Juan Rodrigo Laguna-Camacho, Silvia M. Sánchez-Yáñez, Gabriel Juárez-Morales, Maria I. Cruz-Orduña, Luz M. Ramos-González, Cristóbal Cortez-Domínguez, Roberto L. Cabrera-Santiago and Javier Calderón-Sánchez

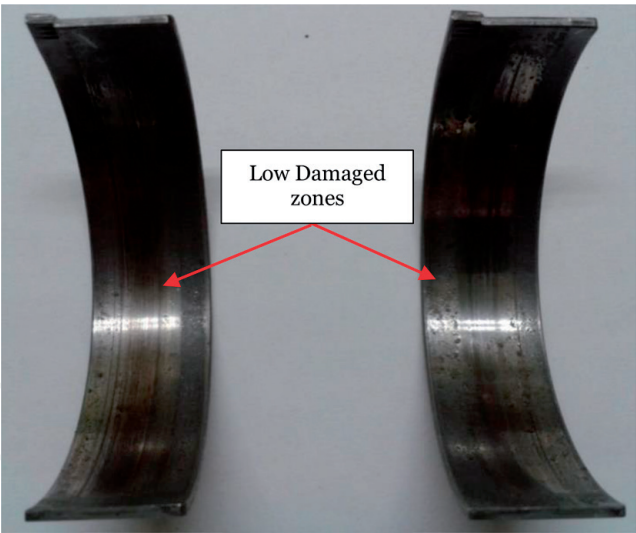
Figure 3.
Lower wear damage on bearings.

In the case of the bearing surfaces with the least wear (**Figure 3**), it is possible to mention that although the wear was less pronounced, delamination of the surface layers was observed, as the magnification of the damage zones increased (**Figure 15a–c**). In addition, it was possible to see particles embedded on the surface

On the other hand, the bearings with the lowest wear exhibited high polished areas on the surfaces in the sliding direction as shown in **Figure 3**, two factors could be significant, the absence of an oil film between the bearing and the shaft led to a metal-to-metal contact, and initial wear debris could act as polisher in the surfaces. In addition, pits on the surfaces were caused by a few wear debris inserted on the bearings. It can be inflicted by the contact pressure between the bearing and the shaft.

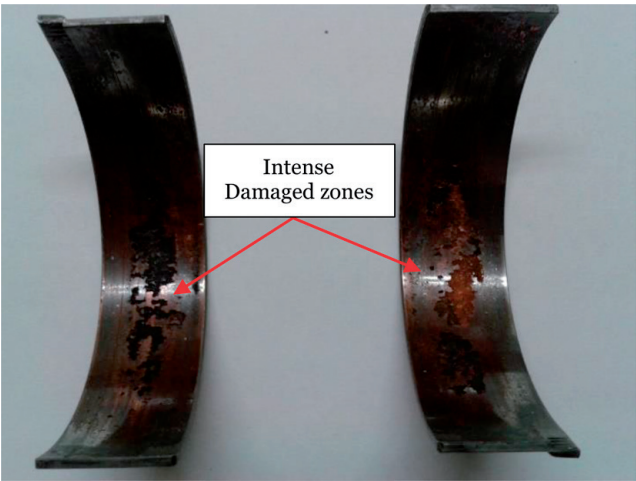
On the other hand, the wear produced in the bearings shown in **Figure 4** is very intense. In the bearing on the left, it is possible to observe that the lead and tin layer was completely torn off in the central part and a dark color was clearly seen, which was due to the oxidation wear that occurred in the steel layer that is the base layer of the bearing. In addition, the bearing on the right exhibited pronounced wear, although in this case the reddish-orange copper layer was clearly located. Here, it is possible to identify wear mechanisms such as sliding wear that became high abrasive damage (scoring) for high loads, fatigue wear due to constant contact with foreign particles, and high temperature.

Figure 4.
Pronounced wear damage on bearings.

In relation to the rod bearings that suffered higher wear damage (**Figure 4**), it was possible to observe that a Cu content appeared after the real service in the chemical analysis which confirmed the severe wear rate was caused by the absence of correct lubrication due to the long service life, roughly 8 years, and probable foreign particles (dust, wear debris) in the interface between the bearings and the shaft. The common sliding/abrasion action with particles between the two surfaces could be a major factor to inflict the wear intensity. In addition, the wear areas could lead to an uneven distribution of the loads, causing an abnormally high pressure area in some specific points on the bearing surface. In addition, Sn content was identified in the chemical results. Both protective layers were totally shifted due to the high abrasive action in some areas. SEM images showed a number of particles embedded on the bearing surface, large cracks, and clear abrasive wear due to the particles acting directly on the surfaces. Optical images presented wear areas with material totally detached from the surface.

The roughness results showed the surface modifications due to the contact action between the rod bearings and connecting rod journal shafts. The main changes were identified in the high wear areas in the rod bearings in **Figure 4**, where a higher depth was obtained in the profiles. The roughness behavior in the rod bearings with the lowest damage was consistent in all the measured section. Finally, hardness tests were performed to show the differences between the inner part (lead-tin layer) and the two protective layers (steel and copper). The results presented a low hardness value of the inner part (21.89 ± 1.20) compared to the other two, 192.97 ± 8.7 HV, copper layer, and 196.61 ± 5.11 HV, steel layer, with close values.

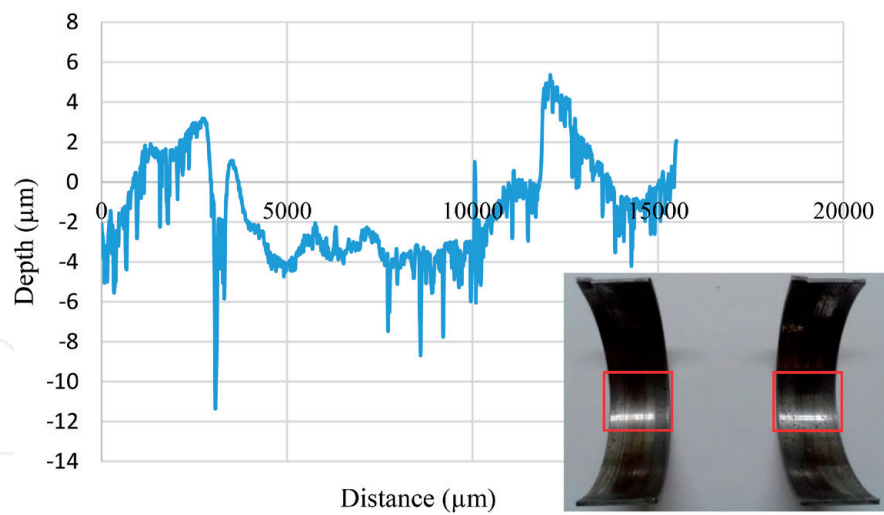
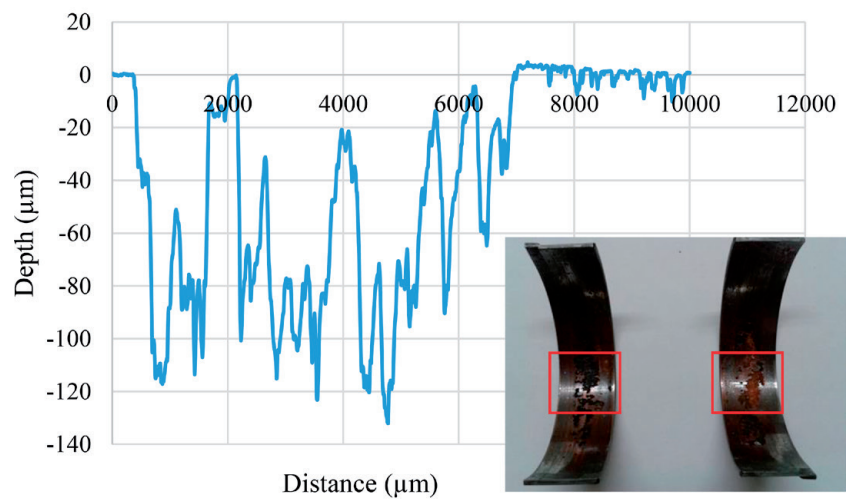
The photograph presented in **Figure 10a** shows how the surface of the damaged area changes in a consistent manner in the central part. In this particular case, the sliding wear was much less compared to **Figure 10b**, where the wear damage was more intense, with a high detachment of the outer layers, showing areas of greater depth due to the wear intensity.

Figure 10.
Roughness profiles of the low wear area.

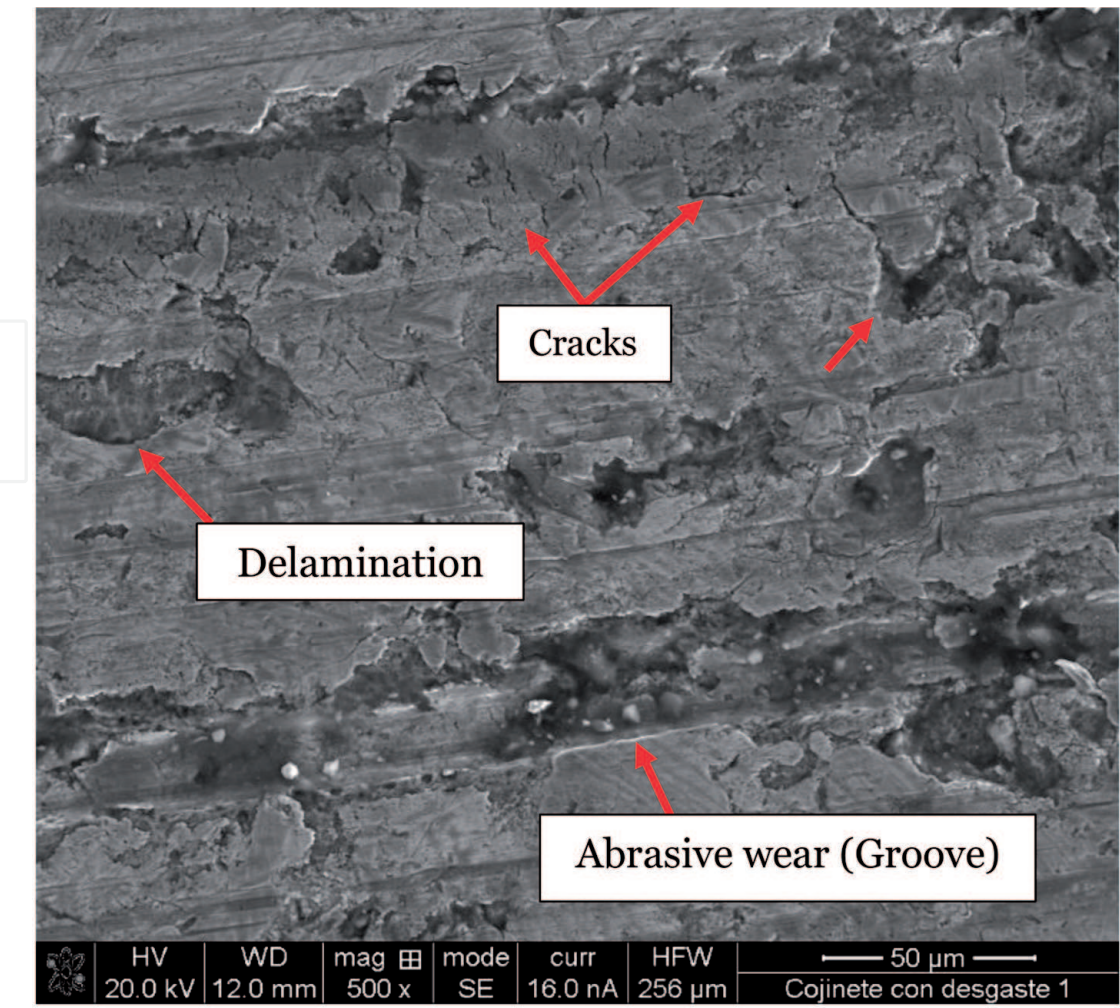
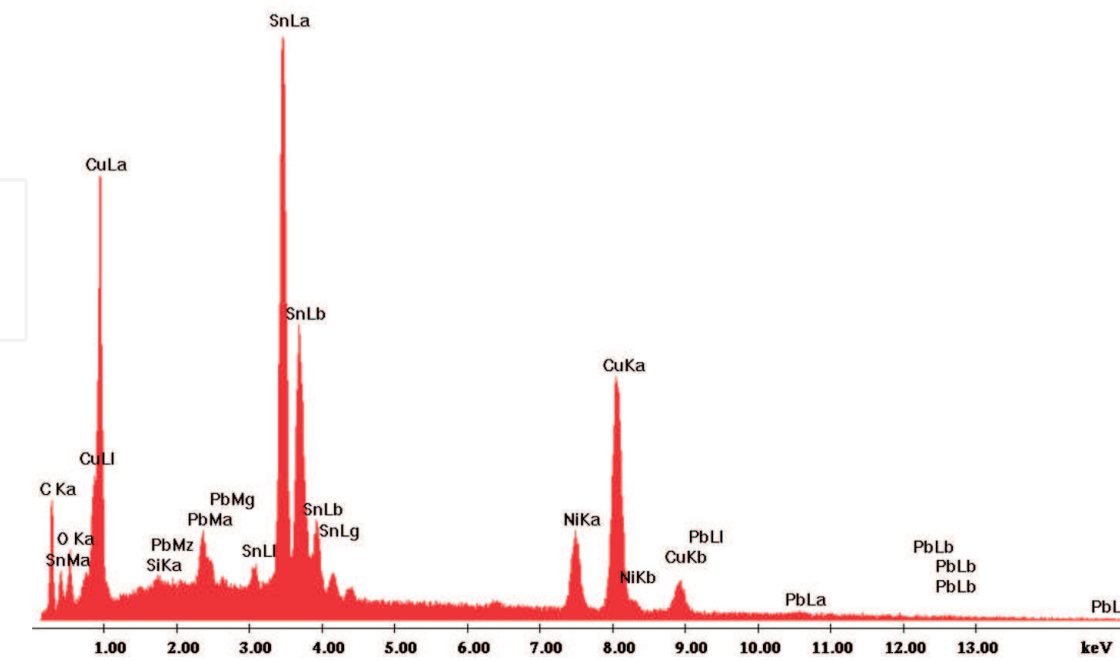
On the other hand, once the rod bearings have been working during the actual service, the wear occurs on the surface as shown in **Figure 13a**. It was detected that the chemical composition was modified with respect to that presented with the bearing without any wear. Here, the Cu content was new, and this took place because the lead and tin layer was removed by the constant wear due to sliding, friction, and three-body abrasion that is generated by the wear debris insertion, contaminants, and foreign particles coming from of the oil filter or the atmosphere.

A comparison of the chemical composition of a rod bearing that suffered wear and an unworn bearing is presented in **Table 3**. In the chemical composition of the worn bearing, there is a reduction in the lead content (Pb) and an increase in the tin content (Sn). In addition, elements such as copper (Cu) and nickel (Ni) appeared after real service, which could be due to the foreign particles and contaminants produced during the contact with the crankshaft journal. This indicated that the layer of lead, tin, and antimony (metal Babbitt) was torn out from that area, so the copper content that is one of the intermediate layers in the bearing was clearly identified.

Figure 13.
(a) Worn rod bearing surface and (b) EDS analysis.

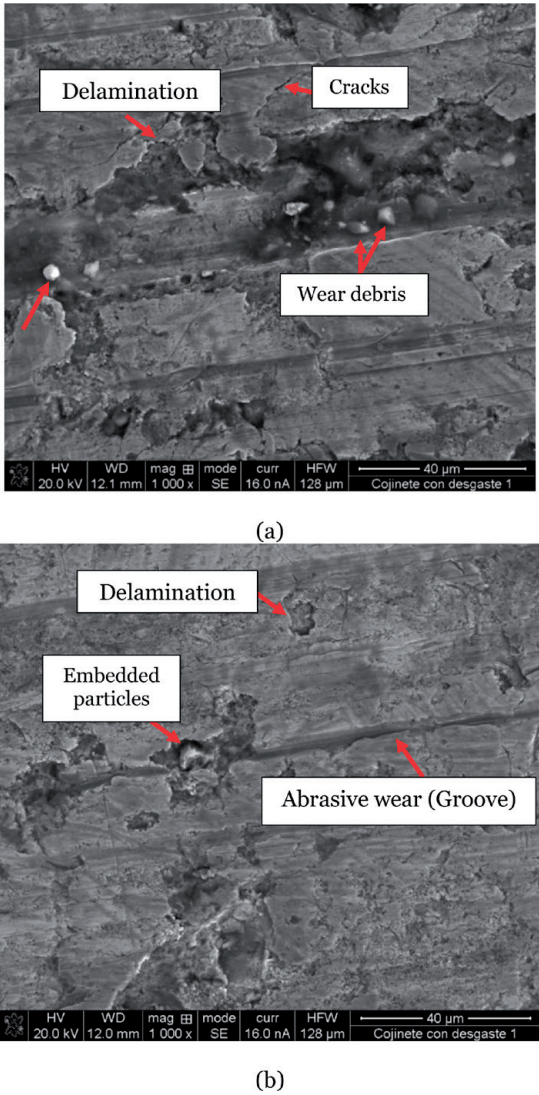
Figure 14.
(a) and (b) Worn rod bearing surface at 1000× in two areas.

damage. On the other hand, **Figure 14a** and **b** exhibited the damage caused in the bearings of the connecting rods after 8 years of actual service with proper and constant maintenance. On the bearing surfaces with the greatest wear (**Figure 4**), it was possible to observe cracks on the surface, delamination due to severe tearing of outer layers produced by sliding wear, and particles that were detached by the same action [2–5]. Some particles observed in the grooves are formed on the surface, and as the magnification of the damage area is increased, this wear mechanism is much clearer.

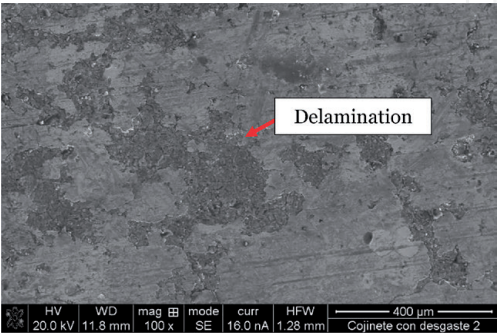
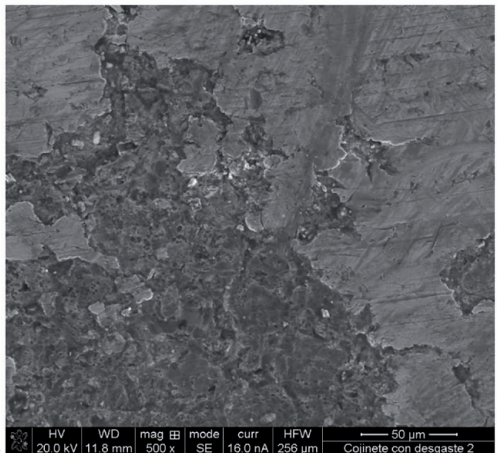
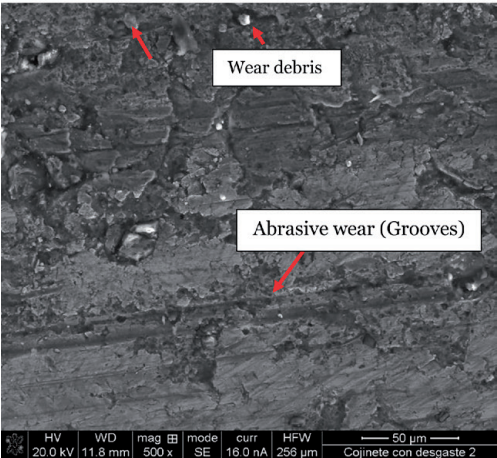
Figure 15.
(a)–(c) Worn rod bearing surface at 100× and 500× in different damaged areas.

by the same sliding action of the two surfaces in contact and grooves with less depth and intensity than those observed in **Figure 14a** and **b**.

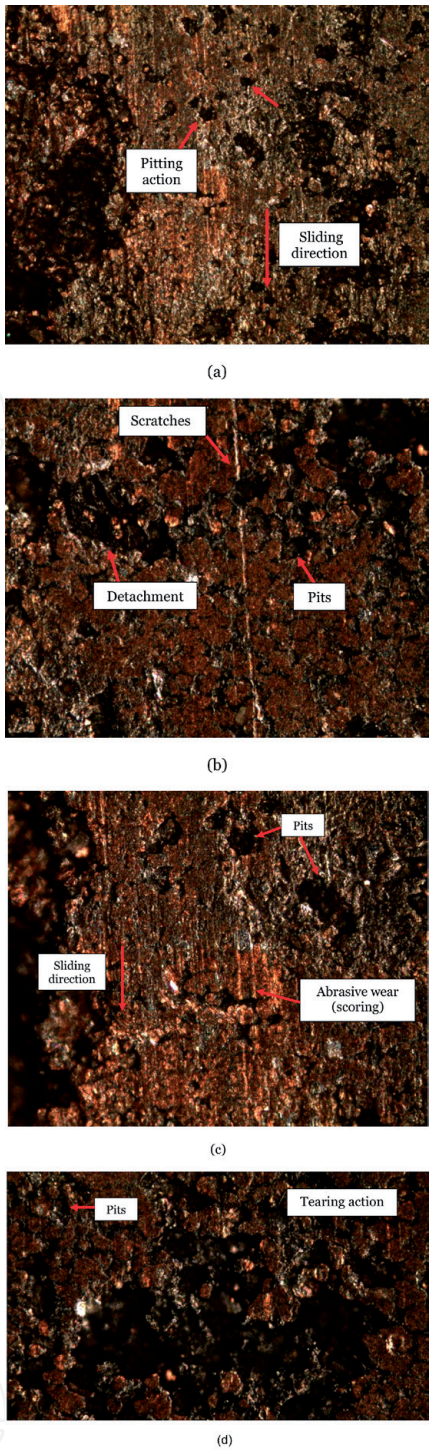
Figure 16.
(a)–(d) Worn rod bearing surface in different damage areas.

In **Figure 16a–d**, it is possible to observe images of the wear damage in the bearings shown in **Figure 4**, caused by the intense tearing of a part of the first protective layer (Babbitt metal layer, composed of lead, tin, and antimony). An Olympus GX-51 optical microscope was used to obtain these micrographs. In a magnification of the same area, it was possible to observe that the fatigue damage was important since there are areas of severe material detachment, pitting action was also identified. In this particular, high abrasion wear (scoring) was the main wear mechanism to be considered by the action of foreign particles of various shapes and sizes on the surfaces that could lead to accelerate the wear process [5–7].
