## A Case Study on the Fire Safety in Historic Buildings in Slovakia

Agnes Iringová

### Abstract

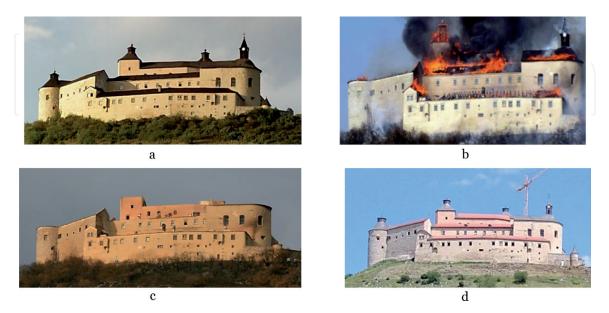
#### Figure 1.

Here is the example of fire in the castle of Krásna Hôrka from 2012. The fire progress is shown in **Figure 1b**. Fire was caused by children who carelessly handled free flame near the castle hill. They threw a burning object into dry grass that ignited. As there was strong wind, fire spread rapidly onto the combustible castle roofs covered by wooden shingles (see **Figure 1a**). The castle consists of three buildings. The original upper castle dates from the fourteenth century; the middle and lower castles were built later by the original owners. The castle housed a permanent display of period works of art giving basic information on the castle and its original owners. There were original exhibits with a high museum value. The original roof structure consisted of timber trusses covered with wooden shingles and took the area of about 5000 m<sup>2</sup>. The lower and middle castle has vaulted ceilings; the upper castle has steel-bearing ceiling structure with a wooden flap. The castle has stone and brick external walls.

The castle of Krásna Hôrka before fire, during fire, after fire and at the present time. (a) Original castle timber roofs before fire in 2012; (b) fire in the castle in 2012; (c) the castle after fire in 2012; (d) the castle at the present time.

The Gothic tower contained a water reservoir of about 66 m<sup>3</sup>; the upper castle contained fire-water hose systems and wall hydrants. Powder fire extinguishers were installed in all spaces. Although the castle was protected at the time of fire by both passive and active fire protection, its protection was not sufficient considering the outside source of fire, climatic conditions and burning rate of dried roof timber.

The fire lasted for about 3 days in terms of the quantity of timber structures and unfavorable natural conditions—strong wind. The roofs burned down (see **Figure 1c**). The firefighting was slowed down due to the road that was badly accessible for the fire brigade—there is only one access road leading to the castle. The water source was far from the burning area, and it was not possible to use the water reservoir in the castle.

The fire affected mainly the Gothic castle that was restored in 1982. The part of the ceiling fell down; some exhibits such as swords and other historical weapons were destroyed. The interior exhibits in the lower and middle castle and the Francis Museum survived without harm. Overall, 90% of all historic exhibits were saved. The castle building suffered fire damage especially on its construction, and the total damage was estimated at approx. 8.05 million €.

Nowadays, the castle's restoration is coming to an end. All roofs, including loadbearing and truss structures, were built as replicas of the original structures, taking into account the forms they had at the time of the last major castle's style alternation after fire in 1817 (1818). The original wooden shingle roof is replaced by burnt ceramic roofing, and the bastions have metal roofing (see **Figure 1d**). In this case, fire was caused by negligence and climatic conditions.

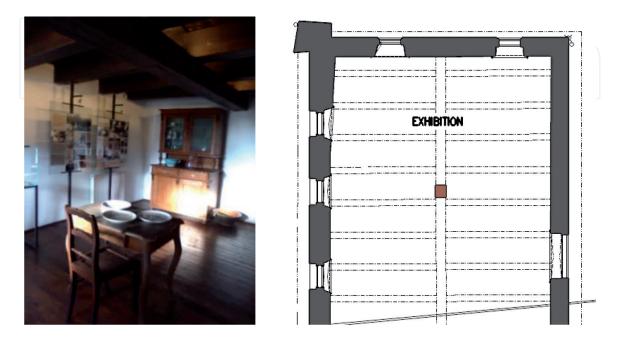
**Figure 3.** Layout and visible ceiling in a model solution (left) and ground plan with assessed wooden truss (right).

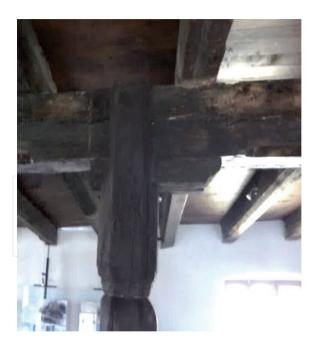
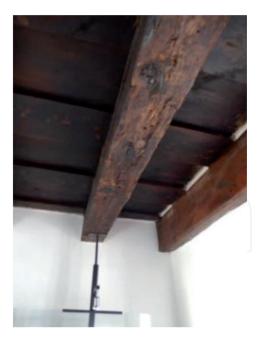
#### Figure 4.

Supporting using a wooden beam and column (left) and ceiling wooden beam with a wooden decking (right).

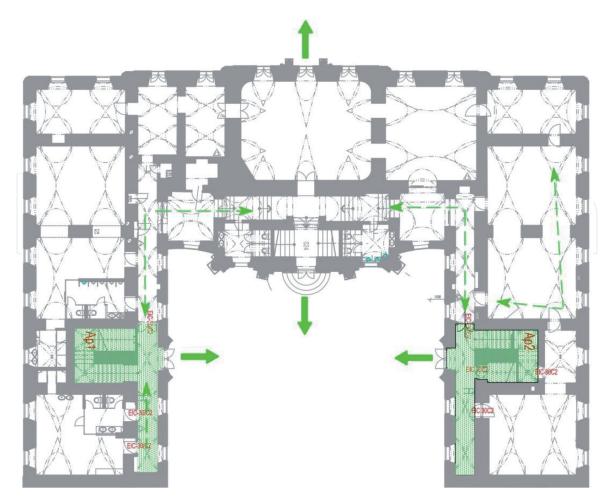
Here is the solution example of a model building. The new owner of a manor house changed the building's functional use and fire height by adding a floor into the unused attic space. The manor house is a typical baroque building with a U-shaped ground plan. The manor house had originally three above-ground floors with a mansard roof. The building once served as a residence of a noble family. After restoration, it will serve as a hotel. There are social spaces containing inner halls, smaller salons, restaurants, kitchen and sanitary operational background on the ground floor and first floor. Hotel rooms with technical and operational facilities are located on the upper floors (see **Figure 5**).

Each side wing contains one double-wing staircase that was originally open and classified as unprotected at the time of evacuation. Designed building's alternation by hotel rooms built in the attic changed building's fire height and extended staircases beyond the allowable dimensional limits defined in Table 16 STN 730802. It was necessary to alter existing staircases in the side wings. The staircases on each floor were fire-separated from the other fire-loaded spaces and ventilated through existing windows facing the inner courtyard (see **Figure 5**).

**Figure 5.** *Emergency routes on the first floor leading to an open area in a model solution of the restored manor house.*
