A Survey of Physical Parameters and Natural Radioactivity in the Wooden Church of “Archangels Mihail and Gavril,” Draghia

*Ancuța Țenter, Marin Cotețiu, Alexandra Cucoș,
Bety Burghеле, Kinga Szacsvai and Verginica Schroder*

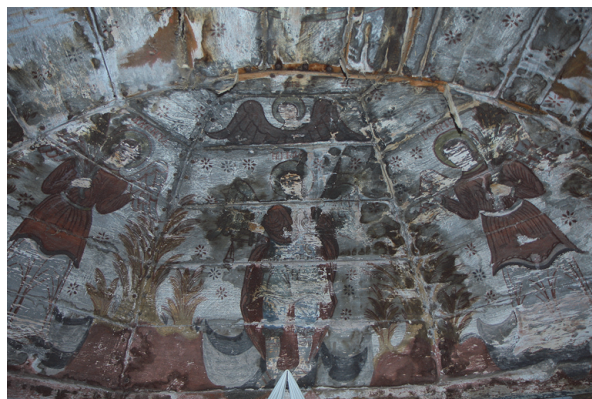
Figure 5.
Semicap altar—degradation caused by humidity infiltration.

Tannins from the wood support and solubilized organic substances were migrated in the pictorial layer in the infiltration zones (**Figure 5**).

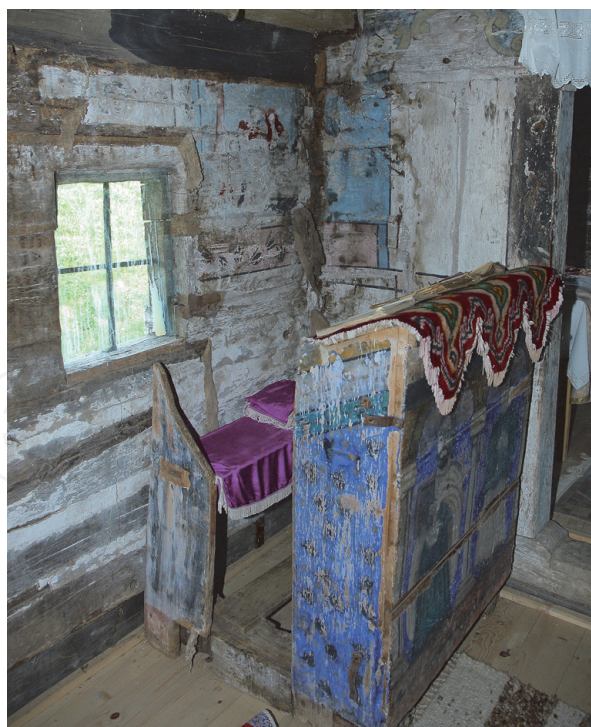
Figure 6.
Section from the north wall.

As a result of the degradation of the binder, combined with the volumetric changes of the wood substrate under the action of absorption and loss of humidity, the adhesion of the pictorial layer on the substrate also occurred, resulting in evolutionary detachments, the exfoliation being mainly in the form of roof slabs or scales and isolated alveolar forms.

These degradations were highlighted by direct visual examination and with magnifying glass, in shining light. There are massive losses of pictorial layer, up to the support, due to the wear caused by deletion and involuntary hit of the surface (**Figure 6**).

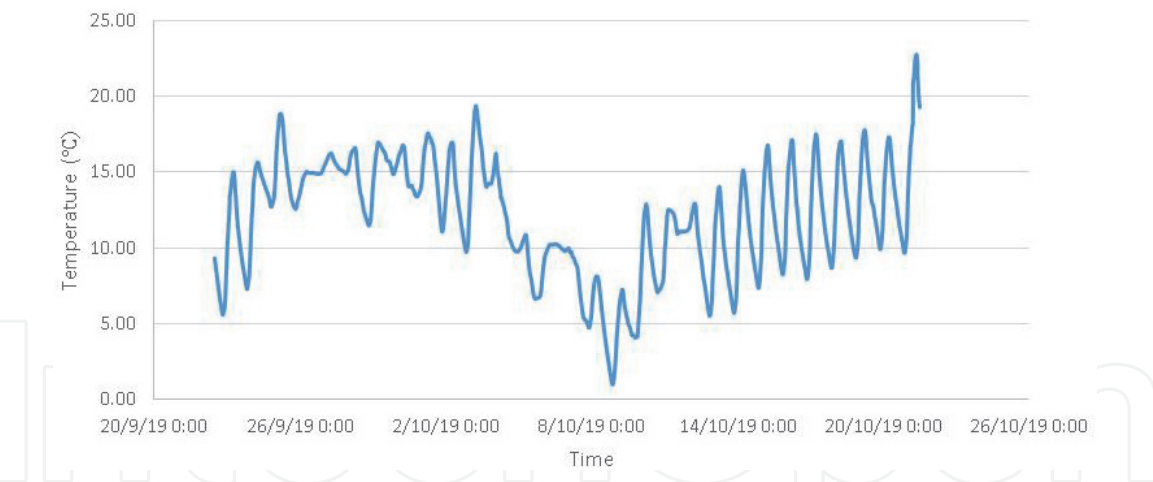
Figure 9.
Time series of indoor temperature during the second measuring campaign (September–October 2019).

Overall, an inside average temperature of 13°C was recorded during the monitoring period. However, the temperature inside the wooden church ranged between 1°C and a maximum of 33.44°C . A 36 h window (23.09.–24.09) showed a

temperature difference of 11°C indoors. These increases and decreases in temperature at such short intervals, which occur quite frequently during the monitored period, are not the most suitable conditions for the state of conservation of the painting. They produce expansions and contractions of the material, causing ruptures and cracks in the oil on the canvas. These frequent repetitions cause the material to become excessively friable [26].

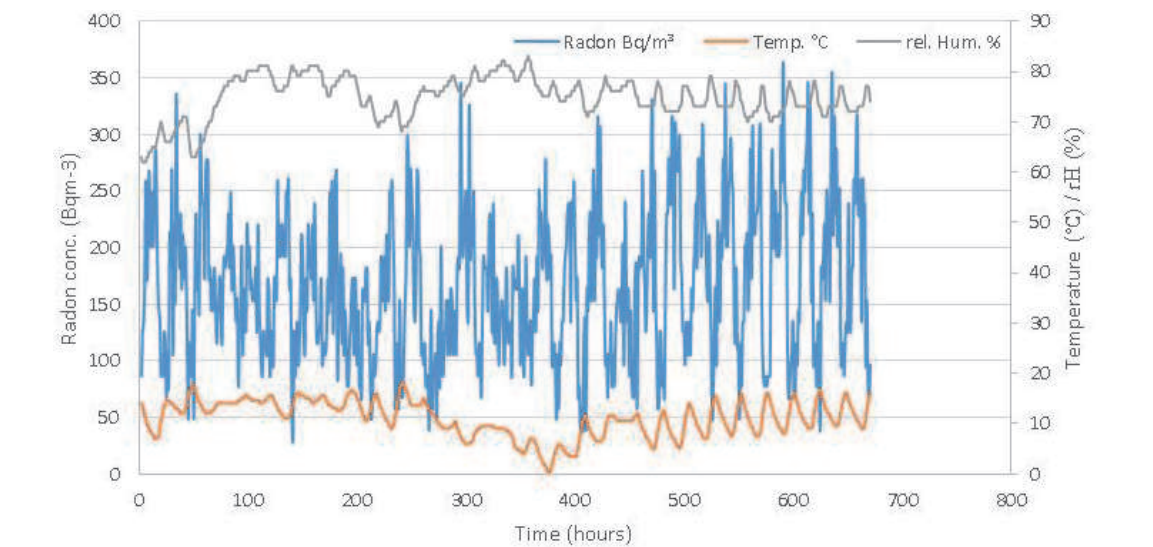
Figure 10.
Time series distribution of radon and physical parameters in the wooden church of “Archangels Mihail and Gavril,” September–October 2019.

Alongside temperature data loggers, a Radon Scout was installed to record hour-by-hour data of radon, temperature and rH indoors. During this period, a minimum value of 0.5°C and a maximum value of 18°C were recorded, leading to an average value of 12°C (**Figure 10**).

Active radon measurements carried out during the two separates campaigns yielded indoor radon activity concentrations ranging from 29 to 364 Bq m⁻³. During the first campaign, one of the windows could not be closed properly; this allowed a high air exchange rate that led to the dilution of indoor radon to an average value of 46 Bq m⁻³. By the time the second campaign took place, the faulty window was restored. The average value of 166 Bq m⁻³ was recorded during the second monitoring campaign. The indoor radon time series for the two seasons [35] monitored were represented in **Figures 7 and 10**.

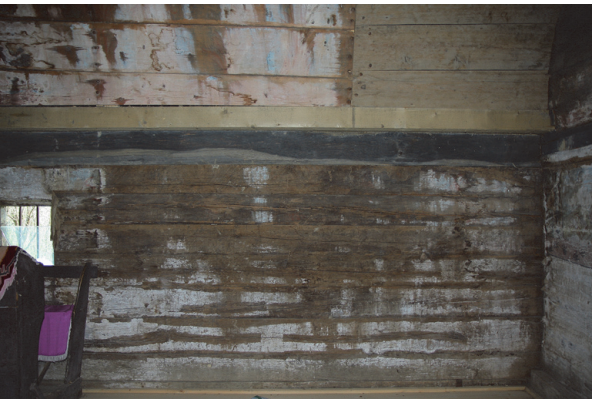
Figure 13.
Degradation state of paintings near sampling point 10, 11, and 12.

The highest average values (80.30, 80.90, and 80.30%) were recorded in sampling points 10, 11, and 12, behind the door of the church. This may explain the state of advanced degradation, the painting being almost completely obliterated, more so than in other areas inside the church (**Figures 13 and 14**).

The outdoor climatic changes increase the preservation issues inside the wooden church, causing a constant indoor microclimate fluctuation, making the task of keeping the mural painting in optimal conditions in the long term a very difficult one. Under these conditions, a recommendation would be to install a portable air

dehumidifier with a setting function allowing the relative humidity of the indoor air to be decreased between 50 and 60%.
