Correlation of Professional Performance to Acceptable IAQ in Critical Care Medical Facilities

H.W. Holder¹, K.V. Easterwood, Jr.², D.E. Johnson³,
J.W. Sealy⁴, M.D.Larranaga⁵ and D.C. Straus⁶

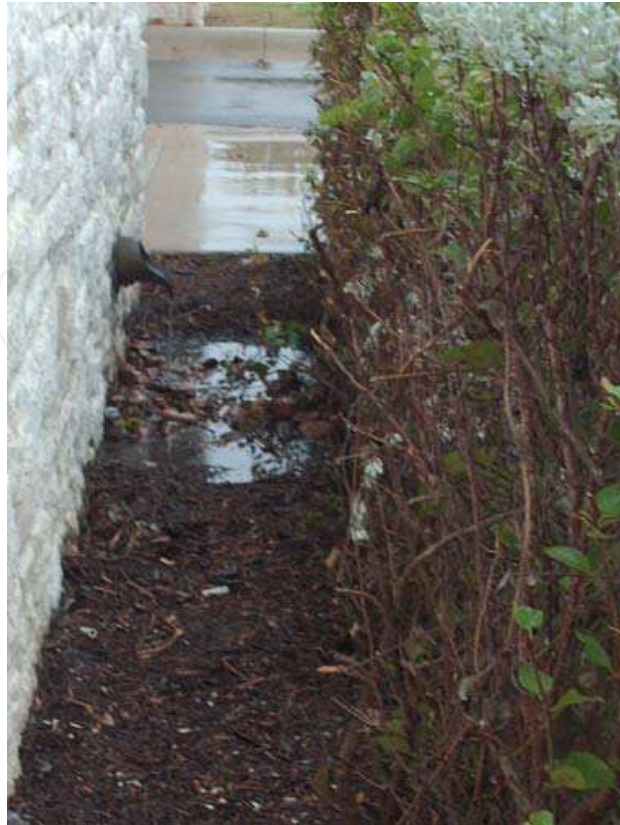
This single story surgery center was constructed in 2004. It was 19,000 square feet and constructed under a design/build delivery system.⁵ Its exterior was composed of applied stone veneer and an Exterior Finish Insulation System (EFIS). The hospital staff noticed mold growth, wild swings in temperature, and wet indoor environment almost from the day they occupied the building. An investigation ensued and determined that defects discovered associated with the shell of the building, or envelope, was a major contributor, along with the HVAC, to the difficulties they were encountering. Site drainage violated code and held water against the building. It is fundamental to the proper placement of a building to locate it on the site both vertically and horizontally. The horizontal aspect of the placement is guided by local zoning codes. Vertical placement is guided by common sense, water should drain away from a building and thus, downhill. Building codes have language to ensure that the common sense approach is met. For example the building code reads: "The ground immediately adjacent to the foundation shall be sloped away from the building at a slope of not less than one unit vertical in 20 units horizontal (5-percent slope) for a minimum distance of 10 feet (3048 mm) measured perpendicular to the face of the wall or an approved alternate method of diverting water away from the foundation shall be used." (International Building Code [IBC] Chapter 18: Soils and Foundation, 1803.3 Site Grading, 2000).

Fig. 1. Site drainage violated code and, held water against the building.

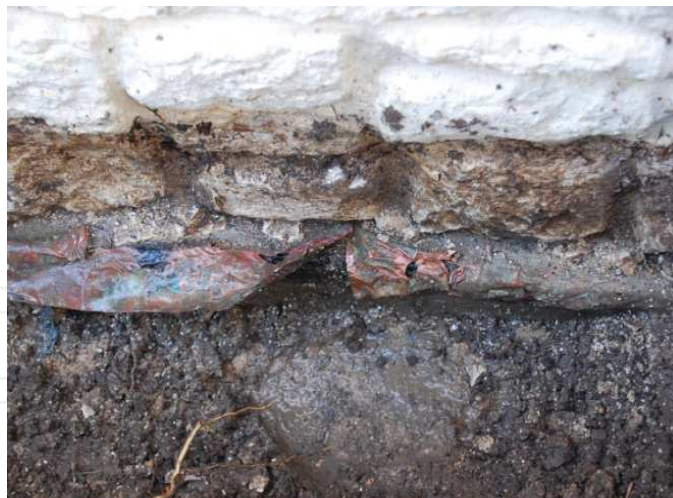
When combined with the fact that water stands against the building, the base flashing not only did not allow water to drain it instead reversed the flow of water such that outside water entered the building. The end result was mold growth along the entire perimeter of the building.

Fig. 2. The copper-coated base flashing at the applied masonry veneer wall terminated below grade and therefore did not allow for the water to drain.

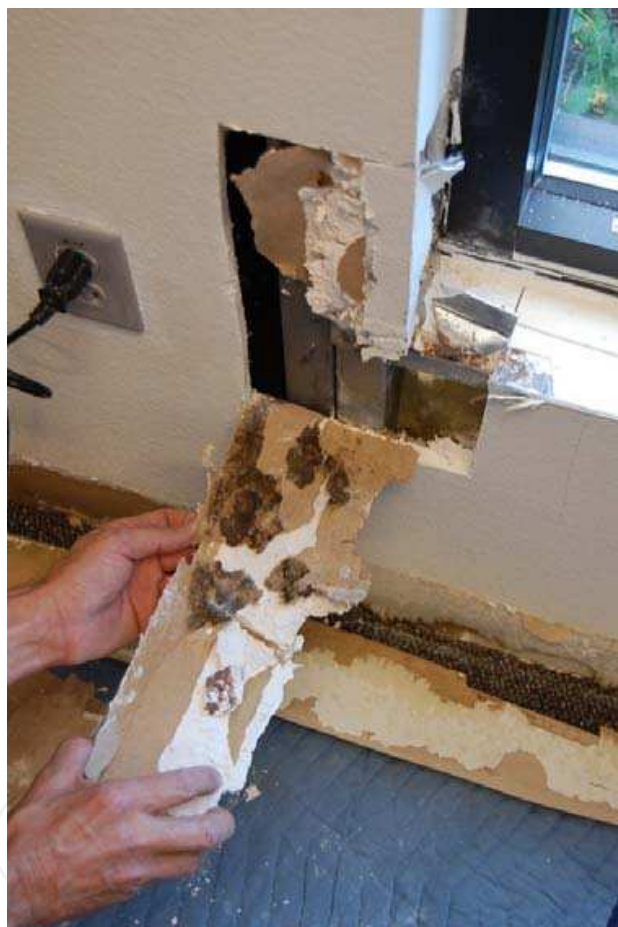
Fig. 3. Mold caused by moisture in the wall cavity.

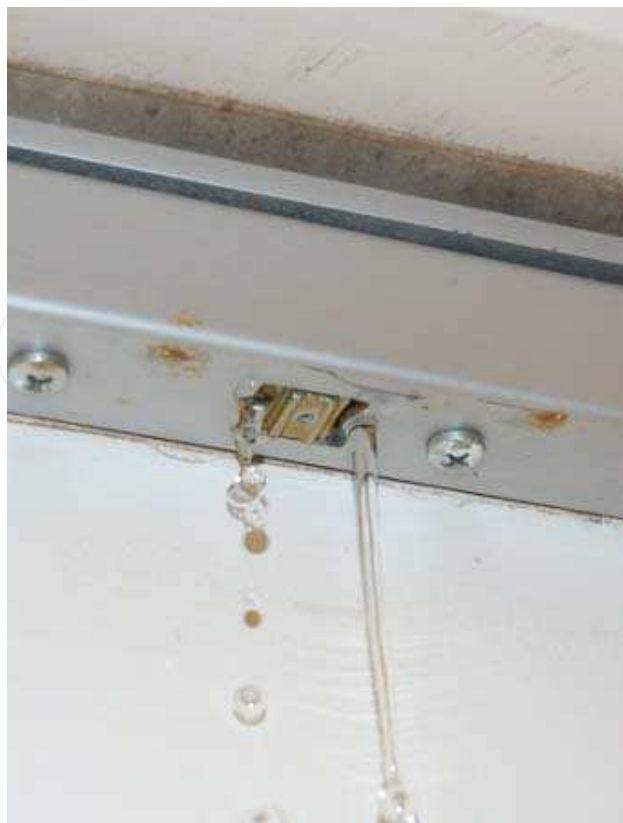
Doors, windows, and louvers all penetrate the walls, thus flashings are also used to divert water to the exterior of a building. Codes (IBC Section 1405.3; Flashing., 2003) and manufacturer's details leave no doubt that the flashing of openings is a requirement, and that information as to materials and methods are readily available. The consequence of ignorance or neglect is water pouring into the building.

Fig. 4. Water entering the building because of inadequate flashing.

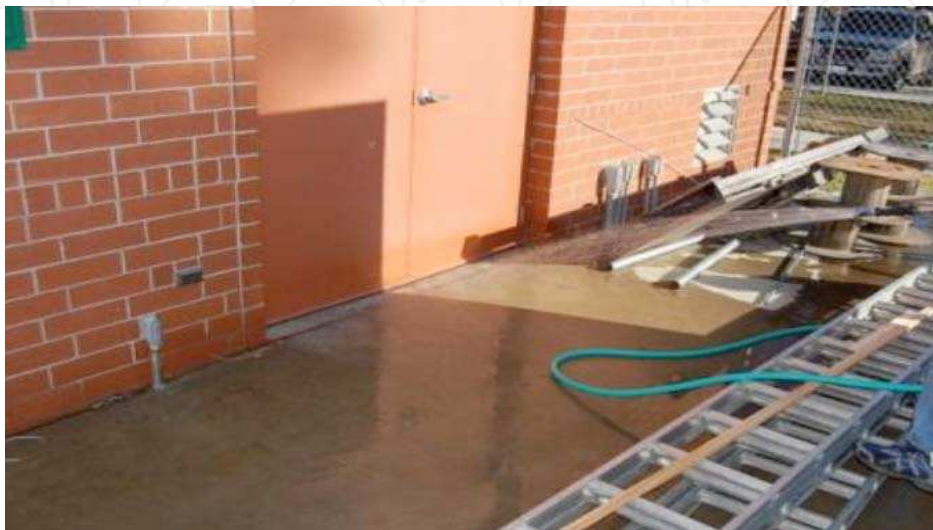
Fig. 6. Site drainage violated code and held water against the building.

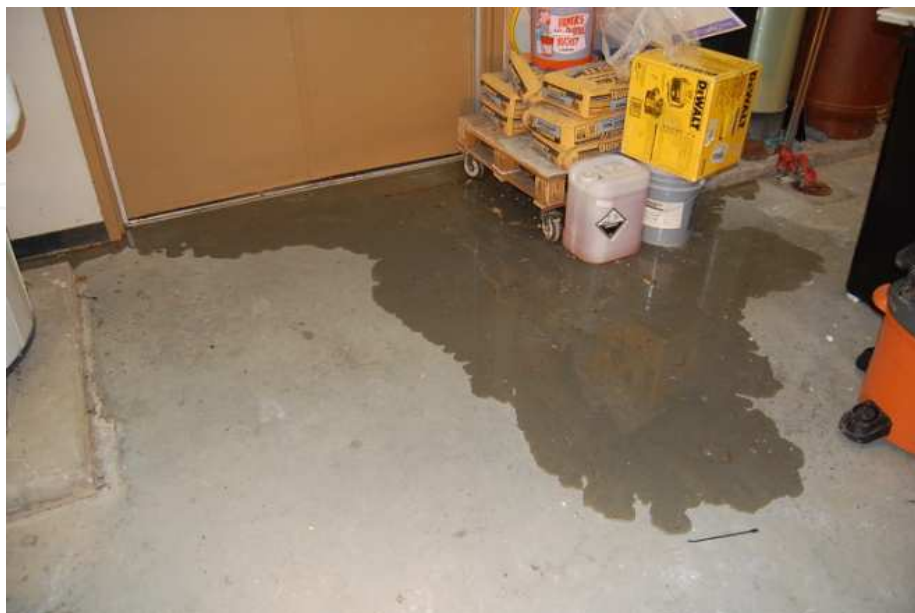
As in CS 1, common sense and conformance to building codes were not observed at this project. For example, fig. 7 showed water standing at a door that subsequently entered the building.

Fig. 7. A flawed detail at the base of the building compounded the threat to the building posed by standing water.

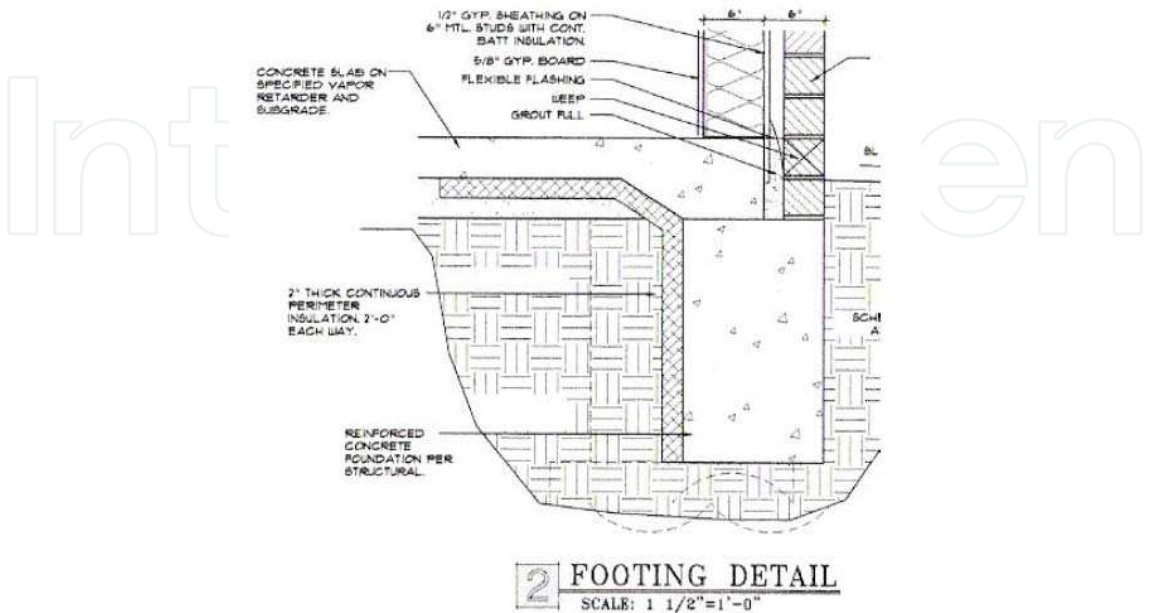
Fig. 8. The architect’s detail correctly shows the acceptable method of installing base flashing when the masonry terminates into grade.

However, he failed to follow manufacturer’s recommendations and buried the exterior sheathing into the grout fill. Inattention to detail by both architect, who failed to refer to the manufacturer’s guidelines, and contractor, who failed to notice the defect, led to the unacceptable condition. As a result of these errors water stands within the wall cavity posing a continuing threat to building materials.

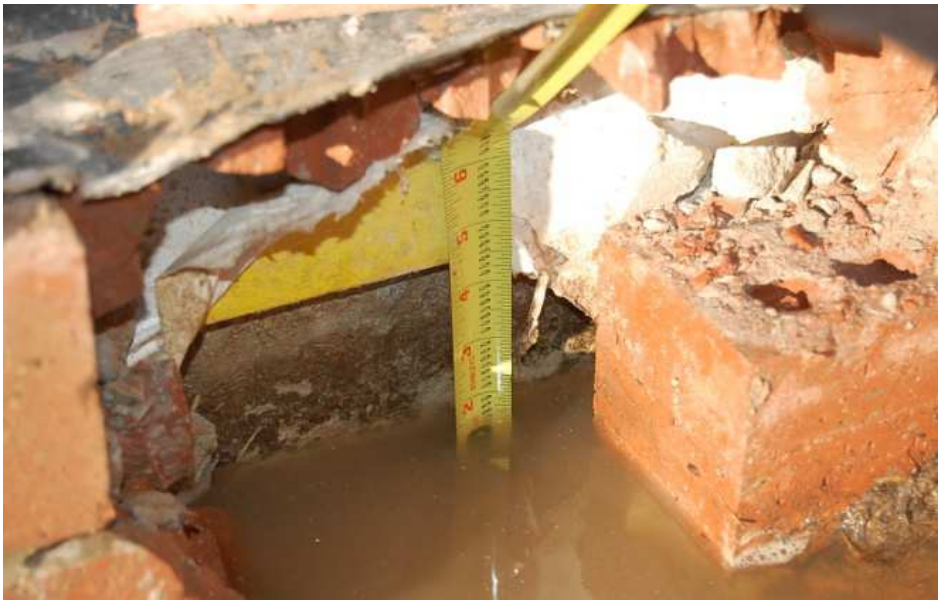
Fig. 9. Water standing inside the wall cavity.

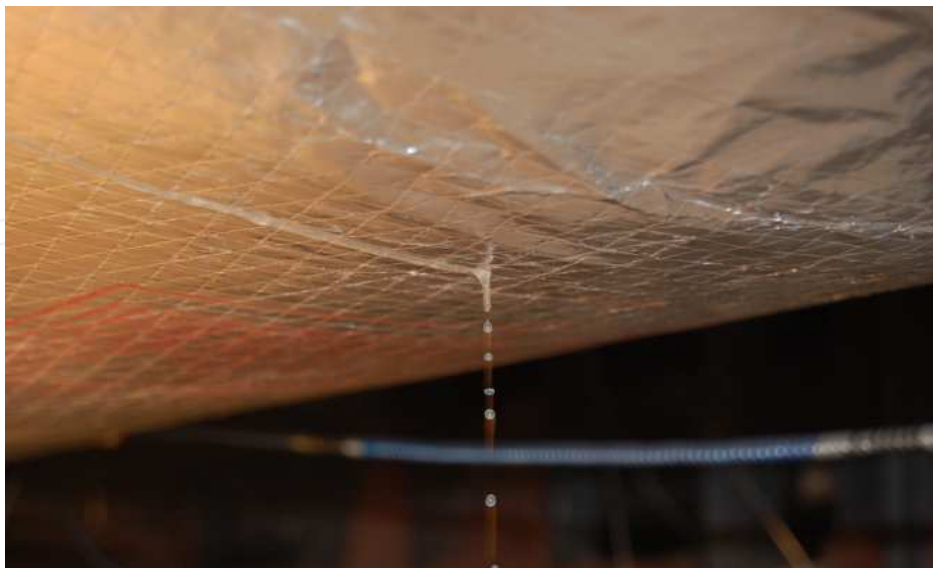
Fig. 10. Water running out of insulation.

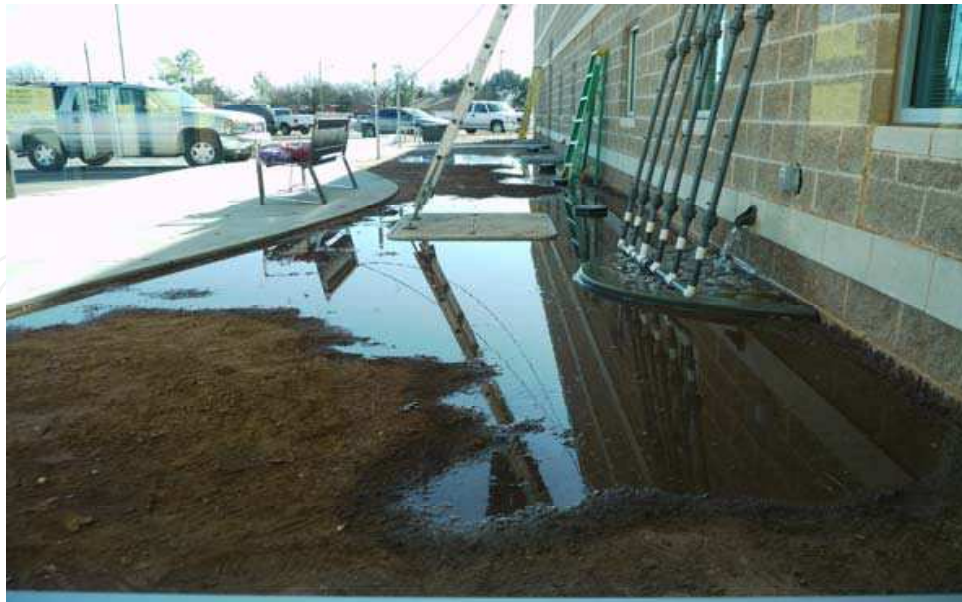
Fig. 11. Improper site grading.

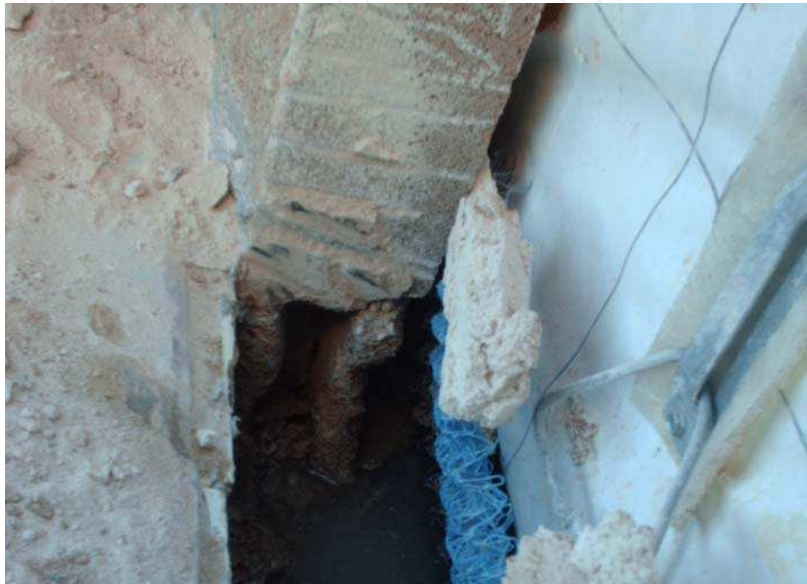
Fig. 12. Water standing inside wall cavity.

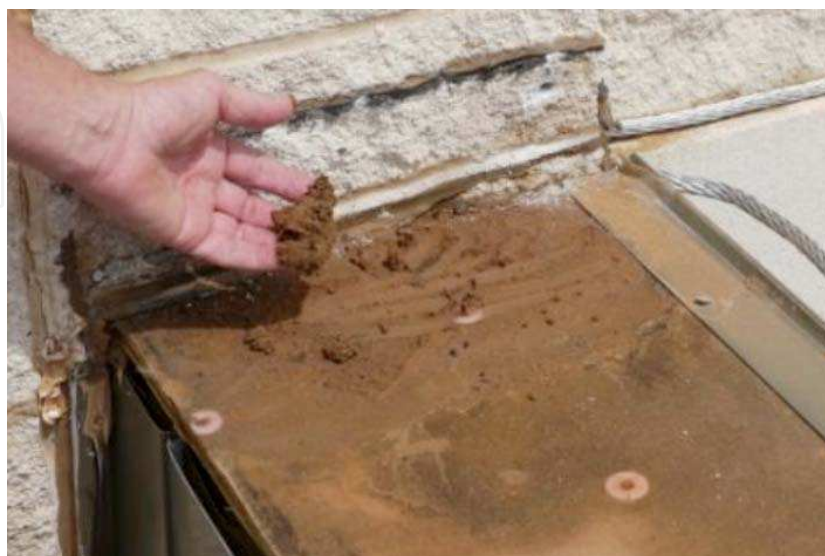
Figures 13, 14 and 15 show the progression of dust (particulate) from the parapet, into the exterior wall via mislapped flashing and finally into the ceiling space of the hospital. In agricultural settings dust is especially problematic in a critical care hospital. In a 2009 published study dust was found to contain endotoxins, allergens, microbial pathogens, bacterial toxins, fungal spores, and mycotoxins that can cause adverse human reactions. (Purdy & Straus 2009)

Fig. 13. Infiltration of dirt and moisture under parapet cap.

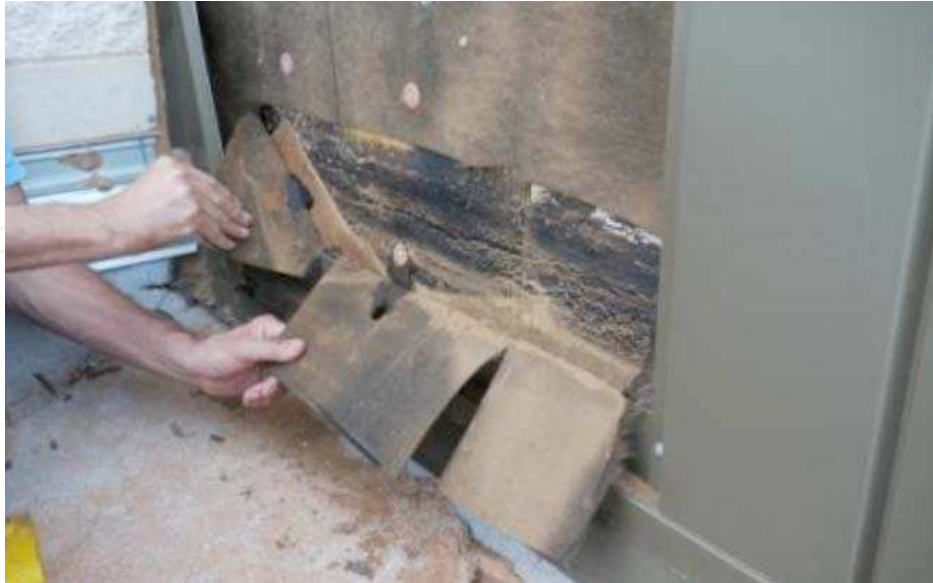
Fig. 14. Infiltration of dirt and moisture under parapet wall.

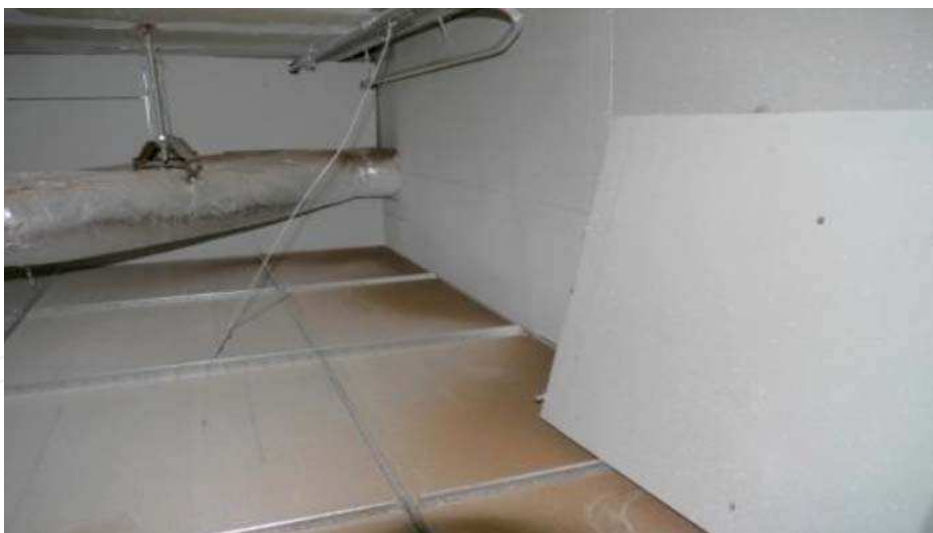
Fig. 15. Infiltration of dirt into the attic space above lay in ceiling.

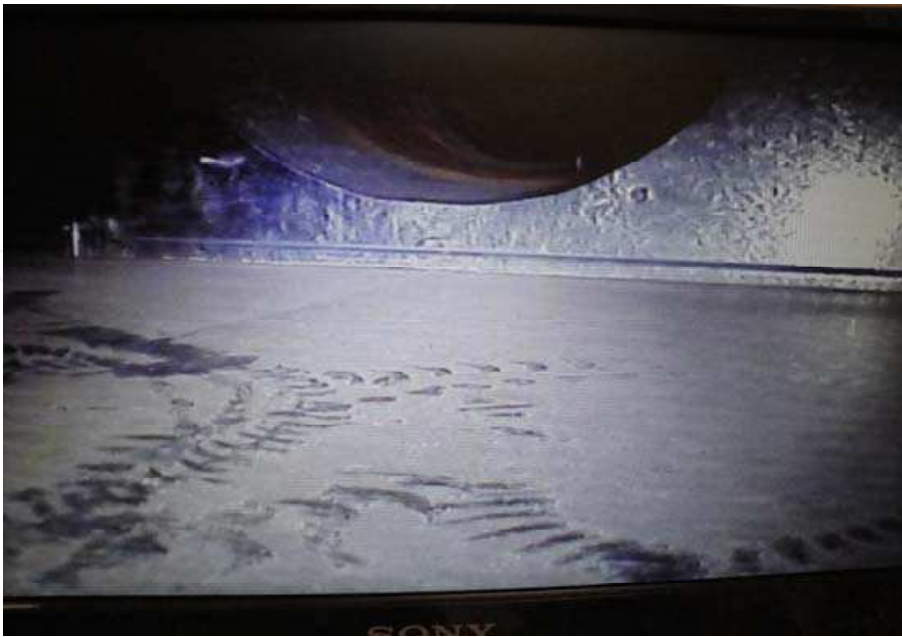
The building was under construction for a long time and the duct work was never protected during construction. The duct work was not cleaned before operating the equipment. Dust in the ductwork was deep enough to leave ruts when a robot was used to photograph the ductwork to an operating room.

Fig. 16. Tracks of robotic camera in the dust of the HVAC ductwork.

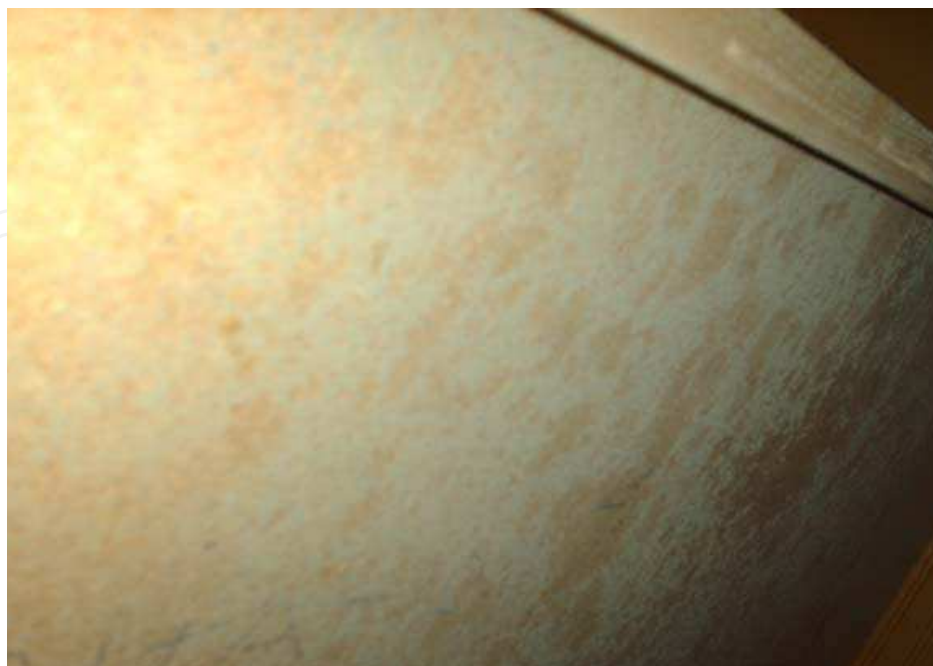
Fig. 17. Mold under a nurses desk.
