Post-Tsunami Lifeline Restoration and Reconstruction

Yasuko Kuwata
Kobe University,
Japan

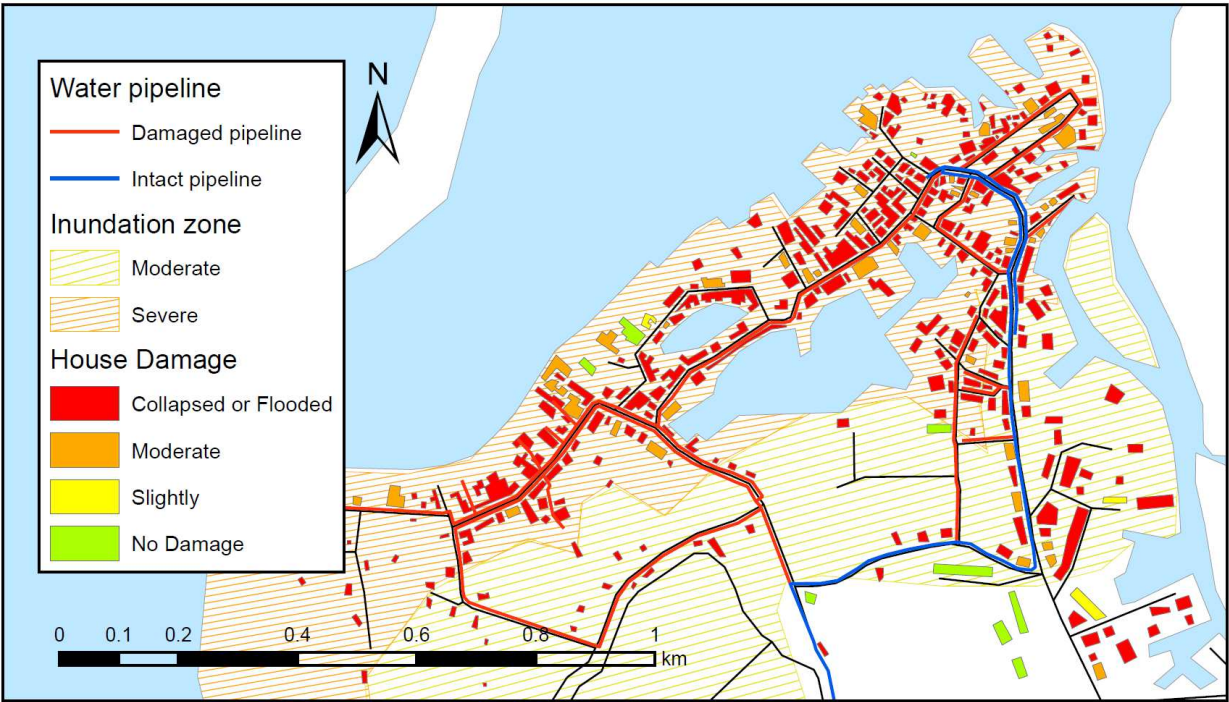
Many parts of the water pipelines were destroyed in the western part of Nam Kem village, as shown in Fig. 1, which illustrates the damaged and intact pipelines in the inundation zones. Whereas the water-supply pipelines located 200 m from the coastline were completely destroyed by the tsunami, no pipeline damage is seen in regions 500 m from the coast. The level of damage to houses is also confined to the inundation zone. The people of Nam Kem village were the most severely affected, with 199 killed and 255 missing, after the report of Bang Muang TAO (small district of Phang Nga province).

Fig. 1. Pipeline and house damage in Nam Kem village due to the 2004 tsunami. Inundation zones and house damage were taken from damage assessment reports of the local government. Water pipeline information is based on a PWWA report (PWWA, 2007)

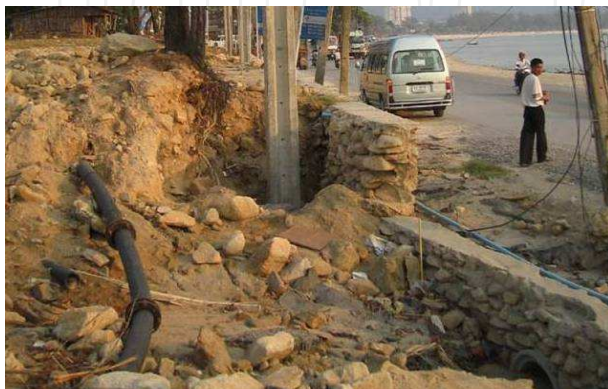
Pipeline damage was caused by collisions of driftwood and pebbles that were carried by the tsunami wave, as well as ground scouring caused by the tsunami. Coastal embankments and river bridge abutments were scoured, leaving the underground pipeline and surrounding facilities exposed (see Photo 1). There was extensive damage to the water meter because it was positioned above the ground and connected to fragile pipes (see Photo 2).

Photo 1. Exposed pipeline after scouring of embankment soil (Phuket, Thailand)

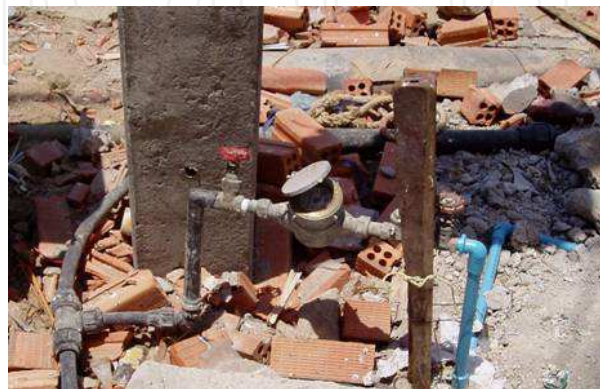
The residential pipe on the customer side of the meter was generally a fragile vinyl pipe (VP), whereas the service pipe on the PWWA side of the meter was a flexible polyethylene pipe (PE). Although the vulnerable water meter sustained severe damage, the repaired meter and piping maintained the previous standards. In addition to the physical damage to the facilities, it is believed that the water-supply facilities were broken by scrapers during the recovery work after the tsunami since the location of the pipeline beneath the ruins could not be identified. Fortunately, the water purification plant was located in the mountains as far as 18 km from the coast, and it was undamaged.

Photo 2. Water meter above ground. Black-colored polyethylene pipe is the service pipe of PWWA, and the blue-colored vinyl pipe is the residential pipe (Khao Lak, Thailand)

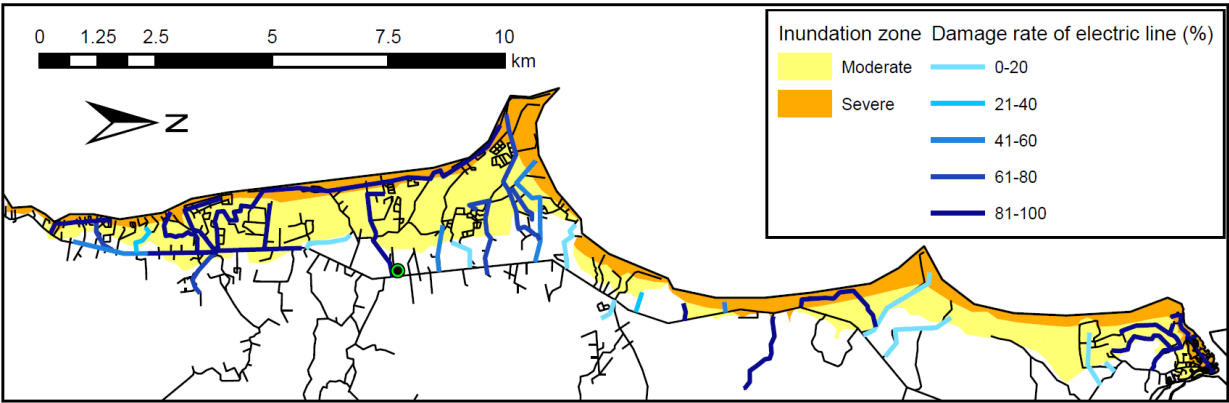
The electric power supply for the 40,000 customers of Phang Nga province is managed by Provincial Electricity Authority [PEA] of Phang Nga. Out of the eight administrative districts, Khura Buri, Ta Kua Pa, and Thai Mueang sustained severe damage to their electric power facilities. The main facilities, including the aerial electric power line, service transformer, and electric power meter, were damaged. For instance, damaged lengths reached 36 km for the high voltage line and 28 km for the low voltage line. As shown in Fig. 2, the high-voltage line ran along the main roadway, the Petch Kasem road, parallel to the coastline. The interruption in the inland low-voltage line was caused by the tsunami striking the high-voltage trunk lines along the coast. The damage rate (damaged aerial electric line length per total line length) was 80 to 100% in the inundation zone, where the inundation height was estimated to be 6 to 7 m.

Fig. 2. Inundation zone and electric power line damage in Khao Lak, Thailand. Damage rate is after Provincial Electricity Authority of Phang Nga.

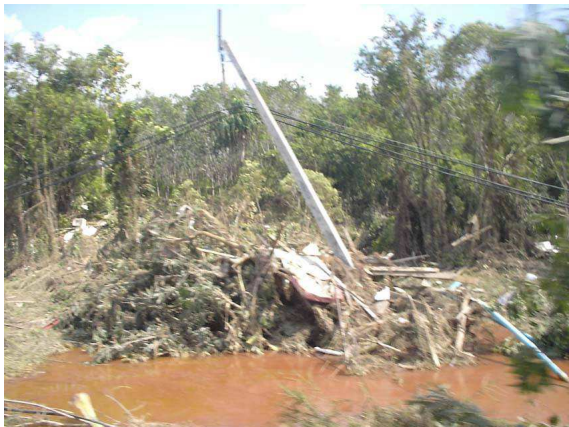
The electric power service interruption was caused by the collapse of electric poles because of the tsunami (Thailand witnessed a weak earthquake, so most of the damage was caused by the tsunami). Some poles had cracks at the bottom and others had cracks at the center. The locations of the cracks varied because of the random nature of the colliding driftwood (see Photo 3). The other cause of damage was the scouring of the pole foundations (see Photo 4), which caused the poles to tilt or fall, resulting in the snapping of the power lines.

Photo 3. Electric pole tilted by collision with tsunami driftwood (Khao Lak, Thailand)

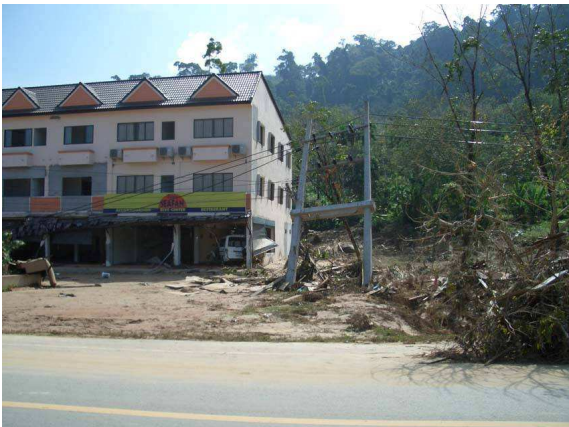
Photo 4. Electric pole tilted as a result of the scouring of the ground by the tsunami (Khao Lak, Thailand)

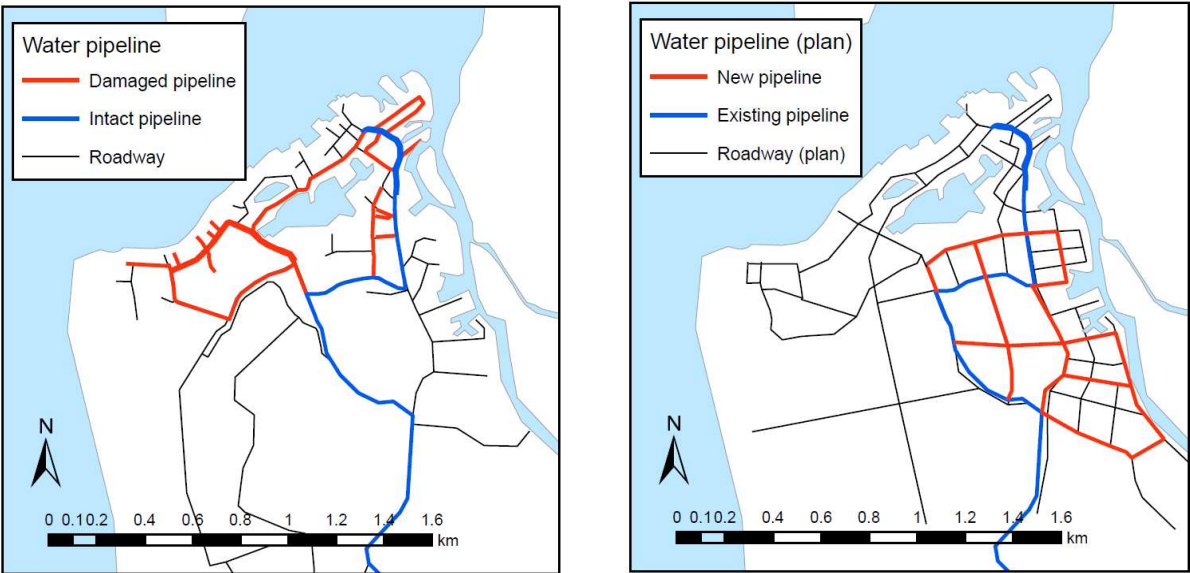
Since the land readjustment planning was accepted in the disaster restoration planning and the house rebuilding was fast, the lifeline recovery in the village was also installed in the same place as before. According to the DPT planning, the cost of the planned water-supply pipeline is estimated by the network map, as shown in Fig. 13 (2). When the repair costs of the damaged pipelines and the construction costs of the planned pipeline are compared, as shown in Fig. 12, the costs are 117 thousand USD and 105 thousand USD, respectively, which are not so different. Similarly, the costs for the electric power line are also not very different from each other. It is observed that the cost for lifeline facilities is not different between the new plan and the repair scenario.

(1) Current pipeline after tsunami (2) Planned pipeline based on DPT planning
Fig. 12. Nam Kem village reconstruction planning (DPT, Thailand)

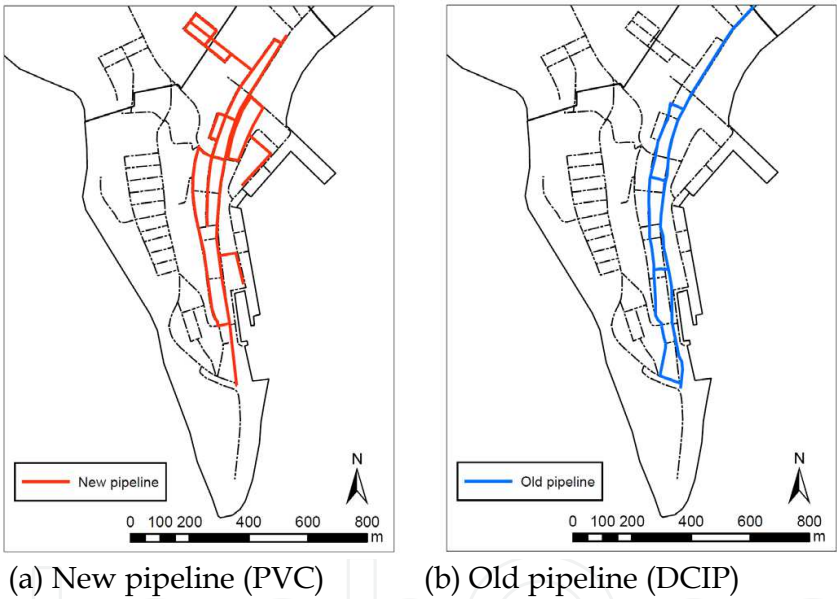
Based on the reclaimed land development and new roadway construction, the water-supply pipeline used before was left under the surface before the tsunami, and the new pipeline was constructed over it, as shown in Fig. 15. A polyvinyl chloride pipe (PVC) was adopted in the reconstruction work in spite of the ductile iron pipe (DIP), which was used before the tsunami. As shown in the plan of pipeline networks in Fig. 12, the pipeline in Aonae district was completely reconstructed. In contrast to the previous pipeline, the new pipeline draws streamline.

Fig. 15. Water supply pipeline networks of Aonae district before and after tsunami, underlying on the new roadway
