Lessons Learned from Recent Earthquakes – Geoscience and Geotechnical Perspectives

Robert C. Lo¹ and Yumei Wang²

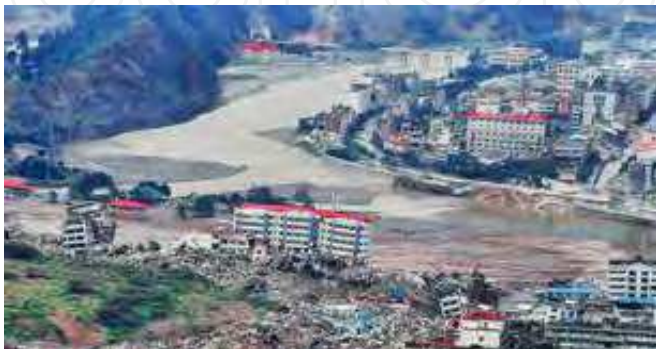
Fig. 8. Old Beichuan Town After Earthquake. <http://www.eeri.org/site/meetings/us-china-us-china-symposium>

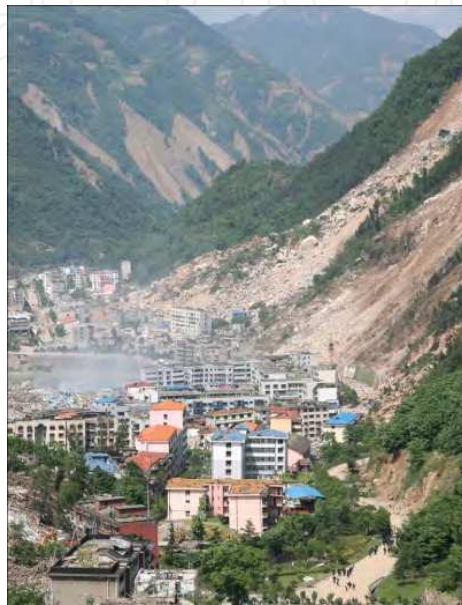
Due to the steep and rugged topography in the affected mountainous region, wide spread landslides (see Figs. 9 and 10) have been major destructing factors, besides strong earthquake shaking (EEEV 2008, EERI 2008). About 20,000 fatalities, near one-fourth of the total, were caused by 15,000 geohazards in the form of landslides, debris flows and rockfalls, with the largest landslide involving a volume of 1.1 billion m³. In the high, steep slopes (see Fig. 10) along the 270 km long Longmenshan tectonic belt, the large vertical acceleration and topographic amplification of ground motion have resulted in more than 10,000 potential geohazard sites after the event (Yin et al. 2011).

Fig. 9. Landslides in Proximity of Old Beichuan Town. <http://www.agu.org/news>

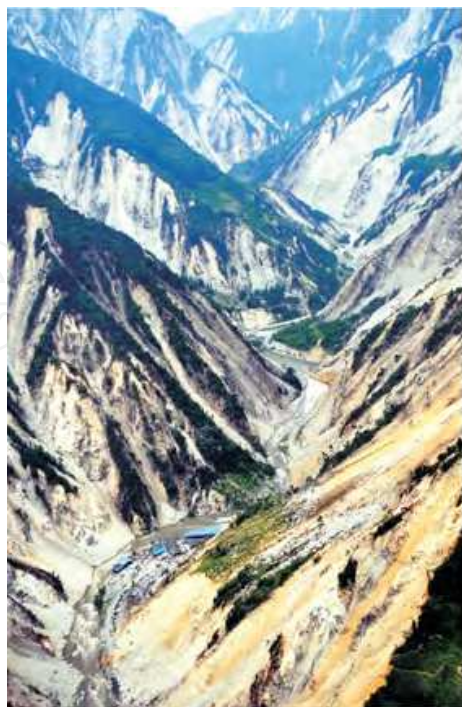
Fig. 10. Landslides along Minjiang River near Wenchuan County. (EEEV 2008)

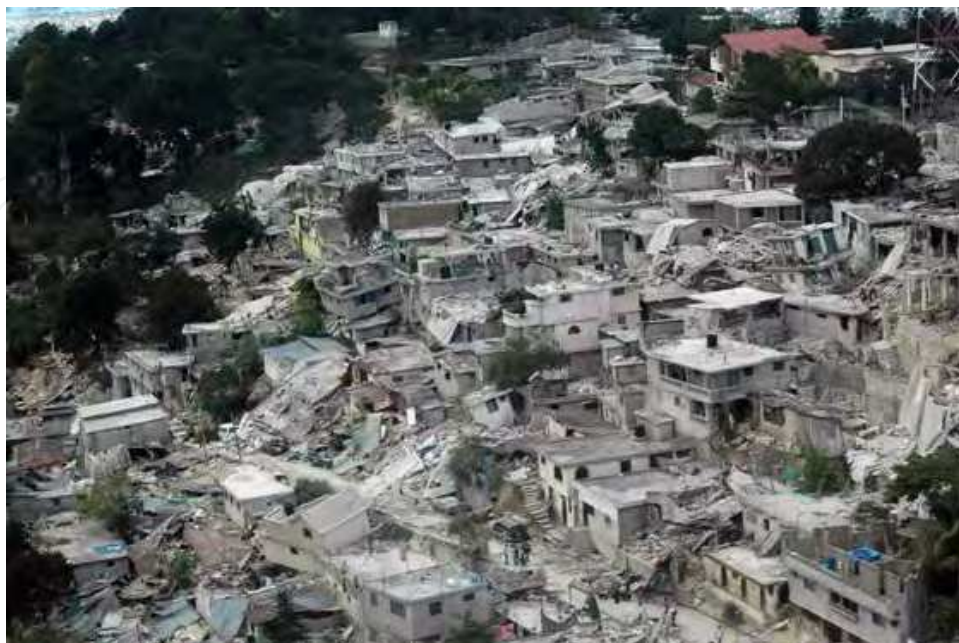
Fig. 19. Damaged Buildings Located on Hill Slope. <http://www.worldcatastrophe.com>

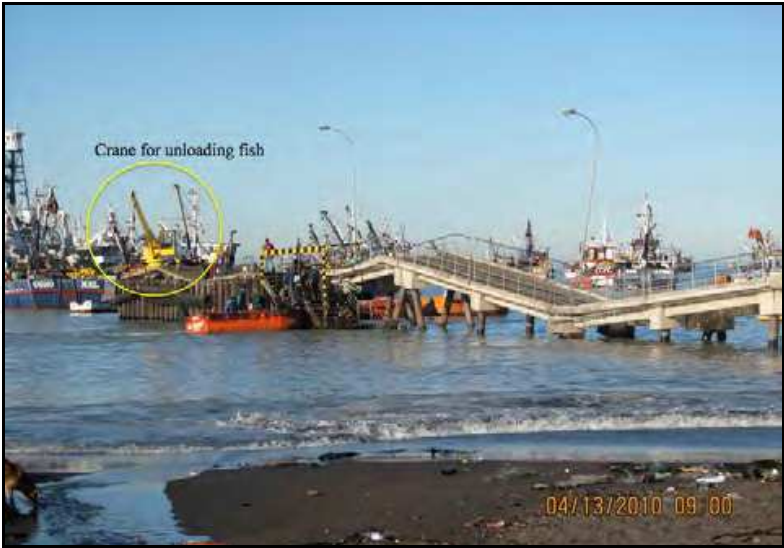
Fig. 22. Distorted Fish-Unloading Concrete Pier at Coronel Port, Chile. (TCLEE 2010)

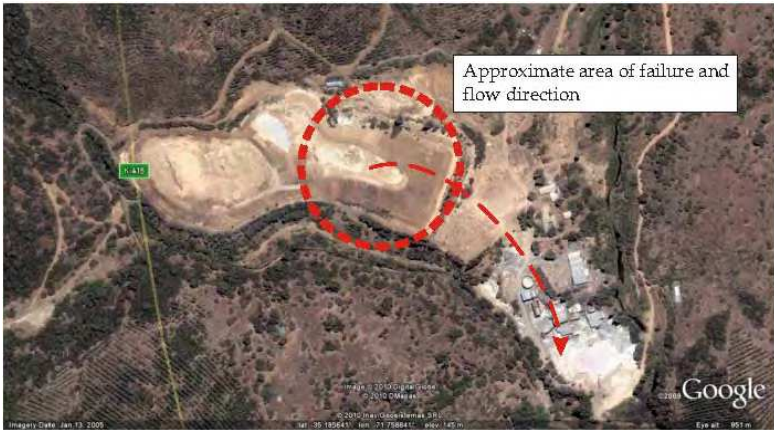
The flow failure of a tailings dam triggered by the earthquake is shown in Figs. 23 and 24 (GEER 2010). Compared with a large number of tailings dam failures in the 1965 La Ligua earthquake and two failures in the 1985 Santiago earthquake, tailings dam performance in this event seems to show some improvement. Compacted engineering fills and structures supported by improved ground using stone columns and micro-piles were reported to perform well.

Fig. 23. Bird's-eye View of Las Palmas Tailings Impoundment Prior to Failure. (GEER 2010)

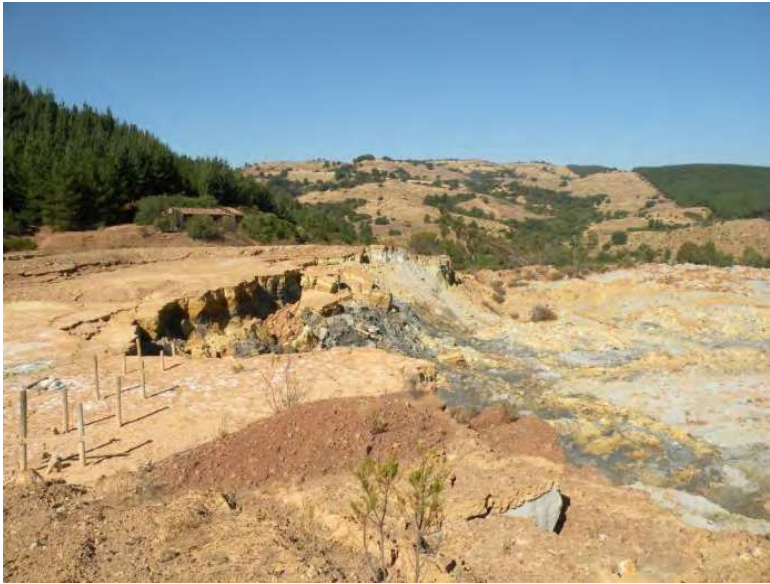
Fig. 24. Upper Scarp of Failed Tailings Impoundment. (GEER 2010)

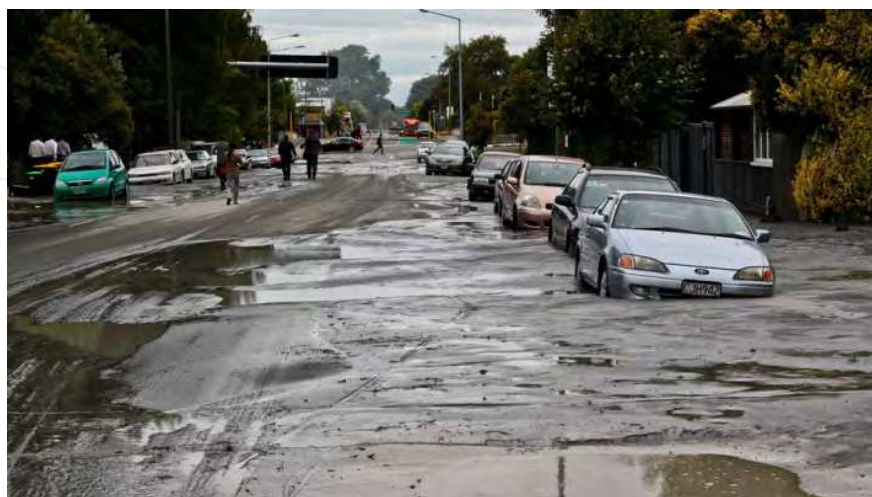
Fig. 26. Liquefied Sand Deposited on Street, 2011. [http://otilya.com/view/ News/Asia-Pacific/New-Zealand](http://otilya.com/view/News/Asia-Pacific/New-Zealand)

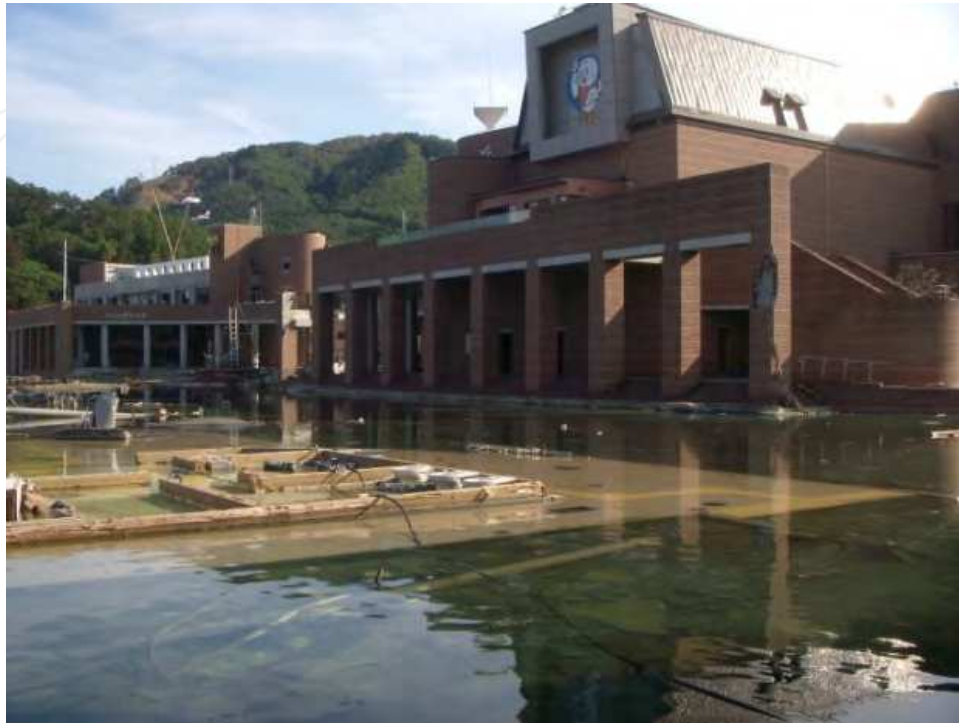
Fig. 33. Waterfront Buildings in Onagawa, Japan Inundated by Tidal Water Due to Earthquake Subsidence. http://tectonics.caltech.edu/slip_history/2011_taiheiyo-oki/index.html

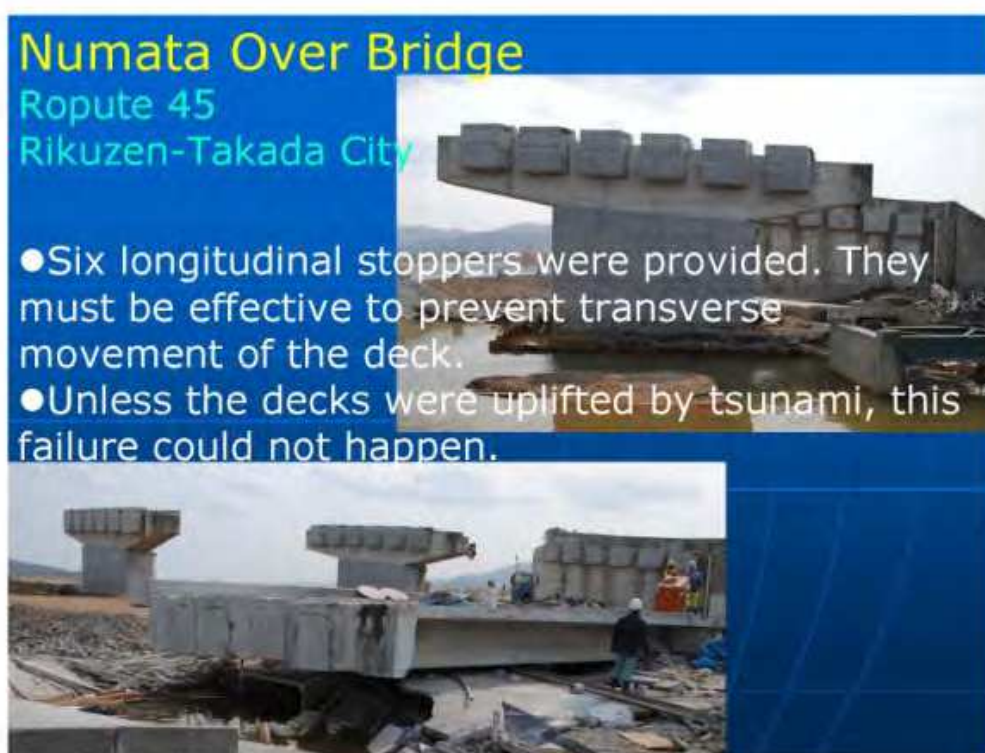
- Forces associated with tsunami – In addition to the inundation effect of rapidly moving waves, tsunami also exerts additional physical forces to structures such as hydrodynamic pressure including uplift (see Figs. 36, 37 and 38), debris impact and wave scour (see Figs. 39 and 40). The overturning of seawalls could be caused by the combined effect of tsunami hydrodynamic pressure, uplift and scour. Both passive and active measures are used to mitigate tsunami damage. Passive measures are use of buffer zone and/or natural barriers such as mangroves and sand dunes to avoid building structures in near shore areas. Where structures are required in tsunami-vulnerable zone, both inundation effect and tsunami-related forces have to be considered in the overall design and operation of these structures. Well designed concrete buildings, which have crawl space on the first floor to allow tsunami flowing through, performed well (see Figs. 41 and 42). However, the “soft-story” effect under seismic loading condition should be carefully evaluated.

Fig. 37. Uplift of Bridge Deck In Spite of Longitudinal Stoppers – Tohoku Earthquake. (Kawashima 2011)

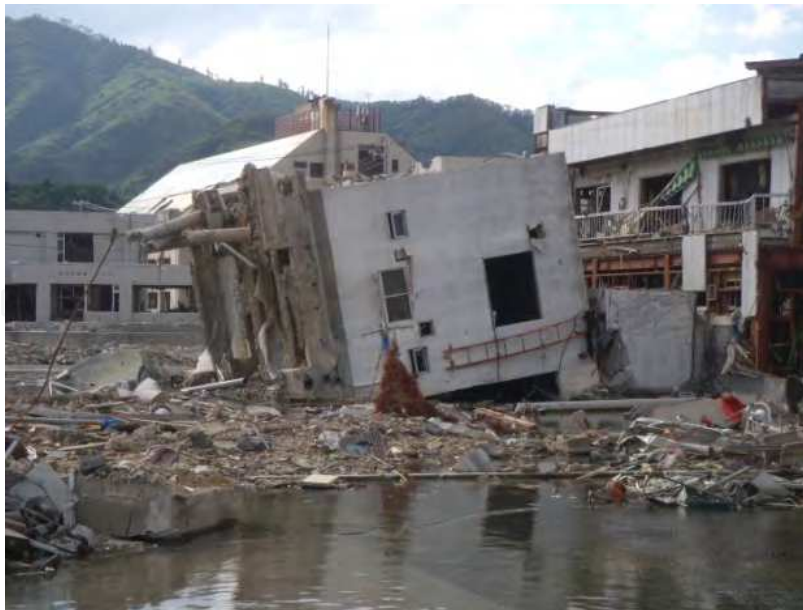
Fig. 38. Overturned Police Station, Onagawa, Japan, 2011.

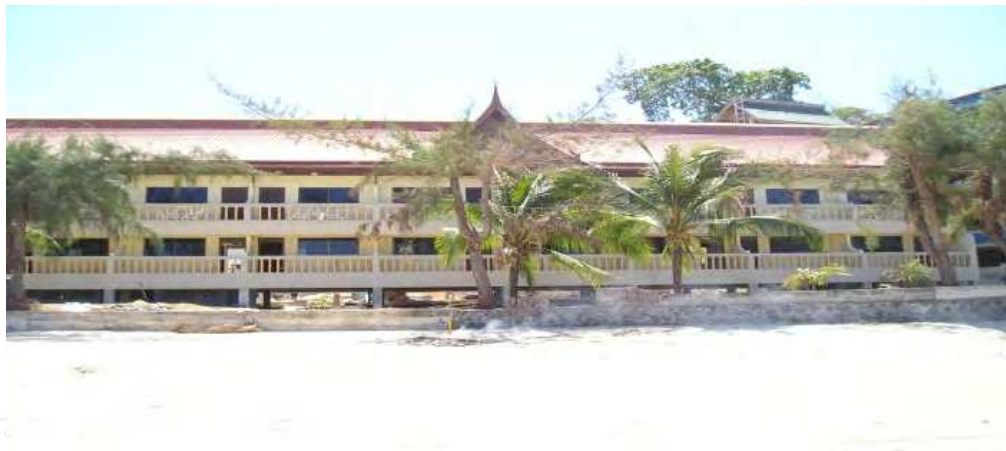
Fig. 41. Building with Crawl Space on the First Floor, Kamala Beach, Phuket Province, Thailand, 2004.

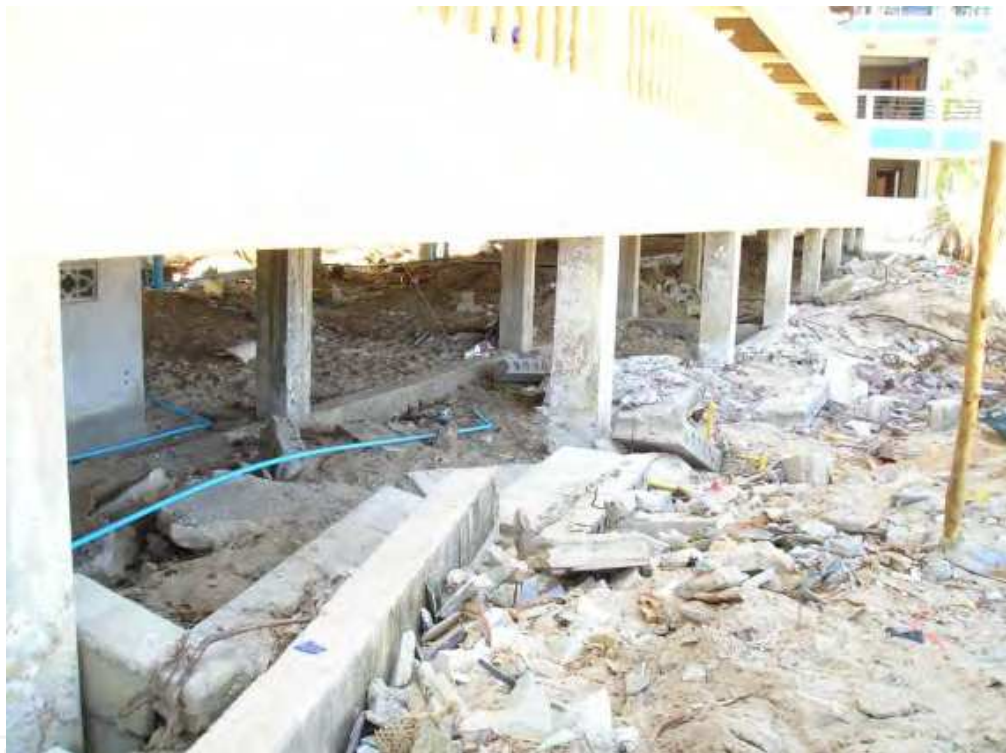
Fig. 42. Close-up of Fig. 41, Showing Inter-connected Grade Beams and Columns.

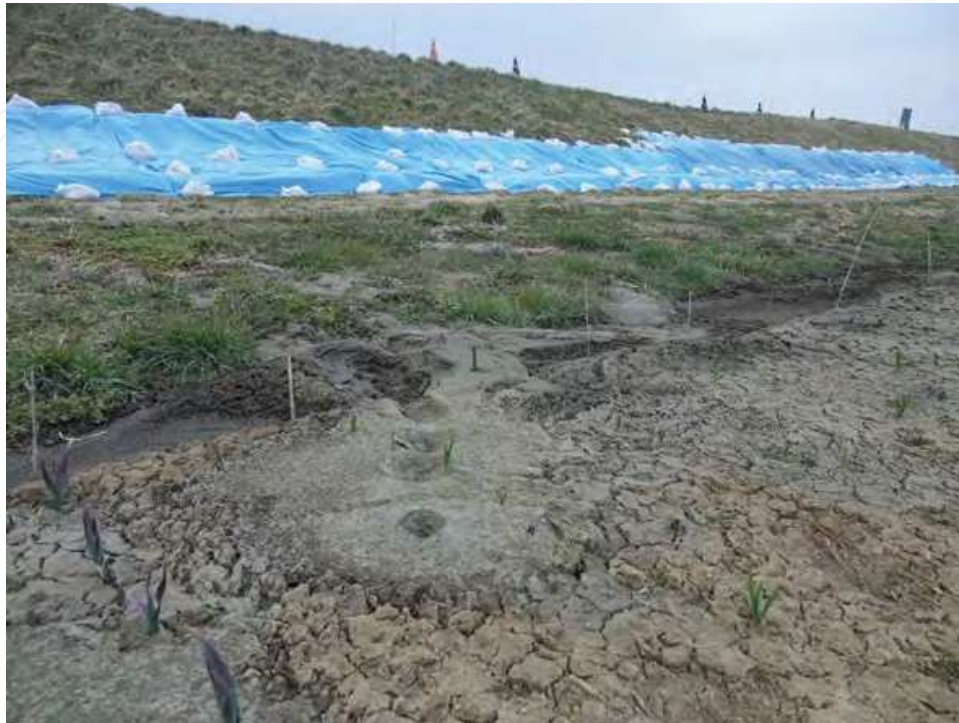
Fig. 44. Levee Slope Repair and Sand Boils at Toe, Japan. (JSCE 2011)

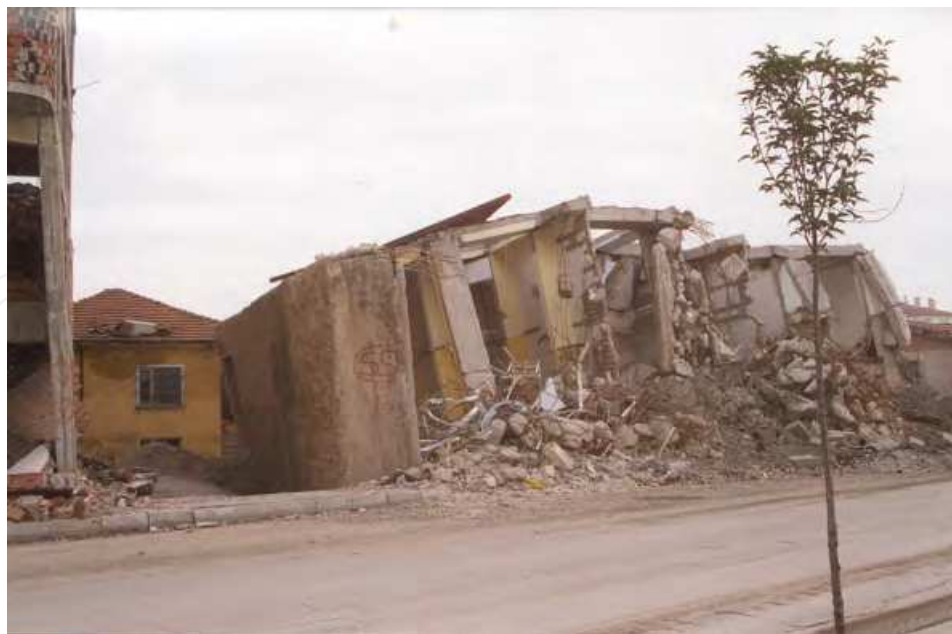
overturning of the building (see Fig. 45). This type of foundation behavior was observed in Mexico City due to the presence of sensitive Mexico City clay during the 1985 Michoacan earthquake, and again in Adapazari City due to the presence of Holocene alluvium during the 1999 Kocaeli earthquake.

Fig. 45. Overturned Building of High Aspect Ratio in Adapazari City, Turkey, 1999.

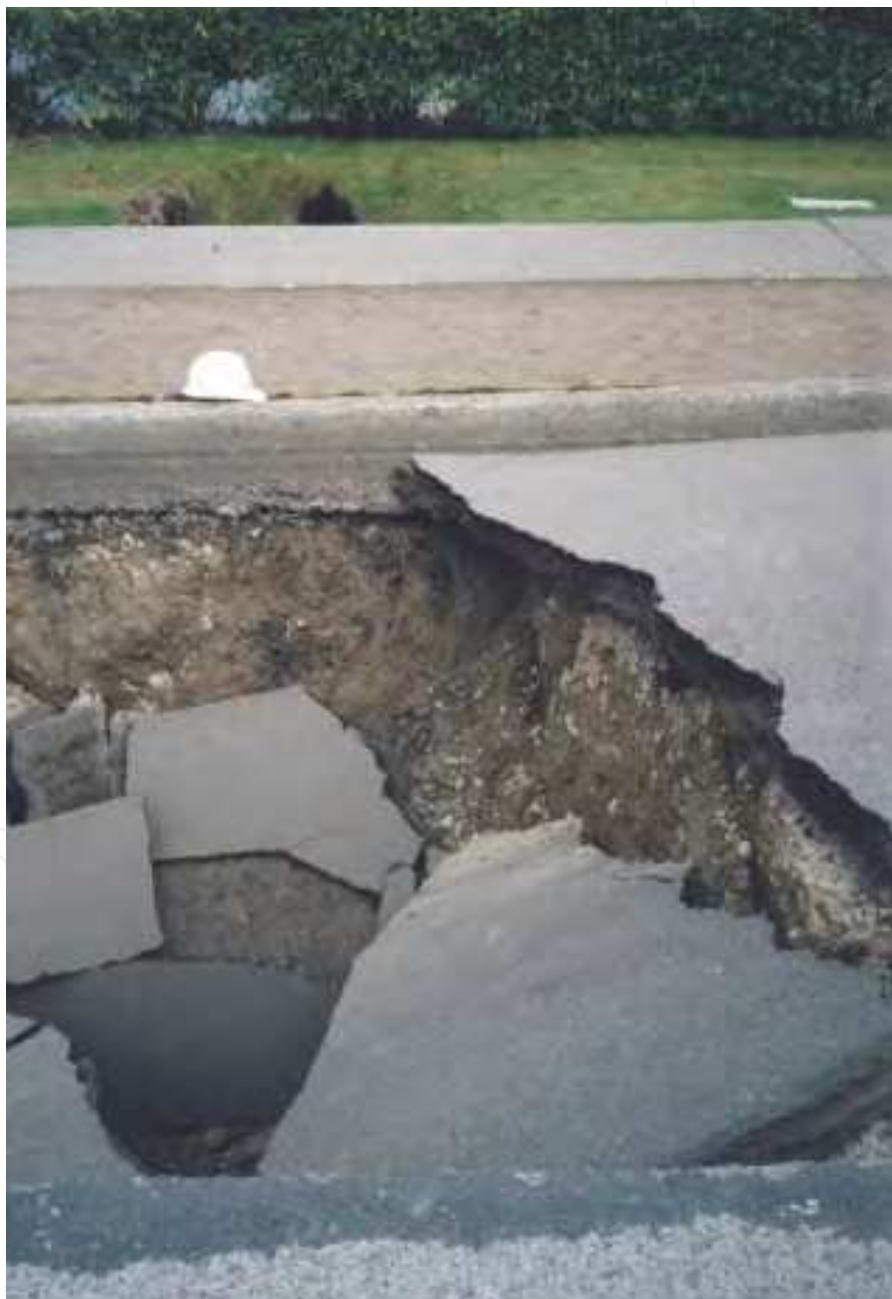
Fig. 46. Sinkhole Formed by Collapse of Roadway During Earthquake, Washington, 2001.

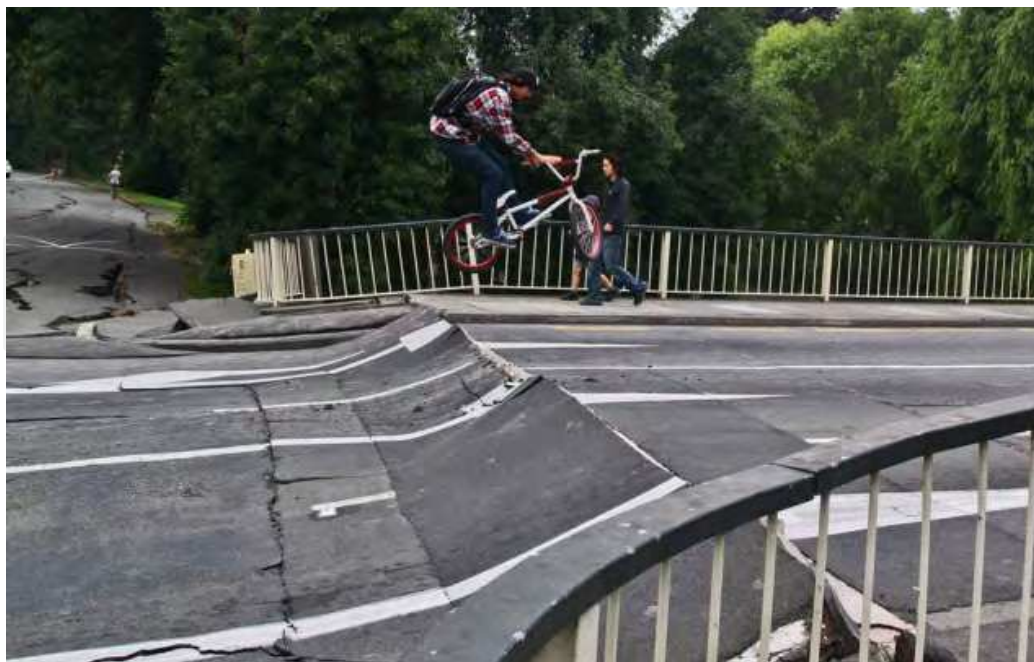
Fig. 47. Settlement of Approach Fill at Bridge Abutment Formed a Bike-Jump for a Youngster. <http://otilya.com/view/News/Asia-Pacific/New-Zealand>
