# Abrasive Effects Observed in Concrete Hydraulic Surfaces of Dams and Application of Repair Materials

José Carlos Alves Galvão,  
Kleber Franke Portella and Aline Christiane Morales Kormann  
*Federal Technological University of Paraná, Institute of Technology for Development,  
Federal University of Paraná  
Brazil*

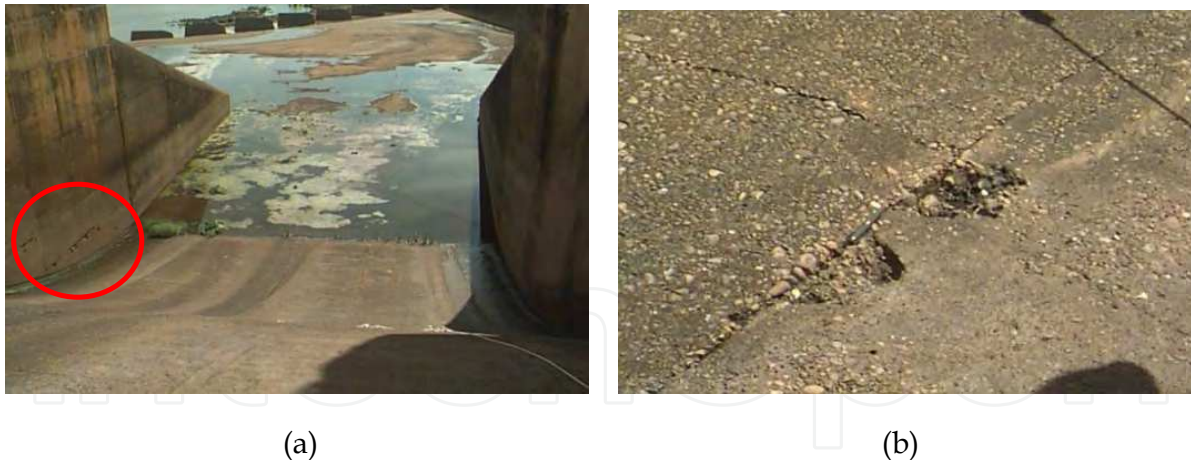
Is shown in Fig. 2a, overview of the spillway. It is observed that the wall of the gate shows signs of erosion (highlighted). Is shown in Fig 2b, defect in a slab of the spillway caused by abrasion.

Fig. 2. (a) Spillway dam presented deterioration by abrasion. (b) Defects in the concrete structure caused by abrasive process

As noted in the inspections, the state of degradation of the dam due to abrasion processes requires additional repairs to the concrete hydraulic structure. To repair the dam shown in Fig. were proposed four types of RM: mortar with silica fume, epoxy mortar, mortar and polymer concrete with steel fibers. These repair materials were evaluated for mechanical properties of strength and durability. The highlight is the test of abrasion resistance according to ASTM C 1138. The samples subjected to abrasion tests were evaluated according to the wear surface.

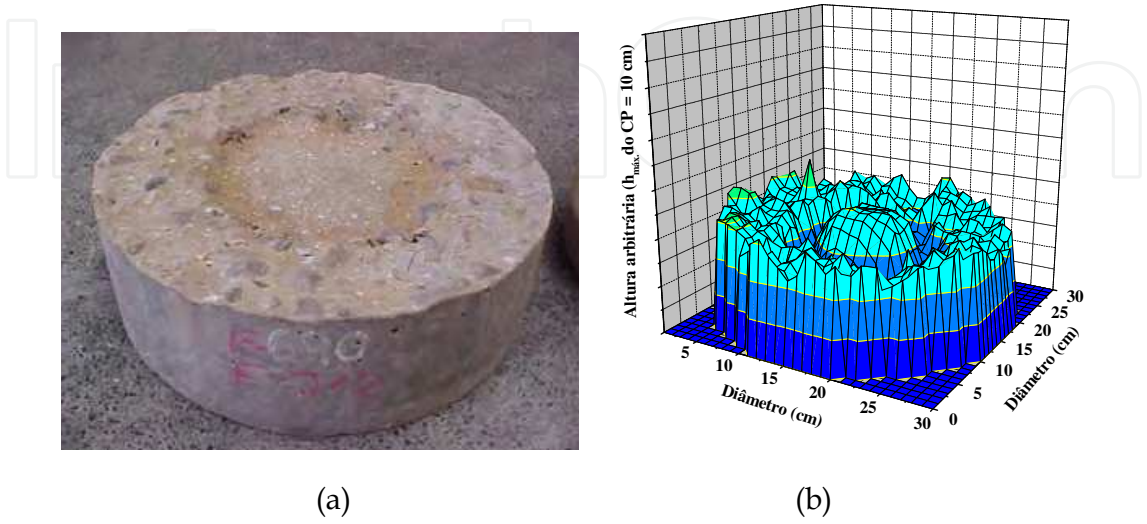
The average mass loss for the substrate system | mortar with silica fume was 5.53% and was virtually in the region of the substrate and the interface between both materials.

Fig. 4, shows the performance of the system substrate | mortar with silica fume, 72 hours after the test.

Fig. 4. Results of testing of abrasion resistance of the RM with silica fume. (a) Specimen after test. (b) 3D schematic graph of wear occurred in the abrasion resistance test (underwater method).

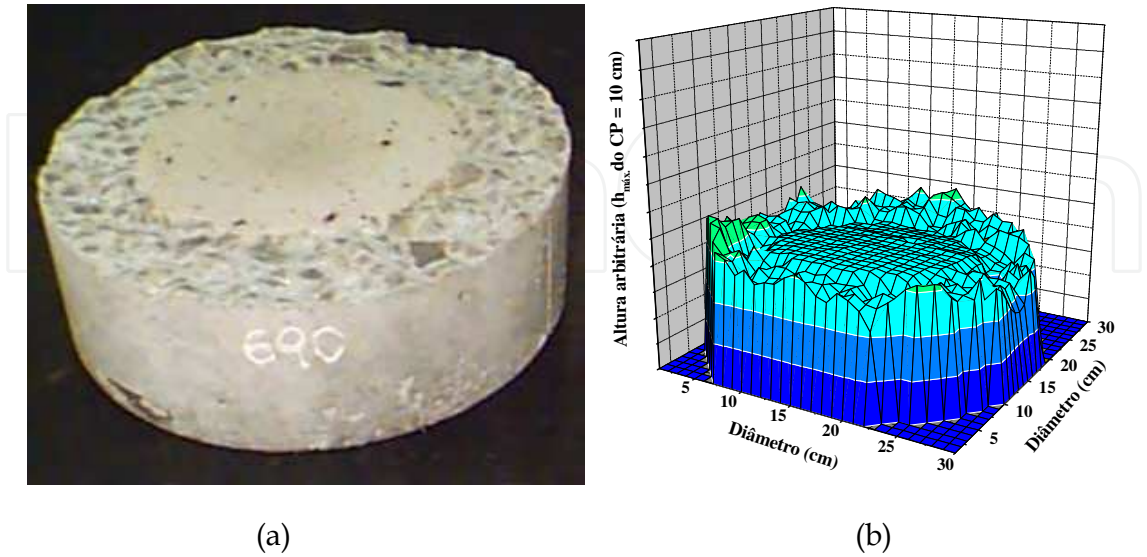
The mass loss for the substrate system | epoxy mortar was averaging 2%. It can be seen in Fig. 5 that much of the material was extracted from the substrate, with little influence in the region of interface. This effect can be attributed to high compressive strength of the material (over 90 MPa).

Fig. 5. Results of testing of abrasion resistance of the RM with epoxy mortar . (a) Specimen after test. (b) 3D schematic graph of wear occurred in the abrasion resistance test (underwater method).

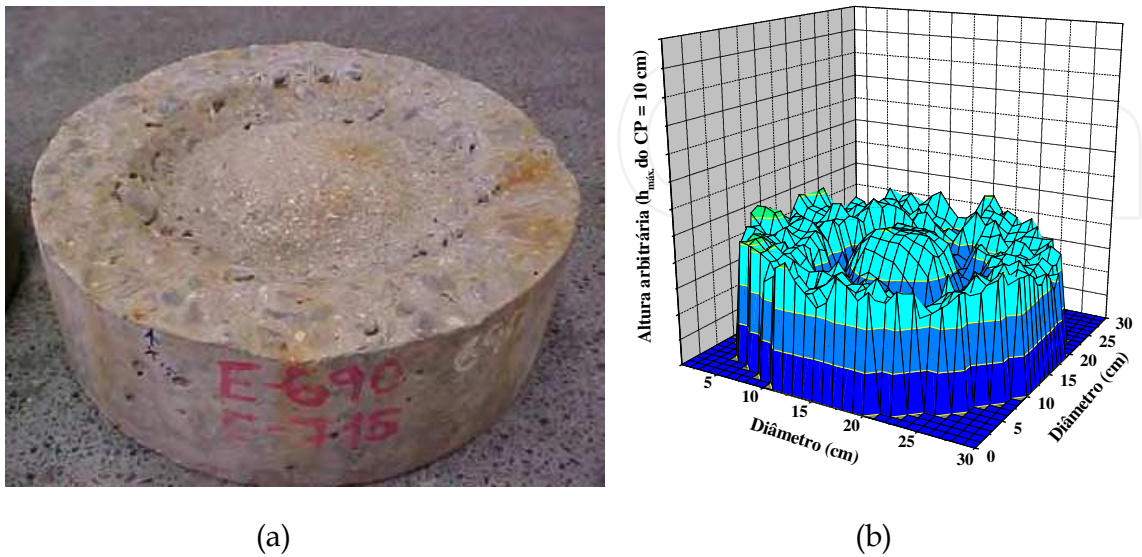
In Fig. 6, shows the performance of the system substrate | polymer mortar. The average weight loss was 6.4% and located in the substrate interface | polymer mortar.

Fig. 6. Results of testing of abrasion resistance of the RM with polymer mortar . (a) Specimen after test. (b) 3D schematic graph of wear occurred in the abrasion resistance test (underwater method).

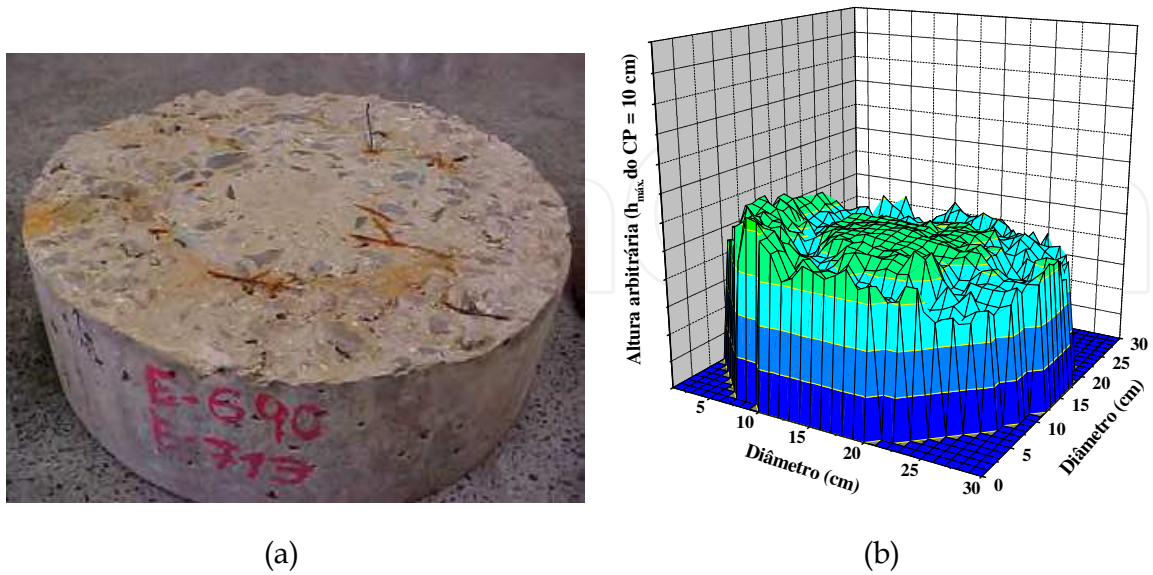
The effect of abrasion on the test substrate system | concrete with steel fibers was also not very pronounced. The mass loss was more intense in the region of RC, as shown in Fig. 7.

Fig. 7. Results of testing of abrasion resistance of the RM with concrete with steel fibers. (a) Specimen after test. (b) 3D schematic graph of wear occurred in the abrasion resistance test (underwater method).

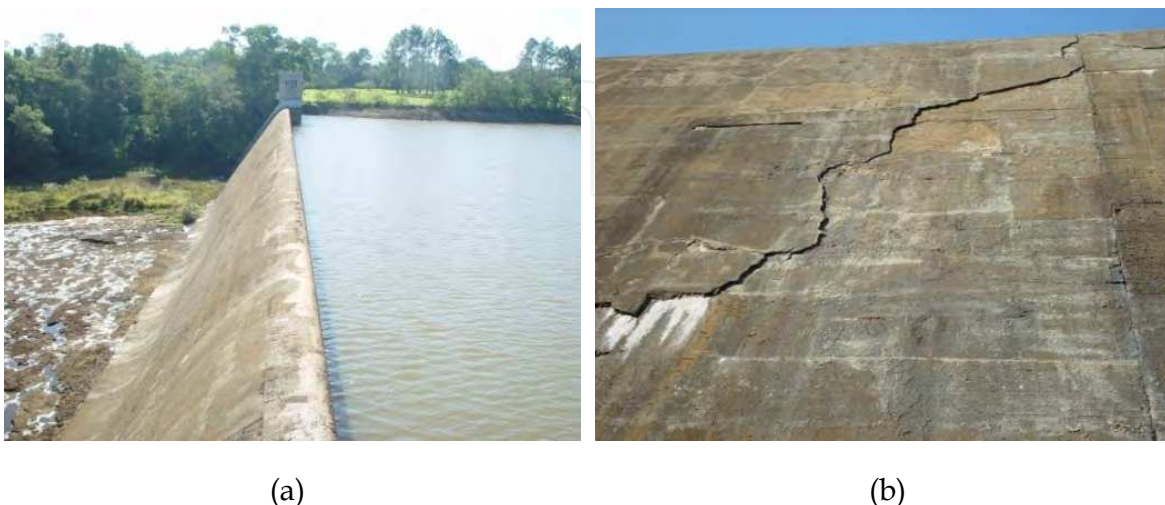
In Fig. 8a presents the overview of the spillway of the dam and in Fig. 8b, a detail of the displacement of the surface caused by hydraulic abrasive processes.

Fig. 8. (a) Overview of the spillway of the dam. (b) Detail of the displacement of the surface caused by hydraulic abrasive processes.

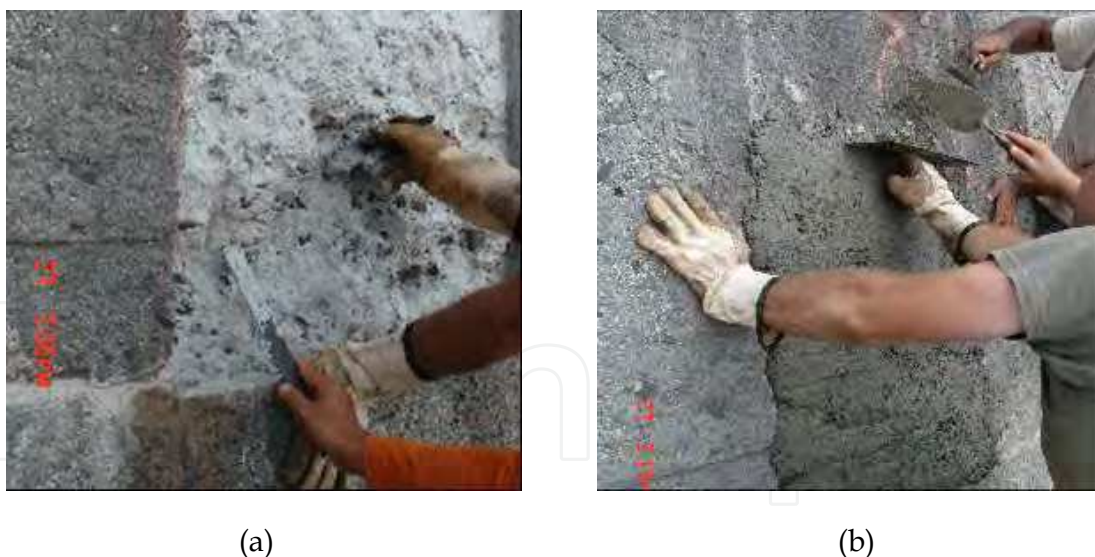
Fig. 10. (a) Application of bridge bonding. (b) Launch of the repair material.

As a bridge bonding was applied on the dry surface substrate, a structural adhesive epoxy resin of high viscosity (Fig. 10a). This care has been taken to ensure good bond strength between the substrate and RM.

The concrete was cast into the point of application of the substrate with a trowel and pestle, removing air bubbles from the material (Fig. 10b).

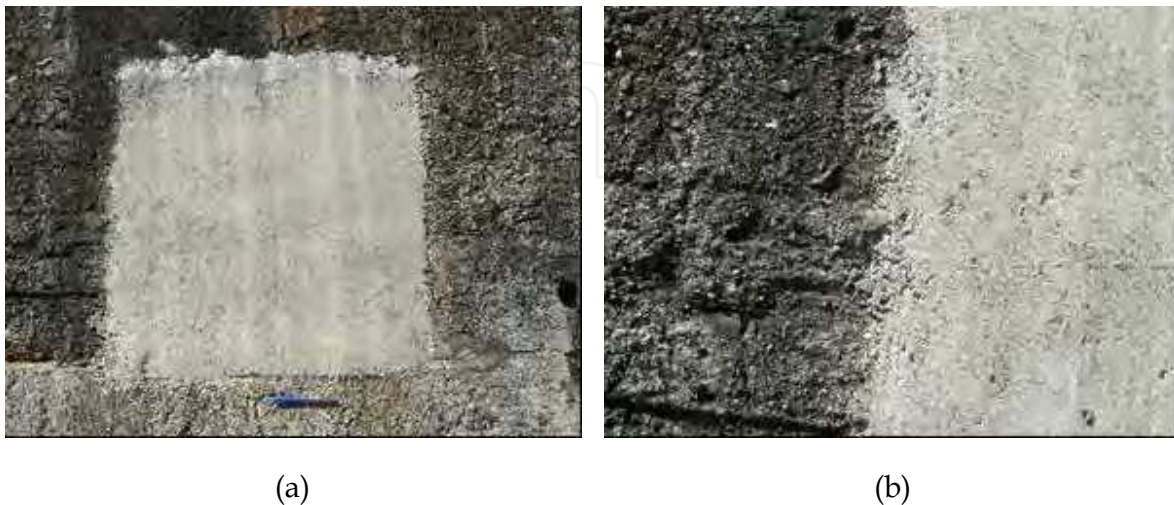
It can be seen in Fig. 11a the repair material applied to the surface of the hydraulic concrete structure is well adhered to the substrate. In the detail of Fig. 11b the interface between old concrete and the RM applied not showed flaws or defects, even after the period of water flow in the spillway of the dam and the middle attacks.

Fig. 11. Application point of repair material. (a) Reference concrete without additions. (b) Detail of the border between the RM and the substrate.

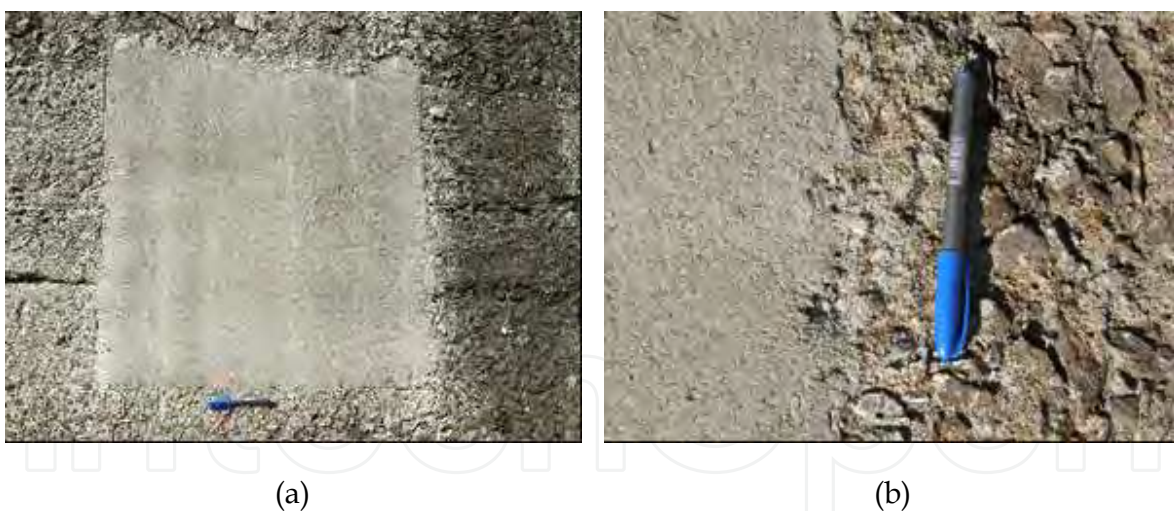
Fig. 12. Application point of repair material. (a) Concrete with addition of recycled LDPE in the content of 2.5%. (b) Detail of the border between the RM and the substrate.

It appears that the point of application above a superior performance compared with other repair materials. At this point the surface has good finish, smooth and free of imperfections, even after the occurrence of water flow in the spillway and aggression in the middle. At no point were visually observed cracks or fissures.

The defects in the substrate were completely contained at this point of application of RM made of concrete with added content in 2.5% recycled LDPE material.
