Seismic Performance of Historical and Monumental Structures

Halil Sezen and Adem Dogangun

1. Introduction

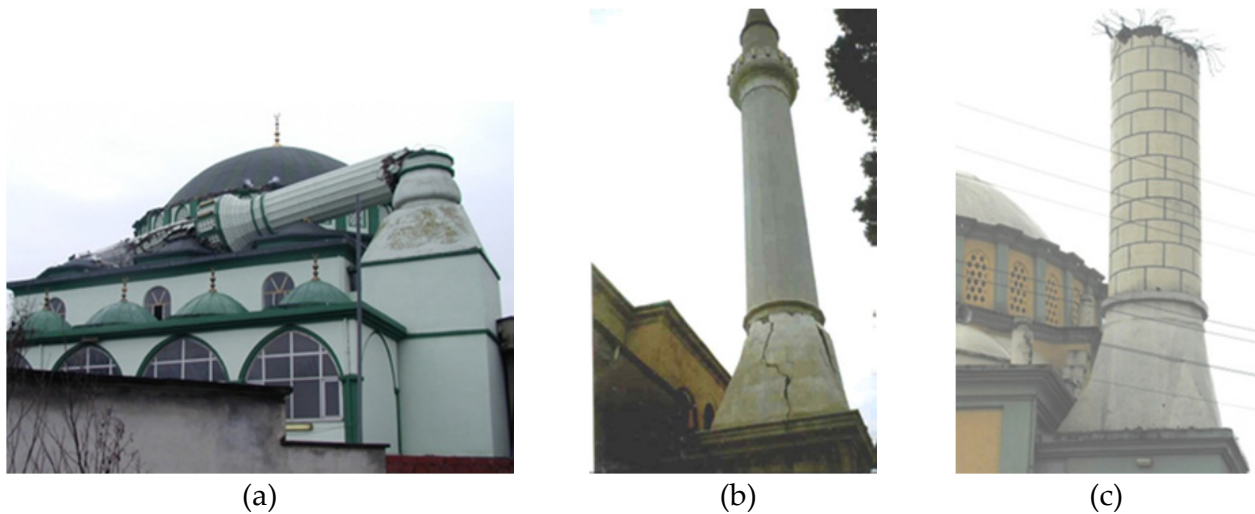
As illustrated in Figures 6b and 6d, percentage of all damaged minarets and only RC minarets are similar. Almost forty percent of the minarets collapsed, and approximately one third of the minarets were undamaged. Failure plane for almost all collapsed RC minarets was within 1.5 meter long region above the minaret base or pyramid-shaped transition segment (Figure 7a), where the longitudinal reinforcing bars were usually spliced. Horizontal circumferential cracks and spalling of concrete were commonly observed at the bottom of the cylindrical body of RC minarets (Figure 7a). Frequently, flexural cracks, concrete crushing or spalling was observed in this region of the damaged RC minarets. As shown in Figure 7, less frequently collapse or damage occurred within the transition segment and middle of the cylindrical body or near the top of the minaret.

Figure 7. Collapse of a minaret near the bottom of cylinder (left), minaret damage within transition segment (middle), and collapsed minaret at mid-height of cylinder (right)

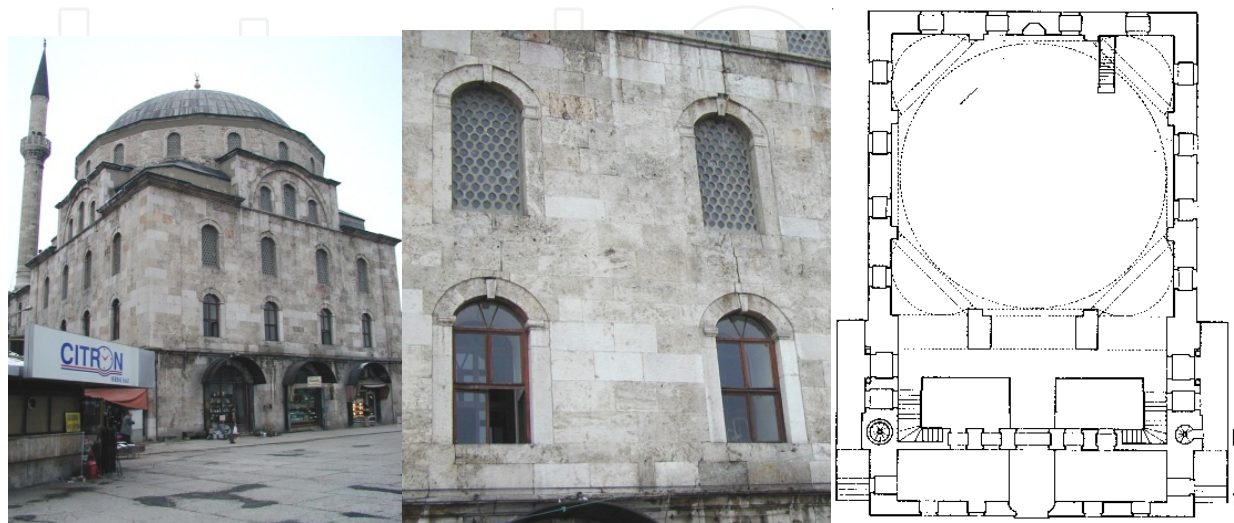
Figure 9. Wall damage and plan view of historical Yildirim Bayezid mosque in Bolu

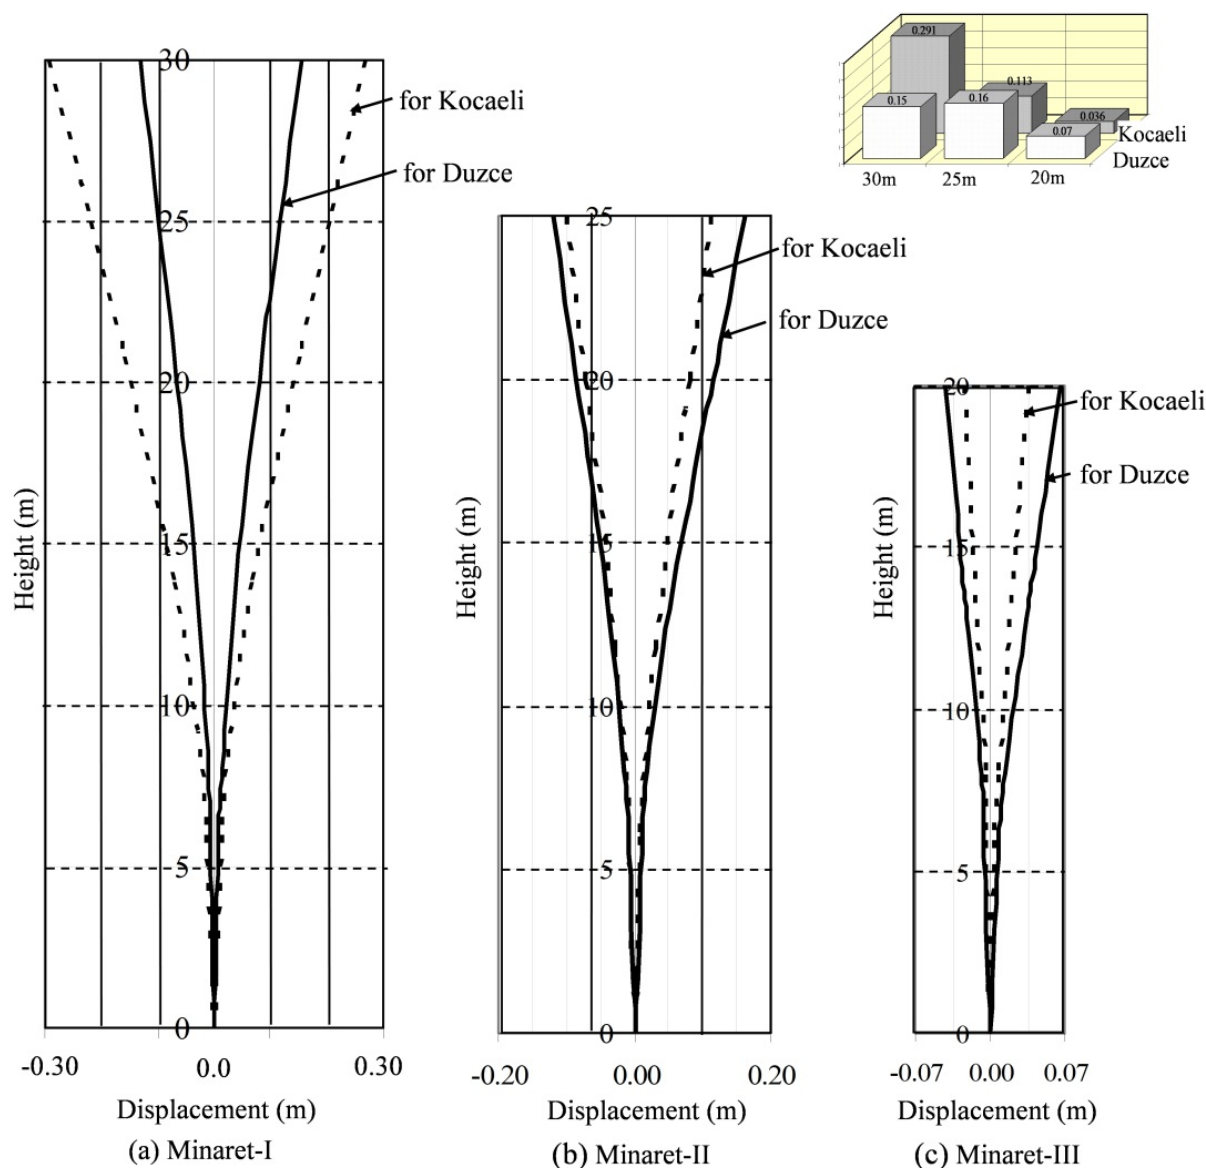
Figure 14. Lateral displacement distribution over the height of minarets for Duzce and Kocaeli ground motions

Figure 14 shows the calculated maximum elastic lateral displacement distribution along the length of three minaret models subjected to 1999 Duzce and Kocaeli earthquake ground motions. As shown in Figure 14 the deflected shapes of the minarets appear to show flexure dominated response with the largest displacements calculated at the top. Although the minarets act as cantilevers, the deformations are much smaller over the height of relatively stiff 6 m high base or boot. The displacements start to increase above the transition segment at about 8 m from ground level. The maximum dynamic displacement of Minaret I is 88%

larger for the Kocaeli input motion (0.291 m) than that for the Duzce ground motion (0.154 m), although the maximum acceleration of the Duzce motion was larger. For the other two shorter minarets Minaret I and II, the maximum calculated displacements are larger for the Duzce ground motion. The maximum dynamic lateral displacement of 0.29 m calculated for the 30 m tall minaret under Kocaeli earthquake exceeds the TEC (2007) code limit of 0.20 m for the Minaret I model (Dogangun et al. 2008).

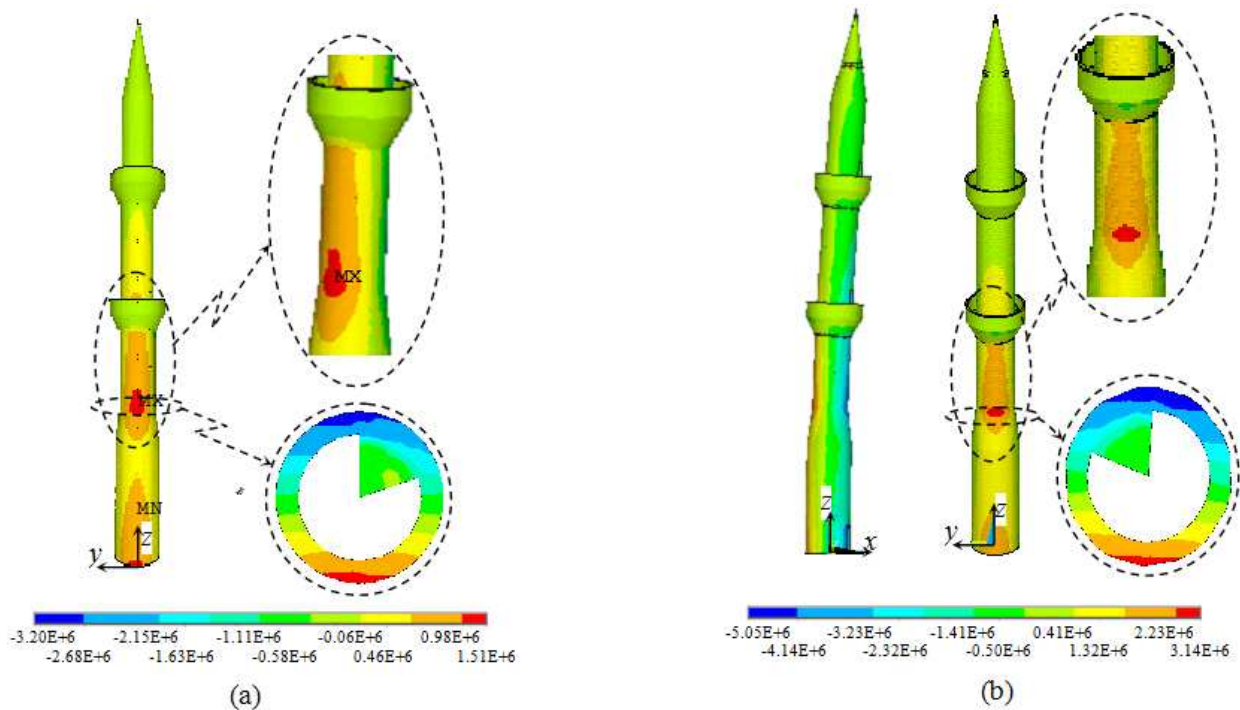
The most critical axial stress contours calculated during the dynamic analysis of minaret models are shown in Figure 15. The maximum tensile and compressive stresses occur at a height of 8 m, immediately above the transition zone (Figure 12). This is consistent with the most common minaret failure mode observed in the field after the earthquakes (Figures 7a, 8a and 8b). The minaret models used here were stand-alone fixed-ended cantilevers, which did have any lateral support over their height. Nevertheless, in some cases one side of the minaret boot or base (bottom 6 m of the minaret models) are supported by or attached to the mosque structure (Type II in Table 4, e.g., Figures 8a and 8b). Such a partial lateral support, even on one side, provides added stiffness near the bottom of the minaret. This will further increase failure potential at the top of the transition zone as shown in Figures 7a, 8a, 8b and 14.

Figure 15. Maximum stress contours for Minaret-I under: a) Duzce, and b) Kocaeli records
