# Power System Protection Design for NPP

Chang-Hsing Lee and Shi-Lin Chen

## 2. Taipower "318 Event"

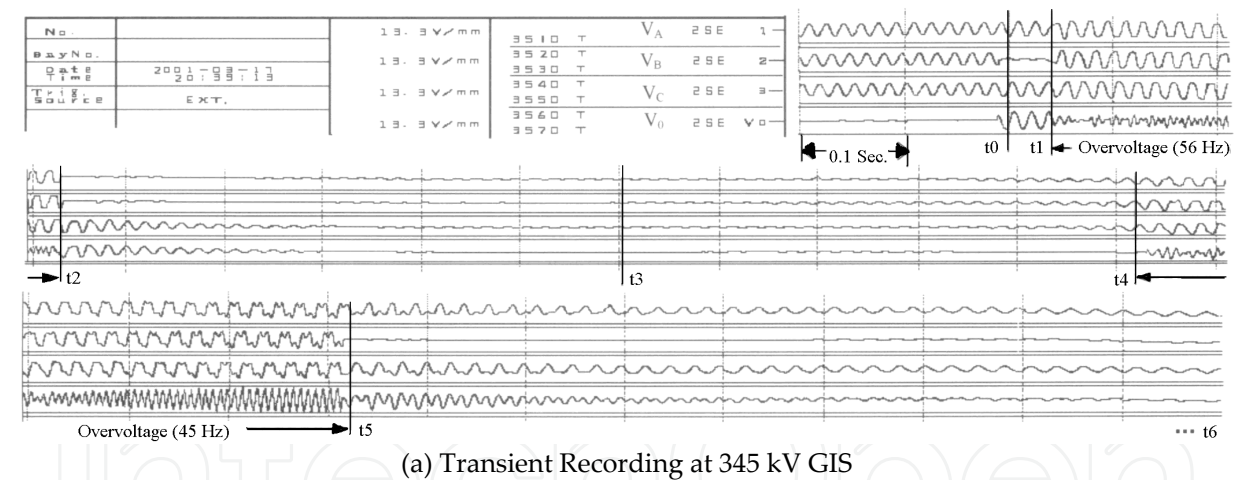
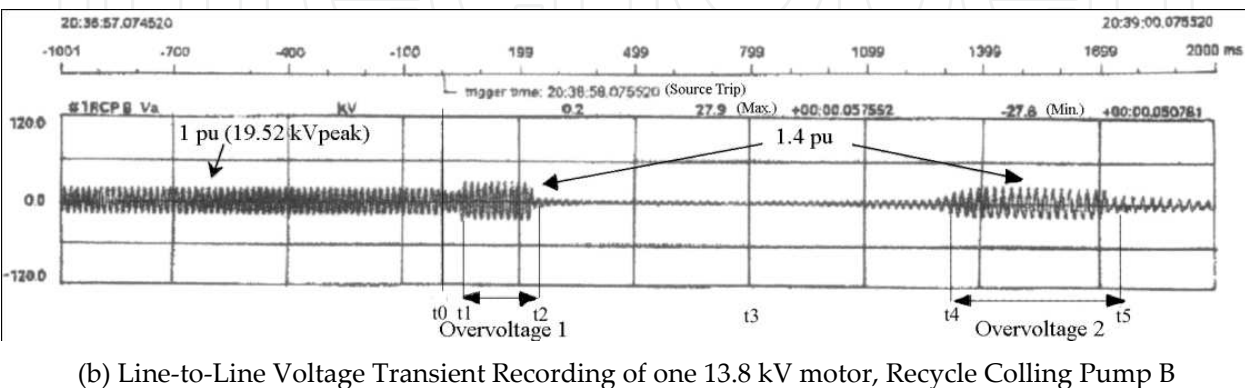
Figure 3. Overvoltages at 20:38 in March 17, 2001

Figure 3 shows the transient recording of overvoltages for both the 345kV bus and one MV (medium voltage) bus at 20:38 in March, 2001. At  $t_0$ , the flashover on the 345kV line occurred leading to its subsequent tripping at  $t_1$ . The tripping took place on the remote end of the 345kV line thus overvoltage can still be observed at the NPP between  $t_1$  and  $t_2$  due to “motor-generating effects” to be explained in the following section of this Chapter. The overvoltage on the 345kV line eventually caused flashover from Phases A and B to ground pulling down the line voltage and all motors on the 4.16kV bus were tripped by their respective under voltage relays at  $t_3$ . At  $t_4$ , the flashover from Phases A and B to ground was cleared and the “motor-generating effects” start to build up the voltages again with the two remaining motors on the 13.8kV bus.

The transient recorder in Fig. 3(a) recorded 2 abnormal overvoltages (at 56 Hz and 45 Hz, respectively) after the last 345 kV-transmission line connecting to the NPP was tripped on the remote end which turned the NPP into an electrical island. As will be explained in the next section, the 1<sup>st</sup> overvoltage was caused by the over-excitation of the motors (e.g. recycle water pump) in the plant who, with terminal voltages supported by large line capacitance, now operated as induction generator after loss of external power.

The 2<sup>nd</sup> overvoltage is caused by a different mechanism. After a few cycles the low voltage relays tripped many of the plant motors leaving only 2 biggest motor (now operating as induction generator) still connected and were supported by a comparatively much larger capacitance leading to not only over-excitation but also magnetic saturation of both the motors and transformers. This created a condition very close to ferroresonance resulting in even bigger overvoltage.

It can be seen from Figure 3 that overvoltage were observed not only on the line conductors of phase A, B, and C but also on the neutral. As will be explained in the next section, neutral voltage transfer can occur through 2 different mechanisms: electromagnetic and capacitive transfer.

It should be noted that while there were 37 switching operations on the EHV side, none of the switching surges were captured by the transient recorder in the 345kV GIS in Fig. 3(a) due to insufficient bandwidth of the transient recorder. In a follow-up field test [9] after the event, it was found that such switching often causes switching surges of around 7 times the rated line-to-ground peak voltage!

During this first overvoltage period, the terminal voltage of motor was about 1.4 p.u. (Fig. 3(b)) but the line voltage was about 1.29 times the rated line-to-ground peak voltage (Fig.

3(a)). This implied that the power transformers have saturated. As a result, a lot of harmonics were produced and the zero sequence components of them would be integrated into the neutral voltage resulting in unexpected high neutral voltage. This period ended at "t2" in Fig. 3(a) when the flashover grounded both phase A and B.

It can be seen from Fig. 3(a) that, during 1<sup>st</sup> overvoltage the neutral voltage gradually rises to 200 kV<sub>rms</sub> while during 2<sup>nd</sup> overvoltage the neutral voltage rose to 626 kV<sub>peak</sub> (Note: the voltage waveform became very non-sinusoidal during 2<sup>nd</sup> overvoltage, we thus use peak value instead of rms value). The source of both overvoltages in the neutral was due to motor and transformer saturation resulting in 3<sup>rd</sup> harmonic voltages at the neutral however during the 2<sup>nd</sup> overvoltage the waveform is much more distorted with higher harmonic content.

As indicated by Fig. 3(a), the neutral on 345kV side does not appear to have been effectively grounded possibly due to grounding failure. The result is that very high neutral voltage was established on the 345kV neutral and if the 4.16kV neutral was not grounded it will see a neutral voltage (through capacitive neutral transfer) of

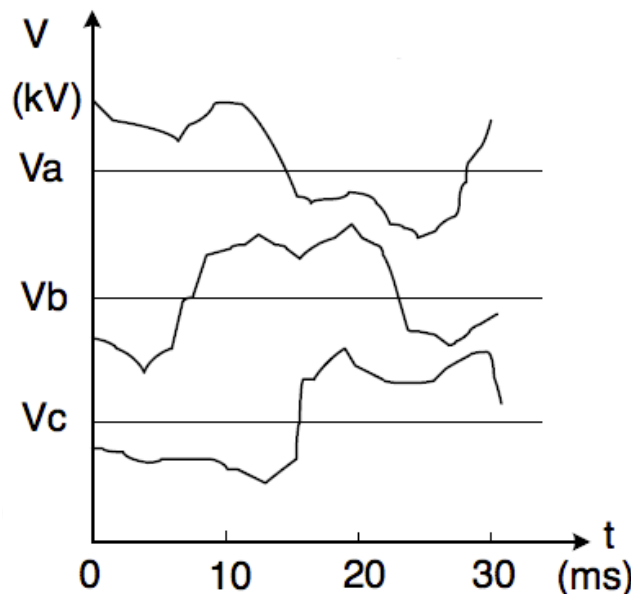
**Figure 7.** Zoom-in of The 4 Cycles prior to t5

It can be seen from Table 2 that the voltage of fundamental frequency was about 1.5 times the rated line-to-ground peak voltage, which is slightly larger than the previous overvoltage. The large DC and even-order harmonics indicate the deep saturation of the start-up transformer. In Table 2 the total of 3<sup>rd</sup> harmonics is 554.7 kV<sub>peak</sub> (Note: The 3<sup>rd</sup> harmonics are in-phase therefore can be added up directly.) Comparing this figure with the neutral voltage of 626 kV<sub>peak</sub> in Fig. 3(a), this indicates that 3<sup>rd</sup> harmonics is the main source of neutral voltage during the second overvoltage period.

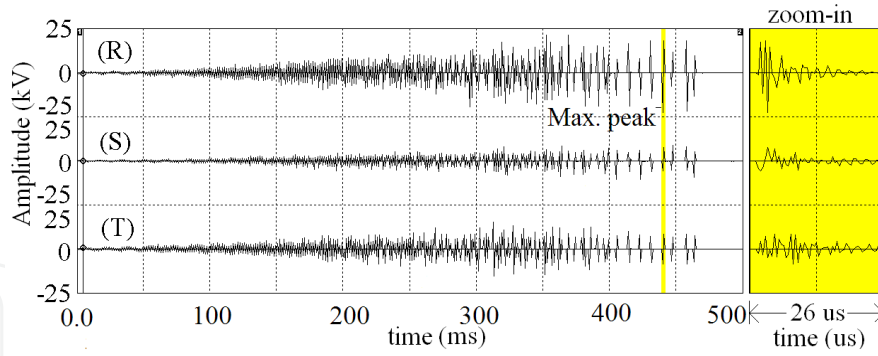
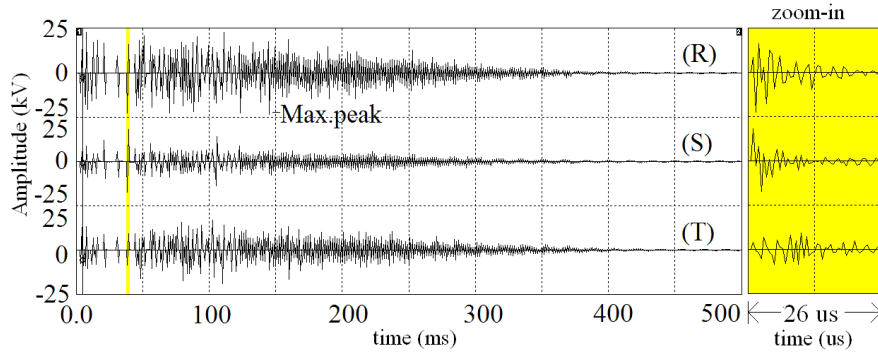
**Figure 10.** Switching Surge Measured on 4.16kV Bus by Operating EHV GIS Disconnect-Switch. (Note: The bandwidth of the measurement system was 2MS/s, the highest achievable in 2003)

Field test result [9] shows that after switching the DS of EHV GIS, multiple 25 kV-level restrikes (approximately 7 times the rated line-to-ground peak voltage) were measured on the 4.16kV bus indicating VFTO can be transferred from the EHV side to MV side. It also indicates that the maximum peak voltages measured on the 4.16kV bus occur neither on the first strike nor on the last strike, and this behaviour is quite different with that in EHV system. The measurement results are shown in Fig. 10.

After the “318 Event”, a recommendation was made to Taipower No. 3 Nuclear Power Plant in 2003 for the installation of surge absorbers (0.8 $\mu$ F capacitor specially designed for surge absorption installed right close to the start-up transformer for each of the three phases) on the MV side in Fig. 1 [9,23]. The recommendation was adopted by Taipower in March 2005 and a subsequent measurement in March 2006 plus one-year monitoring indicated that there were no further VFTO exceeding rated line-to-ground peak voltage on the MV system.

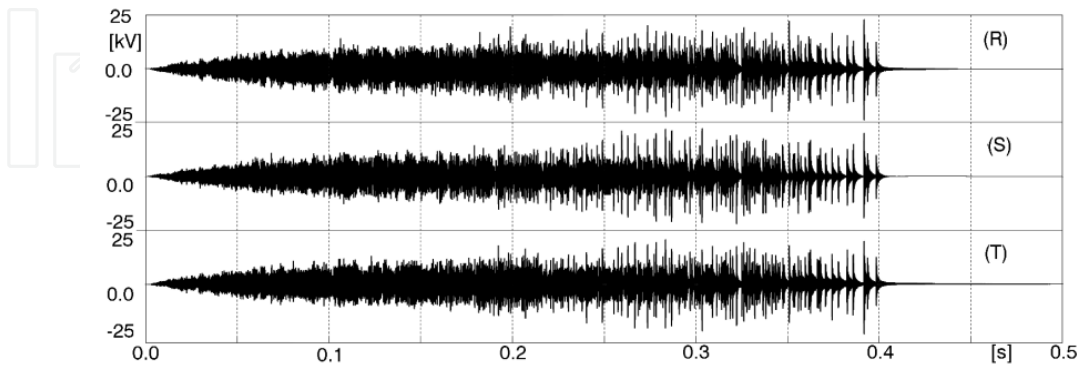
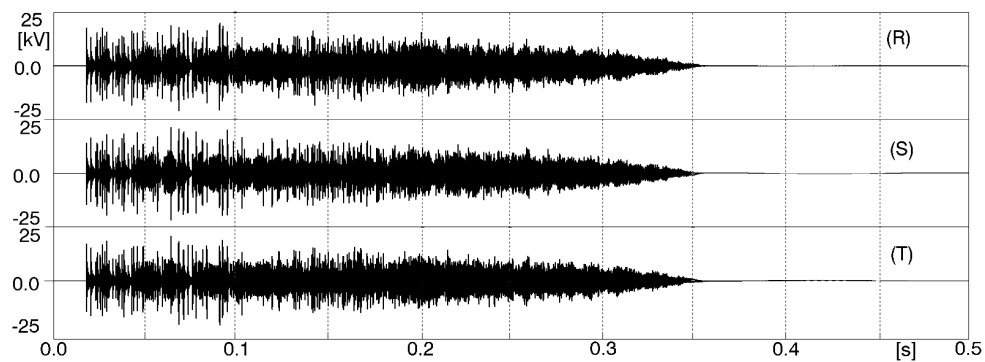
**Figure 11.** Simulation of VFTO at the Field Measurement Point

To further appreciate VFTO transfer mechanism, numerical simulation model was built [23]. To validate this simulation model, the field test condition for Fig. 10 was reconstructed and the simulation result is shown in Fig. 11. It can be seen from Fig. 11 that the waveform envelope are consistent with measurement for both DS opening and closing and that the maximum VFTO on the essential bus occurred neither at first nor at last strike.

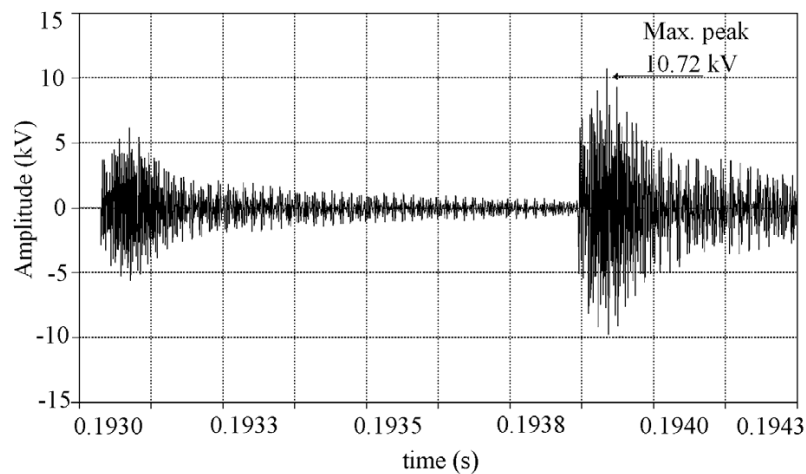
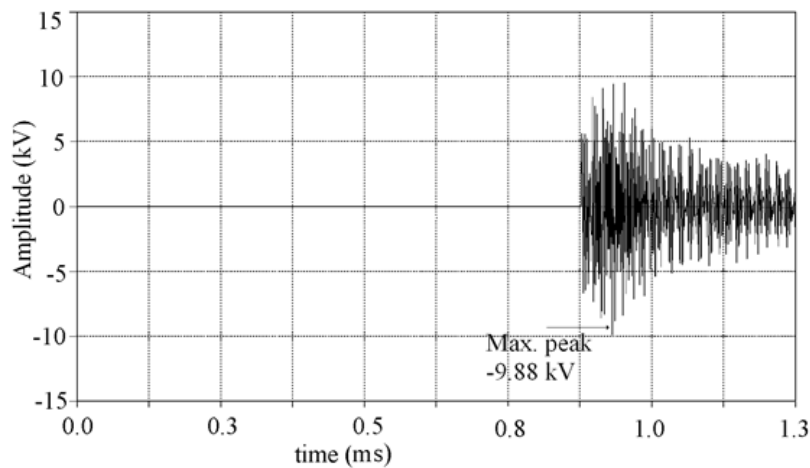
**Figure 12.** Oscillation Voltage ( $V_{osc}$ ) Initiated by a Strike or Restrike Can Be Superimposed to Subsequent Restrike Voltages.

Figure 12(a) shows two consecutive restrikes from a multiple-restrike simulation and Fig. 12(b) shows its counterpart single-strike simulation. It can be seen from Fig. 12(a) that the  $V_{osc}$  initiated by the first restrike is superimposed to the second restrike resulting in a higher peak voltage (10.72 kV vs. the single strike one of 9.88kV).
