# Fatal Accidents During Marine Transport of Wood Pellets Due to Off-Gassing: Experiences from Denmark

Frank Huess Hedlund and  
Øssur Jarleivson Hilduberg

The atmosphere in unventilated wood pellet storage confinements, such as the cargo hold of marine vessels transporting pellets in solid bulk, can be severely oxygen deficient and contain deadly concentrations of harmful gasses, of which the most feared is the poisonous and odour-less carbon monoxide. The hazard has been known for over a decade and has been responsible for many accidents. We examine three fatal accidents on marine vessels in or near Danish waters and argue that they share strikingly similar aetiologies, if not repetitive patterns. It is generally recognized that accidents should be thoroughly investigated and lessons learned shared widely in order to minimize the number of times the same lessons have to be learned. The three Danish cases suggest that this learning process is deeply troubled for the solid biomass segment. The International Maritime Organization IMO/SOLAS has recently revised its guidance on entering enclosed spaces aboard ships in response to the ongoing problem of confined space incidents. We a

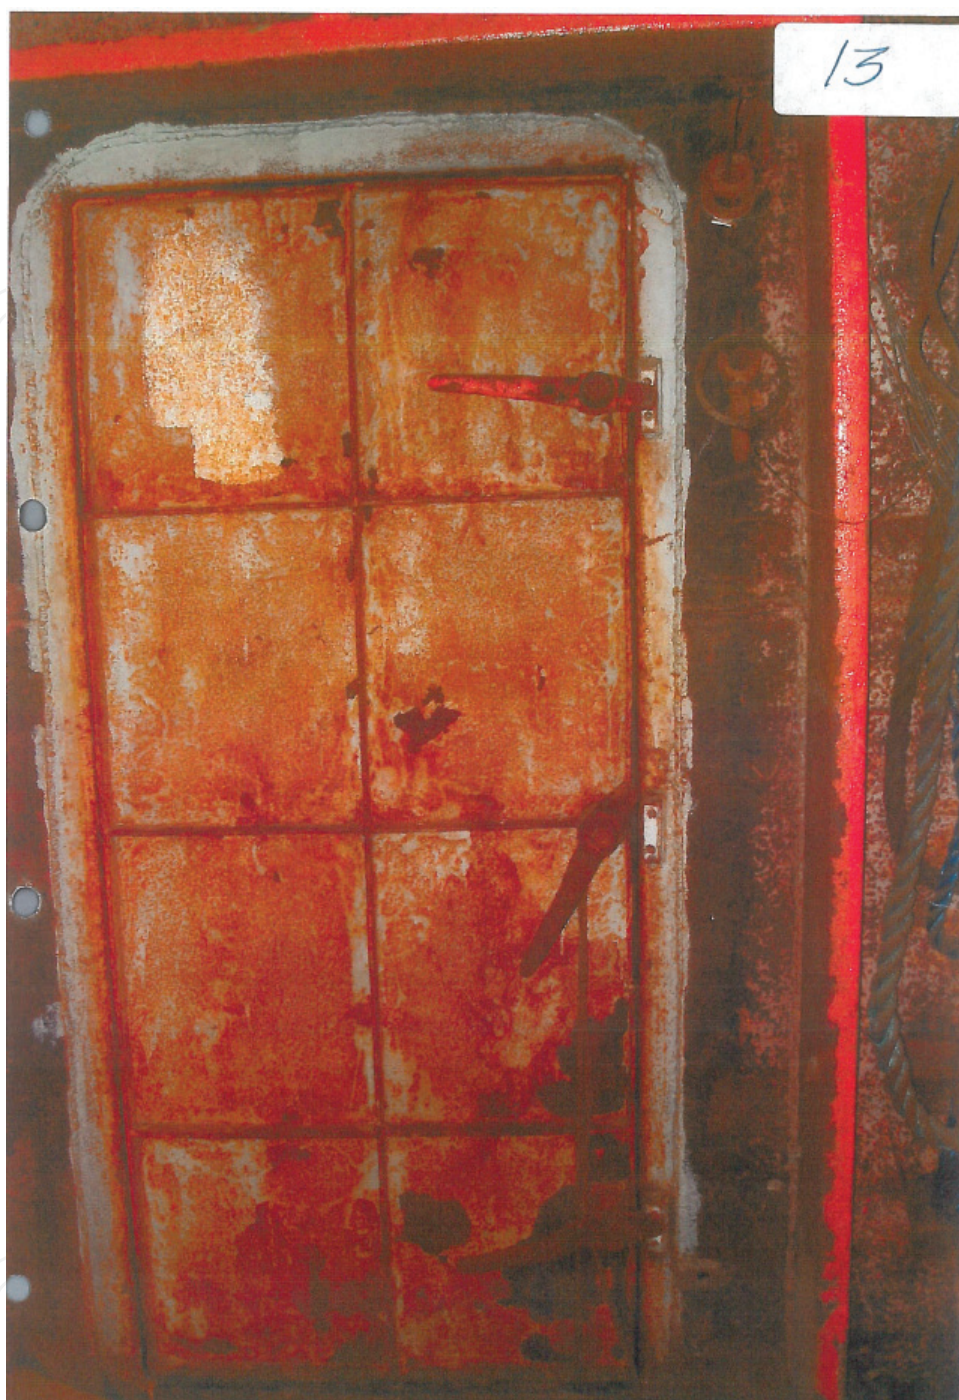
A door in the forepeak compartment allowed access to the front cargo hold. The door had three closing hinges but only two were engaged. It was speculated that gasses might travel from the cargo hold to the forepeak through a crevice in the door opening where the third hinge was not engaged (**Figure 1**).

**Figure 1.** The door in the forepeak compartment, which led the front cargo hold. The door had three closing hinges but only two were engaged. Gasses travelled from the cargo hold to the forepeak through a crevice where the third hinge was not engaged. (AMIRANTE). Source: Police photo file #13 [8].

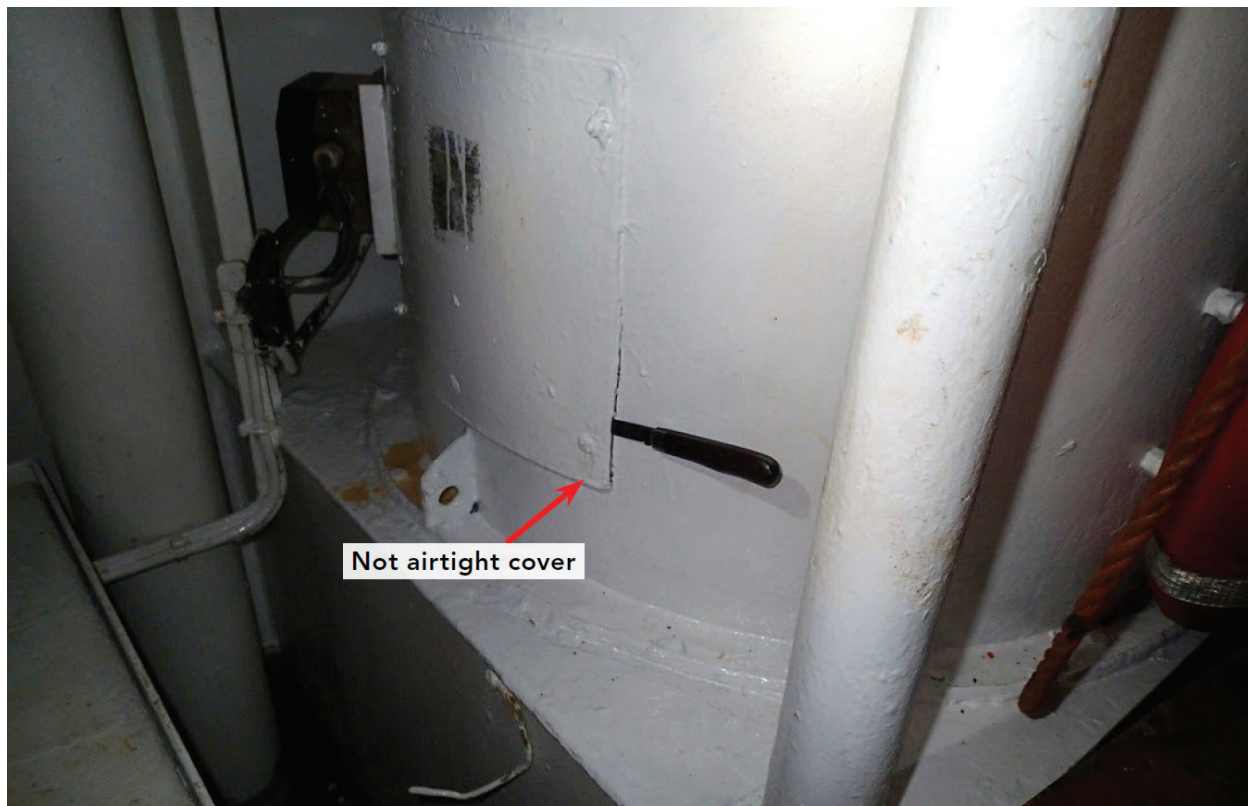
The CO<sub>2</sub> room, forecastle and bow thruster room are adjacent to each other and gasses might travel from one room to another through a number of connecting conduits. The shipping company contracted the classification society to investigate how carbon monoxide could have travelled from the cargo hold to the bow area. The investigation identified a minor gap in a section of the rim of an inspection cover on a ventilation duct that runs from the cargo hold through the forecastle as the most likely route (**Figure 2**).

**Figure 2.** The inspection hatch on a ventilation duct that ran from the cargo hold through the forecabin. A minor gap in a section of the rim (knife blade inserted) allowed gasses to travel from the cargo hold to the bow area. (LADY IRINA). Source: [13].

In response to the fatal accident, the shipping company acquired multi-gas meters and introduced a new work procedure mandating that the person making “First Entry” must carry an operational multi-gas meter. New warning placards with the instruction “ATTENTION—No first entry without use of multi-gas meter” were been put up on access doors.

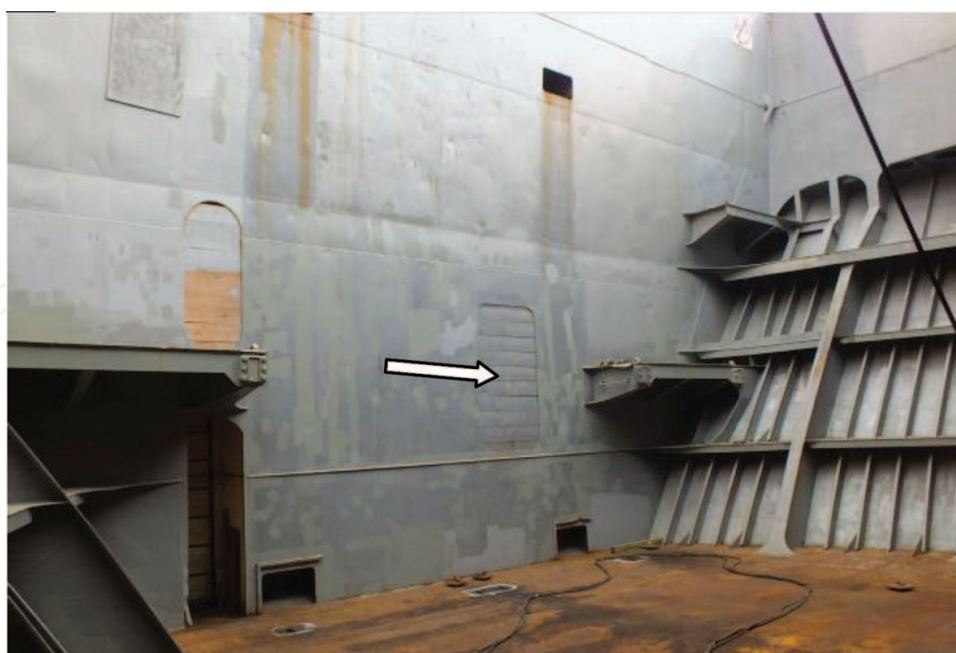
**Figure 3.** An opening in the front cargo hold allowed easy access to the lashing equipment room. When carrying bulk cargo, the opening was closed with planks of wood inserted into guide bars (CORINA). Source: [16].

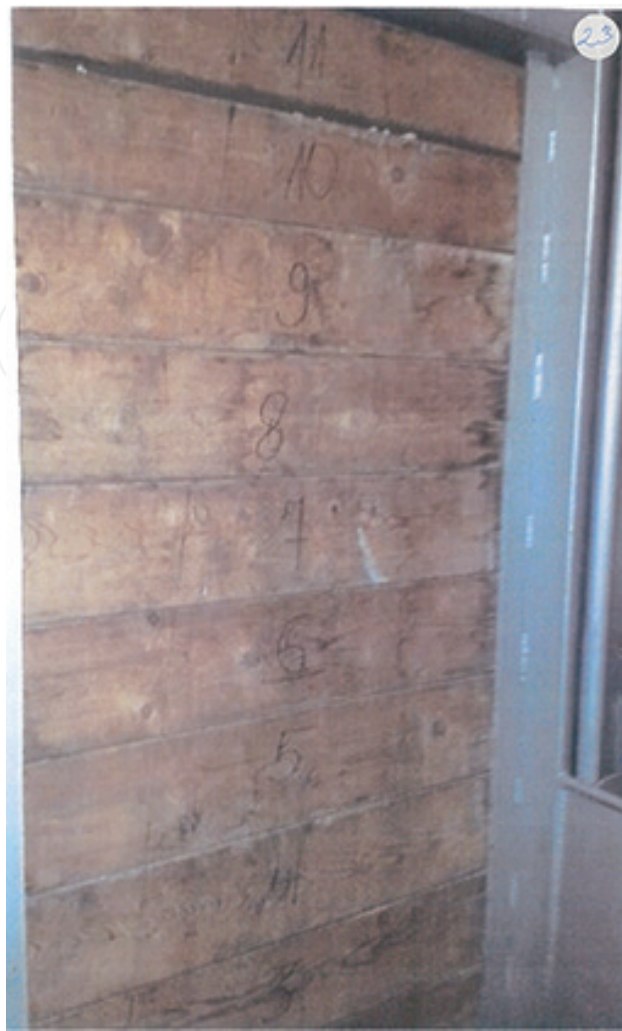
CORINA was general cargo multipurpose vessel adapted to transport of containers. Containers must be lashed, and in order to ease the handling and movement of lashing gear, the vessel was designed with a 2100 mm × 1150 mm opening in the forward bulkhead of cargo hold no. 1. The opening allowed easy access to the neighbouring storage room, where chains, stacking cones and other lashing equipment for containers were kept (**Figure 3**). When carrying bulk cargo, the opening was closed with planks inserted into guide bars. This barrier was not gas tight and gasses from the cargo hold could therefore travel to the fore-castle (**Figure 4**).

**Figure 4.** The plank barrier seen from the lashing equipment room. Wood pellets in the cargo hold are visible between planks 10 and 11. The barrier is evidently not gastight. (CORINA). Source: Police photo file #23 [8].
