Two-Dimensional Hydraulic Modeling and Geotechnical Analysis of Earthen Regulation Dams Located at Arroyo Las Viboras Watershed in a Major Transboundary Mexico-USA Metroplex: How an Ordinary Rain Event Caused Major Damage Related to Extraordinary Flooding?

Oscar Sotero Dena Ornelas, Diane Irene Doser,
Oscar Fidencio Ibañez Hernández,
Griselda Janeth Obeso Cortez and
Miguel Angel Galdean Vega

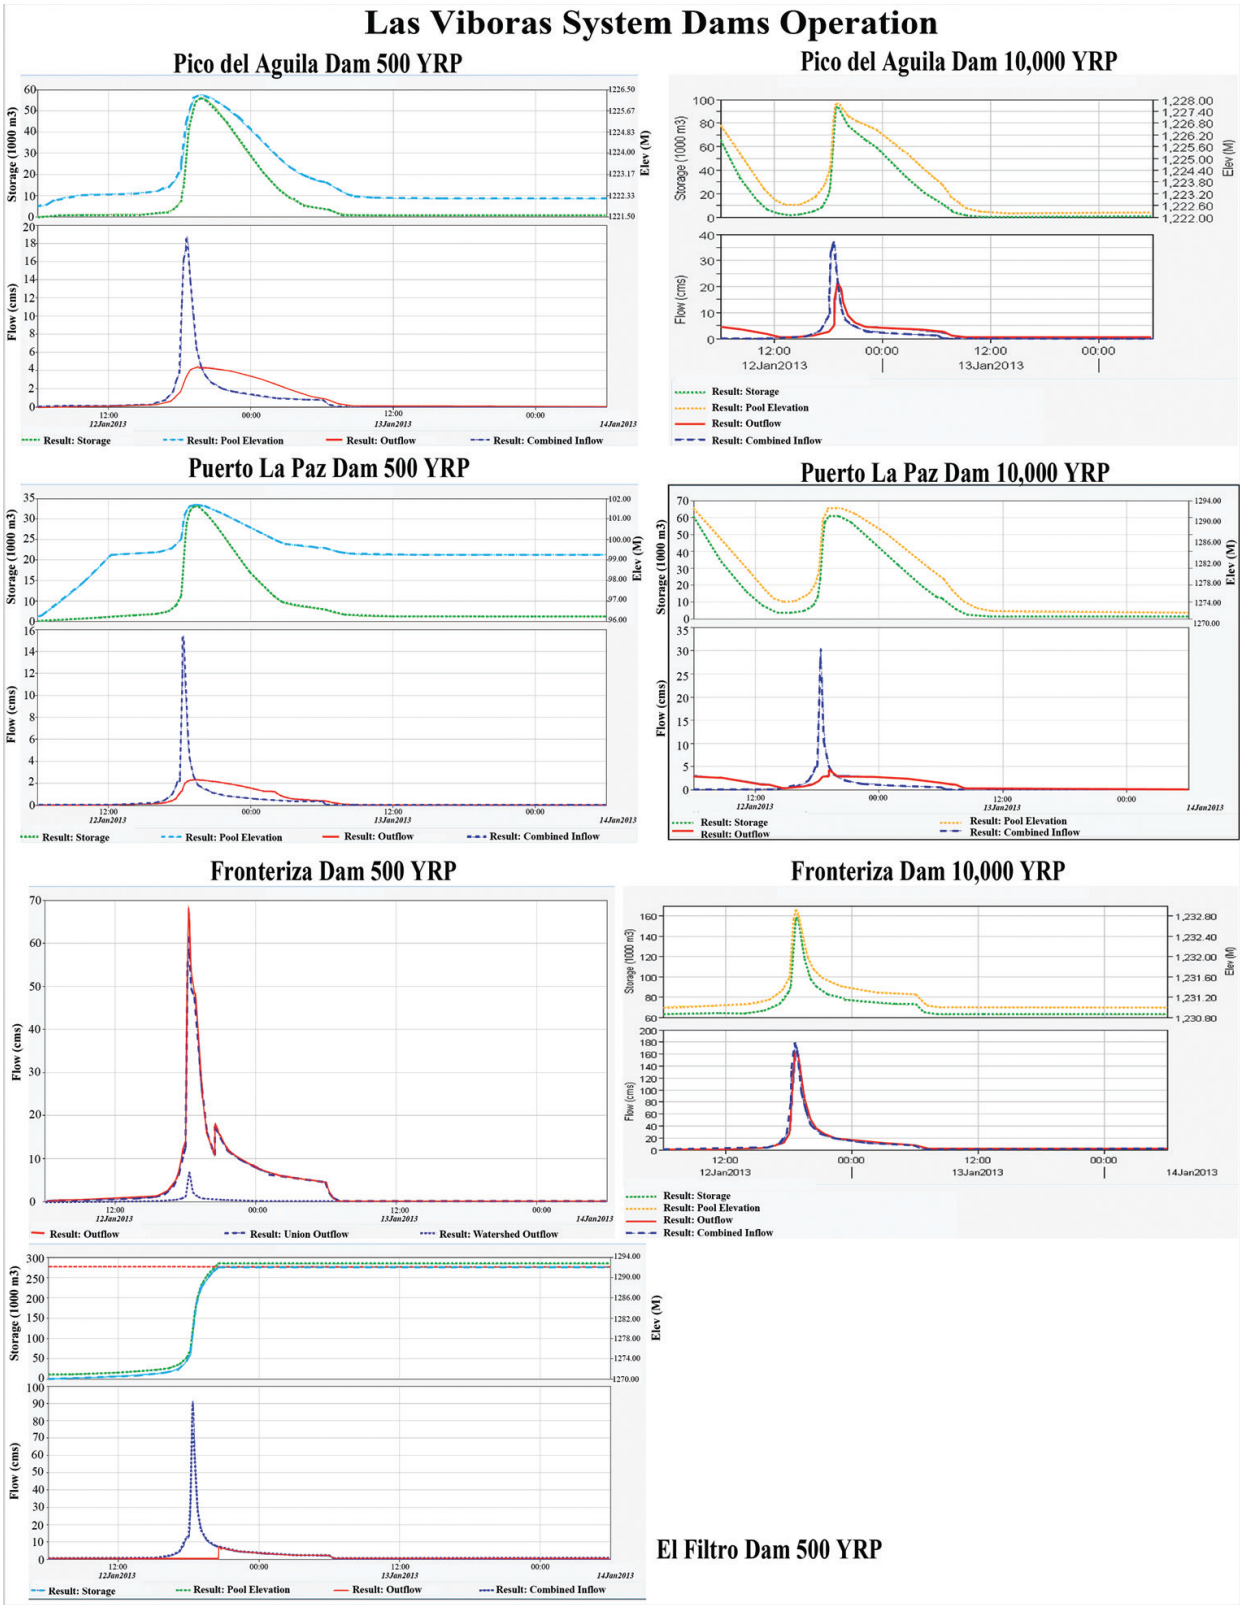
Figure 2. Models of hydraulic operation of dams for 500–10,000 YRP. The results were obtained by 1D hydrologic modeling.

The Pico del Aguila dam has both a riser spillway and emergency spillway. The outlet pipeline has a diameter of 75 cm. The dam crest reaches an elevation of 1221.50 m above sea level and the maximum impoundment capacity is 61,226 m³. The GEOHMS model shows that the total catchment area for this hydraulic structure is 2.11 km², and the model results indicate that this structure operates properly for ordinary rains and extraordinary rain events of up to 500 YRP with a freeboard of 1.55 m. However, for extraordinary or extreme events, such as the 10,000 YRP, the hydraulic operation is seriously compromised since the water flow would overtop the dam's wall, eventually breaching the structure.

This regulation dam is designed to regulate the runoff volumes moving downstream from the southern central part of the highlands of Las Viboras system, which are located at the scarped flanks of the Sierra de Juarez. The results of the hydrologic run show that the dimensions of the reservoir and wall of this regulation dam are able to operate satisfactory up to a 500 YRP rain, with a freeboard of 1.55 m. However, the analysis for a 10,000 YRP rain with full reservoir indicates that the structure will be overtopped by the water volume. Thus, the dam is not hydraulically operating properly according to Mexican law, which requires that any dam should be able to transit a hydrogram corresponding to a 10,000 YRP runoff, assuming that the reservoir is full. In spite of this failure in hydrological safety of the Puerto La Paz dam for extreme events, the structure can very efficiently handle ordinary rains.

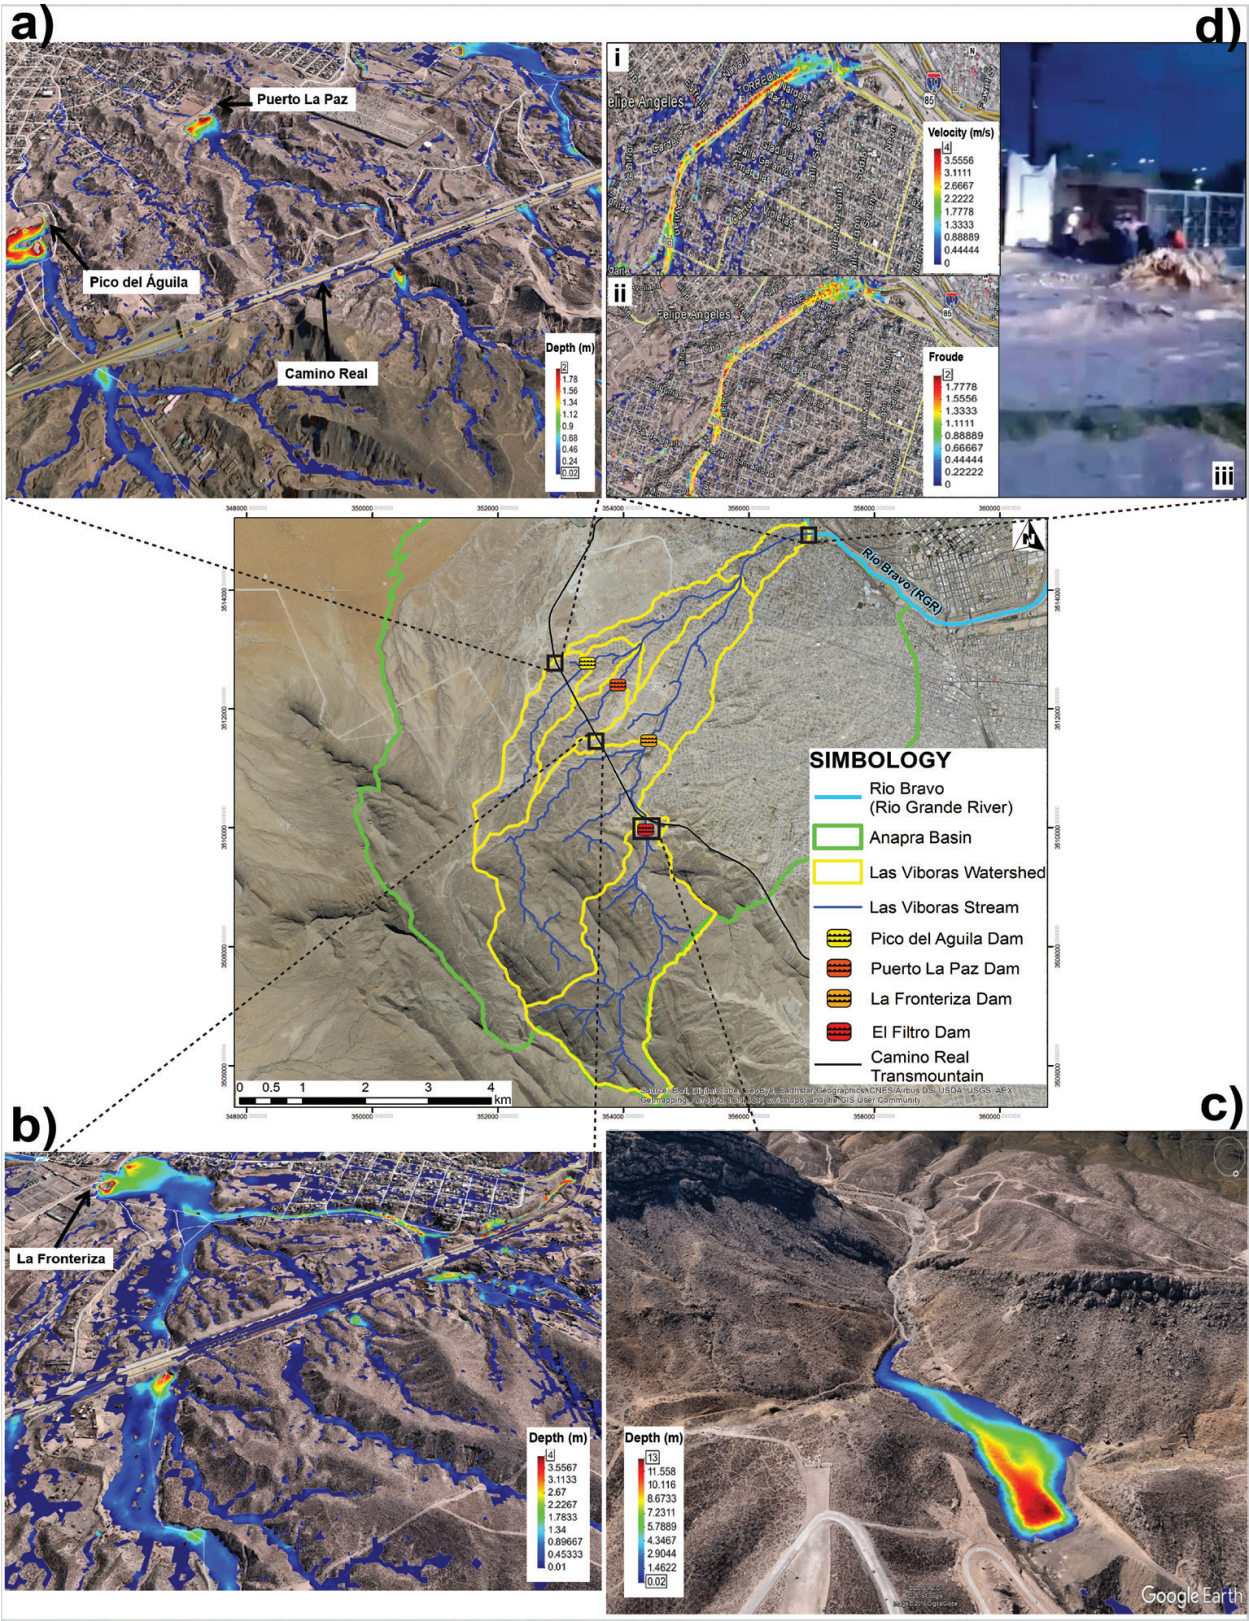
The main result for the 2 YRP modeling showed the lack of water regulation at La Fronteriza dam is a relative concept since the width of the reservoir prevents all water from flowing freely downstream through the channel at 70 m³/s, recording reservoir depths up to 2 m even for ordinary rains (**Figure 3(a)**). Nevertheless, this regulation is not sufficient since this drainage network branch is still the major contributing factor to the nearly 1 m water depths reached downstream of this location. In the same way, the bi-dimensional model at Pico del Aguila dam shows that this structure is properly regulating, reaching water depths of up to 1.60 m behind the dam. This is also the case for the Puerto La Paz dam, where runoff volume is properly regulated reaching depths of 1.80 m (**Figure 3**) behind the dam. Although this combined runoff flow regulation effectively diminishes the rate of water flowing downstream along this tributary stream, water depths of 0.40 m are still reached before the intersection of Las Viboras drainage with the RGR (**Figure 3**). This analysis also indicates that El Camino Real's culverts are retaining water, even for a 50% PE rain; a result not anticipated by the HMS modeling (**Figure 3**). Then, El Filtro dam is retaining, rather than regulating, a water volume flowing from the southern tributary watershed with a catchment area of nearly 6 km². For heavier rains it is anticipated that this poorly constructed wall, lacking riser spillway and emergency spillway or outlets may fail, perhaps just increasing the hydrologic risk rather than reducing it as forecasted by the HMS modeling results.

Figure 3. The results of 2D hydraulic modeling. (a) Water levels at Pico del Aguila and Puerto La Paz dams. (b) Water levels at culverts along El Camino and at La Fronteriza Dam. (c) Water levels at El Filtro Dam. (d) Velocity (i) and celerity (ii) results, (iii) turbulent flow at Las Viboras delivery point into Rio Grande River, photo taken by Azteca Noticias news.

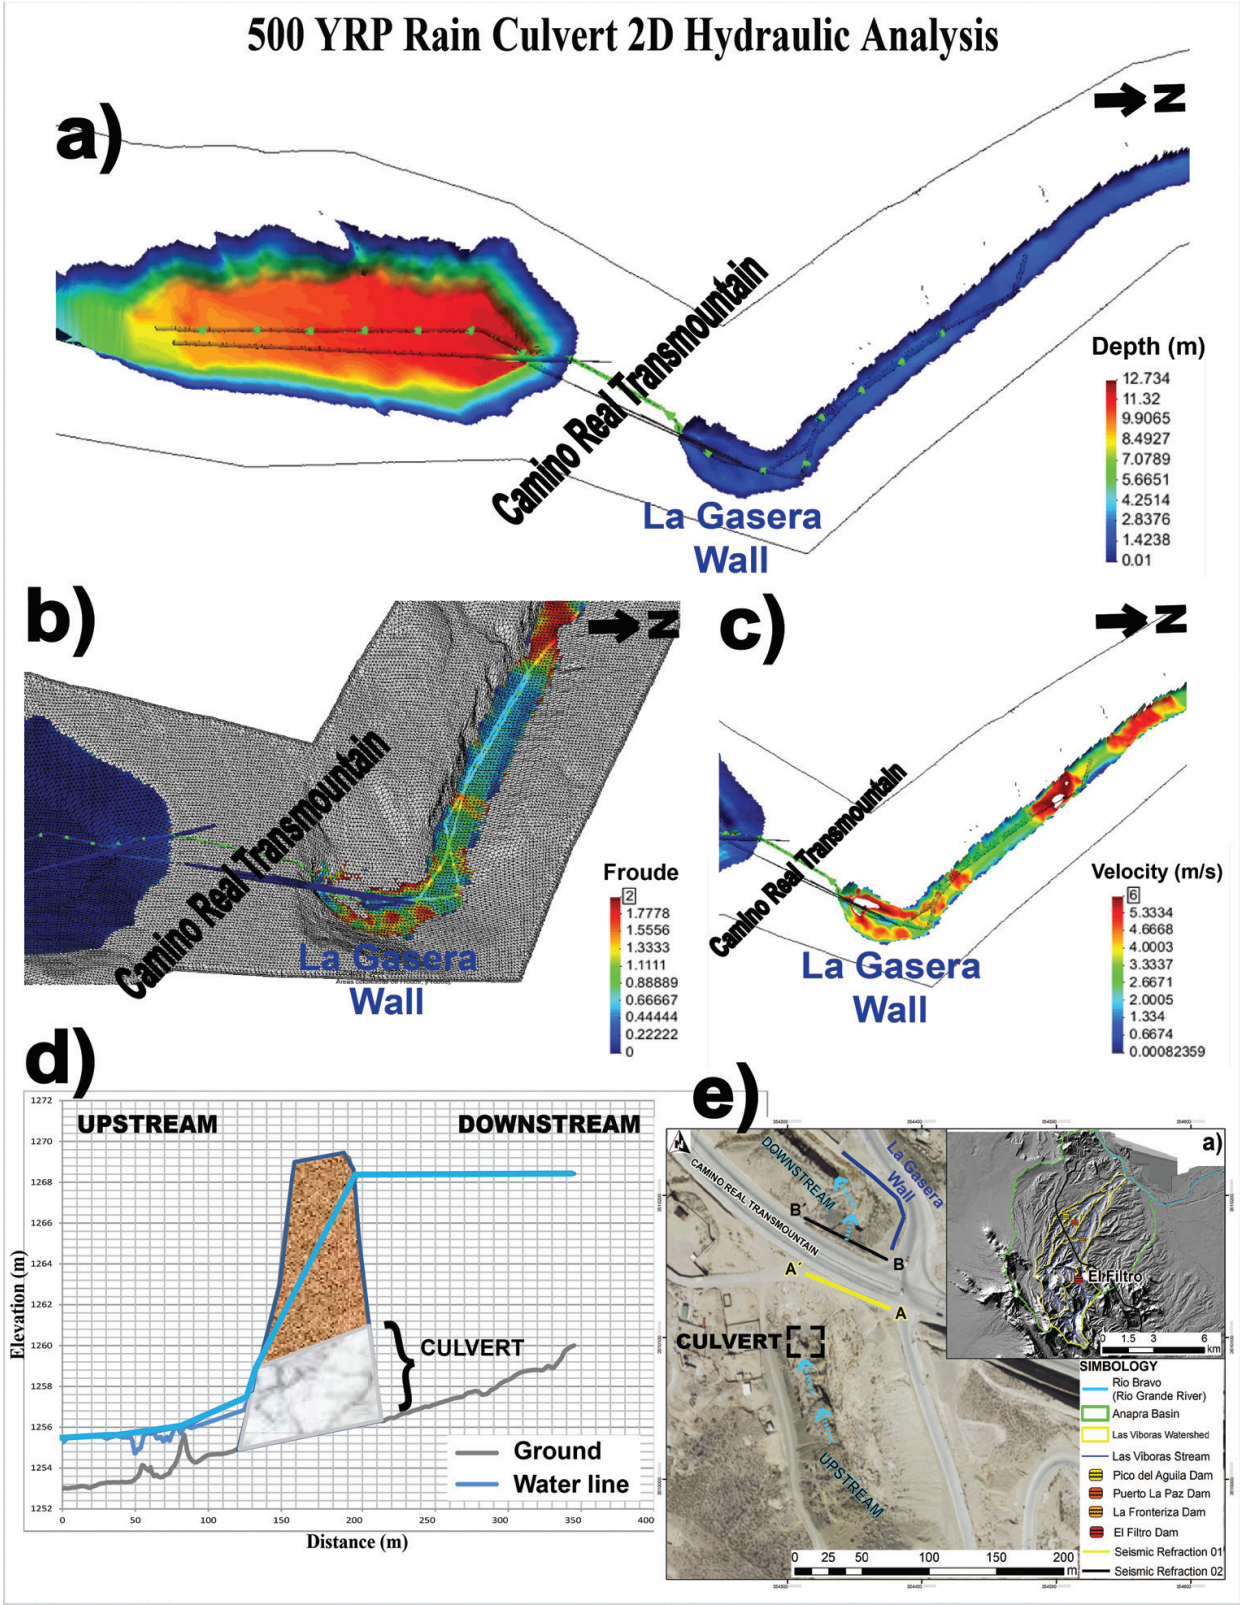
The second hydraulic scenario corresponds to El Filtro dam breaching for a 500 YRP event. The results are consistent with the hydrology, resulting in a runoff volume of 260 m³/s flowing through the simulated breach. This volume shows that the 4.5 × 4.5 m culvert located downstream is not able to efficiently conduct the flow (**Figure 4**), yet the 1D calculations showed it as capable of transporting 360 m³/s. The hydraulic jump generated at the upstream culvert opening reaches depths of 12 m, so that El Camino Real's embankments act as a regulation dam, albeit they are not designed to do so. The detailed bi-dimensional modeling of the breached El Filtro dam-culvert system, also shows that the closed turn of the channel at the downstream culvert outlet produces turbulent and erosive velocities which are scouring the diversion wall of "La Gasera" located only 35 m to the north (**Figure 4**). As consequence of these results, the system was modeled again for a 2 YRP, but with the hypothetical scenario of removing El Filtro dam. The results show dramatic downstream effects; the downstream culvert is completely overtopped with water depths of 4 m both sides of the culvert, whereas water depths increase up to 2 m for the last branch of the drainage network. To conclude the hydraulic analysis, field work was conducted to identify erosional features such as gullies at the slope toe of "La Gasera" wall. The result was even more complex than predicted by the model; the wall scouring process related to several ordinary rain events show that the culvert is partially occluded with debris scoured from the wall. The hydraulic jump caused by the occlusion at the culvert outlet is recorded by water depths of nearly 3 m, as shown by a water line traced upstream across the culvert passage (**Figure 4**).

Figure 4. Hydraulic modeling results for the breaching of El Filtro dam. Inset (a) Water depth. Inset (b) Froude number. Inset (c) Velocity. Inset (d) Cross section showing how El Camino Real acts as retaining wall.

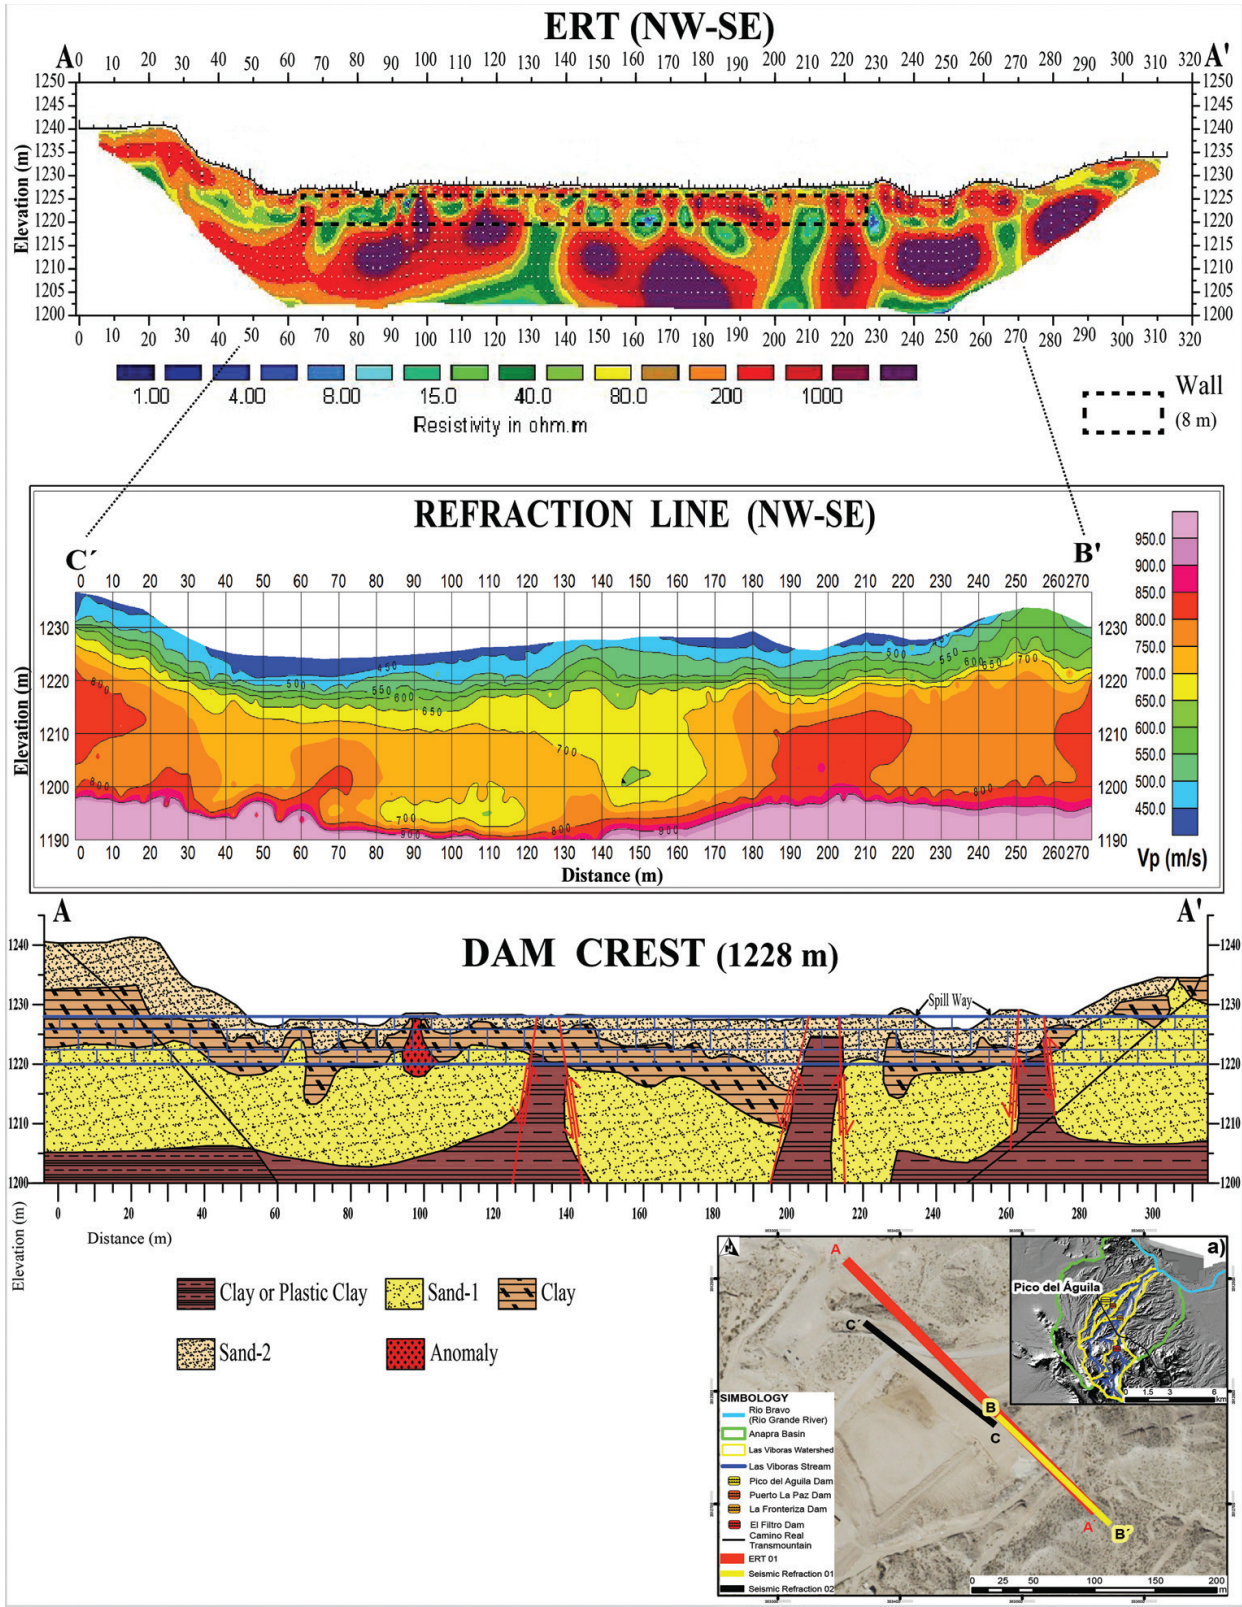
of interlayered beds of sand, gravel, silts and clays [17]. Also, a visual inspection of the wall showed the presence of a displaced block in the vicinity of the spillway. This block is readily identifiable, even in recent satellite imagery. No fractures and/or cracks were observed elsewhere. The geoelectrical analysis (**Figure 5**) of the wall and foundations revealed that, in general, inside the wall body, an interbedded sequence of high, low and high resistivity values are observed. At depths greater than 10 m beneath the wall the structure seems to be resting on a foundation with high electrical resistivity. The electrical resistivity layers do not show a quasi-horizontal and homogeneous pattern. Layers are actually updipping between model coordinates (MC) 70 and 120 m. At 130 m along the profile, a low-resistivity vertical anomaly is identified at the base of the wall. From 140 to 200 m MC the layers are down dipping. Beyond 200 m MC another vertical low-resistivity anomaly is observed. Besides showing a lower range in resistivity values, this anomaly is vertically propagated across the whole wall at MC 230 m. This resistivity anomaly matches the location of the vertical down dropped block observed at the surface, atop of the wall crest. Finally, by the end of the section, the layers beneath the emergency spillway are quasi-horizontal, until a new vertical low-resistivity anomaly is found again at MC 265 m.

The seismic data collected along this structure is a set of two refraction lines that were concatenated. The final V_p seismic section is displaced respect to the electrical tomography by 50 m, meaning that the seismic starts at MC 50 m on the geoelectrical section. The compressional velocity field (**Figure 5**, center) shows the presence of a very low velocity layer of 400 m/s along the whole seismic line, except at MC 140 m where this layer pinches out. The velocity field shows layers with velocities ranging between 400 and 600 m/s from the surface to 8 m in depth. Below this depth a nearly quasi-horizontal layer of 650 m/s bears the foundation of the wall. The seismostratigraphic pattern observed within the wall body (depths from 0 to 8 m) is characterized by the presence of quasi-horizontal layers pinching out into a high velocity structure found at the middle of the section with values ranging between 600 and 700 m/s where the isovelocity contour of 600 m/s reaches depths of only 3 m. No direct probing has been done at this structure to validate these nondirect methods and to assign these geophysical layers specific lithological and geotechnical parameters .

Figure 5. Geotechnical and geophysical assessment results at Pico de Aguila EDR. Top image: geoelectric profile. Middle image: Vp Refraction profile. Bottom image: interpreted results. Inset map at bottom shows location of geophysical surveys relative to extent of dam.

specific lithologies found by direct exploration at the Puerto La Paz (PLP) dam. The interpreted lithological section (**Figure 5**, bottom image) shows that the body of the wall would be then composed of an interlayered sequence of silty sands associated with resistivities greater than 200 ohm-m. The interbedded stratum with resistivity values between 15 and 60 ohm-m is associated with a sandy clay unit. A nearly vertical high resistivity anomaly, located at M.C. 90 m, is perhaps associated with the presence of an abandoned concrete sewer line emplaced across the dam's body. Foundation of the dam is resting on a very high electrical resistive package (>1000 ohm-m) associated with clean sands and or gravel. Seismically, the interbedded sequence is not observed, but this might be a limitation of the method, unable to model velocity inversions [21]. But in contrast, a positive velocity gradient, starting at 350 m/s at the surface and increasing to over 700 m/s at the wall bottom, is observed in the velocity field. The V_p values at the foundation horizon are then defined by the 700 m/s isovelocity contour, interpreted as associated with Tertiary sediments composed by sand and gravel, which makes it a competent strata. Although the foundation layer is competent, the presence of the highly warped region of 600–700 m/s V_p velocities in the middle of the seismic section, reveals that the material forming the body of the wall was severely perturbed by deformation and movement. These materials appear to have been re-emplaced and compacted "a-posteriori." This process definitely does not lead to proper linkage or anchoring of the original layering to the recently emplaced material. This feature must be considered a serious flaw, which seriously compromises the structural integrity of the wall. Furthermore, the quasi-vertical low resistivity anomalies indicate clay bodies are intruding the structure in as similar fashion to that observed within the Puerto La Paz dam wall. Although no direct probing of the material is available, these inferred clay structures compromise the structural integrity of the wall, as evidenced by cracks and openings propagated along the wall slope at the same location as the clay bodies that are revealed by the geoelectrical data.

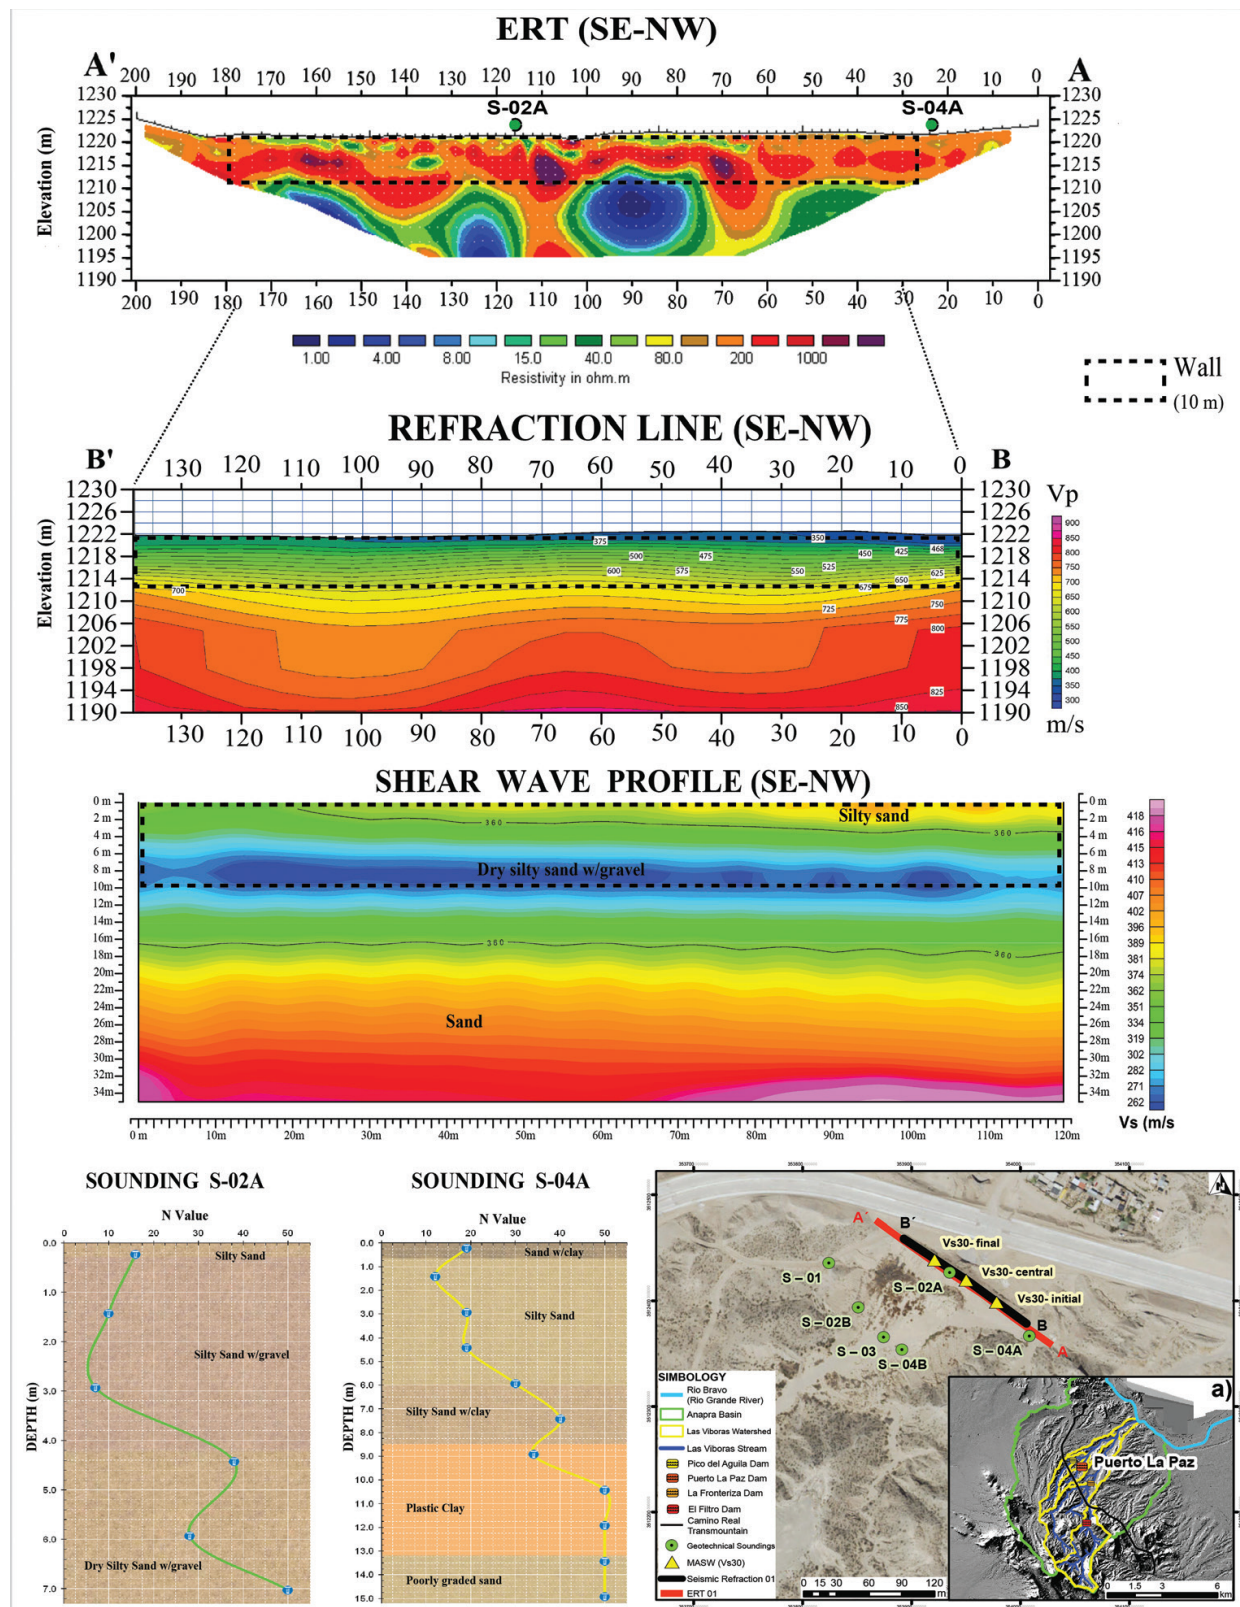
The geological reconnaissance of the topographic closure revealed no presence of bedrock flanks to anchor the structure. Actually, the only geologic unit identified both in the wall flanks and along the reservoir perimeter is a tertiary-age polymictic conglomerate composed of interlayered beds of sand, gravel, silts and clay [17]. Geophysical analysis of the wall and foundations through ERT (**Figure 6**, top) revealed that inside the wall body the strata are vertically displaced, as indicated by the undulating contact horizon geometry. The dam appears to rest on top of a very low resistivity (<8 ohm-m) non-homogeneous body located at 10 m depth. The seismic refraction analysis (**Figure 6**, middle) shows a vertical gradient in compressional velocities ranging from 350 m/s at the top of the wall and 700 m/s at the bottom of the originally designed wall that had a height 10 m above the river channel [1]. At depths greater than 10 m from the wall top, the velocity field reveals a ca. 800 m/s structure. This

Figure 6. Geotechnical and geophysical assessment results for the Puerto de Paz dam. Top image: geoelectric profile. Position of soundings are indicated relative to dam are indicated. Middle Images top: Vp Refraction profile. Bottom image: Vs profile. Bottom left shows direct probing soundings. Bottom right shows geophysical and geotechnical survey locations with respect to the dam.

feature matches the depth and location of the low resistivity (<8 ohm-m) body observed in the ERT profile. The V_s section (**Figure 6**) does not show the same behavior observed in the V_p field, i.e., a positive velocity gradient as function of depth. The S-wave velocity (V_s) field shows a 270 m/s low shear velocity zone (LVsZ) located between depths of 6 and 10 m. The velocities above the LVsZ range from 360 to 380 m/s. The velocity field increases from 360 m/s at a depth of 10 m to 420 m/s at 20 m in depth. The V_p/V_s and Poisson's ratios are respectively: 1.66 and 0.22 at depths of 4 m, 2.2 and 0.37 at the LVsZ and 2.34 and 0.39 at 10 m in depth.

Although direct soundings are available to validate the geophysics, there is only one sounding located atop the wall, and the maximum depth reached is 7 m. This sounding reveals that the materials that form the wall are mainly silty sands. The load capacity parameter N from the standard penetration test (SPT) starts at 16 at the top of the wall and decreases to 7 at 3 m in depth, increases up to 38 blows at 4.5 m and decreases again to 28 at a depth of 6 m. Another sounding is also available at the right shoulder of the wall. This sounding shows the presence of silty sands forming the body of the wall, but since this sounding goes deeper, it records plastic clays at the bottom of the dam wall, which corresponds to the resistivity values of less than 8 ohm-m observed at these depths.

The regulation dam Puerto La Paz is hydrologically capable of handling rains up to 500 YRP, but is hydraulically compromised for a 10,000 YRP volume since the emergency spillway flow exceeds the required freeboard of at least 0.91 m, as required by the Bureau of Reclamation and Mexican law. Although this dam seems to be able to handle runoff volumes even for non-ordinary rains, its structural condition, as revealed by the geotechnical assessment through geoelectrical, seismic studies and direct soundings, is seriously compromised. The wall's foundation rests on top of a thick plastic clay layer which seems to have experienced differential loading effects resulting in the wall's very poor condition observed at surface. Furthermore, the tomographic geoelectrical profile (**Figure 6**) shows quasi-vertical strata displacements matching the displacements observed at surface. The most evident displaced layer is a high resistivity unit of 200 ohm-m atop a very low resistivity unit (<8 ohm-m) interpreted as plastic clay as a result of the correlation of the direct soundings with geophysics. Therefore, this structure poses a serious hydrological hazard, which combined with the overpopulated, low-income neighborhoods located downstream, significantly increases the risk as a consequence of population vulnerability.
