# Failure Analysis of High Pressure High Temperature Super-Heater Outlet Header Tube in Heat Recovery Steam Generator

Ainul Akmar Mokhtar and  
Muhammad Kamil Kamarul Bahrin

## Abstract

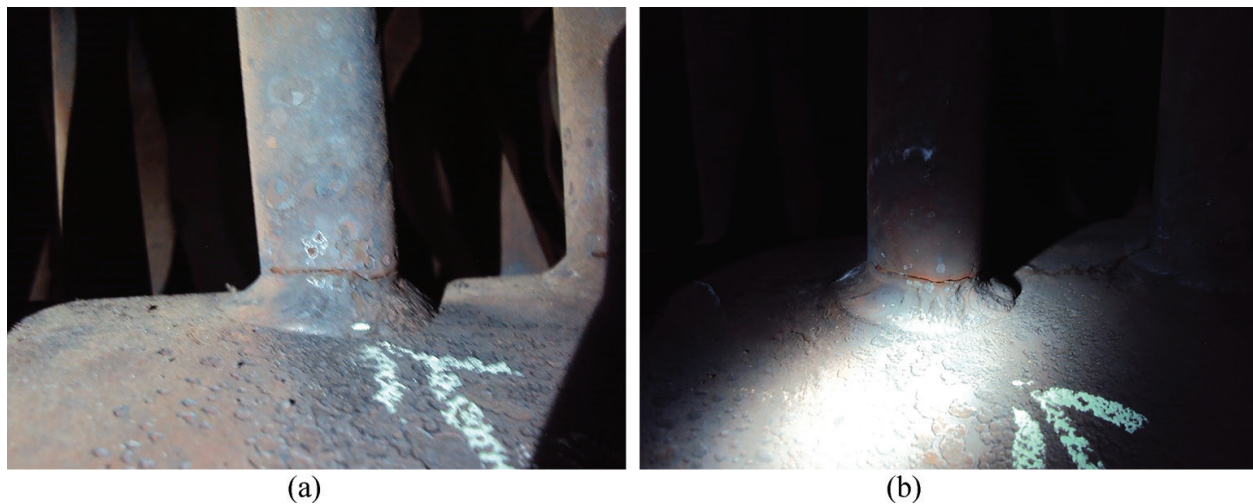
The investigation covered the failure of Tube 8, Tube 9, Tube 10 and Tube 18 of the HPHTSH section. **Figure 2** shows the samples of tube failures. Several analysis methods were carried out to ascertain the potential cause(s) of failure such as visual examination, dimensional

**Figure 2.** Appearance of Row 3 tube failures, (a) Tube 8 and (b) Tube 9.

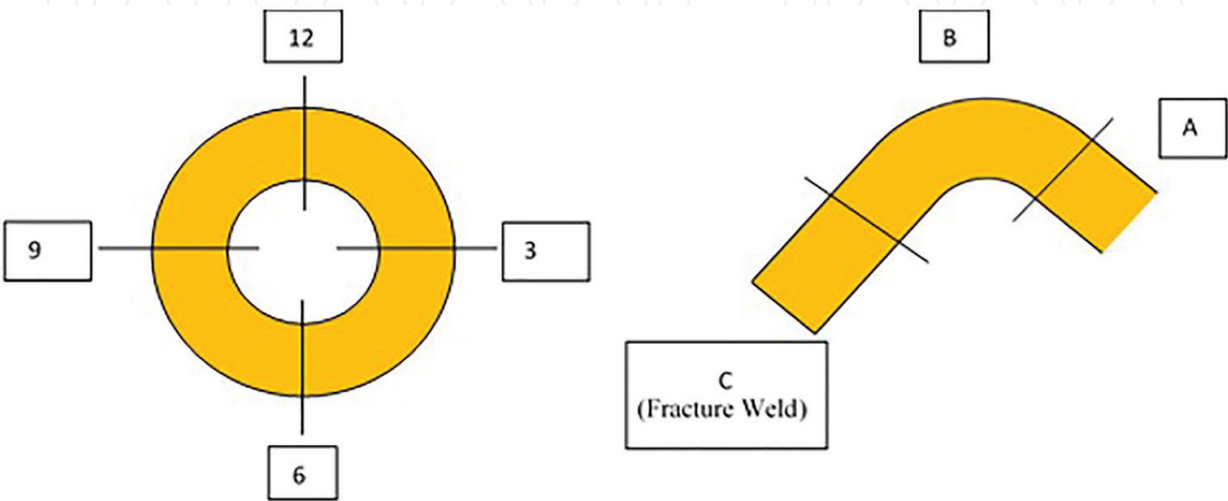
Tube 8 and Tube 18 out of five tubes were chosen for dimensional measurement since the Tube 8 may be a representative of Tube 9 and Tube 10. The tube was cut into six pieces in order to do OD and inner diameter (ID) measurement. The thickness of Tube 8 and Tube 18 was measured by ultrasonic thickness at three locations for each tube, designated as A, B and C. Four spots with respect to clock position 12, 3, 6 and 9 were measured at each location as shown in **Figure 5**. The results are recorded in **Tables 2** and **3**.

The minimum measured thickness readings were compared with the minimum required thickness from the RBI report and Doosan (HRSG OEM) report. Several locations of Tube 8 and Tube 18 showed that the wall thickness was lower than the minimum required thickness, which was considered unsafe and unacceptable. It implied that the risk of stress rupture

**Figure 5.** Dimensional references of thickness measurement on a tube.

was high. The significant wall thinning could be due to the excessive steam oxidation, which caused a high consumption rate of metal.

2. The thickness profile of all the affected superheater tubes shall be measured in extensive manner during outage opportunities. Tube sections with remaining wall lower than minimum required thickness shall be cut and replaced.

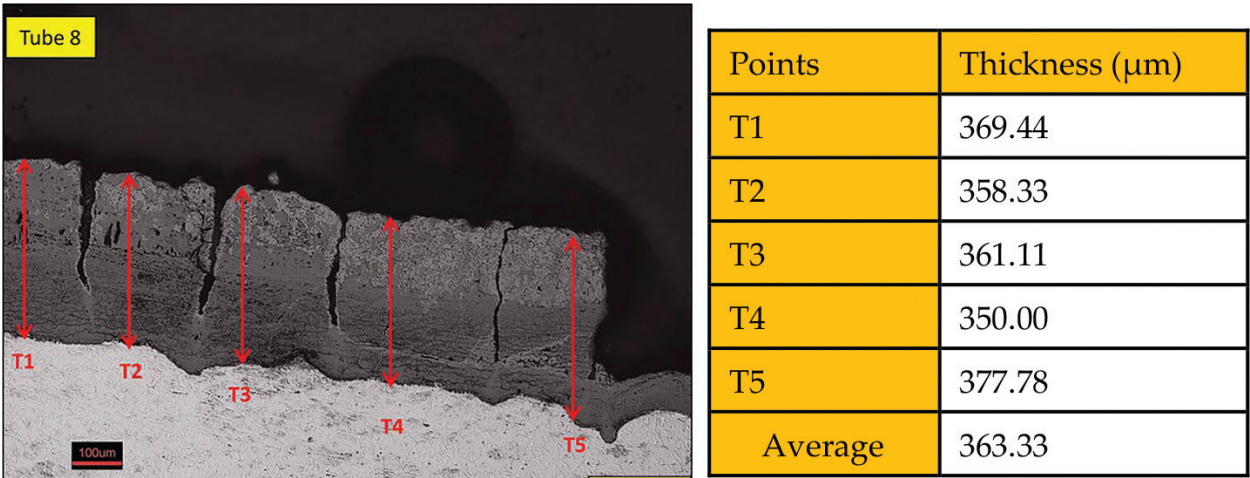
The steam-side oxide scale of micro specimens of Tube 8 and Tube 18 was measured under optical microscope. Both Tube 8 and Tube 18 were found to have undergone excessive steam oxidation. The oxide layer had cracked. The oxide thickness was measured and tabulated in Figures 10 and 11. The maximum thickness of the steam side oxide scale was 363 μm for Tube 8 and 390 μm for Tube 18.

Based from steam oxidation calculation [4], the thick oxide scale suggested that both Tube 8 and Tube 18 had been exposed to temperature in excess of 615°C as compared to material specification of SA 213T91 (design temperature, 602°C). The two tubes had experienced long-term overheating during operation.

Figure 10. Internal oxide thickness at Tube 8 (fracture area).
