The Major Cause of Earthquake Disasters: Shear Bandings

Tse-Shan Hsu

Keywords: tectonic earthquake, disaster, shear banding, seismic-vibration, major effect

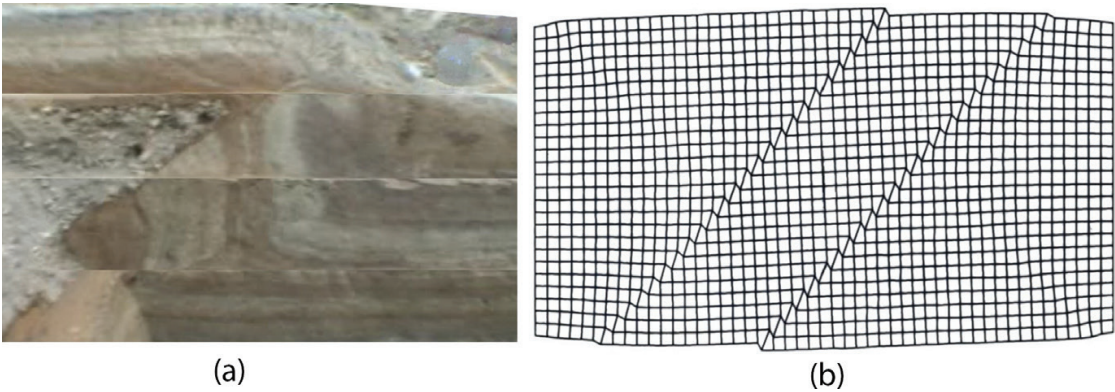
Figure 1. An actual shear band and numerical simulation results [8]: (a) an actual shear band that occurred in Zhushan, Taiwan, during the 921 Jiji earthquake; (b) shear bands produced by the finite element method.

It can be concluded from **Figures 1 to 4** that: (1) shear bands are induced by applying lateral compression or lateral extension on a tectonic plate; (2) highly concentrated excess pore water pressure can be induced in a shear band; and (3) ground vibration is induced by shear banding. Thus, the primary cause of earthquake disasters is shear banding.

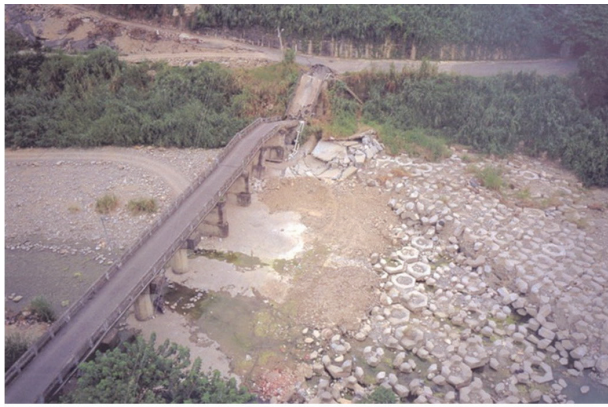
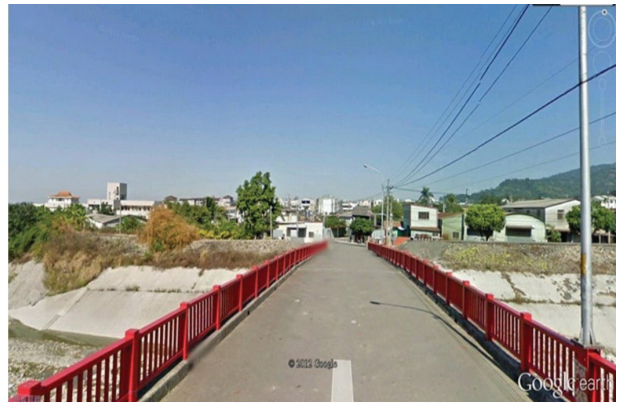
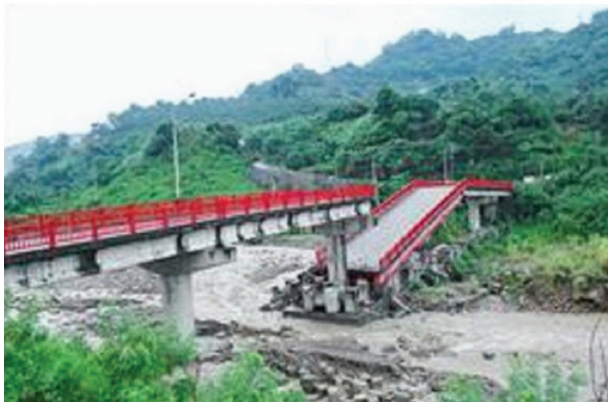
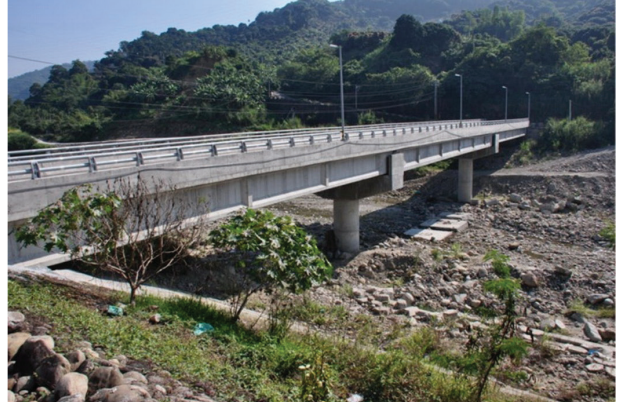
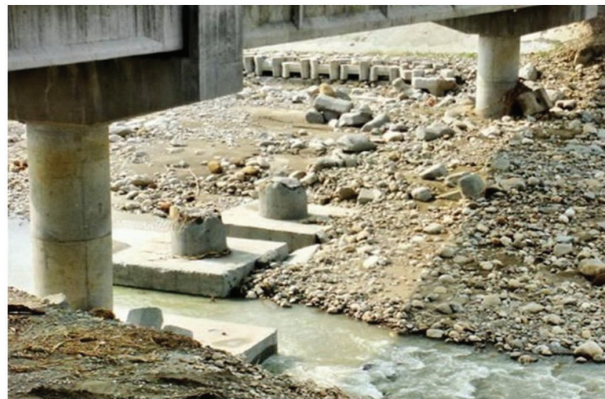
Figure 5a shows the Jianmin bridge which collapsed during the Jiji earthquake. **Figure 5b** shows the rebuilt bridge in 2001 using the new seismic zone division updated in 1999. During Typhoon Fanapi in 2010, the new bridge collapsed again (details in **Figure 5c**). **Figure 5d** shows that the bridge was rebuilt again in 2012 using the new seismic zone divisions updated in 2005. **Figure 5e** shows the exposed pile cap of the bridge only two months after reconstruction.

Figure 5. History of the Jianmin bridge in Taichung, Taiwan: (a) bridge collapsed during the Jiji earthquake, 1999 [10]; (b) bridge rebuilt in 2001 [11]; (c) bridge collapsed again in 2010; (d) bridge rebuilt again in 2012; (e) the exposed pile cap of the bridge [12].

Figure 5a clearly shows that the riverbed around the Jianmin bridge was seriously fractured during the Jiji earthquake. **Figure 6** indicates the shear textures, including the principal deformation shear, D ; the thrust shear, P ; the Riedel shear, R ; the conjugated Riedel Shear, R' ; and the compression texture, S , in the total width of a shear band. Thus, even though the vibration resistance forces were increased, both the old and new Jianmin bridge collapsed due to the effects of shear banding.

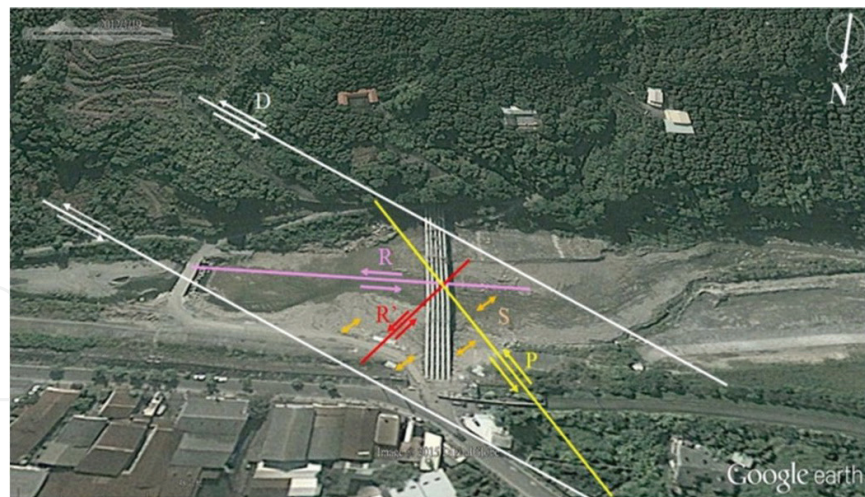
Figure 6. A shear band near the Jianmin bridge (background satellite image was cited from [11]).

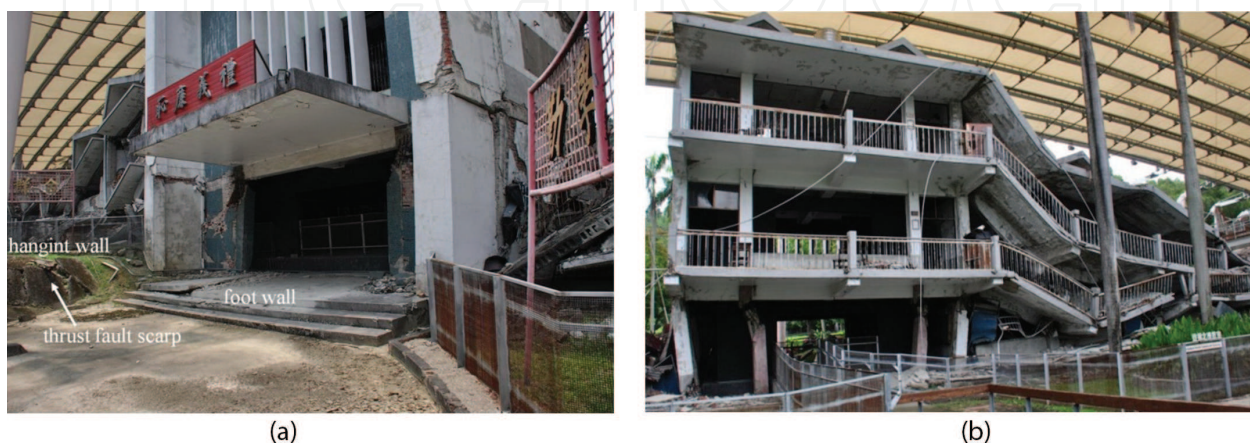
After the 921 Jiji earthquake, Kuangfu Junior High School in Taichung was maintained as an earthquake memorial museum for shear banding, ground uplift, and school building collapse, thereby, preserving the historical facts of the earthquake and providing students and the public educational earthquake material. In 2001, the school was renamed as the 921 Earthquake Education Park. Although the establishment of the museum is well intentioned, the explanations within the museum do not discuss the primary effect, and thus it is difficult to achieve the desired educational function. Taking the Kuangfu Junior High School building as an example, the building collapse is depicted in **Figure 7**. The actual mechanism for such a localized collapse, shown in **Figure 8**, was the occurrence of shear banding during a tectonic earthquake. However, under the guidance of the park instructor, currently, the students and members of the public who have visited consider that the primary cause of the building collapse was the excessive seismic vibration.

Figure 7. The collapse of the Kuangfu junior high school building during the Jiji earthquake: (a) front view; (b) rear view.

With this in mind, correctly stipulating and amending the seismic design specifications of buildings and correctly executing earthquake education are both required to guarantee that buildings will remain stable during tectonic earthquakes, with magnitudes less than the design magnitude.

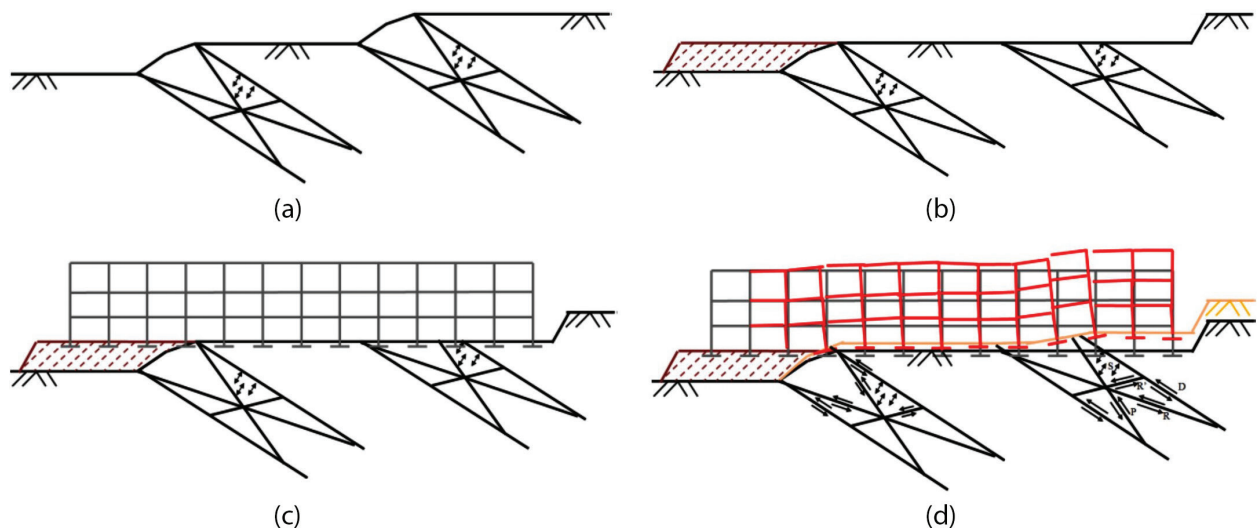
Figure 8. Schematic diagrams of the building construction process and collapse mechanism: (a) tilted slopes caused by shear banding; (b) ground leveling; (c) building constructed on shear bands; and (d) building collapsed by shear banding.

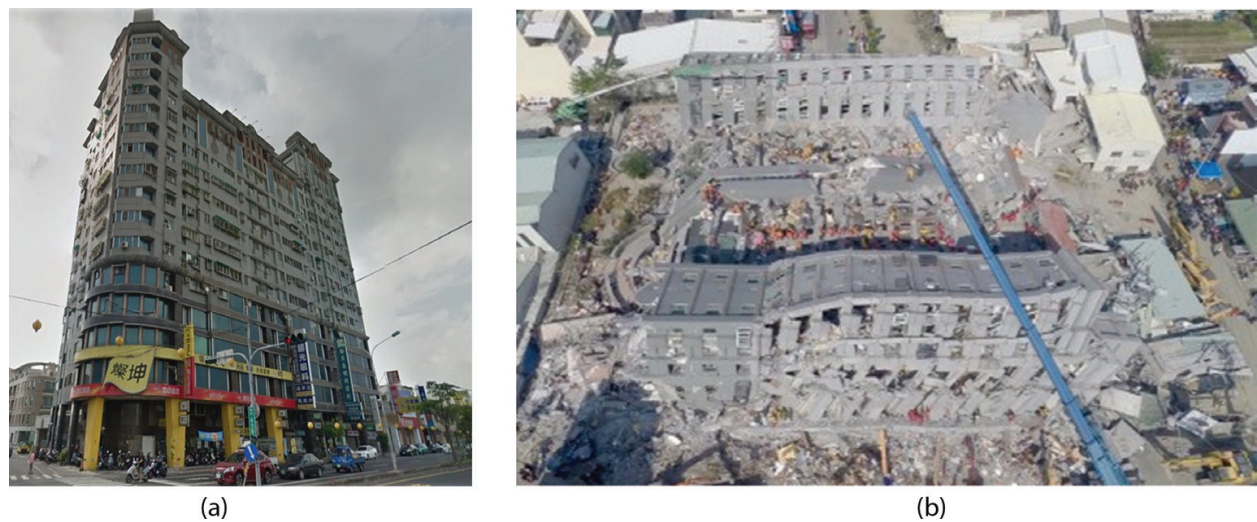
The Weiguan building was completed in 1994. It remained stable during the Jiasian tectonic earthquake with a magnitude of $M_L = 6.4$ in 2010 (refer to **Figure 9a**), but collapsed during the magnitude $M_L = 6.4$ Meinong tectonic earthquake in 2016 (refer to **Figure 9b**).

Figure 9. The Weiguan building: (a) before the collapse [11]; (b) after the collapse [13].

It was found from the monitor record images that before the collapse of the Weiguan building, a 2 m diameter pipe burst in the tap-water supply trunk pipe, embedded under the road adjacent to the building. After the pipe burst, a hole with a 4 m depth suddenly appeared. Because of the sudden appearance of the hole, the conditions of the side walls surrounding the basement, previously constrained, were partially unconstrained.

Since the soil under the road was sandy silt, such a soil layer still retained considerably high shear force resistance in a dry state, which caused Block G to recline on the road's ground surface after the collapse of the Weiguan building (details in **Figure 10**). In addition, sandy silt shear resistance strength drops significantly in a saturated state, which caused Block A to fall 2.5 m deep into the ground after the collapse. When the soil under the road adjacent to Block A lost lateral support, the bottoms of all the columns in the first floor deviated from the fixed end conditions established in the structural analysis model.

As for the cause of the damage to the large-scale water supply pipe, Liu [14] and Hsu et al. [15] pointed out that the peak ground acceleration (PGA) was not the main cause for its damage during the earthquake; the main cause was shear banding. From this, we can conclude that the bursting of the tap-water supply trunk pipe on the road adjacent to the Weiguan building was actually mainly caused by shear banding.

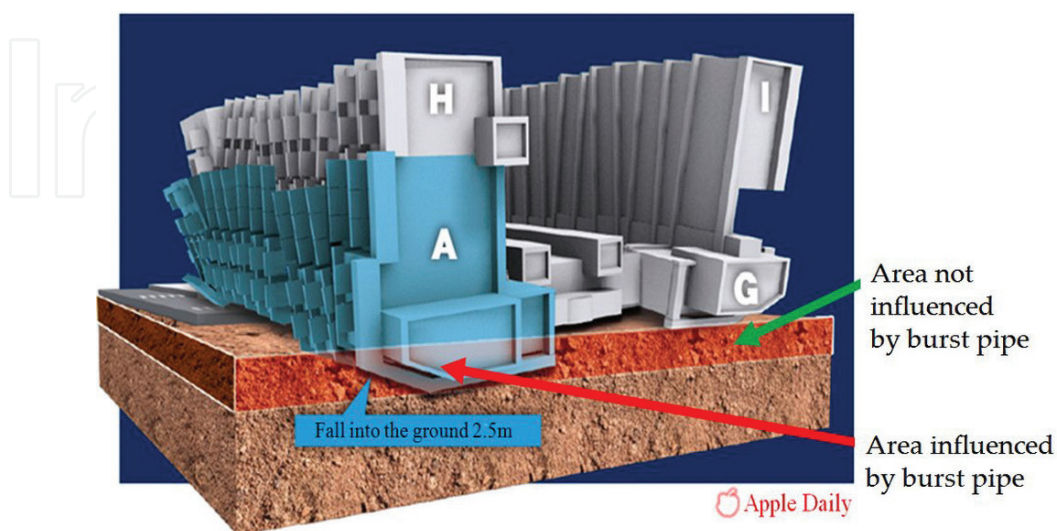
Figure 10. Schematic diagram of the Weiguan building after the collapse [16].

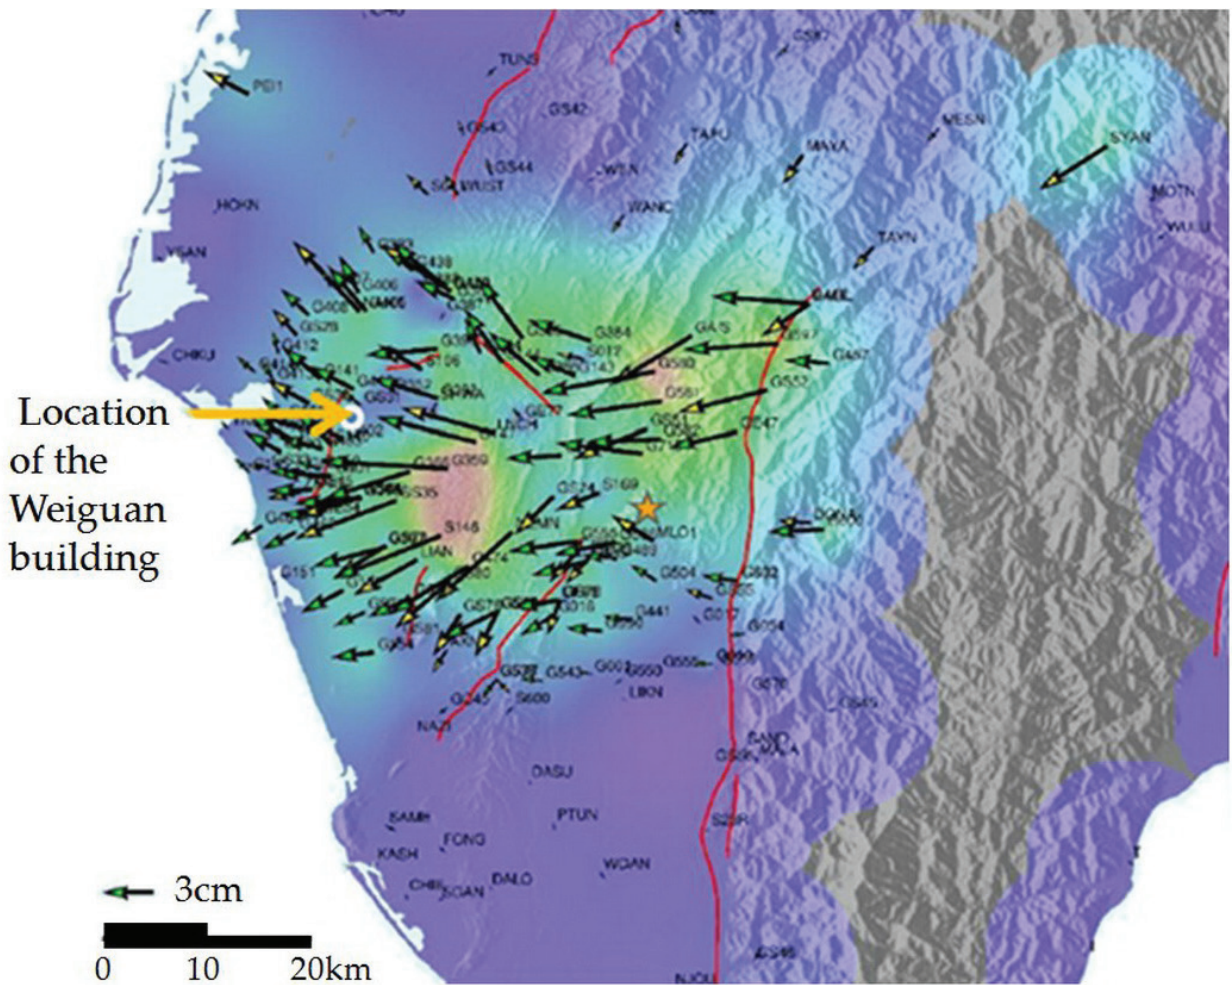
Step 2: The GPS velocity vectors shown in **Figure 11** indicate that shear banding did occur near the Weiguan building. The pipe burst is another piece of evidence for shear banding.

Figure 11. The GPS velocity vectors produced by the Meinong earthquake [17].

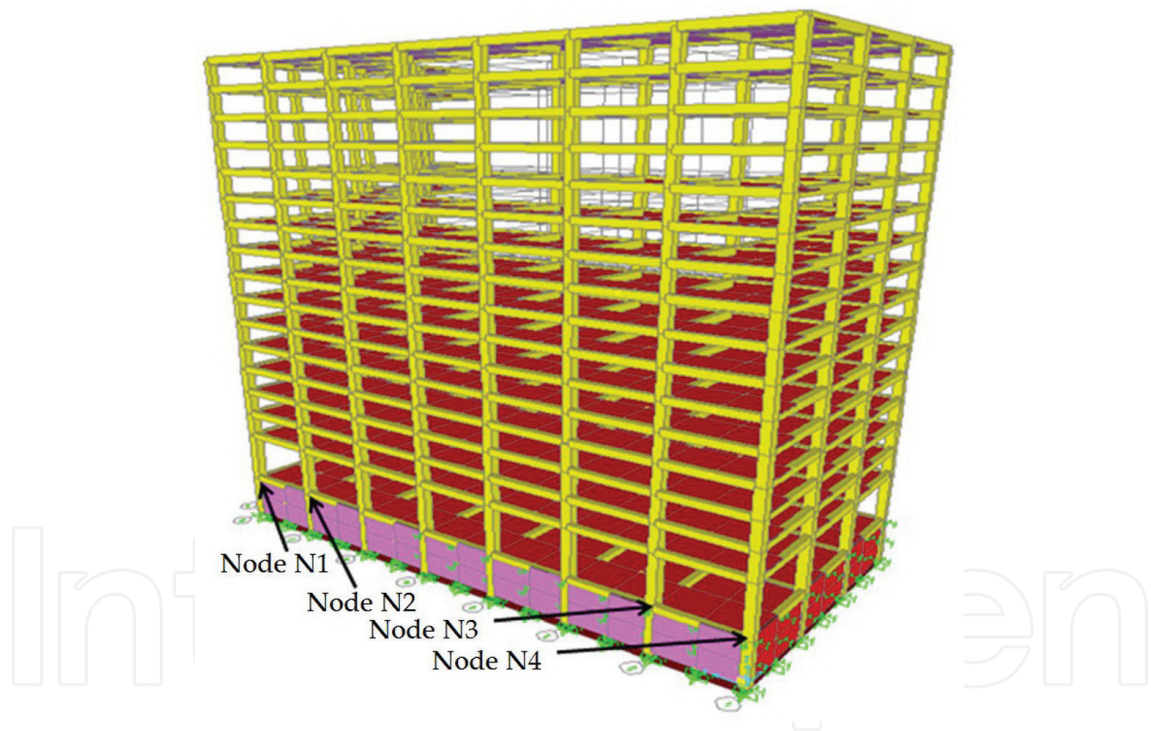
Figure 14. The four major nodes of concern in the structure model.

The maximum displacements for the four joints shown in **Figure 14** from the structure dynamic analyses with and without the shear banding effect are shown in **Table 1**. Case 1 includes the shear banding effect and Case 2 does not.

those of Case 2. The resulting F_{12} fractions are shown in **Table 2**. From **Table 2**, the shear banding effect is very significant for nodes N1 and N2 and less significant for nodes N3 and N4.

It should be mentioned that only for values of F_{12} of less than about 1.4, for the total displacement vector, will the building structure remain under stable conditions. However, the largest value of F_{12} for the total displacement vectors is 1.87. Since the worst conditions occurred at nodes N2 and N1, the tilting of the Weiguan building should begin from the side that was more under the influence of shear banding. Afterward, the tilting quickly propagated to the other side.

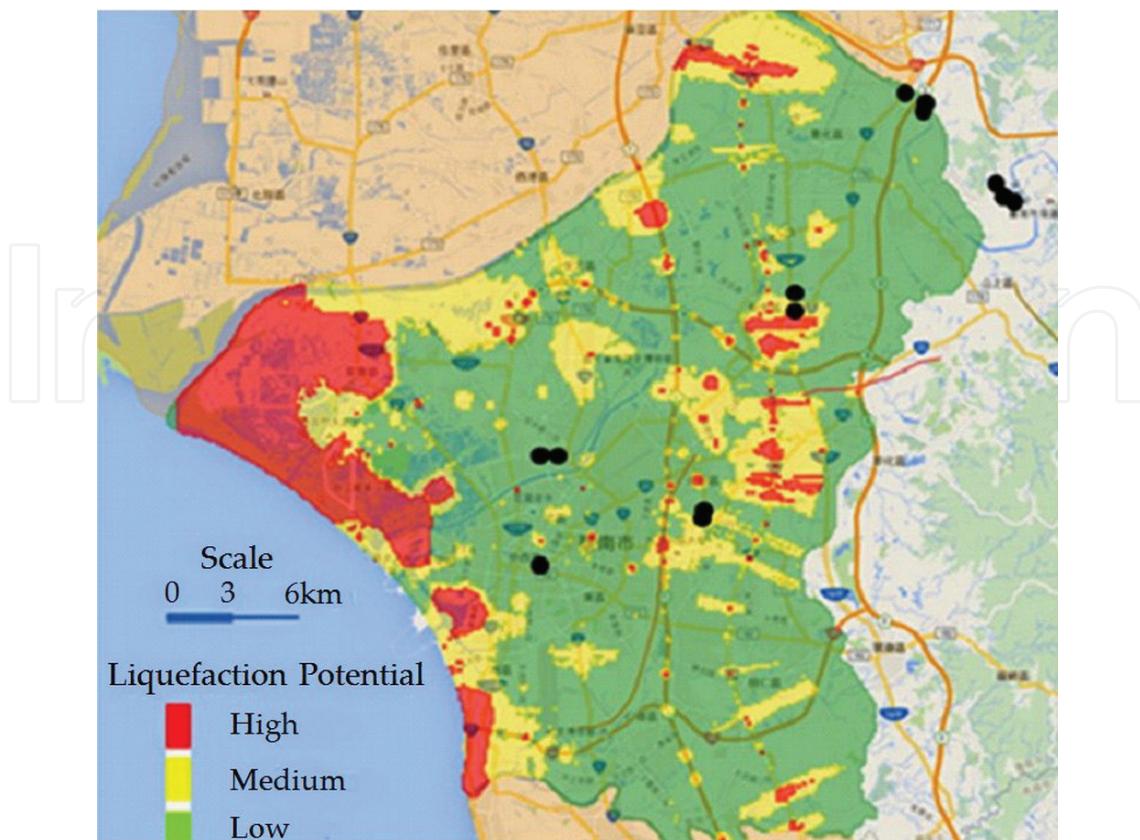
The actual location of soil liquefaction in Tainan City took place during the Meinong Earthquake on February 6, 2016, as shown in **Figure 16**. **Figure 16** also shows that: (1) soil liquefaction is

merely a kind of localized phenomenon; (2) the actual area of soil liquefaction is far less than the area of conventional soil liquefaction potential proposed by the Central Geological Survey, MOEA; and (3) the actual locations of soil liquefaction were mostly outside the areas with high liquefaction potential. Thus, we know that the conventional cause of soil liquefaction is different than the cause of localizations of soil liquefaction.

Figure 16. Comparison between the locations of soil liquefactions induced by the Meinong earthquake and the distribution of conventional liquefaction potential [8, 19].

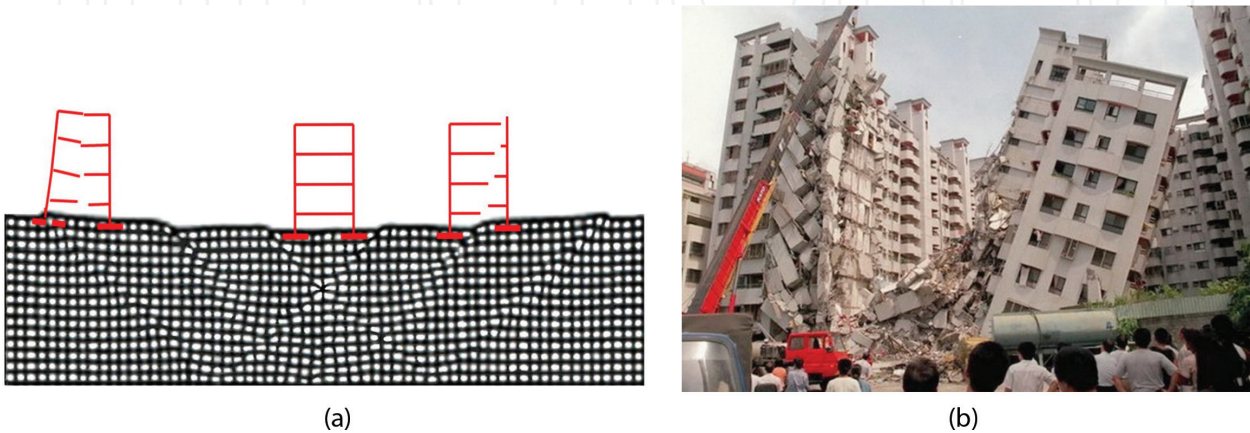
The building collapse pattern induced by localizations of soil liquefaction during a tectonic earthquake is shown in **Figure 17**. This kind of damage pattern is totally different from the pattern caused by foundation punching shear failure or local shear failure.

Different damage patterns will require different disaster prevention methods, so the building damage induced by foundation punching shear failure or local shear failure must not be misidentified as soil liquefaction damage.

Figure 17. Building disaster caused by localizations of soil liquefaction during the Jiji earthquake, 1999: (a) schematic diagram of the building collapse pattern; (b) actual building collapse pattern [22].
