Degradation Monitoring of Photovoltaic Plants: Advanced GIS Applications

Miguel de Simón-Martín, Ana-María Diez-Suárez,
Laura-Álvarez de Prado, Alberto González-Martínez,
Álvaro de la Puente-Gil and Jorge Blanes-Peiró

<http://dx.doi.org/10.5772/intechopen.75650>

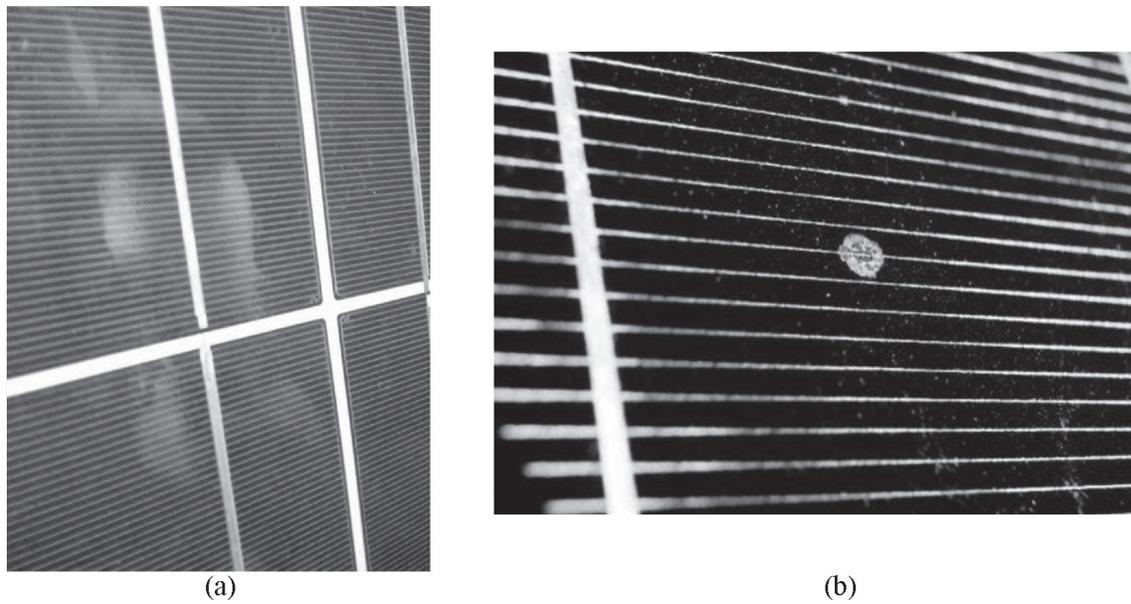
Degradation of the encapsulation material (normally ethylene vinyl acetate or EVA) is an esthetic issue that does not usually affect the performance of a module. It can, however, lead to an average current loss of 0.5%/year or 0.8%/year for Si PV modules [10].

Rising temperatures, the photo-degradation of EVA by UV radiation, and the existence of molecular oxygen lead to the production of acetic acid and volatile gases, that are trapped within the module, and can produce delamination or the formation of bubbles [11].

On the other hand, inappropriate temperatures or an excessively long lamination procedure [14] during the manufacturing of the photovoltaic module can cause bubbles of gas to be formed either as a direct or as an indirect consequence of melting and solidification processes (**Figure 1**). In **Figure 1(a)** an EVA discoloration can be appreciated while in **Figure 1(b)** we can observe an example of a bubble formed over a metal contact.

Figure 1. Examples of (a) EVA discoloration and (b) bubble formation.

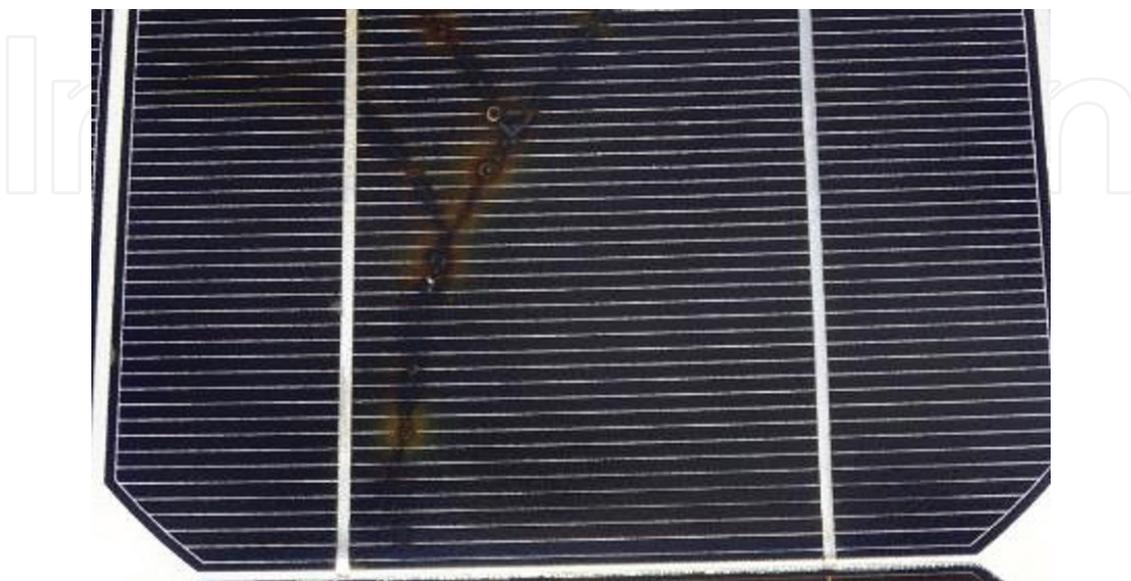
Figure 2 shows a clear example. Cell cracks may occur during or after production. Major sources of cell cracks are during packaging and transport or during the reloading of PV modules and installation in the field.

Small cell cracks show a great tendency to develop into larger, wider cracks during operation of the solar module due to mechanical stress [15] from wind or snow load and thermo-mechanical stress [16] from temperature variations due to changes in weather and intermittent cloud cover.

An inactive cell area of 8% or more is unacceptable. Apart from the risk of power loss there is also the chance of hot spots being formed. This can happen when a cracked cell has a localized

Figure 2. Example of cracks in a PV cell.

reverse current path in the still active cell part. The cell may reverse bias and the full current will be able to flow along the localized path as a consequence of the missing cell area. This can cause hot spots and subsequently burn marks [17].

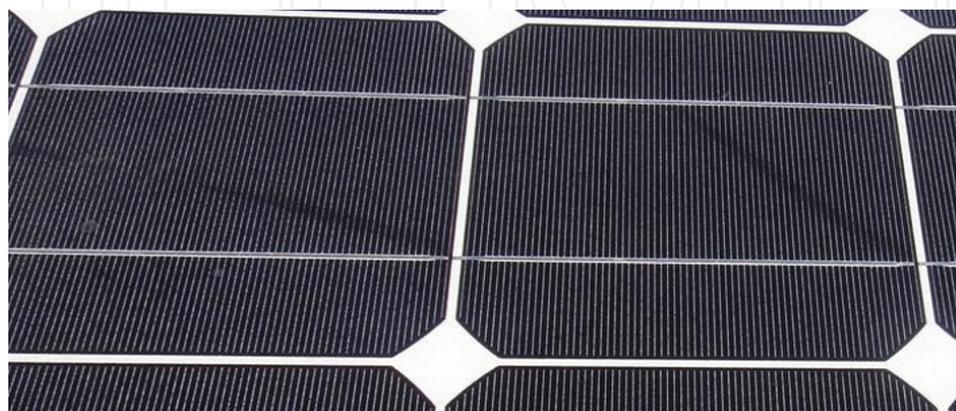
Snail tracks are discolorations of the silver fingers on solar cells. A significant example can be seen in **Figure 3**. The effect looks like a snail has passed across the front glass of the PV module. The discoloration takes place on cell cracks that are not visible at the edge of the solar cell. This typically happens between 3 months and 1 year after installation of the PV modules [18]. Discoloration speed is initially dependent on seasonal and environmental conditions, such that snail tracks seem to spread faster during summer months and in hot climates [5]. PV modules affected by snail tracks have been compared with reference modules under laboratory conditions [19] and results showed a 40% reduction in maximum power under standard conditions with a 25% lower yield than expected when measured over a 30-day period.

Figure 3. Example of a snail track over a PV cell.

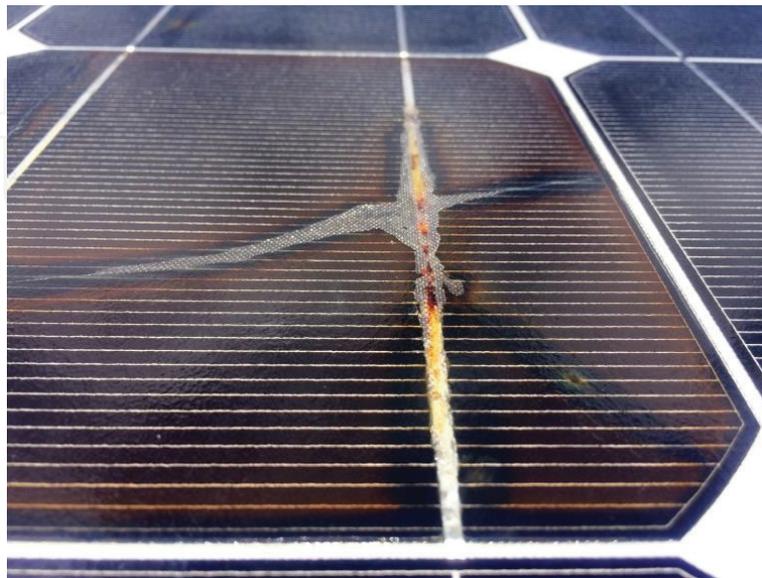
A typical and very common failure in silicon PV modules is burn marks. This failure occurs due to part of the module becoming very hot and can be because of ribbon breakage, solder bond failure, or localized heating from reverse current flow or other hot spots [5]. Burn marks can produce power losses and serious safety problems. They are usually located on or closed to the metal contacts of the PV solar cells, such as it can be seen in **Figure 4**.

Hot spots are areas in a photovoltaic module that have very high operating temperatures when compared to surrounding areas. This may be due to interconnection failures, defects in the cell, dispersion of characteristics between modules of a generator and between cells of the same module connected in series, potential-induced polarization in modules manufactured with novel techniques, or when a cell generates less current than other cells connected in series as a consequence of intermittent cloud cover or partial shading [20]. As a consequence, the cell becomes polarized (the voltage between the terminals becomes negative) and starts to dissipate the power generated by the other serial cells in the form of heat.

Figure 4. Example of a burn mark on a PV cell.

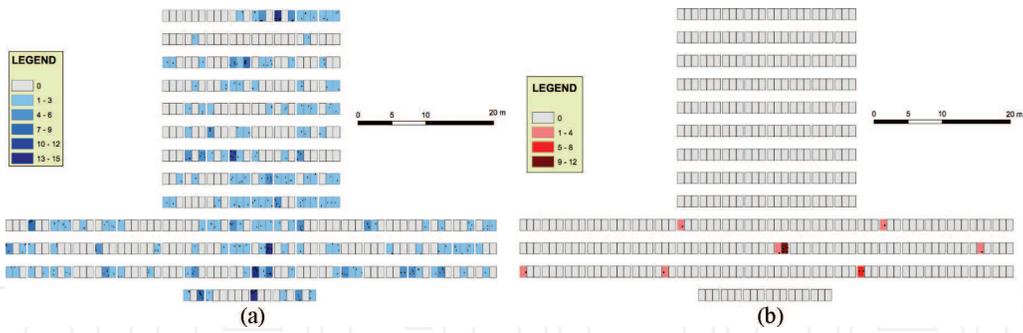
Figure 9. PV faults and defects in the 108 kWp PV plant: (a) snail tracks (b) hot spots and burn marks.

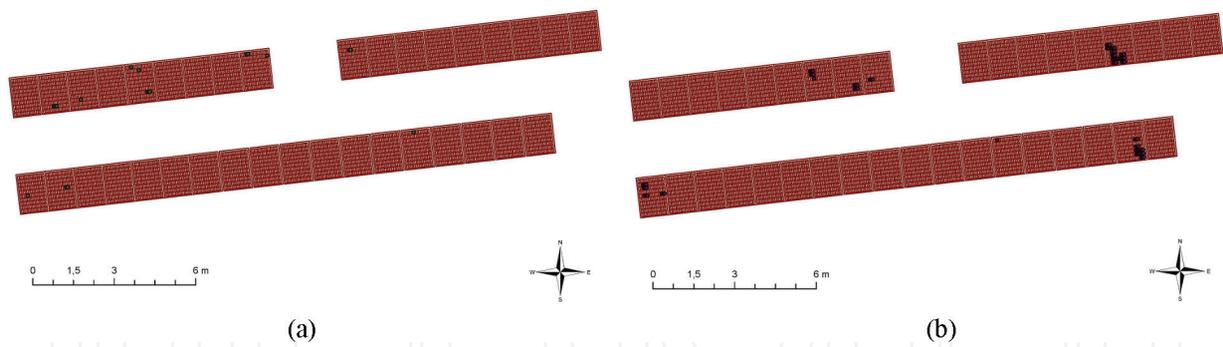
Figure 11. PV faults and defects in the 9 kWp PV plant: (a) snail tracks (b) cell discolorations.

almost no degradation has yet been observed. However, **Figure 11(a)** and **(b)** show some snail tracks and cell discoloration that might lead to the modules needing future maintenance. The distribution of these defects does not appear homogeneous and seems to be concentrated at string series extremes.
