Influence of Geological Structure on Dam Behavior and Case Studies

Arash Barjasteh

Abstract

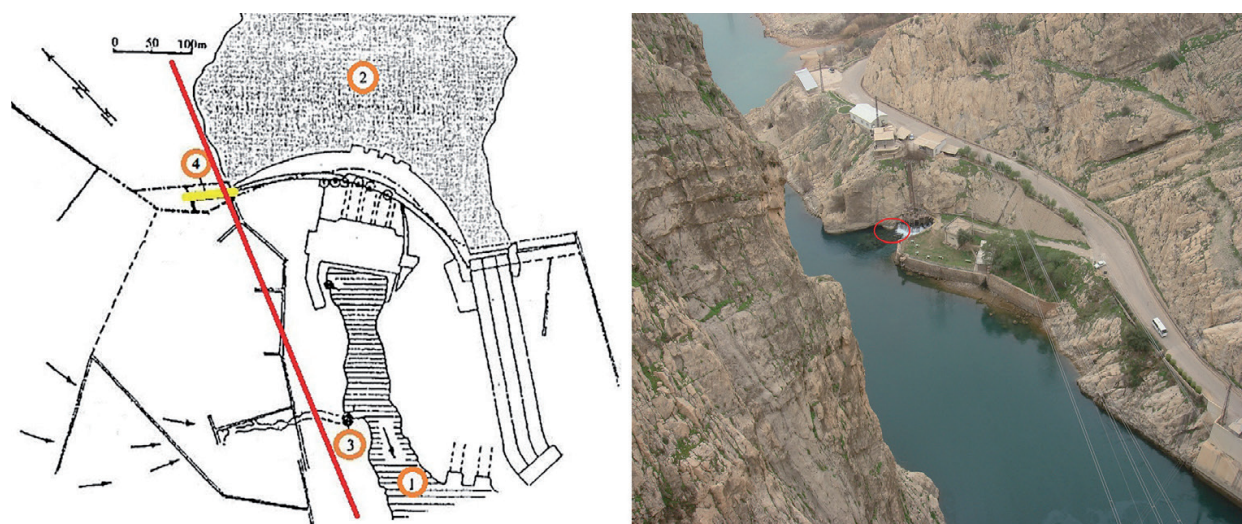
The location of the two springs is aligned with a tectonic lineament trend SW-NE. Besides, the joint sets at the Big Spring location (**Figure 6**) shows the same general trend. This direction is parallel to the average direction of regional compressive stress in the Zagros Belt and indicates the general trend of extensional fractures forming normal to anticlinal structures

Figure 5. General layout of the dam site (left) and downstream view of Big Spring (right). The numbers in the left picture stand for: 1—Karun river, 2—reservoir, 3—Big Spring, and 4—cutoff wall.

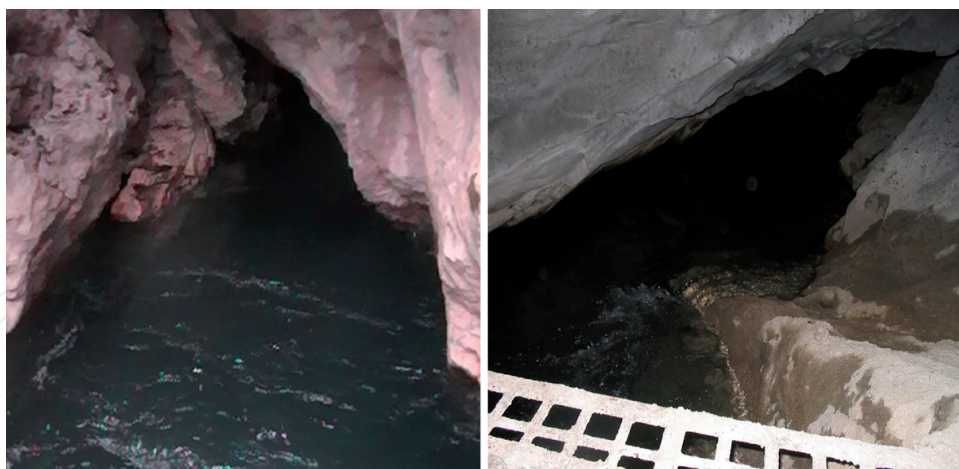
Figure 6. A close view of Big Spring (left) and existing joint cavity (right).

pre or synchronous to folding [27]. The existing karst channel shows parallelism to the joint walls. The vertical dip of joint system on the right abutment could be another factor to support spring recharge through the reservoir area by very far upstream sources.

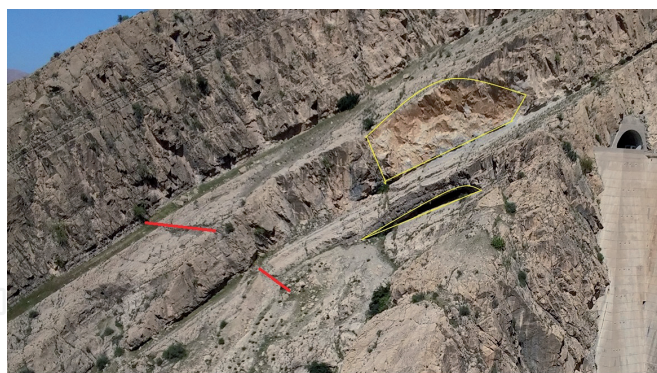
Figure 7. Rock sliding (in yellow) at right abutment of the dam.

Here, due to the downstream dip of bedding, which is unfavorable for a dam site, a natural potential for rock fall and slide on the dam abutments was predictable (**Figure 7**). This geological condition is of key importance since the southwestern (downstream side) limbs of the Zagros anticlines are usually very steeper than the northeastern limb due to the action of thrust faulting that affect the southwestern anticlinal limbs [30, 31]. New observations proved the subject and some rock slide and fall happened especially on the right abutment. There seems to be some flexuring along the bedding plane as well. The vertical tensional joints on the right abutment could amplify rock falling.

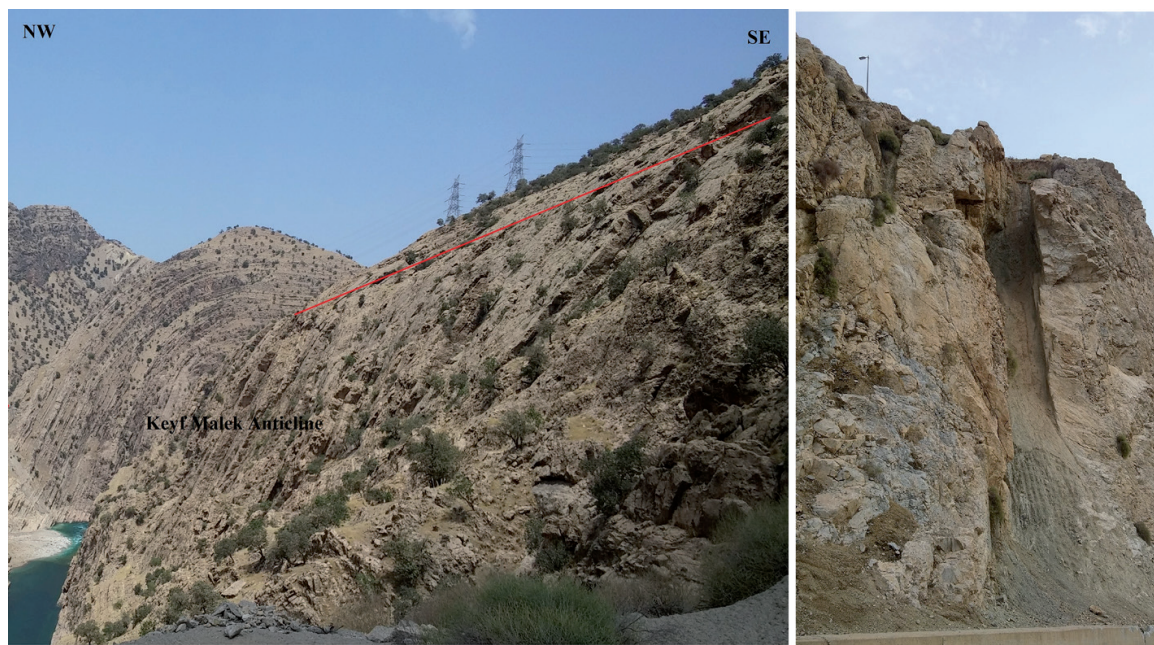
Figure 12. Downstream view of Keyf Malek anticline (left) and longitudinal fault cutting its southwestern limb (right).

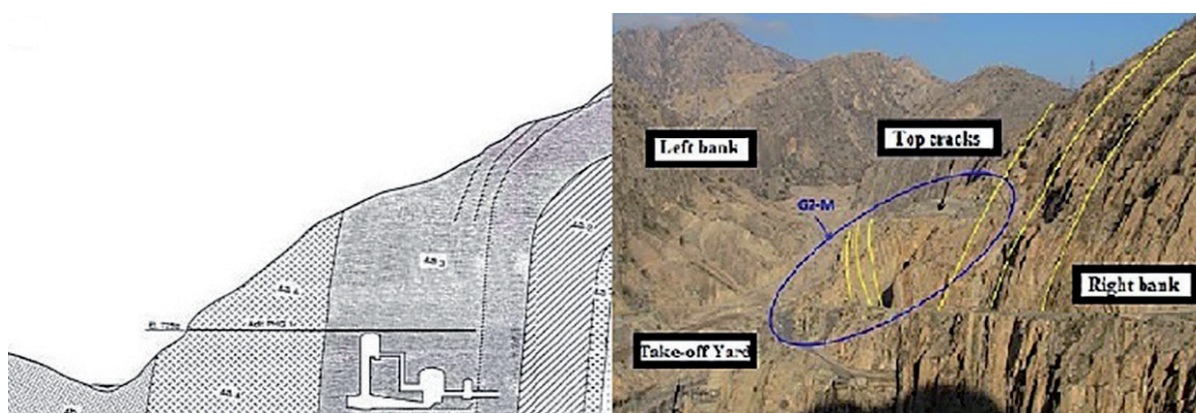
Figure 13. Geological section (left) and downstream view of G2M (right) rock mass.

As was mentioned above, instability of G2M above takeoff yard and leakage through downstream springs in particular Abol-Ghasem Spring are the main subjects of dam behavior in Karun-3 project. The rock slope, called G2M, is placed at the top of access road to the spillway on the right bank of the dam (**Figure 13**). The slope that is composed of limestone, marly limestone and marls besides developed tensional cracks created a potentially sliding mass.

Generally speaking, the slope was probably formed by displacement and collapse of the layers consequently, pushing front layers toward the river valley [33, 37]. Alternation of the competent (limestone) with incompetent (marl and marly limestone) layers at G2M slope, besides the presence of thrust faults on both flanks of Keyf Malek anticline is most probably the main reason for instability of the G2M. It is very probable that a hidden blind fault cuts the core of the anticline regarding very sudden change in dip of the bedding on the southwestern limb of

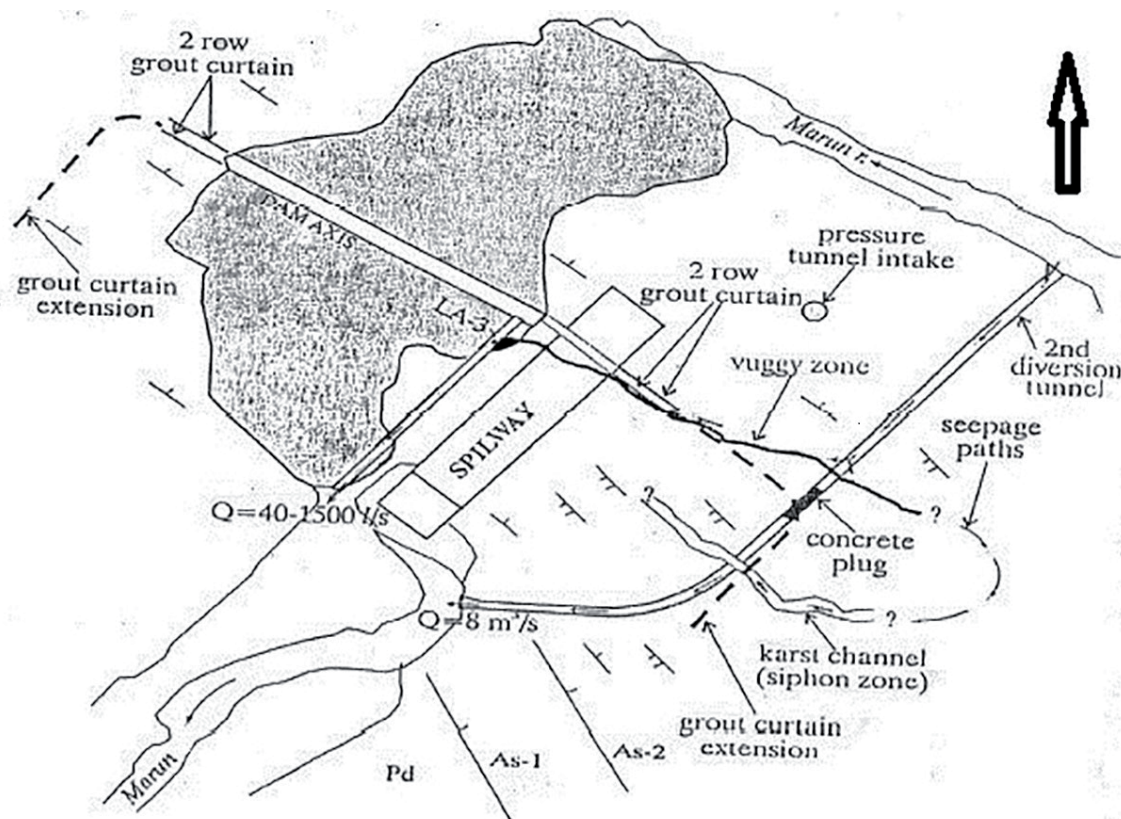
The embankment was overtopped with increasing water elevation, and considerable leakage of up to 7 m³/s occurred from weak zones upstream of the plug. The major flow of approximately 4.5 m³/s was from two large solution channels and leakage around the concrete plug.

Figure 16. A general layout of Marun dam and appurtenant structures.

The remaining flow was from the access tunnel and the grouting adit ($2.3 \text{ m}^3/\text{s}$). The total amount of water leakage through the left bank of Marun dam was about $10 \text{ m}^3/\text{s}$. The water entered the fracture system upstream of the plug and passed along the fissures, washed out the marls interbeds forming large cavities. These are master cross joints traversing the dam site rocks from upstream to downstream. Water was leaking into all tunnels and the dam, and all springs received their water from the same fissure as was reported [39]. In fact, these are fracture swarms as was defined above indicating the intense fracturing surrounding faults or narrow zones with a very high frequency of fractures. These major features are major conduits for fluid flow in the subsurface at some stage that is very favorable for karst development. This is almost similar to the karstic features mentioned for Karun-1 dam (abovementioned) although it is almost visible that karstification is developed more and complete at the Marun dam site. Here, the general trend of fracture swarms is parallel to the general direction of the maximum compressive stress in the Zagros Fold Belt that produced tension-induced, open fractures resulting in significant secondary permeability to the rock. Intersection of longitudinal fractures (vuggy zone) in the Khaviz anticline with transverse fractures (fracture swarms) amplified permeability of the rock and simplified water leakage through the left abutment during the first reservoir impounding. It is very probable that seepage paths were formed along the fracture swarms parallel to the second diversion tunnel.

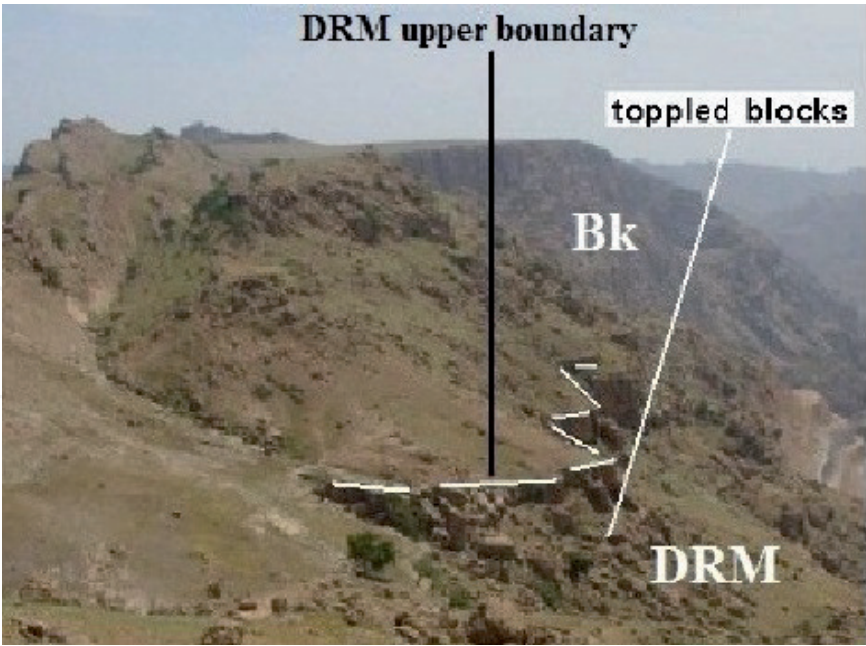
As mentioned above, one of the challenges at Gotvand dam is instability of the dam abutments [42] and its reservoir banks [44]. The dam abutments include considerable volumes of dislocated rock mass of Bakhtyari formation. This is more critical in the right abutment as the rock mass is highly disturbed and deformed (DRM) and apparently illustrates a rock topple (**Figures 17 and 20**). On the other hand, the rock mass in the left abutment shows evidence of a rock slide. The DRM area is specified by extensive development of joints and cracks and its

Figure 20. An upstream view of the displaced rock mass (DRM) on the right abutment [42].

extent along the dam axis was estimated between 150 and 200 m [45]. Consequently, water seepage was considered as an extra problem in the right abutment. Lugeon tests in this zone indicated values more than 60 due to the extent of fracturing. The prevailing hydromechanical behavior of the rocks at this abutment was dilatation and washout based on geotechnical investigations [44, 45].

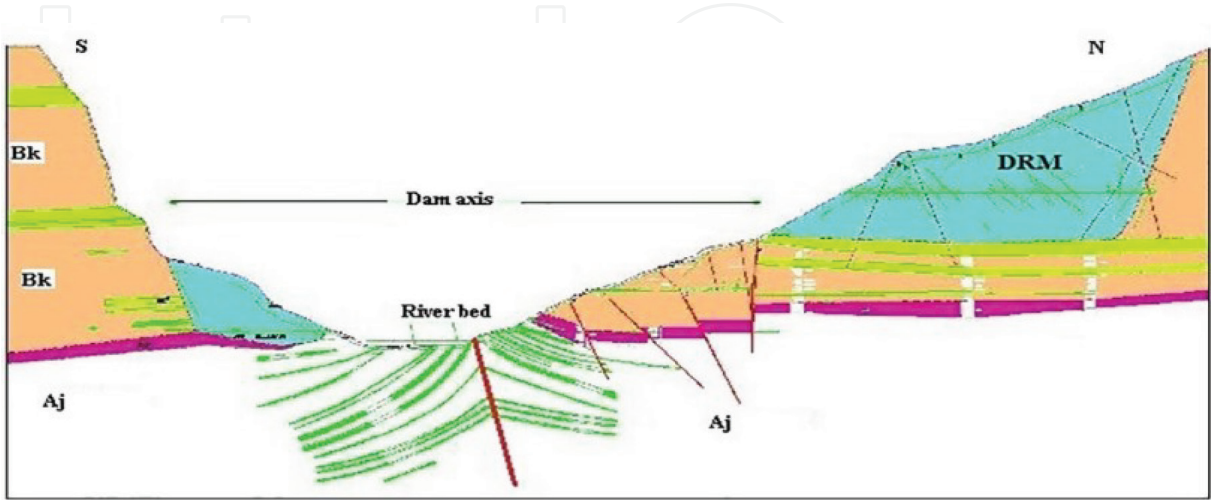
Figure 21. Simplified geological cross section along the dam axis [44].

south and north of the dam site, respectively, caused severe compression resulted in tight folding of the Agha-Jari layers (**Figure 21**). Subsequently, simultaneous compression of the competent sandstone layers and incompetent siltstone and mudstone layers in the Agha-Jari formation resulted in flexural-slip along the bedding planes, accompanied by shearing and jointing of rocks.

Continual development of forced-folding widens joint apertures that make them favorable for gypsum precipitation. Results of Lugeon test for Agha-Jari rocks at the dam foundation show an average value of 6 up to a maximum of 30 LU. Laboratory experiments estimated the solution rate for the core-drilled gypsum of the dam foundation as 2.49 cm/year. As the number of fractures in gypsum layers increases, solution processes progress. It is calculated that the dissolution of gypsum veins increase the mass equivalent permeability up to 75–300 times depending on aperture width and spacing. The availability of fractures and fissures are primary and main factors for solution progress. In this regard, gypsum veins observed in Agha-Jari formation at the dam foundation could be threats to safety and proper performance of the dam.
