Introductory Chapter: Environmental Characteristics of a Dobrudja Famous Archeological Monument

Daniela Turcanu-Carutiu and Rodica-Mariana Ion

1. Introduction

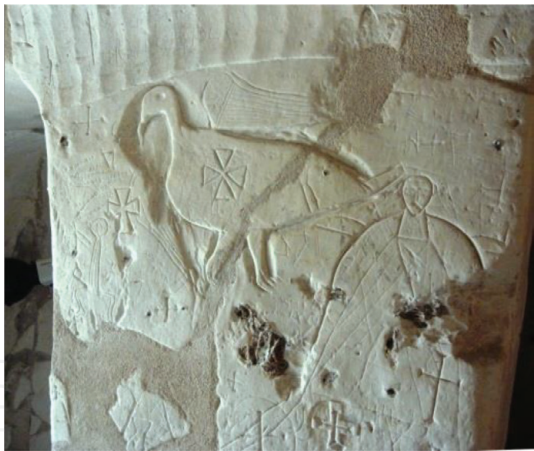
Assembly, dated IX–XI centuries is located in a hill of chalk cliff into a Roman career style, with churches, galleries branched vaults, housing the tombs [1]. Facings are inscribed with symbolic designs and different scenes and a large number of inscriptions. Some of these are palaeoslavonic and Cyrillic and some are written in Glagolitic or in Greek, but mostly in an enigmatic writing that could not be decoded so far [2, 3] (**Figure 1**).

Figure 1.
The interior of the churches and crosses, figures incised in the chalk wall.

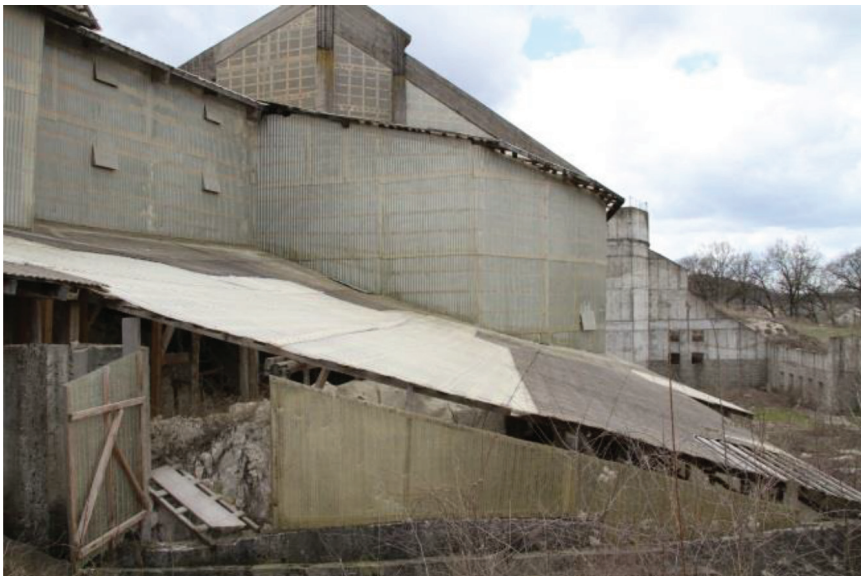
Currently, the wooden structure of the building was repaired under provisional protection, and cardboard asphalt was replaced with polycarbonate enclosures in summer 2006 (**Figure 2**).

Figure 2.
Provisional protection structure.

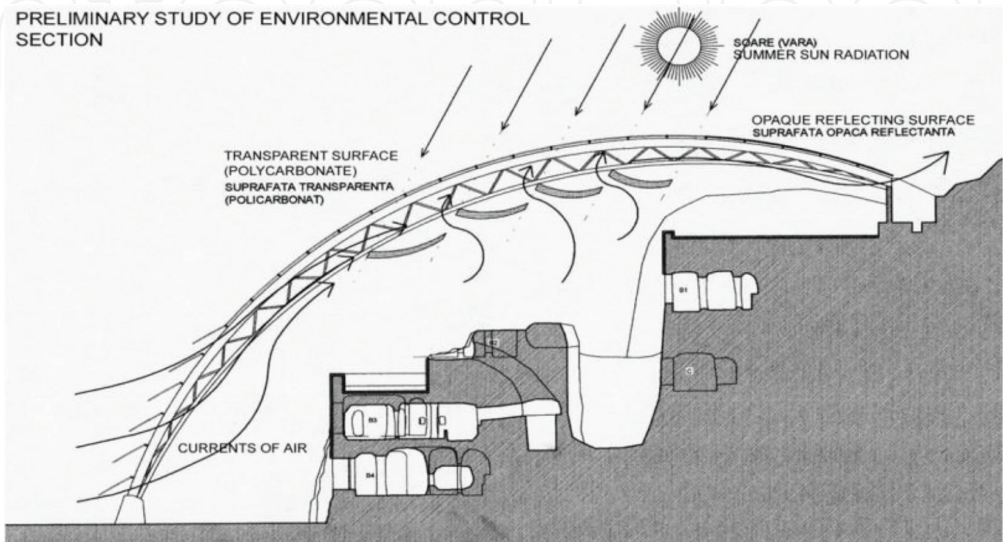
Figure 3.
The scheme of the polycarbonate enclosure.

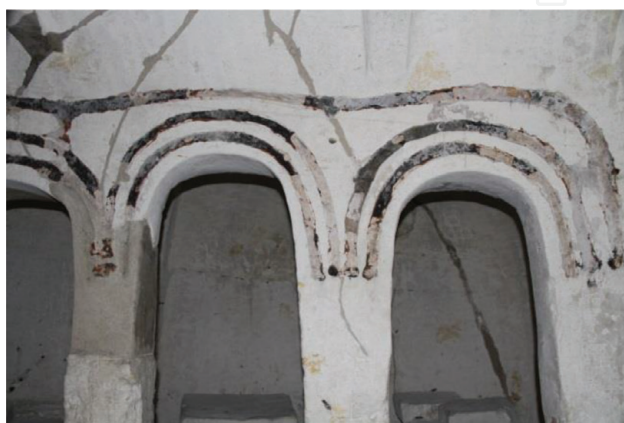
The proposed investigations refer the groundwater conditions' hydro-geological site near the monument, water accumulation in career and possible leakage of leachate to landfill career. For all these, it has been achieved six boreholes to depths of 15–20m, located outside the site with research role (**Figure 4**). Except these, the chemical analysis of pre-elevated water from drilling and the analysis of physical properties of the materials present in drilling have been achieved.

Figure 4.
The photo of naos.

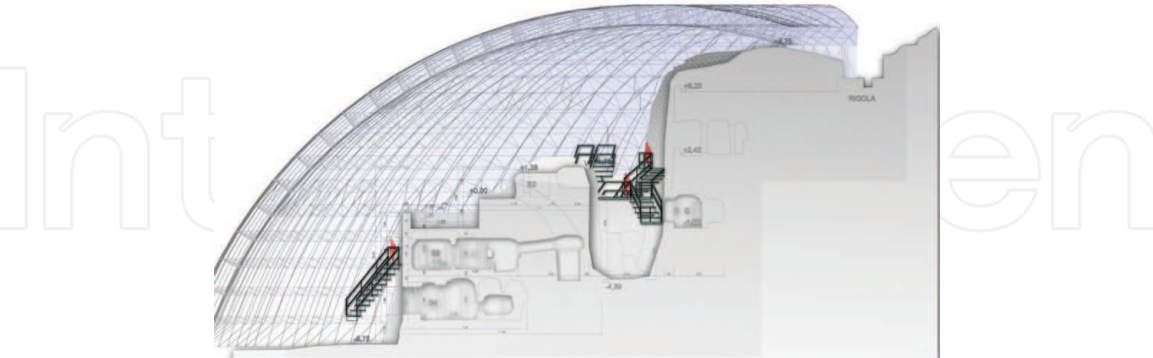
Figure 5.
The section through the Chalk Mountain.

The viable solution remains with the polycarbonate enclosures, with adequate respiration air flux (**Figure 5**).
