# The Position and Function of Macroscopic Analysis in the Failure Analysis of Railway Fasteners

*Guodong Cui, Shuaijiang Yan, Chengsong Zhang,  
Dazhi Chen and Chuan Yang*

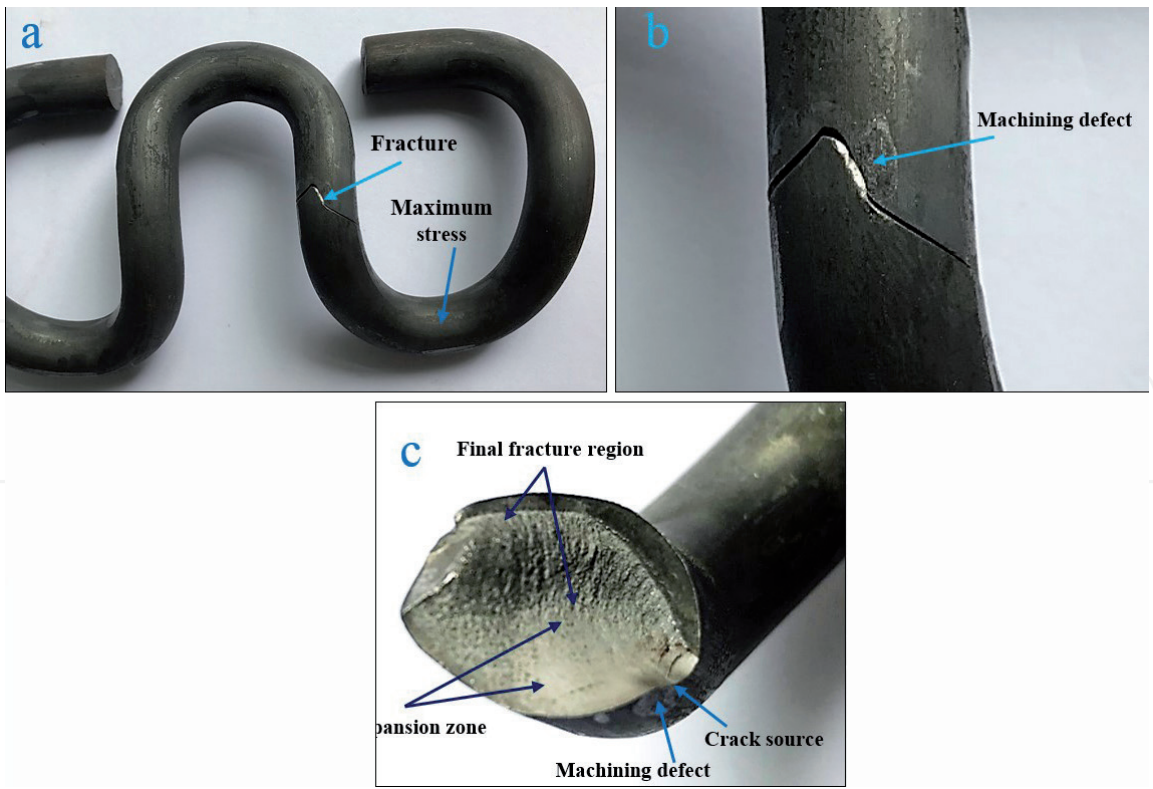
**Figure 1** shows the fracture condition of a rail fastening clip after the fatigue test of  $4 \times 10^5$  cycles. However, according to the TB/T2329-2002 Chinese standard for the fatigue tests of rail fasteners, the samples should not fracture after  $5 \times 10^6$  cycles. In order to find out the reasons of the premature failure, macroscopic analysis was conducted on the failed sample. As shown in **Figure 1a**, the fracture surface is not located in the position bearing the maximum stress during fatigue tests. The detailed observation reveals that a processing defect exists near the crack initiation region, as is shown in **Figure 1b**. This defect is mainly caused by the excessive extrusion of the hot plastic mold during induction heating, resulting in a local stress concentration at the defect. Subsequent quenching further increased the local stress at defects. During the fatigue tests, crack initiated from the stress concentrated position at the defects leading to the premature failure of the tested sample. As shown in **Figure 1c**, the characteristics of the fracture surface were revealed by the macroscopic analysis. The fracture surface shows the feature of a typical fatigue failure mode. The crack initiation region, crack expansion zone, and the final fracture region can be clearly observed on the fracture surface as marked in **Figure 1c**. Since the crack expansion zone occupies a large area, it indicates that,

**Figure 1.**  
*Macroscopic analysis of the premature fatigue fractured rail fastening clip caused by surface processing defects: (a) the overall morphology of the fractured clip, (b) the processing defects near the crack initiation region, and (c) the morphology of the fractured surface.*

after the cracks initiated at the surface defect, the sample undergoes a crack expansion period under the cyclic load before the final fracture. According to the theoretical equation reported in the literature [17, 18], the fracture strength of the tested rail fastening clip can be calculated based on the area of the instantaneous fracture zone and the maximum load applied.

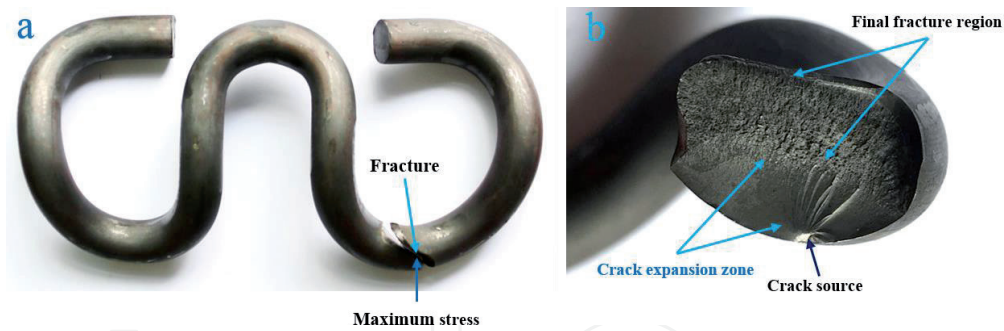
**Figure 2.**

*The macroscopic morphology of the premature fatigue fracture samples processed by the high-frequency-inducing heating.*

heating is more concentrated on the sample surface, it is easy to cause the uneven heating of the samples, resulting in large residual stress. In addition, the macroscopic factors such as insufficient heating time, insufficient heating power, or incorrect heating location of the sample may cause the inhomogeneity of the microstructure in the heat-treated samples. This type of microstructural inhomogeneity will lead to the property difference in certain regions, which can greatly reduce the fatigue life of the railway fasteners and cause the premature fatigue failure. **Figure 2** shows the fracture condition of railway fasteners, and the fatigue test is carried out after the high-frequency-inducing heating process. The premature failure occurred after  $1.2 \times 10^6$  fatigue cycles (normally  $5 \times 10^6$  cycles without fracture).

Compared with the case shown in **Figure 1** (case 1), the fracture position of the fastener is at the region bearing the maximum stress (as marked by the arrow in **Figure 2a**). The appearance of the failed region is normal, no obvious processing defect can be observed, and the fracture morphology also has typical fatigue fracture morphology including the crack initiation region, crack expansion zone, and the final fracture region [20, 21]. The area of the crack expansion region is comparable to that of case 1, but its fatigue life is much higher than the case 1, indicating that the fatigue crack growth rate is significantly lower than case 1. However, because the sample still did not reach the fatigue life of the typical fastener, it belongs to the abnormal fracture type. Different from case 1, the reason of the premature failure of case 2 cannot be directly found from the macroscopic analysis, and the microscopic analysis is therefore required. Since the fastener was produced by high-frequency heating rather than the original intermediate frequency heating, it is suspected that the uneven distribution of microstructure caused the premature fatigue fracture. Therefore, the metallographic microstructure analysis was carried out on the normal and the prematurely failed fastener at the position bearing the maximum stress during fatigue test. The position for extracting the sample parts and the corresponding microstructure are shown in **Figure 3**.

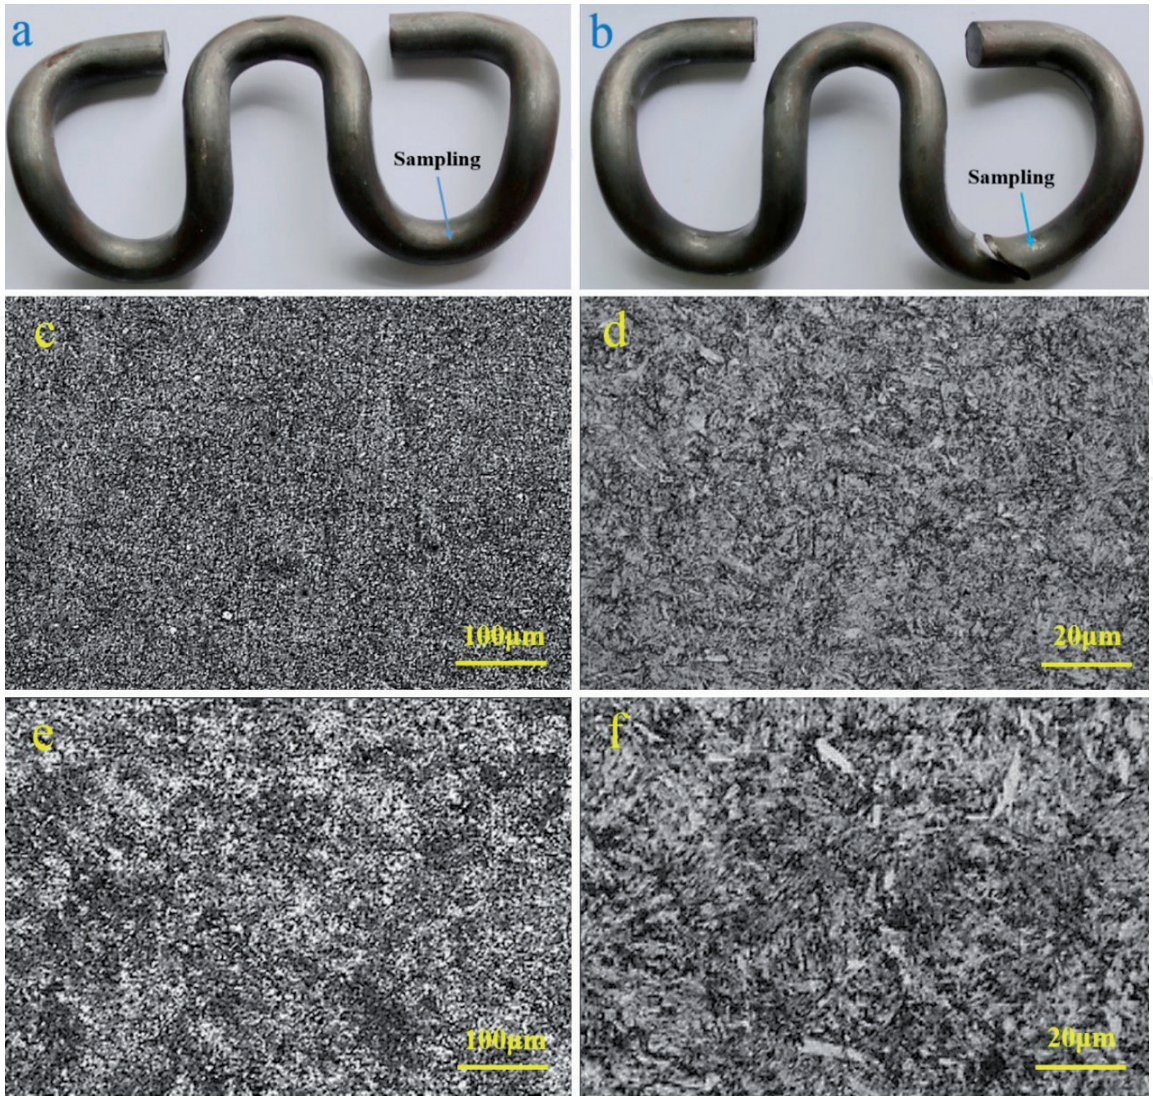
As shown in **Figure 3a** and **b**, the samples for microstructure observation of the normal and prematurely failed fasteners were cut from the same position near the fracture surface. The samples were ground by SiC paper and polished. The Nital solution (4% alcohol solution of nitric acid) was used as the etching solution. An optical microscope was used to complete the microstructure observation of the samples, and the results are shown in **Figure 3c–f**. **Figure 3c** and **d** shows the microstructure of the normal railway fastener after quenching and tempering in the medium temperature range; the typical tempered troostite and a small amount of ferrite can be clearly observed. The troostite and ferrite grains are fine, and they distributed evenly in the microstructure. **Figure 3e** and **f** shows the microstructure of the prematurely fractured samples. The obvious microstructure segregation

**Figure 3.**  
*The sample extraction position of normal (a) and prematurely failed railway (b) fasteners. (b, c) and (e, f) are the corresponding metallographic microstructure of the normal and prematurely failed fasteners, respectively.*

can be observed from **Figure 3e**, which is caused by the large amount of dissolved cementite due to the fast heating rate of the high-frequency-inducing heating. The cementite came from the pearlite before heat treatment. As can be seen from **Figure 3f**, the grains are coarser, and in addition to the undissolved cementite, large block-shaped ferrite can also be observed. This is mainly due to the high heating rate and high temperature caused by the high-frequency-inducing heating. The rapid heating speed leads to the existence of a large amount of undissolved cementite. The heating temperature is too high, resulting in the formation of coarse microstructures [22]. This microstructural inhomogeneity can seriously affect the fatigue performance of the samples. Cracks are more prone to initiate at the microstructure with poor mechanical properties under the applied cyclic load, resulting in the premature fatigue fracture. This example shows that in the process of failure analysis, in addition to the analysis of the macroscopic characteristics of the sample, the macroscopic factors such as the production environment and the service environment of the sample parts are also important and sometimes are important causes of sample failure. It is sometimes difficult to directly and accurately determine the cause of failure from macroanalysis. This requires a combination of macroanalysis and microanalysis to achieve the accurate failure analysis results.

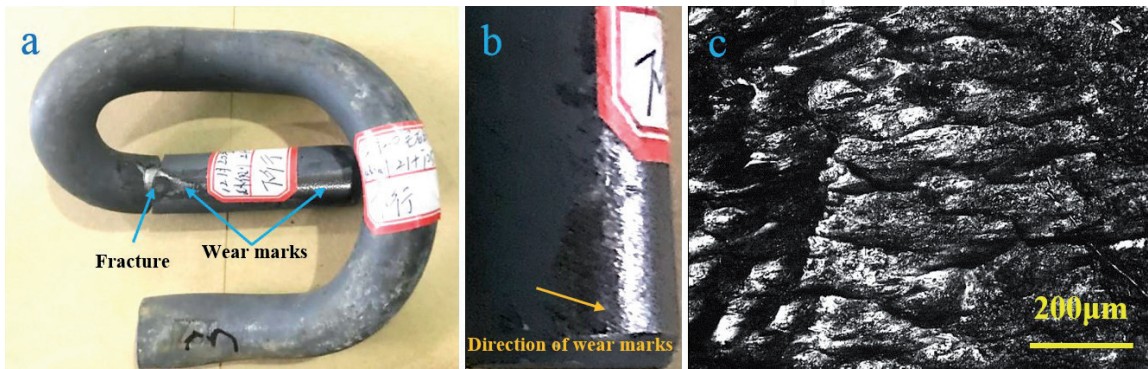
As can be seen from **Figure 4a**, the breaking position located at the root of the straight section of the fastener, and this straight section is installed in the fixed slot. The fracture happened at the boundary between the straight section and the residual curved part, in which the maximum stress is loaded in the broken position in the actual working condition. A detailed observation of the sample surface reveals obvious wear marks. Moreover, the wear marks are in the same direction along the transverse arc of the fastener sample (see **Figure 4b**). As can be observed from the magnified view shown in **Figure 4c**, the wear marks have a certain depth, and their propagation direction is consistent. Based on the direction and depth of the wear scar, it can be preliminarily concluded that the wear scars on the surface of the straight section of the railway fastener were caused by the relative rotation with the spring clip slot it contacted with. However, in the normal circumstances, this type of rotation is not allowed, because the rotation will reduce the pressure between the fastener and the railway track, affecting the train safety. Combined with the relatively deep wear marks, the broken fastener is subjected to a large external force before failure. The reason causing this large external force can only be determined by the on-site investigation with the understanding of the service situation.

According to the investigation of the service scene, the subway operates along a circle line, and the fasteners with premature fatigue failure occurred mostly at or near the curve region of the railway track. This indicates that in addition to the force of caused by the vibration of the track when a train passed, the spring bar is also subjected to the centrifugal force when the train is adjusting directions. Under the combined force of the vibration and the centrifugal force, the fastener rotated relatively in the slot, resulting in a surface with a consistent direction of wear scar. After multiple friction, the wear marks at the position where the fastener is in contact with the edge of the slot became deeper and deeper, and thus fatigue cracks were

**Figure 4.**  
*The macroscopic morphology and surface wear scars of the fractured metro fastener: (a) the macroscopic morphology of the failed fastener showing the position of the fracture surface and the wear marks, (b) the obvious wear scar that can be observed on the surface of the straight section of the fastener clip, and (c) the enlarged view of wear scar.*

The early failure of the railway fasteners caused by the external service environment indicates that in addition to considering the material selection and processing technology and performance of the product, the actual working environments should also be taken into consideration. In order to ensure the operation safety of the equipment, the design and manufacture of the product can be improved based on the actual working condition of the components. Only then can the safety factor in the actual service process be increased.

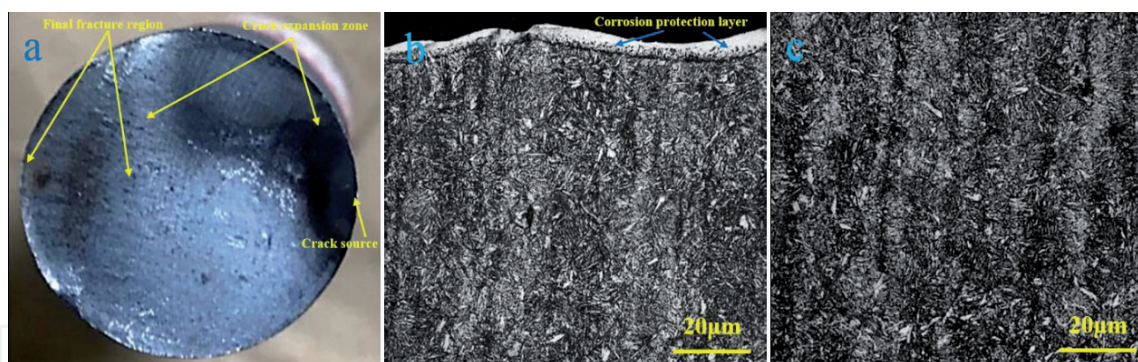
**Figure 5.**  
 The macroscopic morphology of the fracture surface and the microstructure of the samples near the fracture surface: (a) the fracture surface morphology, (b) the cross-sectional microstructure of the sample near the fracture surface, and (c) the microstructure of core region of the sample near the fracture surface.

From the macroscopic analysis of the fracture surface as shown in **Figure 5a**, the crack initiation region has a certain area, and the color is dark blue and slightly black, which is mainly due to the inconsistent deformation of the elastic strips on both sides of the crack, and the oxidation of the fracture surface resulted from the temperature rising caused by the relative extrusion and friction. This again proves that the elastic strips underwent severe torsional deformation during actual service. From the morphology of the crack extension area in **Figure 5a**, the extended area has obvious macroscopic fan-shaped stripes, and the spacing between the stripes is large. The spacing between the fan-shaped stripes is large, which indicates that under the load of the torsion force, the severe wear scars were first produced on the surface where the stress reaches the maximum value. Then, micro-cracks were formed in the most severely worn areas. Under the combined load caused by the vibration of the rail tracks and the centrifugal force, the cracks expanded rapidly, resulting in the final premature fracture. At the same time, samples near the fracture surface were extracted for the preparation of the metallographic sample. The surface and center microstructure of the surface of the prepared samples is shown in **Figure 5b** and **c**. It can be observed that the tempered troostite (or tempered torsite) and a small amount of ferrite are the main microstructure of the elastic stripe after quenching with medium temperature tempering, which is the normal microstructure. A layer of anticorrosion treatment can be observed on the surface, which is a conventional treatment for railway fasteners.
