# Effects of Earthquakes on Buildings in the Ibero-Maghrebian Region

*José Antonio Aparicio Florido*

## Abstract

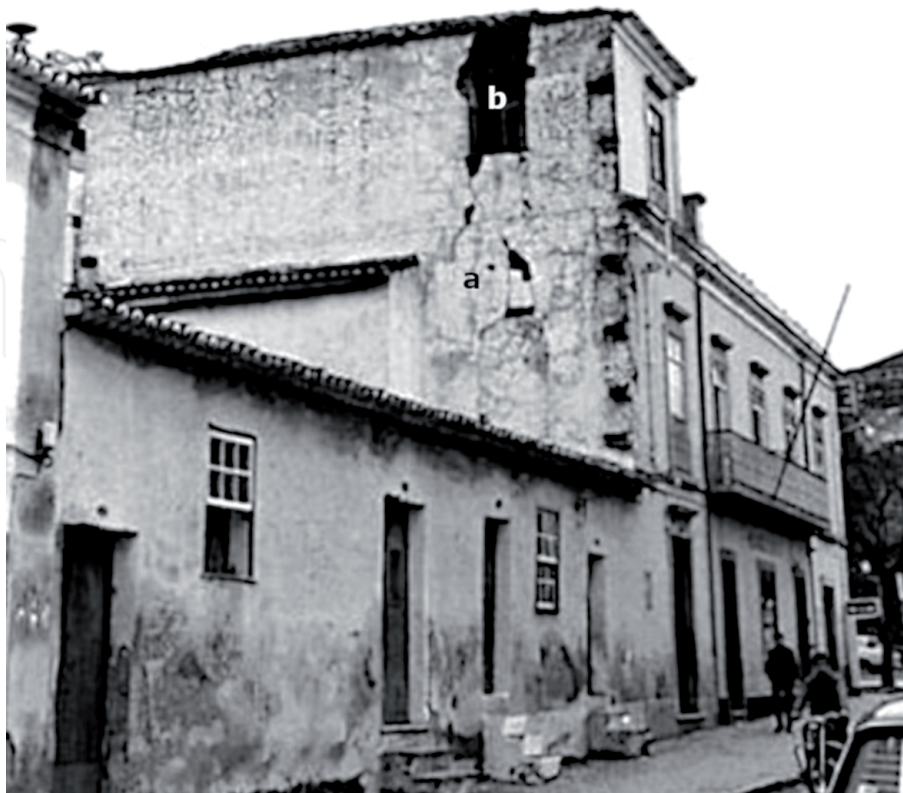
**Figure 1.**  
*Silves, building of class B with damage of grade 3: (a) shear cracks with detachment of little pieces of plaster; (b) partial toppling of external wall. Source: IPMA.*

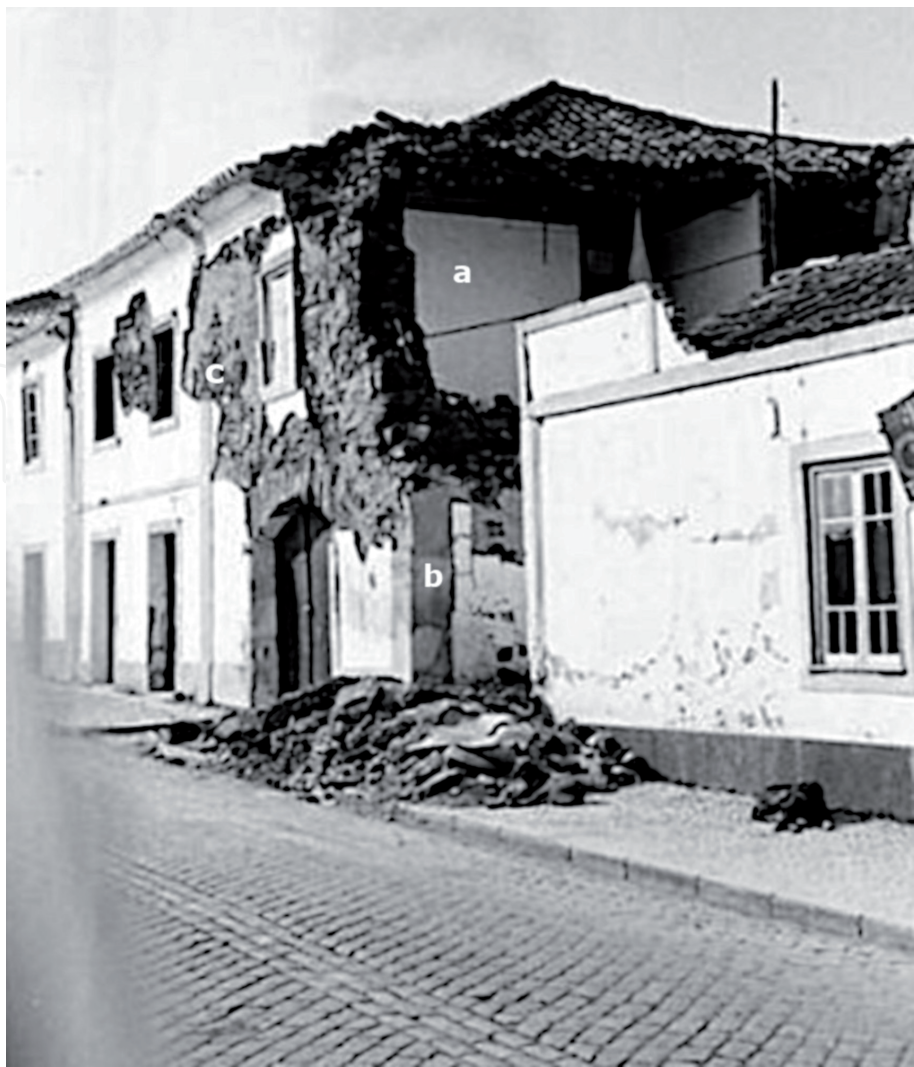
**Figure 2.**  
*Bensafrim, building of class A with damage of grade 4: (a) advanced corner failure and toppling of external wall with partial roof collapse; (b) loss of connection and drift between load-bearing walls; (c) generalized detachment of plaster. Source: IPMA.*

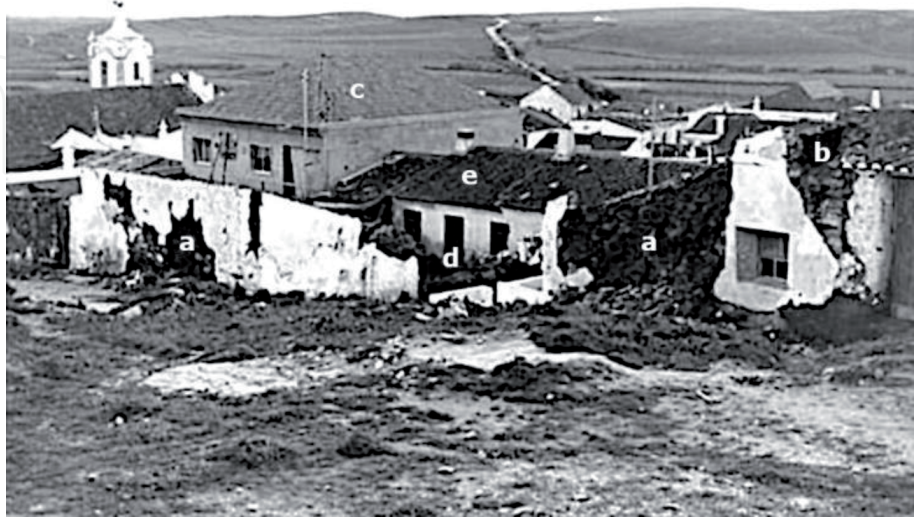
In Vila do Bispo, 8 km from Sagres, many houses of class A were partially or completely collapsed and turned into rubble (**Figure 3**), with a level of destruction similar to Bensafrim. **Figure 4** shows an example of *façade* overturning pulling down the roof and causing a complete collapse of the structure (grade 5). In other photographs we can clearly observe damage of grade 3 in corner failures (**Figure 5**) and grade 4 in the toppling of external wall, seriously affecting the roof (**Figure 6**). Also, the upper body of the church tower of Nossa Senhora da Conceição, built with massive stone, ashlar and burnt clay/sand bricks showed a progressive X-shaped

**Figure 3.**  
*Vila do Bispo, general overview: (a) loss of the outer leaf of load-bearing walls and detachment of plaster; (b) partial toppling of façade wall, pulling down part of the roof; (c) good behavior of a recent construction (class B); (d) simple overturning of a freestanding masonry wall; (e) adobe house without apparent damage. Source: IPMA.*

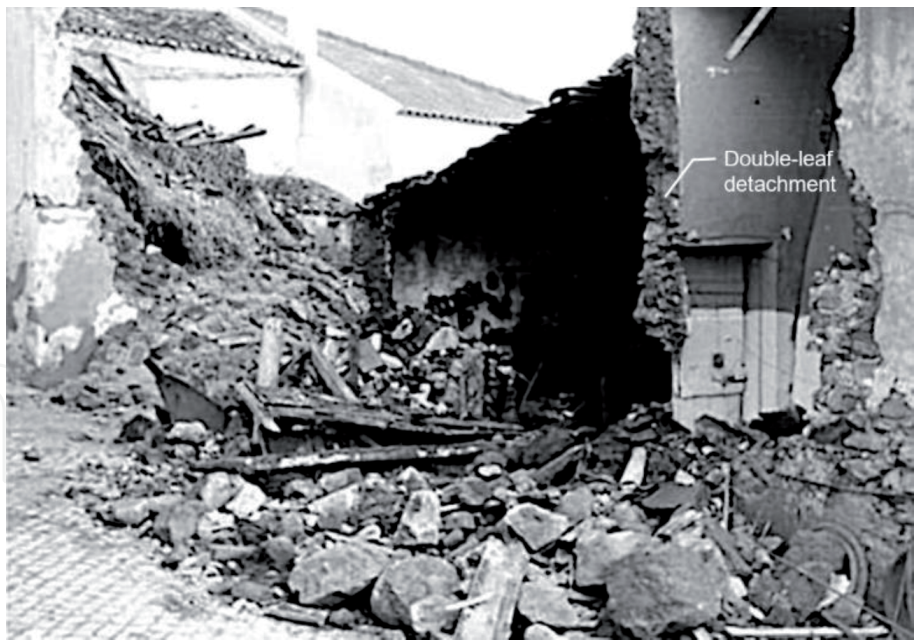
**Figure 4.**  
*Vila do Bispo, total collapse of building of class A made of mixed fieldstone and adobe masonry, mud or clay mortar and roof supported by wooden logs and bed of reeds (grade 5). See the double-leaf shape on an interior load-bearing wall remaining standing. Source: IPMA.*

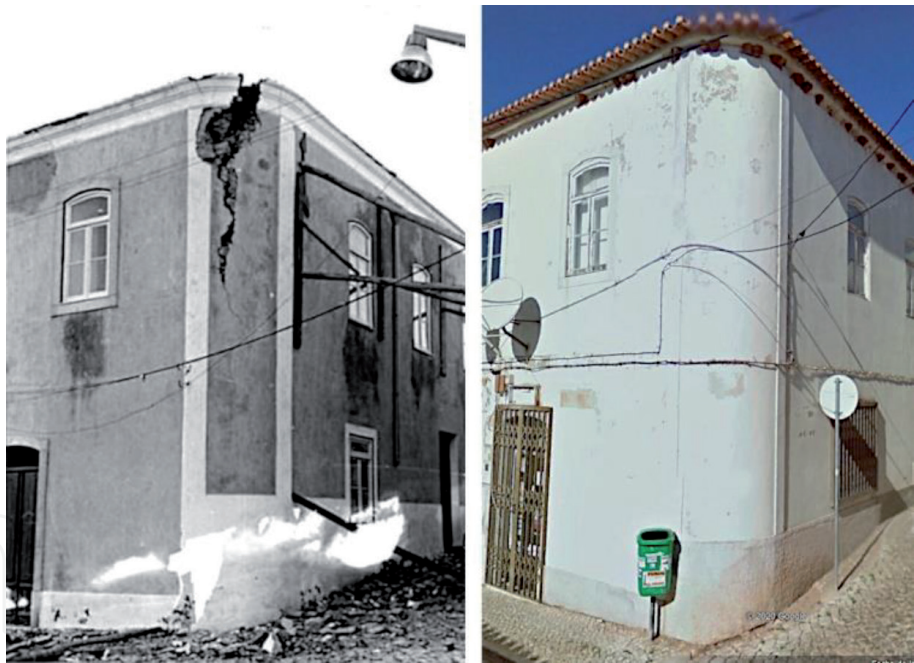
**Figure 5.**  
*Vila do Bispo, building of class A with damage of grade 3 due to loss of connection between load-bearing walls and corner failure (left). This two-story house was repaired and is currently in use (right). Sources: IPMA/Google Earth.*

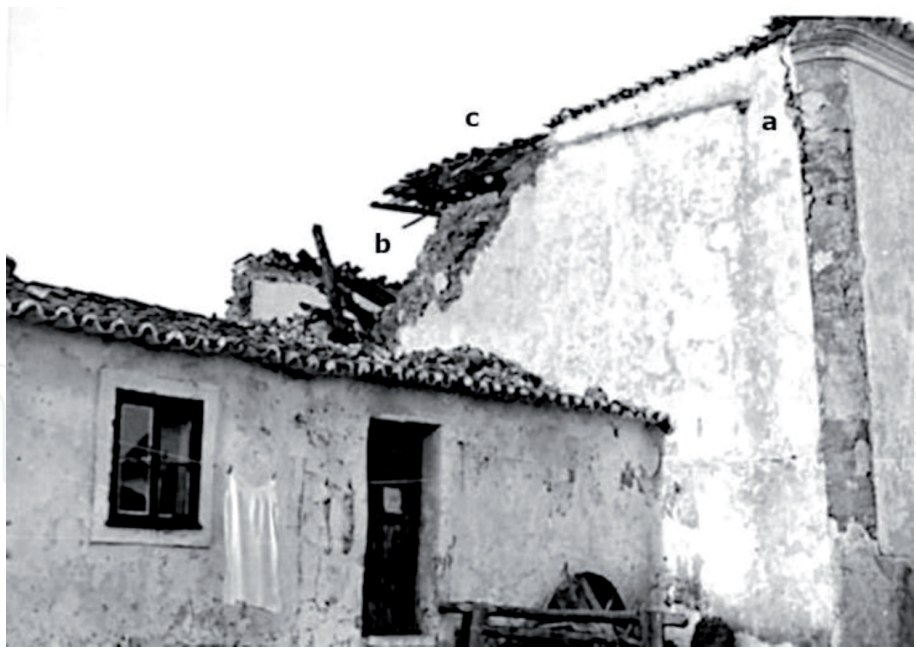
**Figure 6.**  
*Vila do Bispo, building of class A with damage of grade 4: (a) loss of connection between load-bearing walls; (b) toppling of external wall; (c) collapse of roof made of wooden logs and bed of reeds. Source: IPMA.*

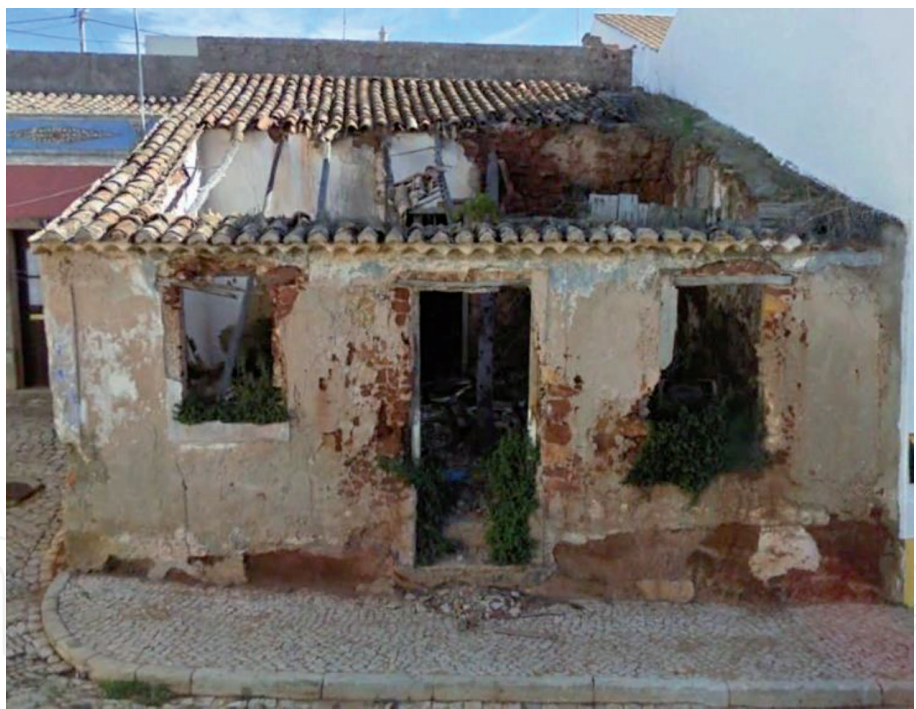
crack and fall of pinnacles [15], which means damage of grade 3 in buildings of class B. In summary, the traditional construction techniques based on adobe masonry and clay mortar showed a high vulnerability and weakness (**Figure 7**).

**Figure 7.**  
*Vila do Bispo, typical house of vulnerability class A built with raw materials: load-bearing walls made with adobe bricks, doors and windows with lintels, and wooden logs supporting a tiled roof over a bed of reeds. Source: Google Earth.*

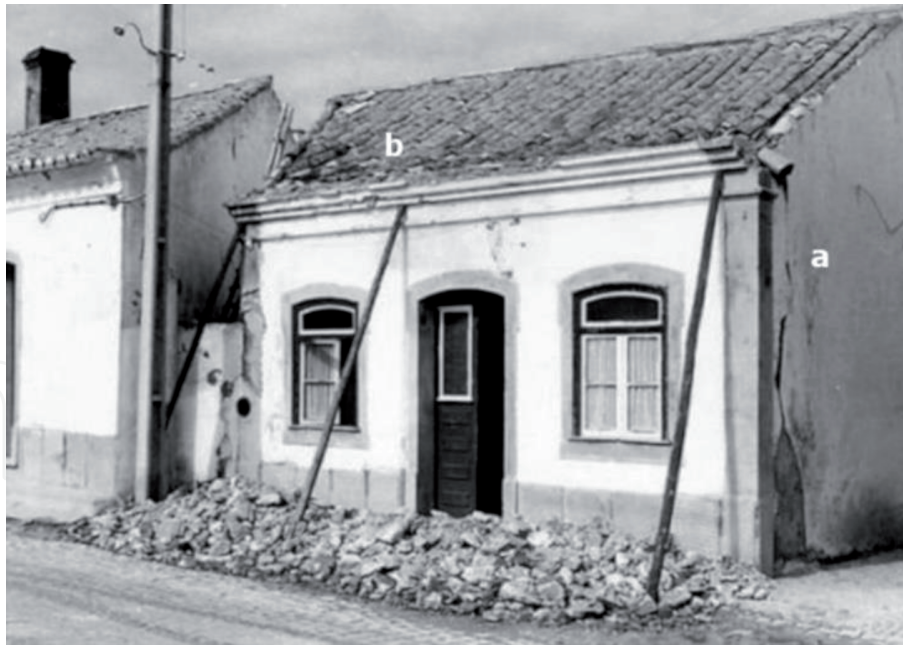
Several houses were totally collapsed in Sagres and many others suffered damage of grade 2 or 3 in buildings of vulnerability class A. In **Figure 8**, one single-story house with gable roof shows shear cracks, detachment of cornices and tiles, partial roof collapse, loss of connection between load-bearing walls and drift from the façade with risk of overturning (grade 3). Also, in Raposeira, 5 km east from Vila do

**Figure 8.**  
 Sagres, building of class A with damage of grade 3: (a) loss of connection of load-bearing walls with drift of façade, and (b) detachment of cornices and tiles with partial roof collapse. Source: IPMA.

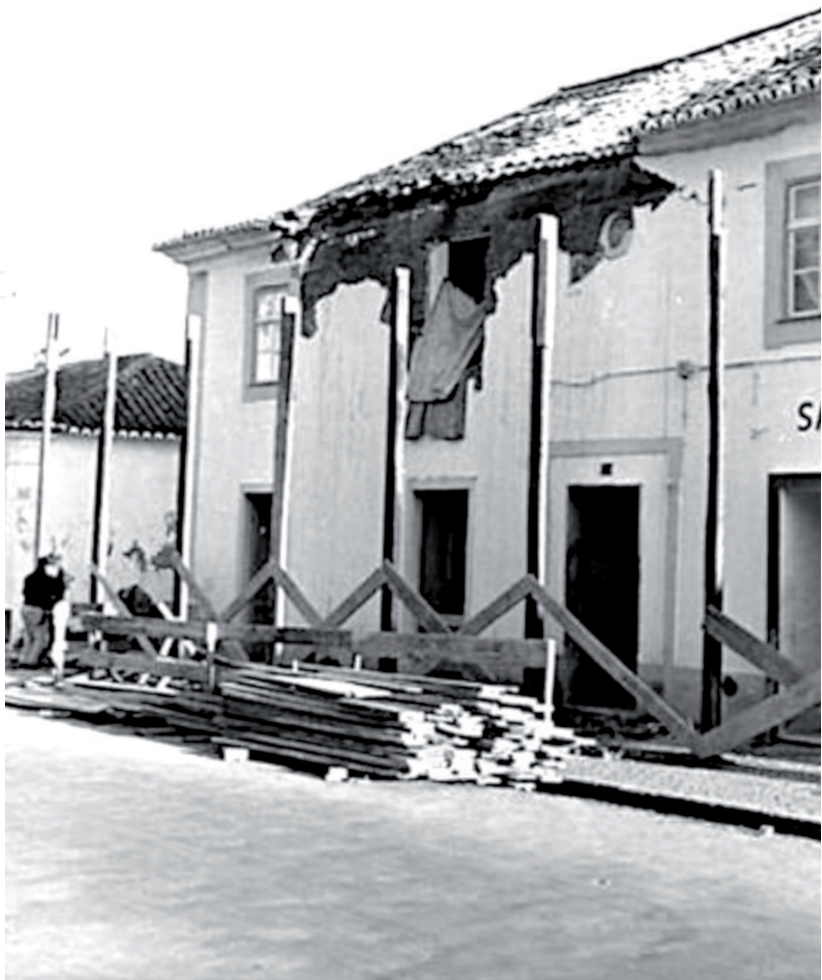
**Figure 9.**  
*Portimão, two-story building of class B with detachment and toppling of the outer leaf of the external wall on the second floor, due to a hammering effect between the wooden joists supporting the roof and the top of the load-bearing walls (grade 3). The lack of shear cracks indicates a ground displacement from back to front. Source: IPMA.*

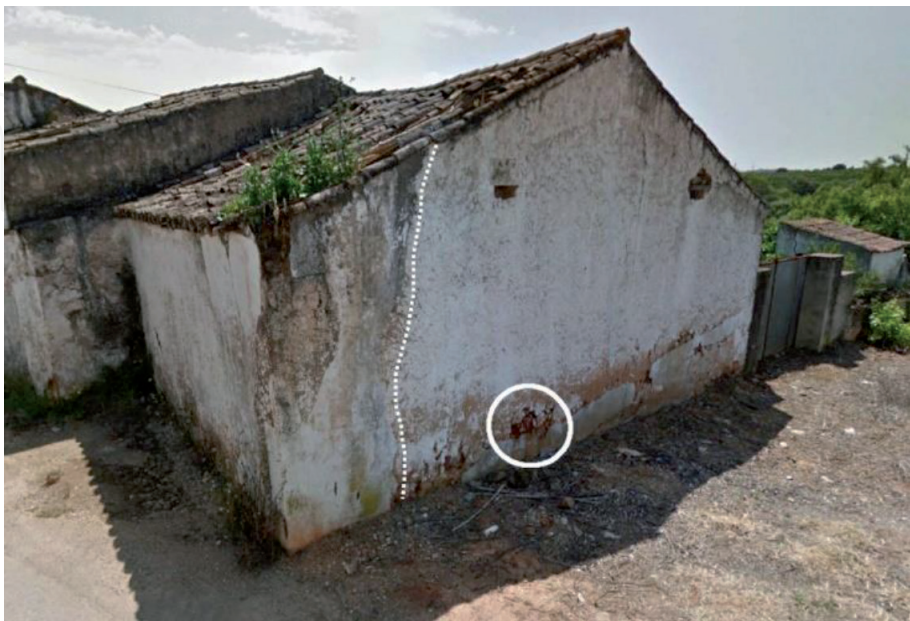
**Figure 10.**  
*Fonte de Louzeiros, building of class A rebuilt after the 1969 earthquake, showing the repair mark of a corner failure (dotted line). Inside the white circle is visible the red color of the clay used to join the adobe masonry. Source: Google Earth.*

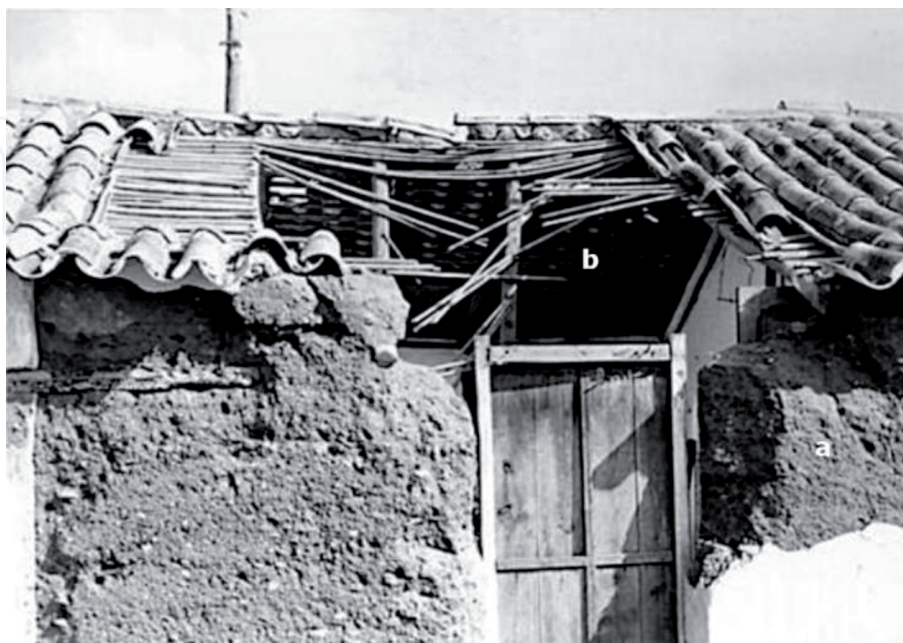
intensity VII, or VI-VII in the Lisbon district. In São Teotónio, Longueira, Vila Nova de Milfontes, Cercal and Sines, midway between Cape St. Vincent and Setúbal, many houses of class A collapsed. The rural village of Longueira, completely built with the same construction techniques of the Algarve, was razed; and the same situation occurs in Vila Nova de Milfontes and Cercal, where only the RC buildings (class C) performed well. In Odemira, partial roof collapse can be observed in buildings of class A (grade 4), due to the hammering effect of the wooden logs supporting the roof against the top of the load-bearing walls, to which they were not well anchored (**Figure 11**).

**Figure 11.**  
*Odemira, damage of grade 4 in adobe masonry house of vulnerability class A: (a) detachment of plaster; (b) partial roof collapse due to the strong pounding of wooden logs against the top of the load-bearing wall. Source: IPMA.*

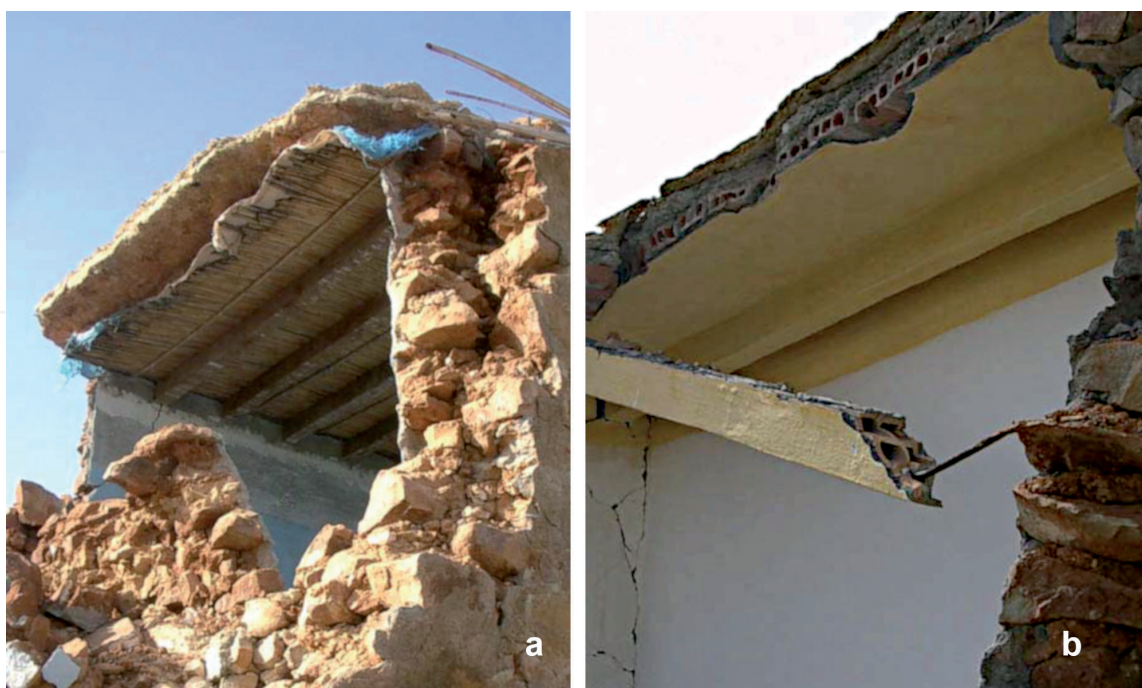
This earthquake hit the province of Al Hoceima, especially the city so named, the municipality of Imzourem and the villages of Ait Kamra and Izemmouren. The rural houses in this geographical area of Morocco, most of them of vulnerability class A, were built using the traditional construction pattern, very similar to those we have just highlighted in the most rustic areas of the Algarve, with more emphasis in Fonte de Louzeiros: single-story load-bearing walls made with unworked raw materials and unskilled masonry techniques, supporting a brittle roof of wooden logs in parallel under a bed of reeds tied together with rope or wire, all covered by a layer of water-repellent mortar and, occasionally, with a plastic film interposed acting as waterproof element (**Figure 13a**). The load-bearing walls were made up

**Figure 13.** Ait Kamra, traditional house pattern: (a) partial collapse showing the double-leaf load-bearing walls, fieldstone masonry bonded with mud mortar and roof of wooden logs and canes covered with a plastic film (blue) and layer of water-repellent mortar (grade 4, class A); (b) handmade joist of hollow bricks assembled with a single steel rod. Source: P Murphy.

of two faces of field stone masonry (double-leaf) not anchored between them, and poorly bonded with high porosity and low adhesion mud mortar. The bending of the walls in both directions due to reverse horizontal forces caused the inner detachment of the double-leaf masonry and the subsequent bowing, peeling, and overturning or collapse of the external skin. Shear cracks also caused widespread wall collapses and massive corner failures and fall of roofs, pulling down huge amounts of debris (**Figure 14**). The use of hollow bricks assembled with a single steel rod to form a handmade joist as reinforcing element for the roof did not provide greater rigidity or better connection between roofs and load-bearing walls (**Figure 13b**).

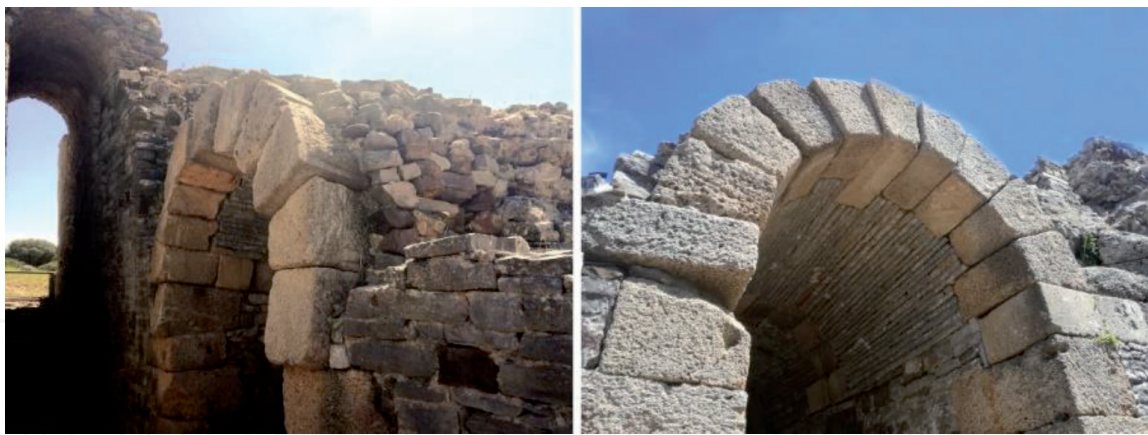
**Figure 15.** *Baelo Claudia, roman ruins (theatre): bowing of a vomitorium wall (left) and expulsion of voussoirs near the parascenium (right), which show a tensile stress in the direction of the slope. Source: J A Aparicio.*

effects can be explained by the instability and slope of the ground, as well as a bad combination between the weight of the structure, the insufficient foundations, and the progressive and slow landslide.

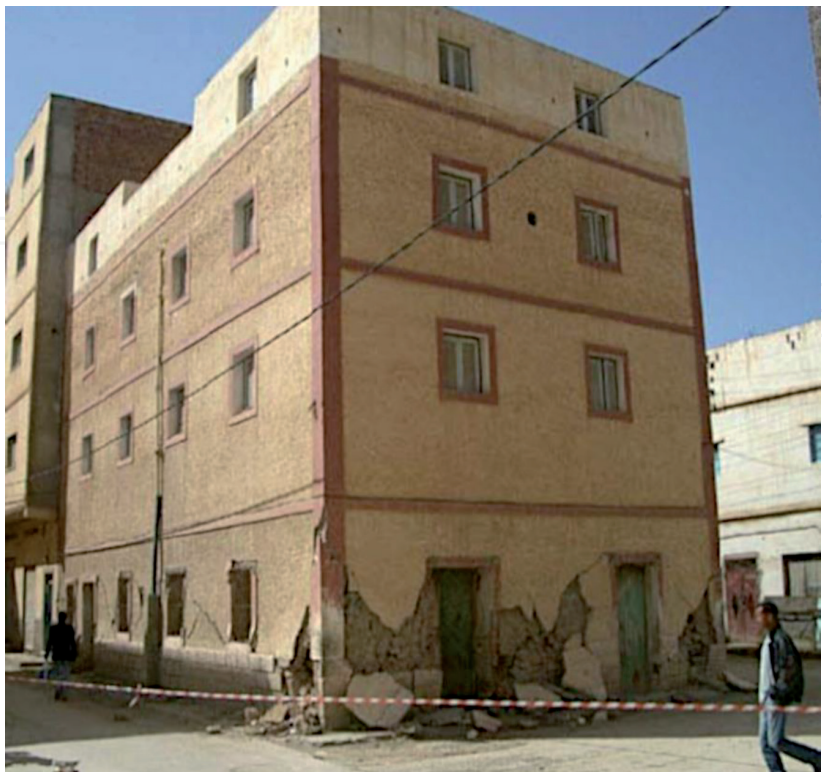
**Figure 16.** *Imzourem, X-shaped damage completely surrounding the load-bearing walls on the ground floor of a four-story residential building of vulnerability class B (grade 3). Source: P Murphy.*

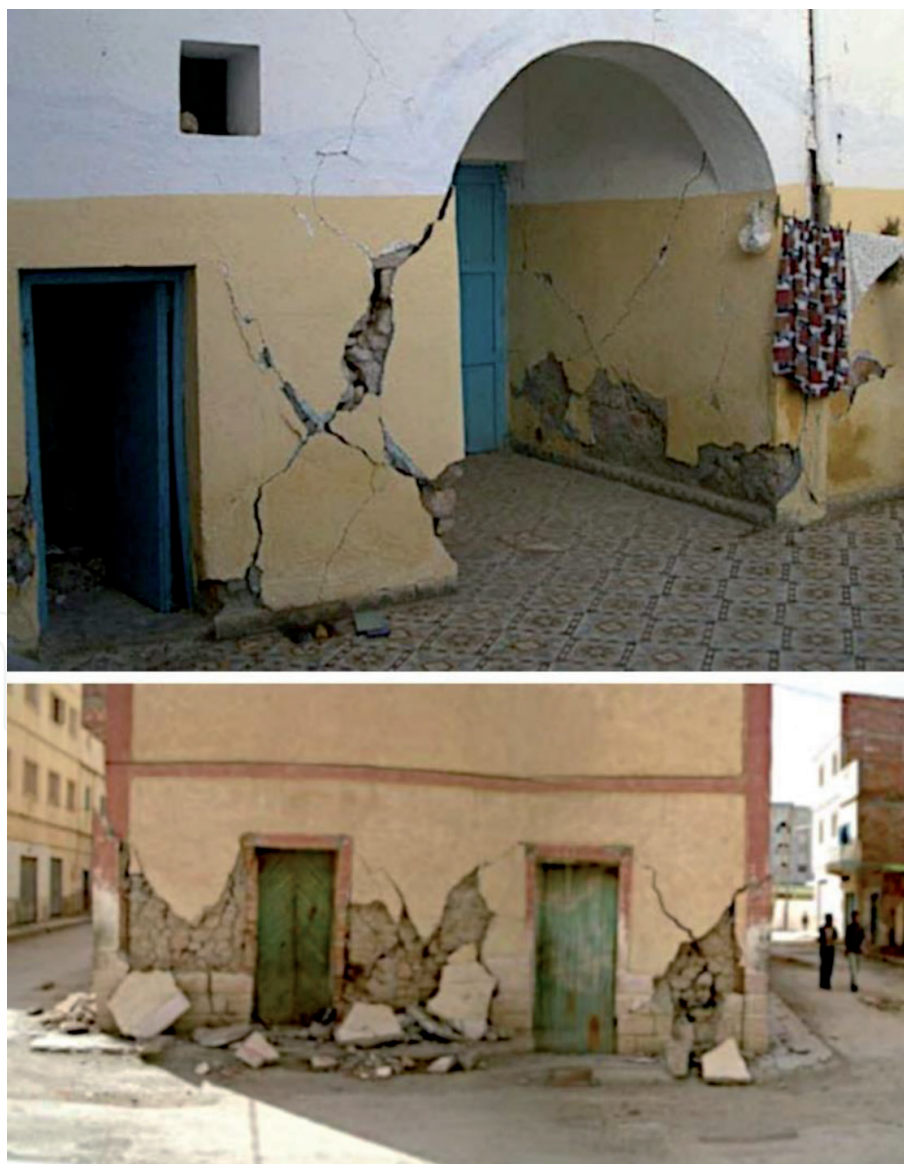
of a soft-story damage, which will be discussed later. X-shaped cracks are sometimes blurred by the loss of outer leaf or toppling of the external walls (**Figure 17**).

**Figure 17.**  
*Examples of X-shaped damage clearly visible in a single-story class A house (above) and blurred by loss of outer leaf in a four-story residential block (below). Source: P Murphy.*

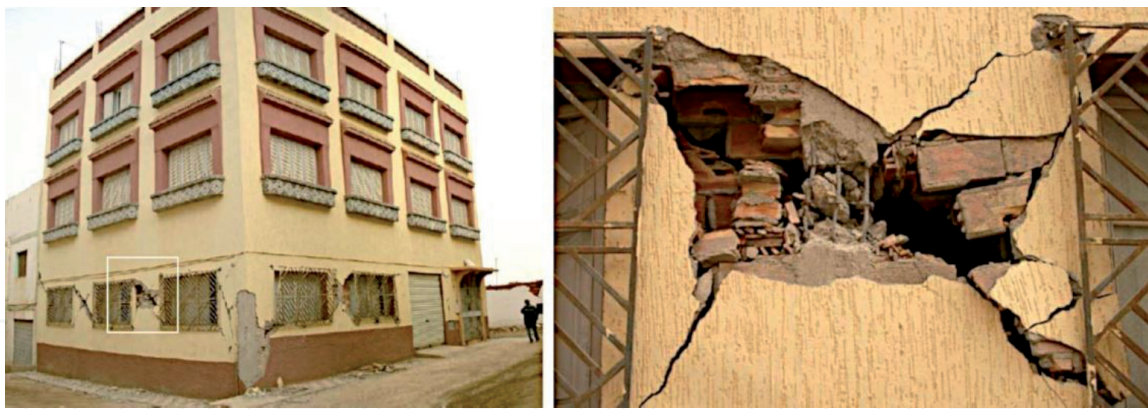
**Figure 18.**  
*Imzourem, short column effect in a three-story residential block of vulnerability class C (grade 4). On the right, a detail of the damage is shown. Source: P Murphy.*

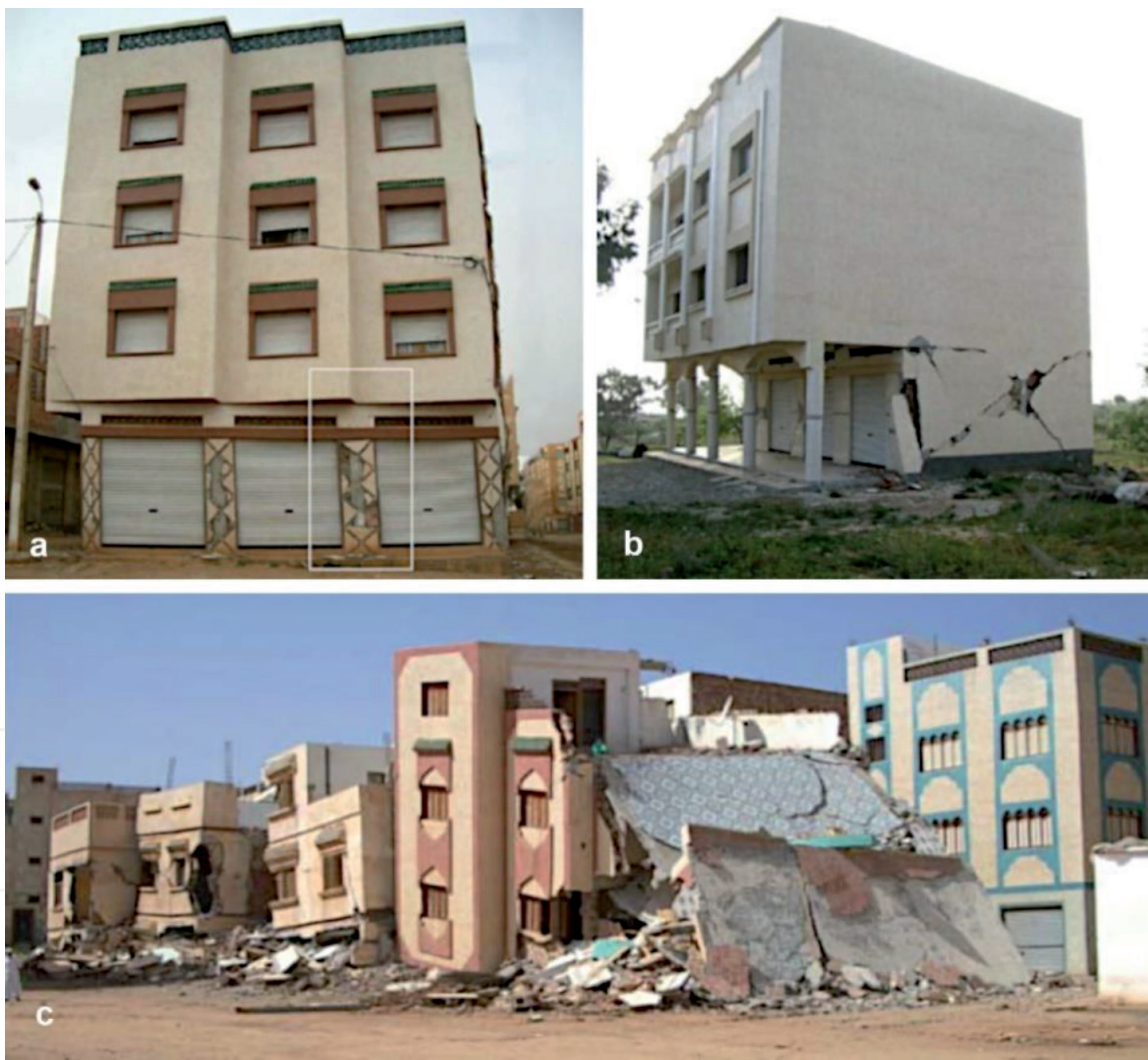
**Figure 19.**  
*Alhucemas, soft-story failures: (a) tilting of RC frames on the ground floor; (b) soft-story damage with clear X-shaped crack on the infill wall; (c) collapse of ground floor due to a previous soft-story damage. Source: P Murphy.*

But the most damaging and characteristic construction pattern of the 2004 Al Hoceima earthquake is undoubtedly the soft-story failure. The distribution of the residential buildings was as follows: four or five floors high, densely partitioned in upper flats by interior infill walls embedded between the RC frames and a ground floor less partitioned or completely diaphanous for use as garage in most cases or as small stores. These walls help to stiff the RC frames, reducing the bending of the columns under horizontal displacements of the structure. In areas of moderate to high seismic risk, the upper floors, which are highly rigidized, perform like an unique and solid block that sends all the elastic stress to the ground floor frames. As a consequence, the connections between the column heads on the first floor and the slab on the second floor come under load. If the column-slab joint is not reinforced with the stirrups needed, the column would be excessively bended, producing a type of failure called “plastic hinge” [21]. As a consequence, irreversible tilting of the structure or collapse can occur (**Figure 19a**), transferring the damage in many cases to the upper floors, due to the strong impact during the fall (**Figure 19c**).

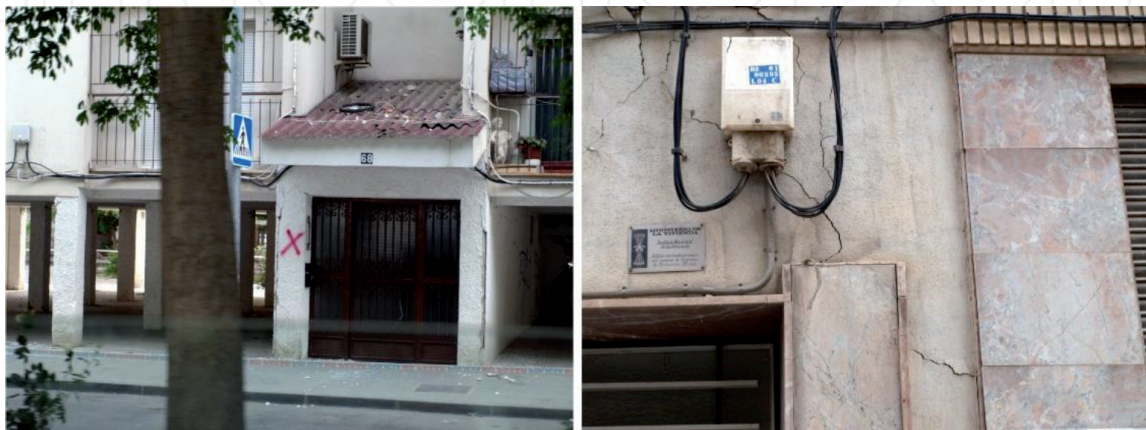
However, although it seems difficult to explain, older RC buildings did not suffer a greater damage than those built after the 2002 standard. In **Figure 20** we can appreciate slight shear cracks in the façade of pre-1968 RC buildings, not showing apparent structural damage or deformations of RC frames on the ground floor, despite the lower stiffness due to the lack of infill walls (grade 3, class C). Paradoxically, in **Figure 21** we have the complete collapse of the four-story residential block mentioned above, built during the transition period to the 2002 earthquake-resistant standard. This means that improving rules does not always implies improving resistance.

**Figure 20.** Lorca, shear cracks in pre-1968 RC buildings of class C (grade 3). There is apparently no evidence of structural damage, and on the ground floor (left) the columns forming an evident soft story have no sign of tilting. Source: IERD.

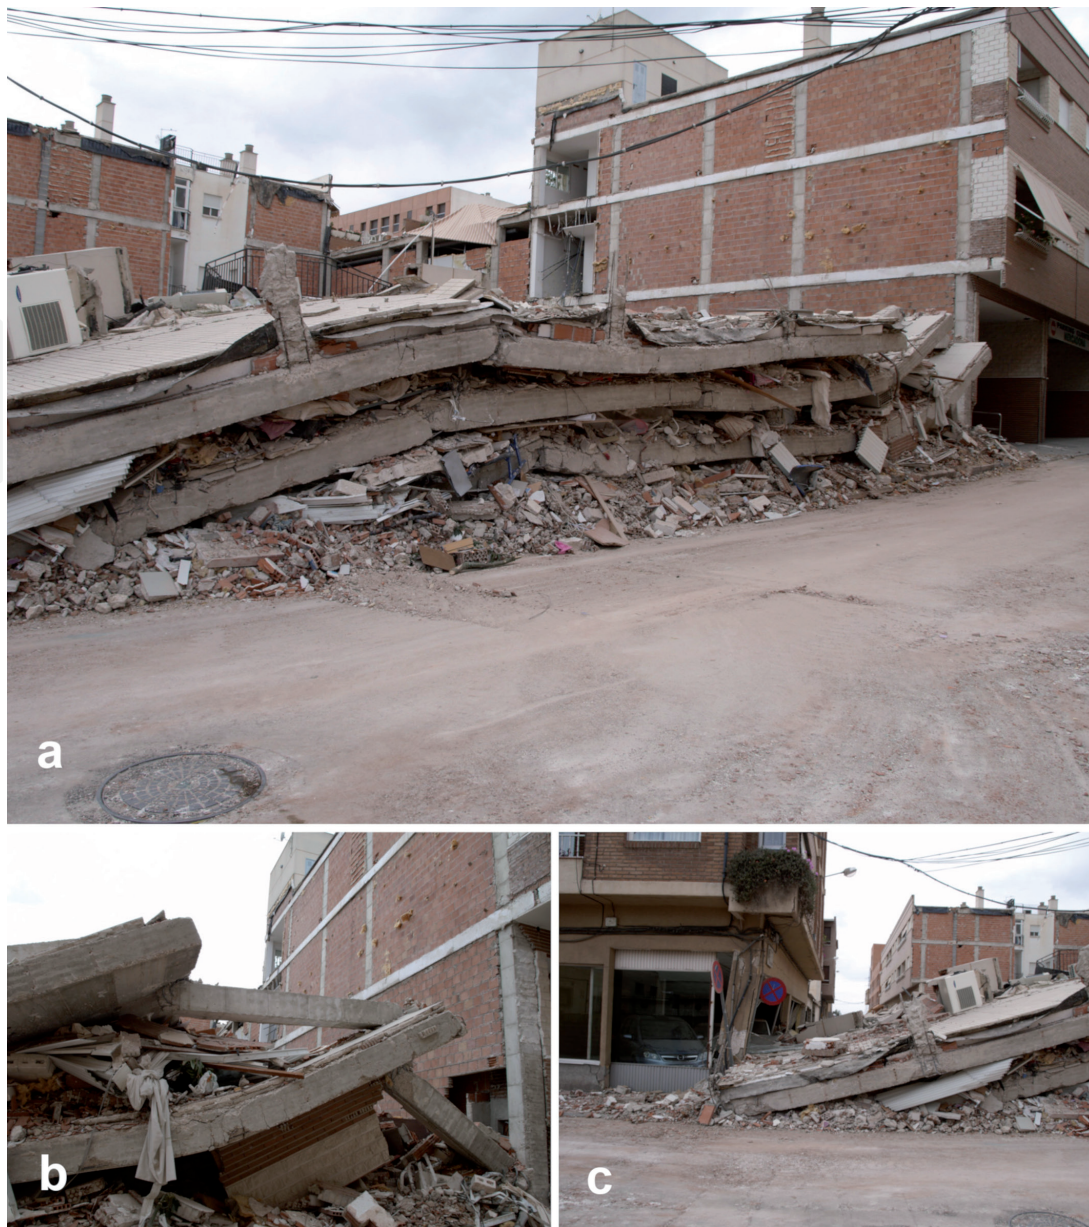
**Figure 21.**

*Lorca, complete collapse of RC residential building (grade 5) designed under the earthquake-resistant standard prior to the 2002 standard: (a) the three slabs are completely collapsed without any gap to allow survival; (b) plastic hinges and overturning in the direction of the slope of the street; and (c) plastic hinge in the adjacent building caused during the collapse, wedging against the base of the column. Source: IERD.*

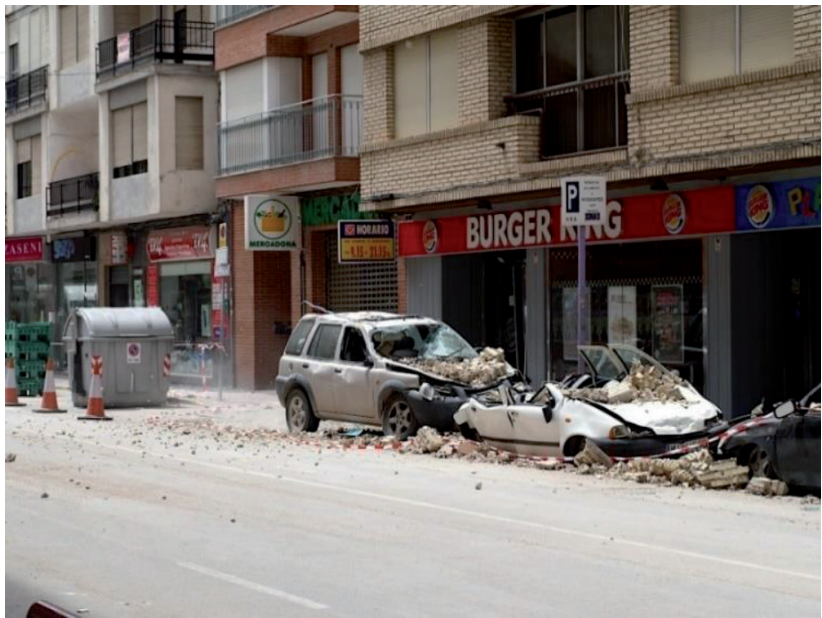
The 2011 Lorca earthquake caused nine fatalities due to the fall of these non-structural elements from façades (**Figure 22**) and the evident cause-effect relationship led to a conclusion that became an axiom: non-structural elements also

**Figure 22.**  
*Lorca, debris fallen on vehicles and sidewalk. The center of the street is free of danger. In Lorca, people died while walking or looking for protection near the façades. Source: IERD.*

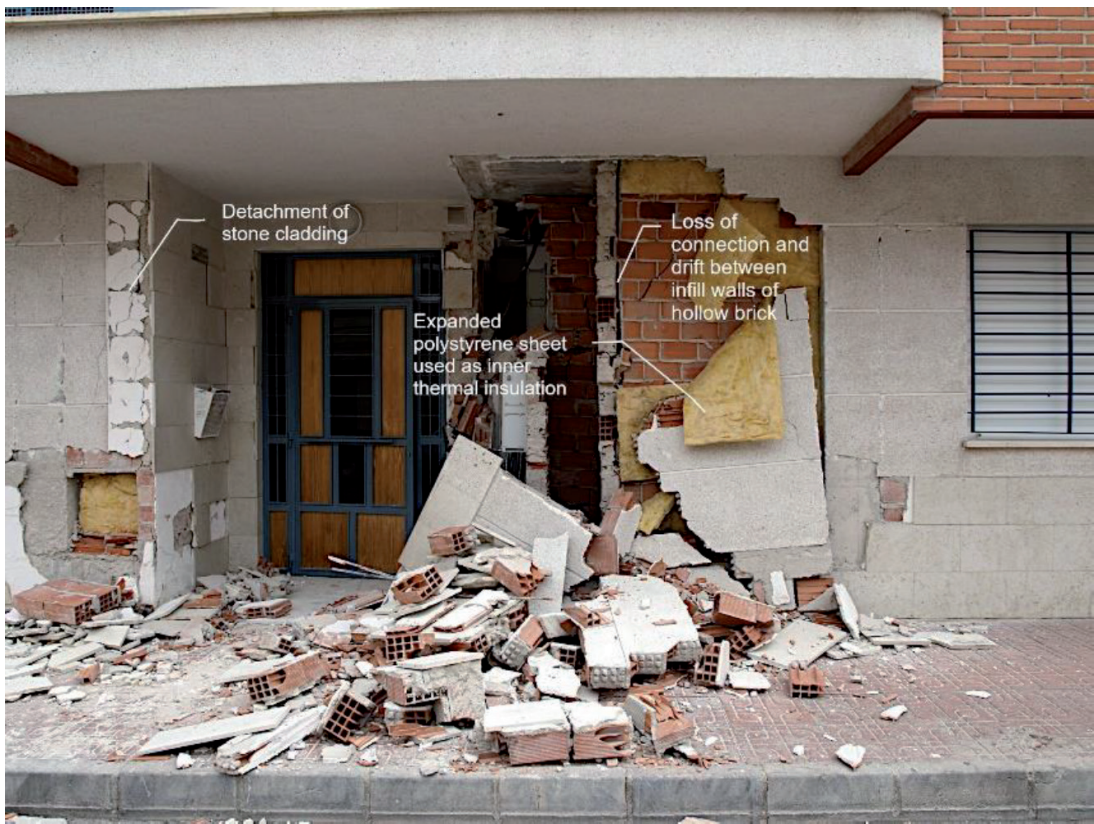
**Figure 23.**  
*Lorca, shear cracks caused the detachment and loss of stone cladding and the toppling of the outer leaf of the brickwork wall (grade 3, class C). Source: IERD.*

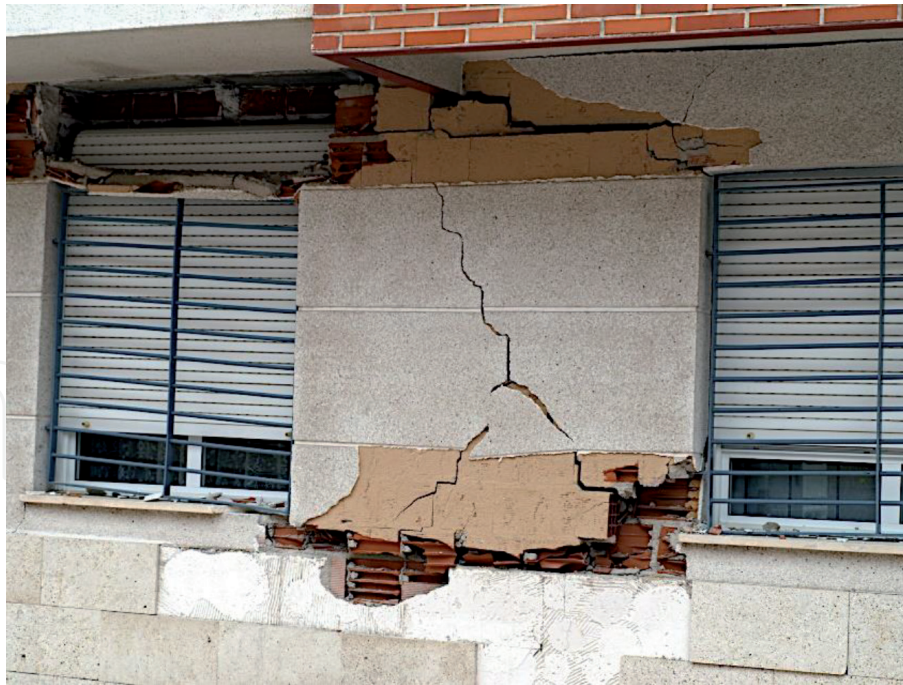
**Figure 24.**  
*Lorca, loss of stone cladding, fall of window lintel and X-shaped crack on external wall about to fall down.*  
Source: IERD.

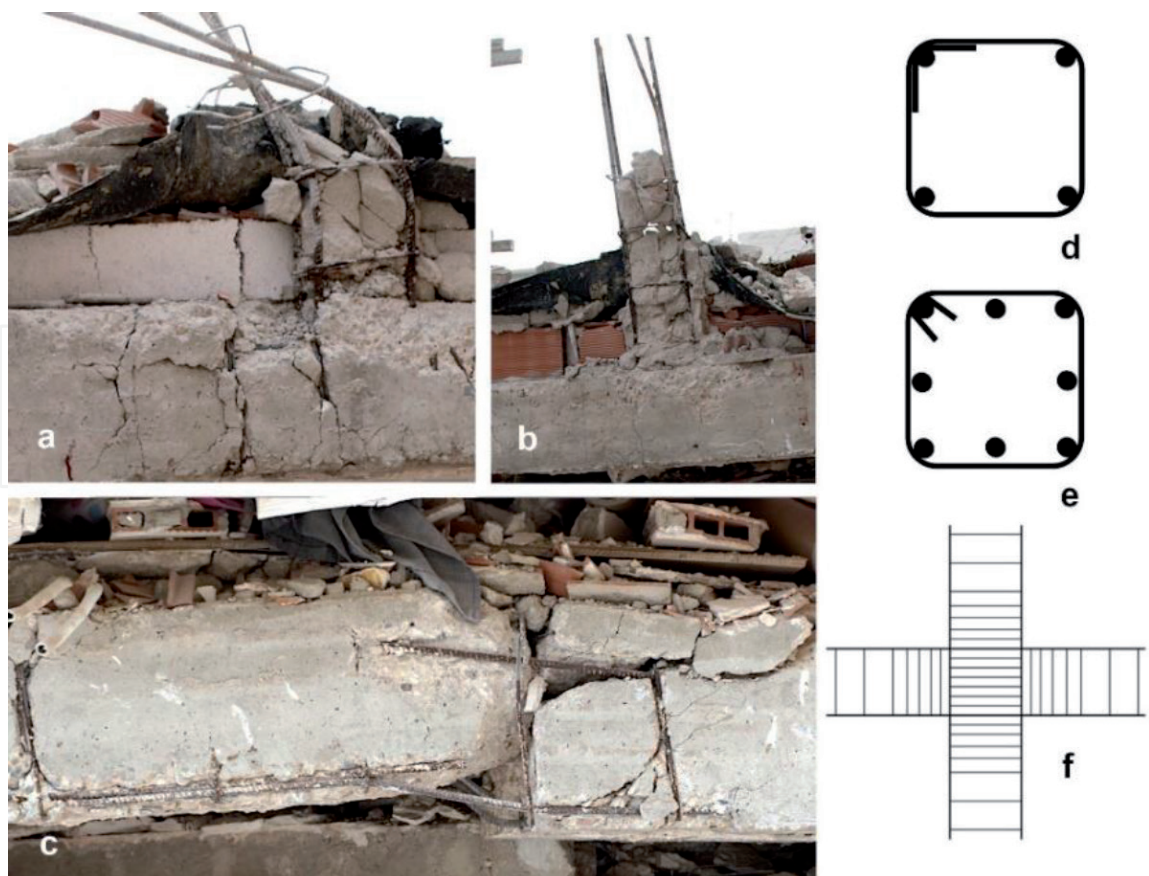
**Figure 25.**

Lorca, details of the RC residential block collapsed in Lorca, showing the four-rebar cores of beams and columns: (a) and (b) show the regular equidistance between the stirrups near the column-beam joints; (c) beam with similar arrangement of rebars; (d) drawing of the four-rebar longitudinal distribution used in this building with stirrup ends bent at 90°; (e) more adequate design for seismic resistance, with eight rebars and stirrup bent at 135°; (f) correct way to reinforce the RC column-beam joints. Source: IERD.

The damage to the column-beam joints of RC frames is consequence of the lack of steel reinforcement at the coupling node. As shown in **Figure 25**, the stirrups have a regular equidistance along the column as in the beam-column joints; as a result, the RC structure plastifies. A greater number of stirrups in the coupling node, progressively reducing the distance between them towards the intersection core, would increase the structure resistance and distribute the displacement energy along the full length of the columns, not transferring all the cyclic reversal of loads to the column-beam joints (**Figure 25f**). In addition, in areas with a moderate to high level of seismicity the stirrups should be anchored to the longitudinal rebars, overlapping 135° hooks [24] to avoid the opening of the closed-loop and

outward bending of the rebars (**Figure 25e**). The Turkish Earthquake Code 2007 and Indian Standard IS13920-1993 are two examples of the implementation of these earthquake-resistant requirements.

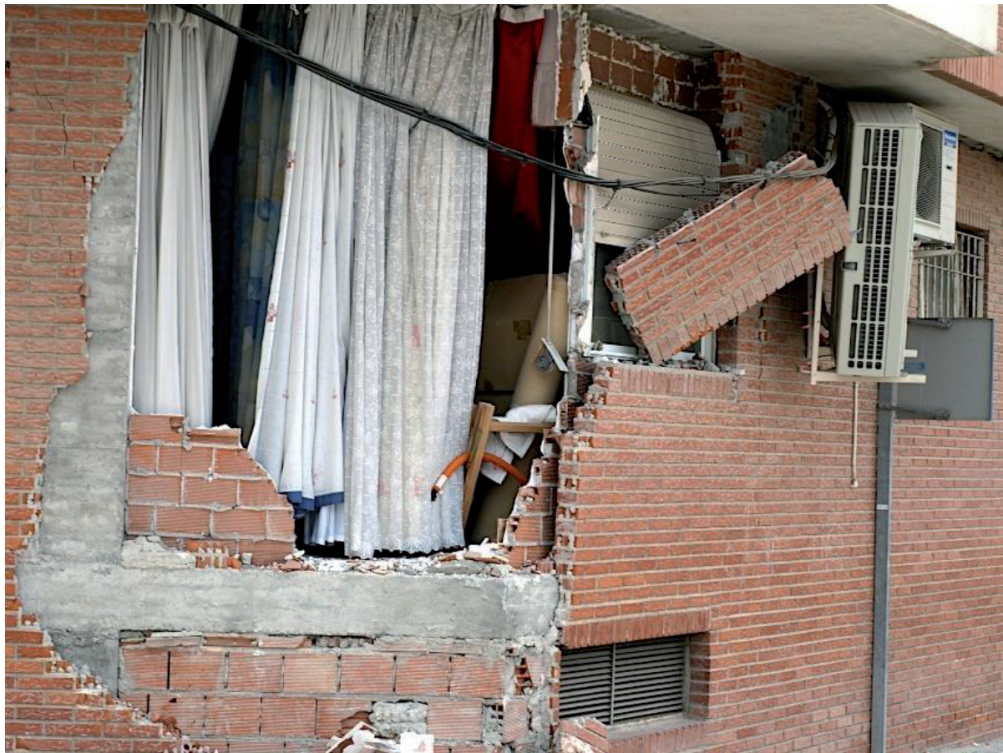
forces. As an example of better structural behavior, in **Figure 26** we can observe a complete damage in a double-leaf infill wall in a housing block with overturning of internal and external faces, but without apparent cracks in the RC frame and with no signs of plastic hinges or deformation in the column-beam joint (grade 3, class C). On the contrary, in **Figure 27** the loss of cladding allows us to clearly appreciate the occurrence of shear cracks at the base of the column-beam connection of the second floor, implying in all cases a moderate structural damage. It is due to the much more stiffness of the slab, which overloads the column resistance by sending all the energy of horizontal forces to the column base, not reinforced with an adequate seismic-resistant design. This damage, although less frequently, is not exclusive to the column-beam or column-slabs joints and can also occur in the middle body of the column (**Figure 28**), especially in case of short-column effect.

**Figure 26.**  
*Lorca, complete overturning of double-leaf wall with overturning of both brickwork faces, but without apparent cracks in the RC frame. Source: IERD.*

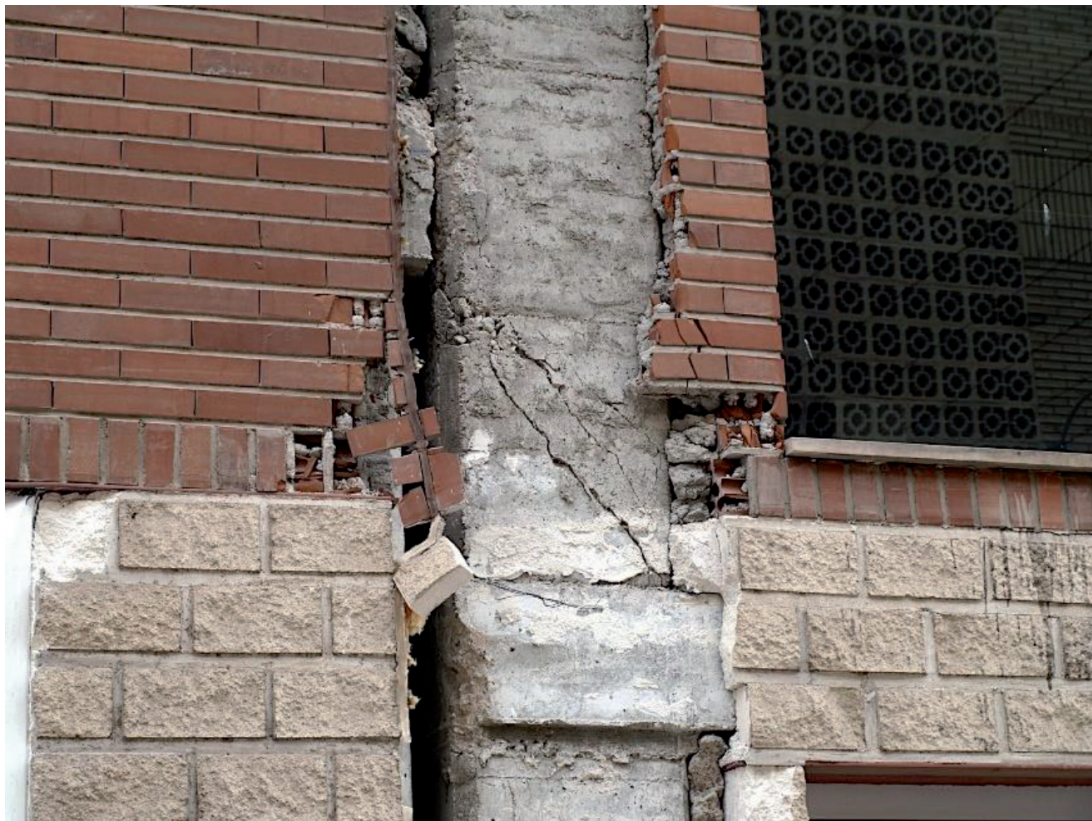
**Figure 27.**  
*Lorca, cracks in the column-beam base suggest the incipient formation of a plastic hinge. The loss of cladding is due to a hammering effect with the adjacent building. Source: IERD.*
