# Effects of Earthquakes on Buildings in the Ibero-Maghrebian Region

*José Antonio Aparicio Florido*

## Abstract

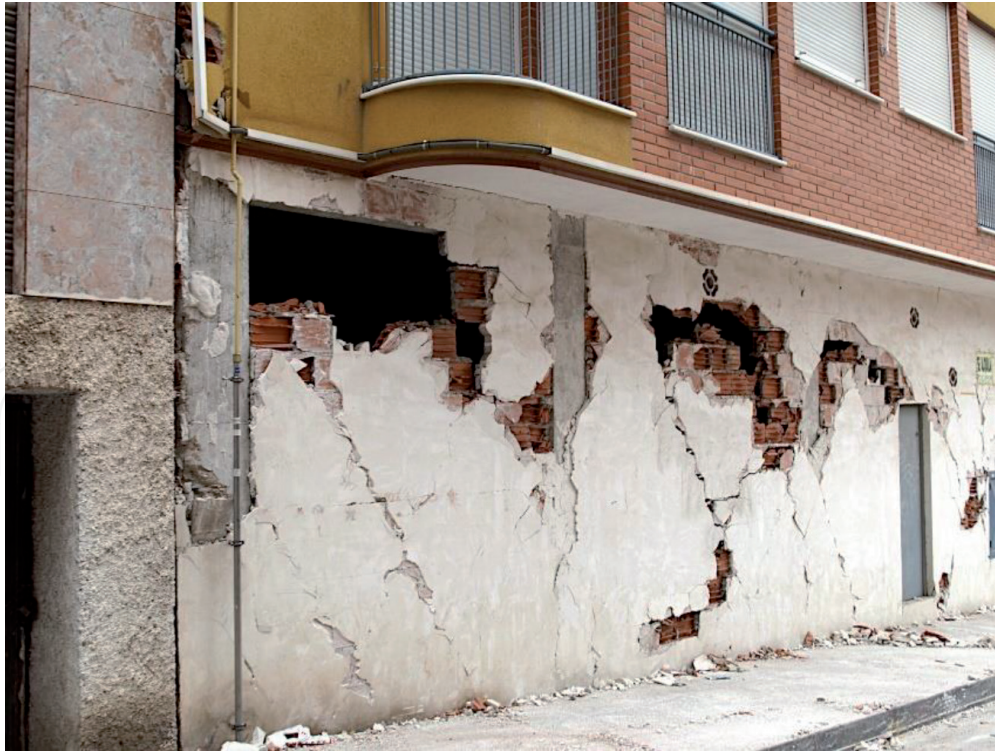
**Figure 28.**

*Lorca, X-shaped cracks in infill walls and loss of concrete in the middle body of the RC column suggest a soft story effect. Source: IERD.*
