# Pacing System Malfunction: Evaluation and Troubleshooting

Majid Haghjoo, MD, FACC, FESC Rajaie Cardiovascular Medical and Research Center, Iran University of Medical Sciences, Iran

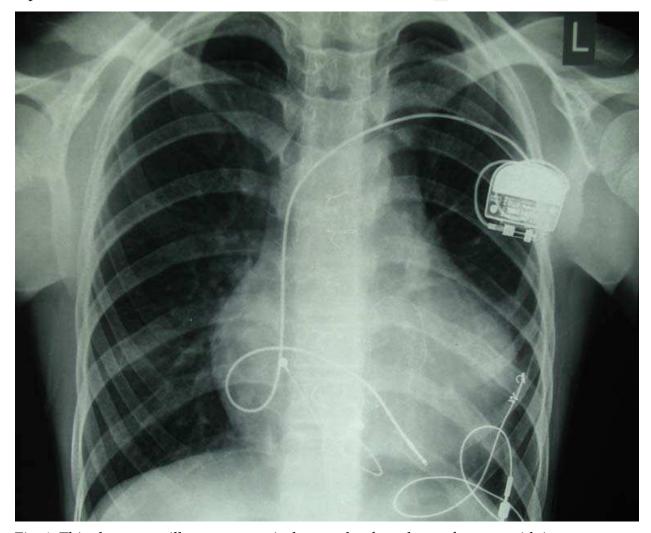
Lead conductor fracture is the most common cause of an open circuit. Although the clinician might expect that fracture of a lead would result in the absence of any visible pacing artifact, this is frequently not the case. This occurs because the current passes across the gap in the conductor coil though the fluid in the lead with high resistance. In such circumstances,

energy reaching the heart is subthreshold with no capture, but a stimulus will be present. The ECG with an intermittent conductor fracture may show a varying amplitude artifact if recorded with an analog machine. Lead fracture is associated with infinitely high lead impedance if the insulation remains intact. However, total lead transsection (concomitant conductor fracture and insulation defect) may show normal or minimally elevated impedance. Chest x-ray may show conductor fracture (figure 1). In contrast to the unipolar lead, diagnosis of the conductor fracture is very difficult in a coaxial bipolar lead unless there is total disruption of both conductors at the same place. Reprogramming to unipolar mode is a temporary measure in partial fracture of bipolar lead. In pacemaker-dependent patients with complete lead transsection, temporary pacemaker implantation is necessary before definitive management. Definitive treatment of conductor fracture is lead replacement.

Fig. 1. This chest x-ray illustrates a typical example of conductor fracture with intact insulation. Conductor fracture occurred near to the fixation sleeve.

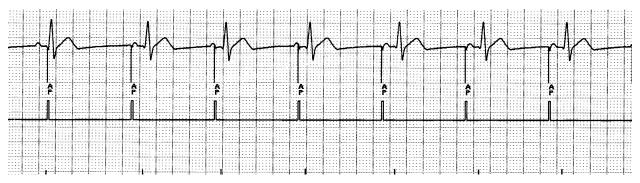
Fig. 2. This tracing shows inappropriate atrial pacing because intrinsic depolarization is not seen by the pacemaker.

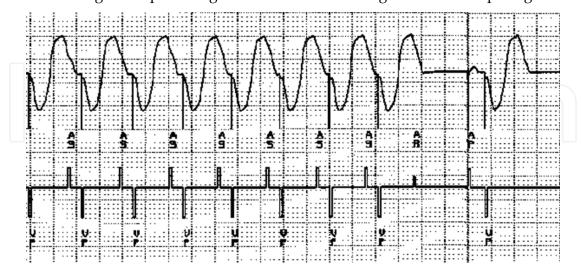
Pacemaker-mediated tachycardia (PMT) is characterized by the active participation of the pacemaker in the tachycardia (figure 3). There are several forms of PMT. Typical form of PMT is endless-loop tachycardia (ELT). ELT only occur in patients with P-synchronous dual-chamber pacing (DDD, VDD) and intact retrograde ventriculoatrial conduction. ELT is classically initiated by a PVC. If the PVARP has expired and retrograde P-wave is sensed, the sensed atrial event triggers the ventricular output. This setups a repetitive sequence of the sensed retrograde P-wave, triggering a ventricular output at the end of maximum tracking rate interval (Den Dulk et al, 1982). In addition to PVC, atrial undersensing, atrial oversensing, and atrial noncapture may initiate ELT. PVARP extension after a sensed ventricular event is the main defense against the ELT. If ELT is initiated, PVARP extension and withholding the ventricular output for one cycle are the major modalities to terminate ELT. Second form of PMT is secondary to tracking of atrial signals (atrial tachycardia/flutter/fibrillation) (figure 4) or oversensing on the atrial channel (Greenspan et al, 1984). This is not a pacemaker malfunction and terminated by applying magnet. Third form of PMT is called repetitive nonreentrant ventriculoatrial synchronous rhythm (Love, 2007). Several factors predispose the patient to this kind of PMT. First, intact ventriculoatrial conduction is needed. Second, a sufficiently long PVARP should be programmed to avoid ELT induction. Third, a relatively rapid baseline rate is also required to render the atrial tissue refractory. In this condition, retrograde P-wave is not sensed (functional undersensing) allowing atrial escape interval to be completed and atrial pulse is delivered with no capture (functional noncapture). Then, the ventricular output is delivered at the end of the programmed AV interval. Therefore, this rhythm is characterized by ventricular pacing, atrial undersensing, and atrial noncapture in the presence of normally functioning dual-chamber DDDR or DDIR pacemakers (figure 5). To prevent this rhythm, a new algorithm called noncompetitive atrial pacing (NCAP) has been introduced. Other preventive strategies are providing short AV intervals at high rates or AAI pacing.

Fig. 3. This tracing was recorded from a patient with dual-chamber pacemakers who presented with frequent palpitations. Pacemaker interrogation showed frequent episodes of pacemaker-mediated tachycardia initiated by a PVC and terminated by a P-wave falling within the PVARP.

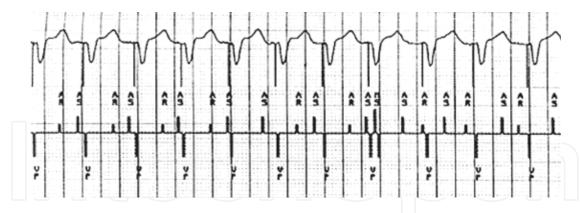
Fig. 4. This figure is recorded from a patient with dual-chamber pacemaker and paroxysmal palpitations. Device interrogation showed tracking of the atrial signals during paroxysmal atrial tachycardias.

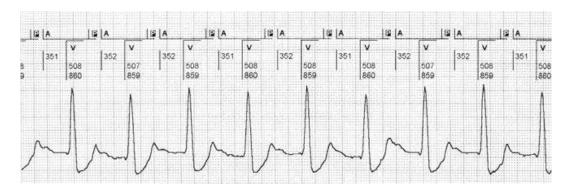
Fig. 5. This figure shows a classical example of repetitive nonreentrant ventriculoatrial synchronous rhythm. This rhythm is characterized by ventricular pacing, atrial undersensing, and atrial noncapture in the presence of normally functioning dual-chamber pacemakers.
