# Effectiveness and Limitations of Vegetation Bioshield in Coast for Tsunami Disaster Mitigation

Norio Tanaka

*Graduate School of Science and Engineering, Saitama University  
Japan*

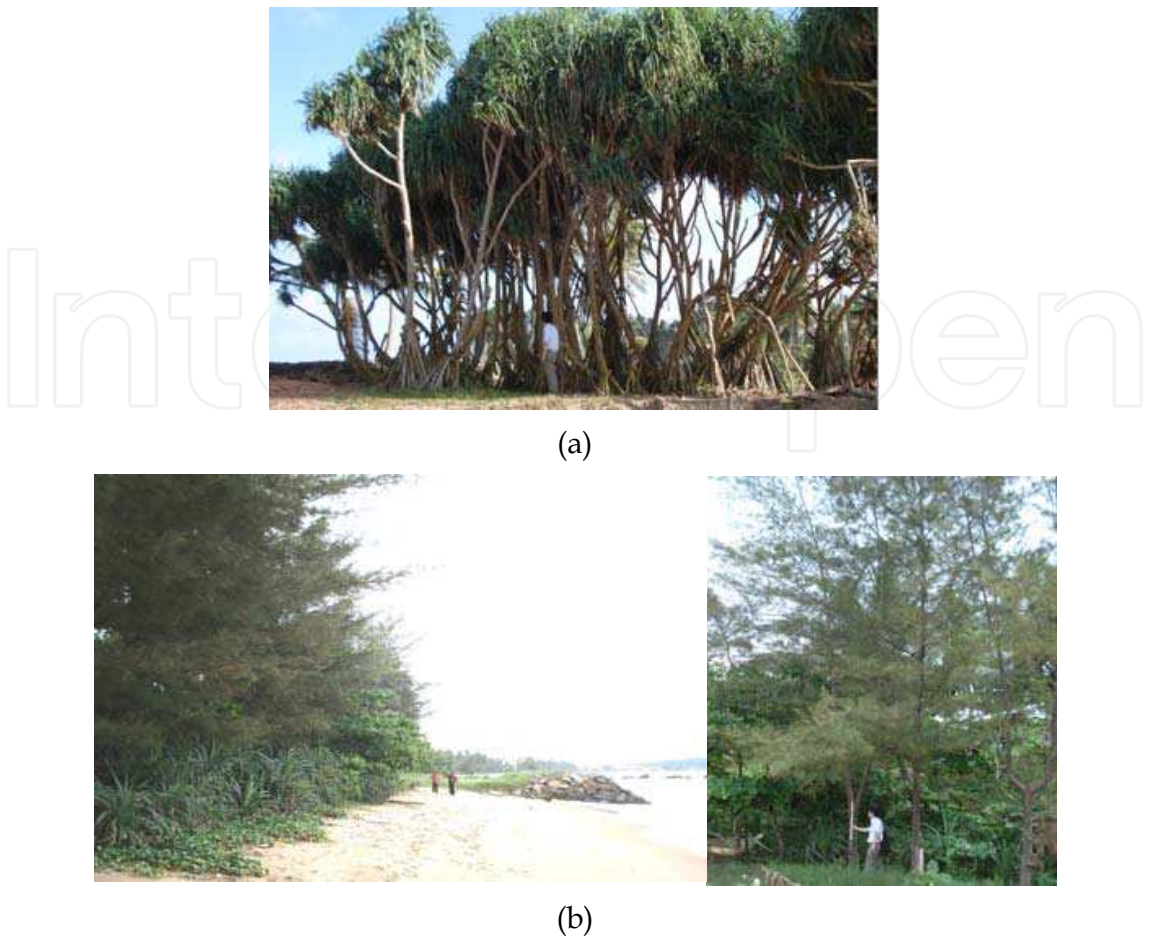
Fig. 2. Effective coastal vegetation, (a) *Pandanus odoratissimus*, and (b) *Casuarina equisetifolia* in tropical countries (undergrowth bushes is young *P. odoratissimus*)

A combination of different tree species is recommended in a buffer forest (Tanaka et al., 2007, 2008b, 2009). *Pandanus odoratissimus* (Fig.2a) was observed to grow under the shade of the taller *Cocos nucifera* and *Casuarina equisetifolia* (Fig.2b). In field observations, two layers of vegetation, *P. odoratissimus* and *C. equisetifolia*, in the vertical direction exhibited a strong potential to decrease the damage behind the vegetation cover (Tanaka et al., 2007), but a combination of *P. odoratissimus* and *C. nucifera* had little effect because they leave wide gaps vertically. *C. equisetifolia* is recommended as an appropriate tree species for a mixed forest. If it does not break, it traps debris. Considering the other roles, i.e. trapping debris and providing something to climb to escape or a soft-landing place for people, that coastal vegetation plays (Shuto, 1987; Tanaka et al. 2006b, 2007), a two-layer forest of *P. odoratissimus* and dense *C. equisetifolia* should be planted and preserved near the coast, and other broad-leaved trees should be grown behind this buffer forest (towards inland), as shown in Fig. 3 (Tanaka et al., 2007).

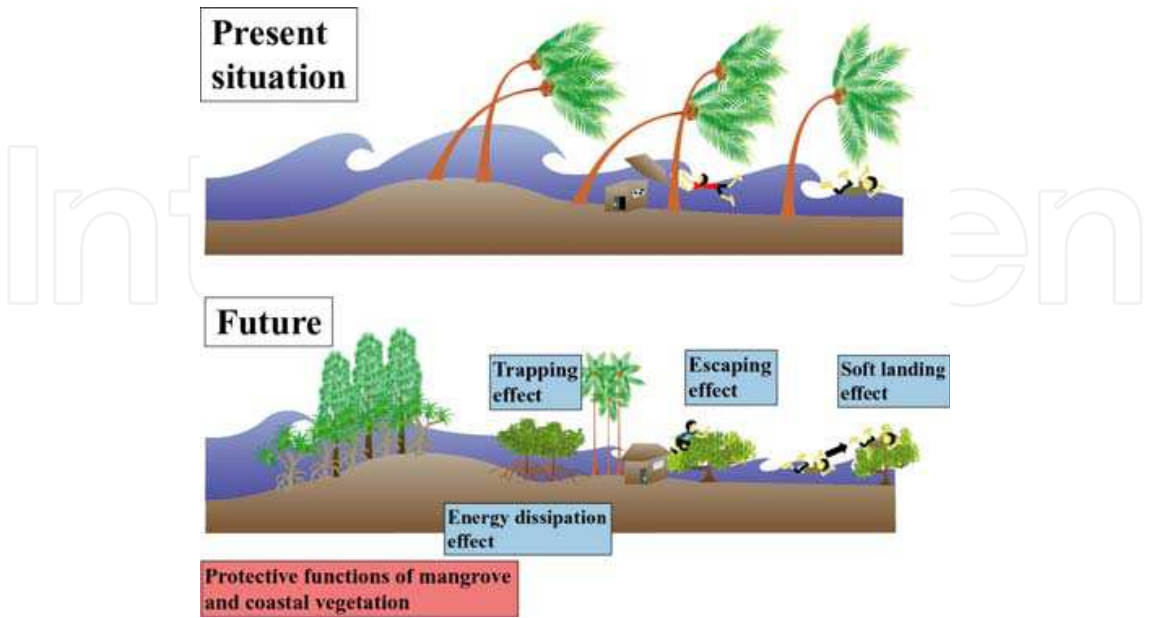
Fig. 3. Functions of coastal vegetation for tsunami disaster mitigation (modified from Tanaka et al.(2007))

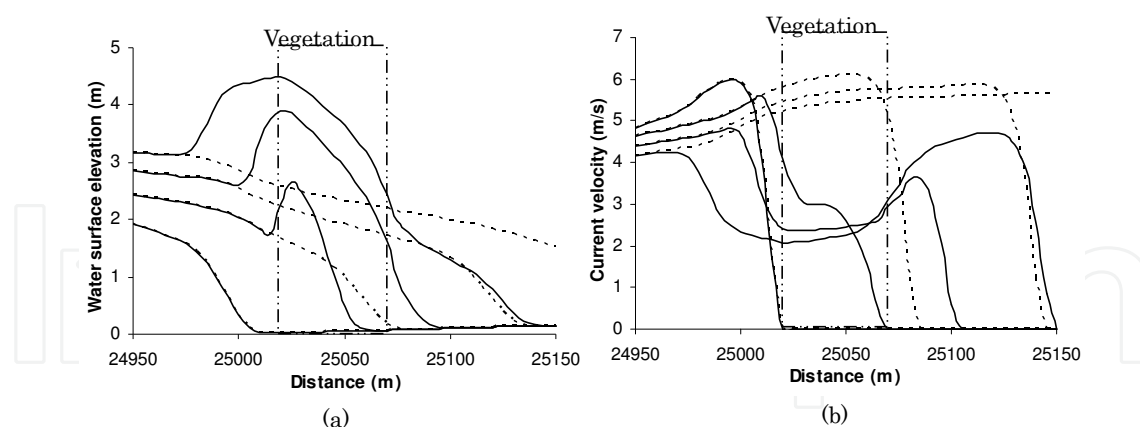
Fig. 4. Spatial variation of (a) water depth, and (b) current velocity for tsunami periods of 10 min (modified from Nandasena et al.(2008b)). Line: with vegetation, dashed-line: without vegetation. Flow is from left to right

A densely grown coastal vegetation belt of *P. odoratissimus* for reducing the tsunami energy was quantitatively analyzed by an enhanced one-dimensional numerical model that included variations of topography and tsunami characteristics (Nandasena et al., 2008b). The drag and inertia forces were assumed as the total resistance generated by the vegetation. Fig.4 shows an example of their simulation. It can be observed that the wave reflection was dominant at the vegetation front. Vegetation also reduces the velocity, water depth inside forest, and tsunami front arrival. Expecting this kind of vegetation effect, many researches conducted numerical simulations. The model output by Hiraishi & Harada (2003) suggested a more than 90% reduction in maximum tsunami flow pressure by a 100 m-wide forest belt when the tree density is very high (30 tree trunks per 100 m<sup>2</sup>). Model results obtained by Harada & Imamura (2006), and Tanaka et al. (2006a, 2008b) for various types of coastal vegetation, including mangroves, were very similar. Tanaka et al. (2006a) modelled the relationship of species-specific differences in drag coefficient to tsunami height. The species differences in mitigating tsunami water depth, velocity, and tsunami arrival time behind a forest in relation to tsunami height were found to be quite large, and *P. odoratissimus* was considered more effective in reducing the velocity and water depth of the current through the forest than other common trees, including the coconut tree (*C. nucifera*) and a kind of mangrove (*Avicennia alba*) using a numerical simulation (Tanaka et al., 2006a). These results point out the importance of preserving or selecting appropriate species to act as tsunami barriers and offer sufficient shoreline protection. For *P. odoratissimus*, extensive numerical simulations were conducted and effects of the vegetation has been quantitatively evaluated with many different tsunami conditions by Thuy et al.(2010b)

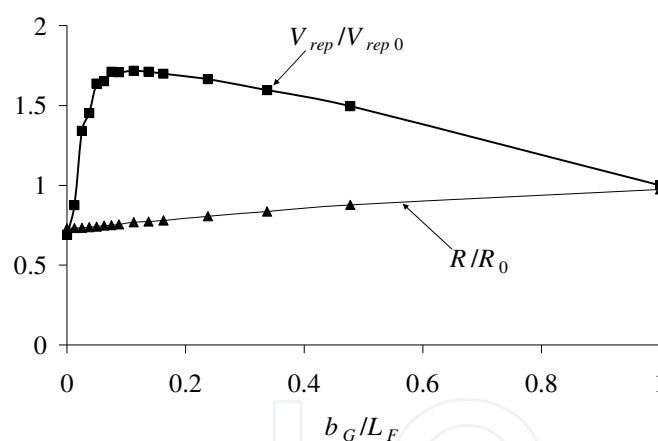
Fig. 5. Variation of representative velocity behind a gap ( $V_{rep}/V_{rep0}$ ) and run-up height ( $R/R_0$ ) in relation to the ratio of a gap width( $b_G$ ) and channel width( $L_F$ ). Subscript 0 indicates the case of no vegetation. (modified from Thuy et al.(2009))

construction of access roads to a beach or for sand mining, the mouths of rivers, mangrove channels opening onto the sea (FAO, 2007), and coral reefs for constructing headlands or embayments (Fernando et al., 2005). The water flow through the gaps is accelerated as it moves into the constriction (FAO, 2007; Fernando et al., 2005, 2008; Mascarenhas & Jayakumar, 2008; Thuy et al., 2009). When the gap is narrow, it increases the velocity immediately behind the gap, although the water depth will actually decrease in most cases (Nandasena et al., 2008a). The areas behind a coastal forest can still be protected from the tsunami (FAO, 2007; Thuy et al., 2008), but gaps increase the hazards in the gap line (Fernando et al., 2005, 2008; Cochard et al., 2008). As the gap width increases, the flow velocity at the end of the open gap first increases, reaches a maximum, and then decreases (Fig.5), while the run-up height increases monotonously. The maximum velocity in the condition by Thuy et al.(2009) is 1.7 times the maximum velocity without a coastal forest (Fig.6).

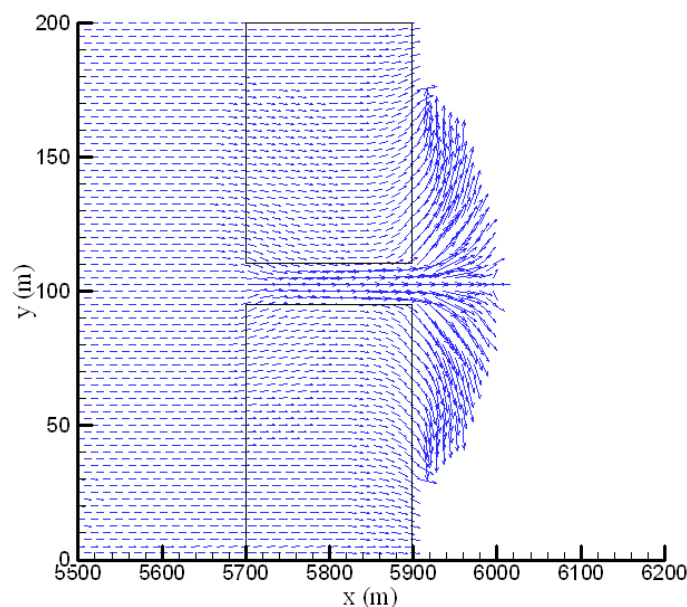
Fig. 6. Flow pattern around a gap (modified from Thuy et al.(2009))

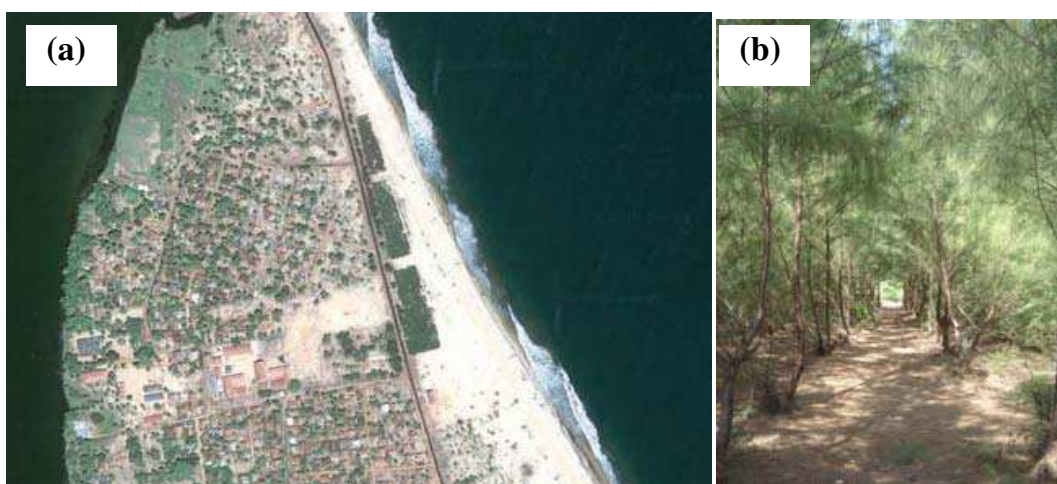
Fig. 7. Planting situation in eastern coast in Sri Lanka, (a) aerial photo (from Google Earth), (b) straight gap inside forest (photo by Methsiri Samarakoon)

Although the danger at the gap has been pointed out, large number of coastal vegetation belt were still constructed with the gap after the Indian Ocean tsunami. Fig.7 shows the planting situation in eastern coast in Sri Lanka. A lot of *Casuarina* forests are planted there but some forests has supposed to make dangerous zone behind or around the forest although the tsunami damage in most of the area are supposed to be mitigated. As it is not realistic to consider a coastal forest without any gap in the barrier, careful planning is required in the design of an actual coastal forest to incline the gap direction away from the tsunami current direction or to stagger it to reduce the water velocity through the gap (Thuy et al., 2009).

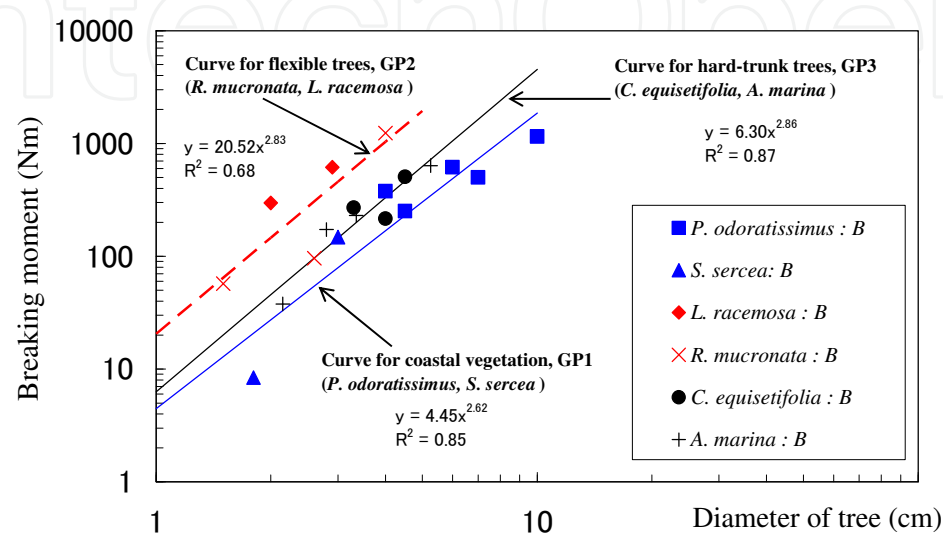
Fig. 9. Breaking moment curve of representative coastal tree species in tropics (modified from Tanaka et al.(2009))

Tanaka et al. (2006b, 2008b) conducted tree breaking tests in situ using small diameter trunks or branches and showed that the breaking moment curve of representative tree species (Fig.9) can be classified into three parts by elasticity and habitat as

1. the curve for coastal vegetation (ex. *P. odoratissimus*),
2. the curve for elastic trees
3. the curve for trees with hard trunks (ex. *C. equisetifolia*).

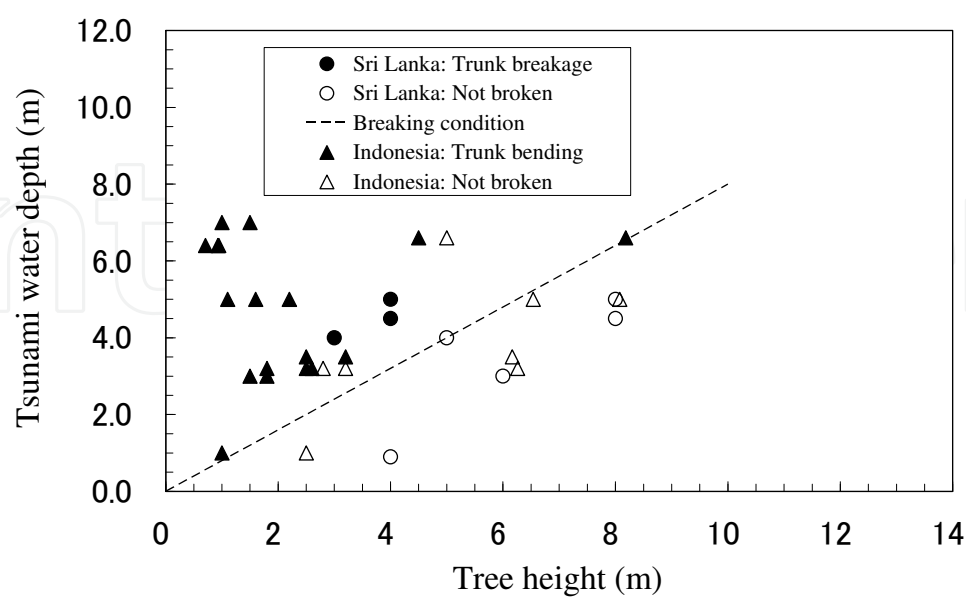
Fig. 10. Tree breaking situation in relation to tsunami water depth and tree height (modified from Tanaka & Sasaki (2007))

Although the breaking test was conducted in Sri Lanka before the 2006 Java tsunami (Tanaka & Sasaki, 2007), the breaking condition coincided well with the actual damage observed at the sites of the Java tsunami, except for *C. equisetifolia* (Tanaka et al., 2009). *C. equisetifolia* does not have aerial roots, but its diameter becomes greater at ground level than at breast height as the tree grows. Thus, its trunk was rarely broken. Most of the damage to *C. equisetifolia* was due to uprooting. This indicates that the breaking condition is not well expressed by the breaking test using *C. equisetifolia* with small trunk diameters. Further study of the breaking or uprooting conditions for *C. equisetifolia* is recommended with real-scale breaking or uprooting tests like those of Peltola et al. (2000) because *C. equisetifolia* is expected to be an effective species for dissipating tsunami energy in Sri Lanka, Thailand (Tanaka et al., 2006a, 2006b, 2007; FAO, 2007), and India (Mascarenhas & Jayakumar, 2008). Tanaka & Sasaki (2007) examined the height at which *P. odoratissimus* and *C. nucifera* trees were broken in two tsunamis (the 2004 Indian Ocean and 2006 Java tsunamis) and found that the threshold of tsunami water depth at which a tree trunk broke was about 80% of the tree height for *P. odoratissimus* (Fig.10). *C. nucifera* was seldom damaged except for small trees, but when it was toppled, the critical tsunami height was about 80%, the same as *P. odoratissimus*. Because the breaking point of *P. odoratissimus* is 1-2 m high, the moment by drag at that point is smaller than that of a tree without aerial roots. Although the threshold tsunami water depth for breaking *P. odoratissimus* is similar to that for *C. nucifera*, the trunk

strength of *P. odoratissimus* is not as great and it receives a large drag force from the tsunami current when the tsunami water depth is greater than the height of its aerial roots. The studies by Tanaka & Sasaki (2007) and Tanaka et al. (2008b) elucidated the breaking condition for a single tree when the scouring around the tree is not severe. However, the breaking condition is not applicable for critical tree damage in the fringe area of a forest, especially the frontal vegetation on sand dunes where the substrate is not hard and severe scouring occurs.

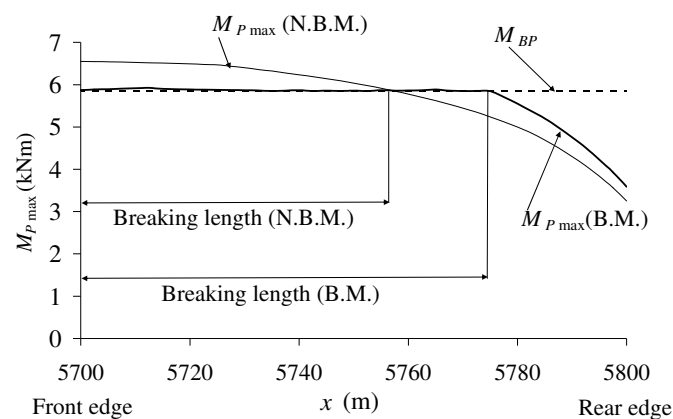
Fig. 11. (a) Damage length for two numerical model, (b) relationship between tsunami water depth (at the front of vegetation) and reduction of water depth( $[d_{max0}-d_{max}]/d_{max0}$ ), tsunami force ( $[F_{max0}^*-F_{max}^*]/F_{max0}^*$ ) and survival rate (number of remained trees /total tree) of *P. odoratissimus*. Subscript 0 indicates the case of no vegetation,(modified from Thuy et al.(2010a))

vegetation, reduction of water depth and tsunami force behind the forest are discussed. The study elucidated that: (1) tsunami moment is decreased from the front to the behind due to the decrease in water depth inside the vegetation, and (2) the reduction rate in water depth and tsunami force increases when the incident tsunami water depth exceeds the initial breaking. Fig. 11(a) shows spatial distribution of the maximum tsunami moments ( $M_{Pmax}$ ) along the forest for two models. According to the result, the damage length of forest by the model including tree breakage (B.M.) is about 77.5m (77.5%) and increased in comparison with the model that does not include tree breaking (N.B.M.) due to the decrease in vegetation resistance in the front area where vegetation is broken. Fig. 11(b) shows the relationship between the tsunami water depth in front of vegetation in the case of no forest and the reduction of water depth ( $(d_{max0} - d_{max})/d_{max0}$ ), tsunami force ( $(F_{max0}^* - F_{max}^*)/F_{max0}^*$ ) behind the forest and survival rate of *P. odoratissimus* (number of remained trees/total tree), where subscript 0 indicates the case of no forest. The results show that trees start breaking at water depth of 4.8m (Fig. 11(b), I.B.). When tsunami water depth reaches to 5.5 m all the trees are broken. The reduction rate in water depth and tsunami force decrease when the tsunami water depth exceeds the initial breaking of water depth.

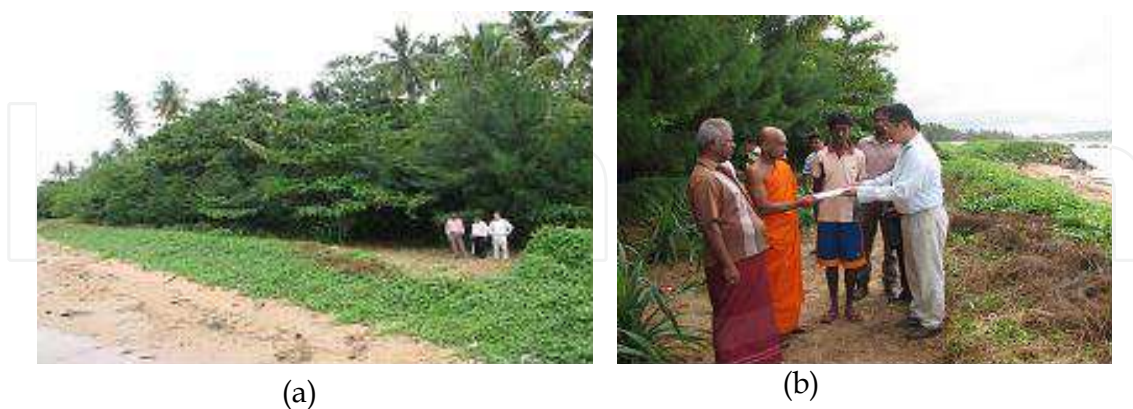
Fig. 12. Pilot project in Matara city. (a) growth situation after 18 months, (b) long term maintenance by local temple

A survey was conducted by a team comprising researchers from Saitama University, Japan, and the University of Peradeniya, Sri Lanka (the SU-UoP team) to examine the present situation of coastal vegetation for tsunami mitigation in Sri Lanka. Many government institutions and NGOs have also undertaken such projects along the southern and western coasts in Sri Lanka. An evaluation was carried out to assess whether the coastal vegetation fulfilled the functions of dissipation of wave energy and trapping debris, and offering opportunities to escape and make a soft landing (Tanaka et al., 2007). Currently, 50% of the vegetation barriers are planted in one or two rows due to land availability constraints in areas along main roads or railway tracks. Dissemination of knowledge and coordination with government institutions and research institutions are very important for establishment and management of effective coastal vegetation for tsunami mitigation with community participation, especially at the initial development stage.

The findings of Tanaka et al. (2007) suggested several options for coastal vegetation management that could effectively reduce the impact of tsunamis and other natural disasters in the future. Accordingly, the SU-UoP team proposed a pilot-scale coastal plantation in the Matara Thotamuna area in the southern coastal belt near the mouth of the Nilwala River, Matara City, Sri Lanka (Fig.12(a)), which was severely affected by the 2004 tsunami. *C. equisetifolia* and *P. odoratissimus* were planted in a mixed culture, and their growth was monitored continuously. The average height and girth of *P. odoratissimus* were around 92 cm and 117 cm, respectively, and the average height and trunk diameter of *C. equisetifolia* were 627 cm and 4 cm, respectively, 18 months after planting (Perera et al., 2008). The project was very successful and effective compared to similar projects that suffered from poor maintenance and operation. The project indicated that support from local authorities and communities are vital to make such programs successful, especially in initial development stage. For long-term maintenance of the pilot project, management of the site was handed over to the local temple (Fig.12(b)). This is one of the ideas for sustainable maintenance.
