## Early Complications after Pacemaker Implantations

Kabayadondo Maidei Gugu and de Meester Antoine  
*Jolimont Hospital  
Belgium*

## **Cardiac Pacemakers - Biological Aspects, Clinical Applications and Possible Complications**

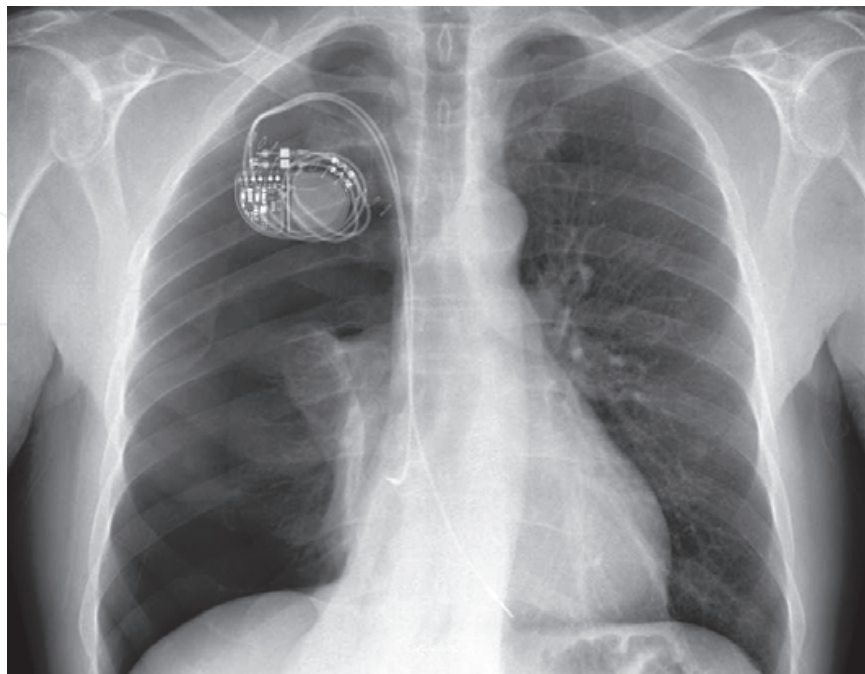
A 61 year old man presents to his general practitioner with right thoracic pain and dyspnoea, progressively worsening since three days. He was discharged from cardiology a week before, for implantation of a double chamber pacemaker for sick sinus syndrome with symptomatic atrial fibrillation and bradycardia. Clinical examination revealed good cicatrisation of the implantation site, normal cardiac sounds with no murmur, but abolished respiratory sounds in the right lung. Twelve-lead electrocardiogram (EKG) showed a sinus rhythm with paced ventricular response (typical left bundle block pattern). Chest X-ray confirmed the presence of a complete right pneumothorax (Figure 1). The patient was therefore treated with a chest tube and his recovery was uneventful. The additional hospital stay was three days.

Fig. 1. Chest X-ray showing complete right pneumothorax, which was treated with a chest tube.

**Comments:** Iatrogenic pneumothorax after subclavian venous access is a rare complication whose incidence varies from 1-5% depending on the series, on the realisation of routine post-procedural chest X-ray and on the exact definition of this complication (consideration of both complete and partial pneumothorax, the need for chest tube insertion, hemothorax or gas embolism) (Res et al., 2004). It is usually an immediate complication and is rarely witnessed after discharge. To avoid this complication, access through a central cephalic vein is possible. However, this technique is subject to failure in approximately 20%. The operator's anatomical knowledge and experience reduce this risk. Pneumothorax is usually asymptomatic and resolves spontaneously in most cases. It is to be suspected in all patients presenting with dyspnoea, unexplainably low blood pressure and variable or elevated stimulation thresholds. Chest tube placement with aspiration is necessary if pneumothorax exceeds 10% of lung volume, if tension pneumothorax or hemothorax are diagnosed.

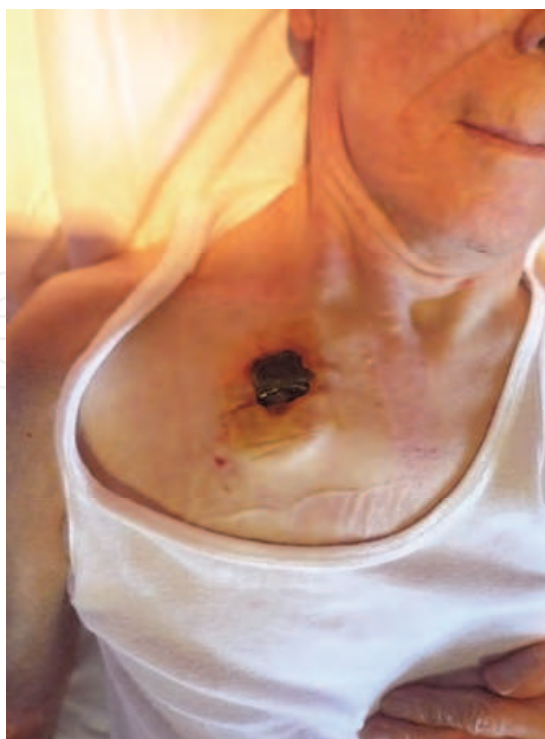
An 80 year old male needed pacing for complete atrioventricular block is re-admitted three months after implantation. Despite daily wound care by a home-based nurse, the suture line at the site of implantation would not cicatrize. Patient history included myocardial infarction for which percutaneous cardiac intervention (PCI) with a bare metal stent was performed, as well as receiving classical medical treatment that included clopidogrel and aspirin on a daily basis. After implantation, a large hematoma formed in the generator pocket. A conservative treatment was initially proposed. On re-admission, the hematoma had almost completely disappeared, but severe skin necrosis was impeding site closure to the extent that the leads were visible with the naked eye. The absence of infection, as proved by numerous negative swab cultures, allowed for the pacemaker generator to be re-implanted under the pectoralis muscle.

Fig. 2. Hematoma. Lack of suture line healing, pacemaker leads visible.

**Comments:** Pocket hematoma is the most frequent complication (5% of cases) and can lead to prolonged hospital stay and in the latter case, re-implantation (1-2%) (Kiviniemi et al., 1999 ; Wiegand et al., 2004). Risk factors include use of high doses of low molecular weight heparin, of the association aspirin-clopidogrel, and inexperienced operator. Aspirin alone or an oral anticoagulant like warfarin, to take international normalized ratio (INR) of  $< 2.0$ , does not increase the risk of hematoma. Electrocautery or a second look to the pocket is useful to minimize bleeding and the risk of large hematoma. Selective use of topical thrombin is reserved for high risk patients; in Reynolds's series, the incidence of significant hematoma dropped from 20.8% to 8%. Sometimes drain placement may be necessary and sufficient. Evacuation of hematoma is realised in less than 0.5% with a major risk of infection; potential reasons include persistent bleeding, pain refractory to analgesics, failed healing and skin necrosis.

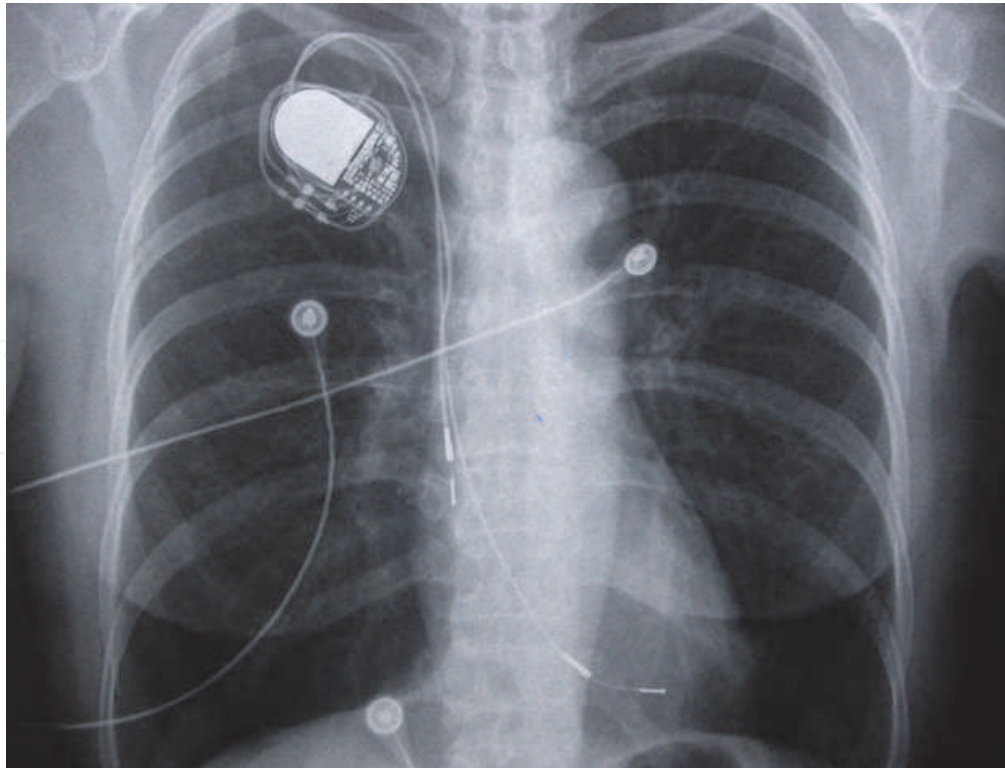
A 60 year old female patient with no medical history and under no current treatment was admitted for complete atrioventricular block causing shortness of breath and dizziness. Implantation of a double chamber pacemaker was performed with ease. P/R sensings were measured at 3.1 mV and 7.8 mV respectively, and both thresholds for stimulation are 0.5 volt/0.4 msec. The next day, the patient represented with dizziness and faints. Lead displacement was suspected. EKG no longer showed physiological stimulation and chest X-ray confirmed lead displacement (Figure 3). Lead repositioning and active fixation was performed successfully.

Fig. 3. Chest X-ray showing migration of both atrial and ventricular leads.

**Comments:** Lead displacement can be found in 2-10% of cases depending on the series (Kiviniemi et al., 1999 ; van Eck et al., 2007). Atrial leads migrate more often than ventricular leads. Active fixation reduces the risk, especially in patients having undergone cardiac surgery. Manifestations include undersensing, failure to capture and increase in pacing thresholds. Repositioning of leads is primordial. Causes of undersensing include lead displacement, fibrosis at the site of fixation of the lead, myocardial ischemia and necrosis, some antiarrhythmic agents (flecainide), dyskalemia, or transient undersensing following an electric shock (Table I) (de Meester, 2008). When lead displacement is induced by the patient, following a repetitive rotational movement (twisting of the box) and leading to winding of the leads around the generator, we talk of Twiddler's syndrome; this is observed in certain psychiatric cases, or when the pocket is too big for the pacemaker generator.

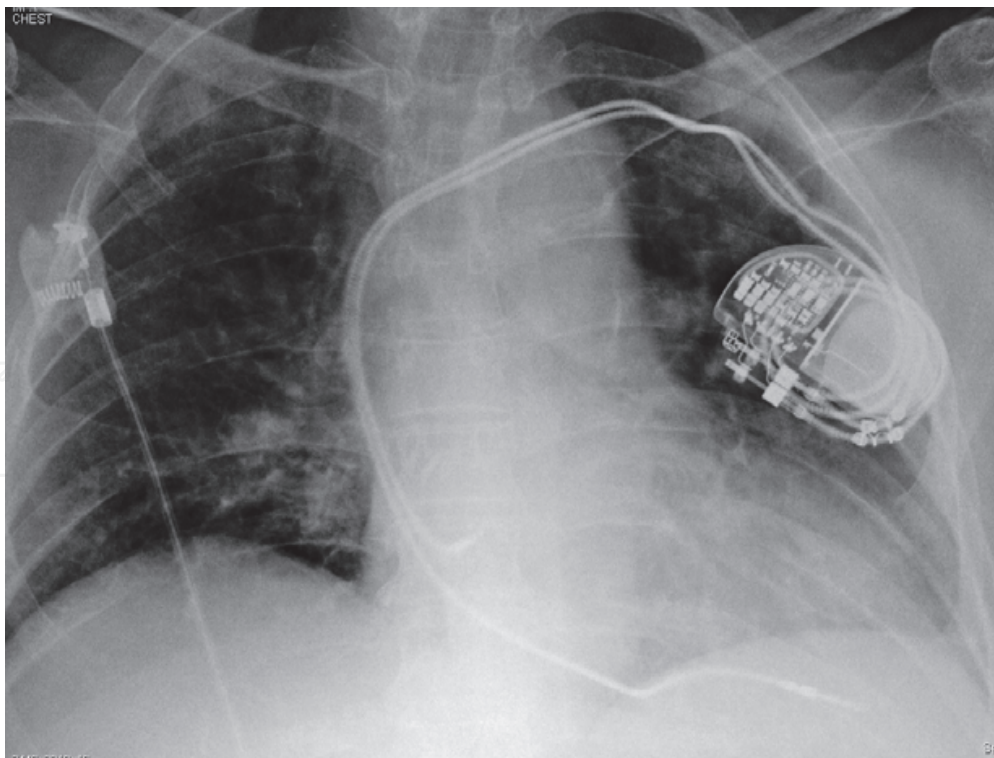
A 77 year-old patient had a physiological pacemaker implanted for symptomatic sinus bradycardia, with sinus arrest. A few days after the intervention, she presented with continuous chest pain. Upon clinical examination, blood pressure was 130/80 mmHg, heart sounds were regular but a pericardial friction rub was audible. EKG showed a sinus rhythm with ventricular capture. Chest X-ray revealed a ventricular lead projecting further than the apex (Figure 4). Cardiac ultrasounds confirmed myocardial perforation by the lead and a minimal pericardial effusion. We decided to abstain from removing the lead, which would have been to some extent invasive in this elderly patient. Treatment by anti-inflammatory drug was installed and was sufficient for pain relief.

Fig. 4. Chest X-ray showing atrial and ventricular leads, with the ventricular lead clearly beyond the cardiac shadow

**Comments:** Cardiac perforation is a serious complication, with risk of tamponnade and death. It occurs in less than 2% of cases (Ellenbogen et al., 2002). Clinical symptoms are variable, including chest pain, shortness of breath and more rarely hypotension and shock. Advanced age, use of active fixation leads and operator inexperience are contributing factors (Mahapatra et al., 2005). Furthermore, atrial leads seem to perforate more frequently (Hirschl et al., 2007). The new Magnetic Resonance Imaging (MRI)-compatible leads are more rigid, but increased frequency of perforation does not seem to be induced by the use of these leads. Treatment is not standardised, but removal (and replacement) of these leads is crucial in the case of tamponnade and shock. Pericarditis without perforation has been observed in 5% of cases and must lead to close follow-up. Figure 5 illustrates a case of tamponnade. The patient remained stable after drainage.

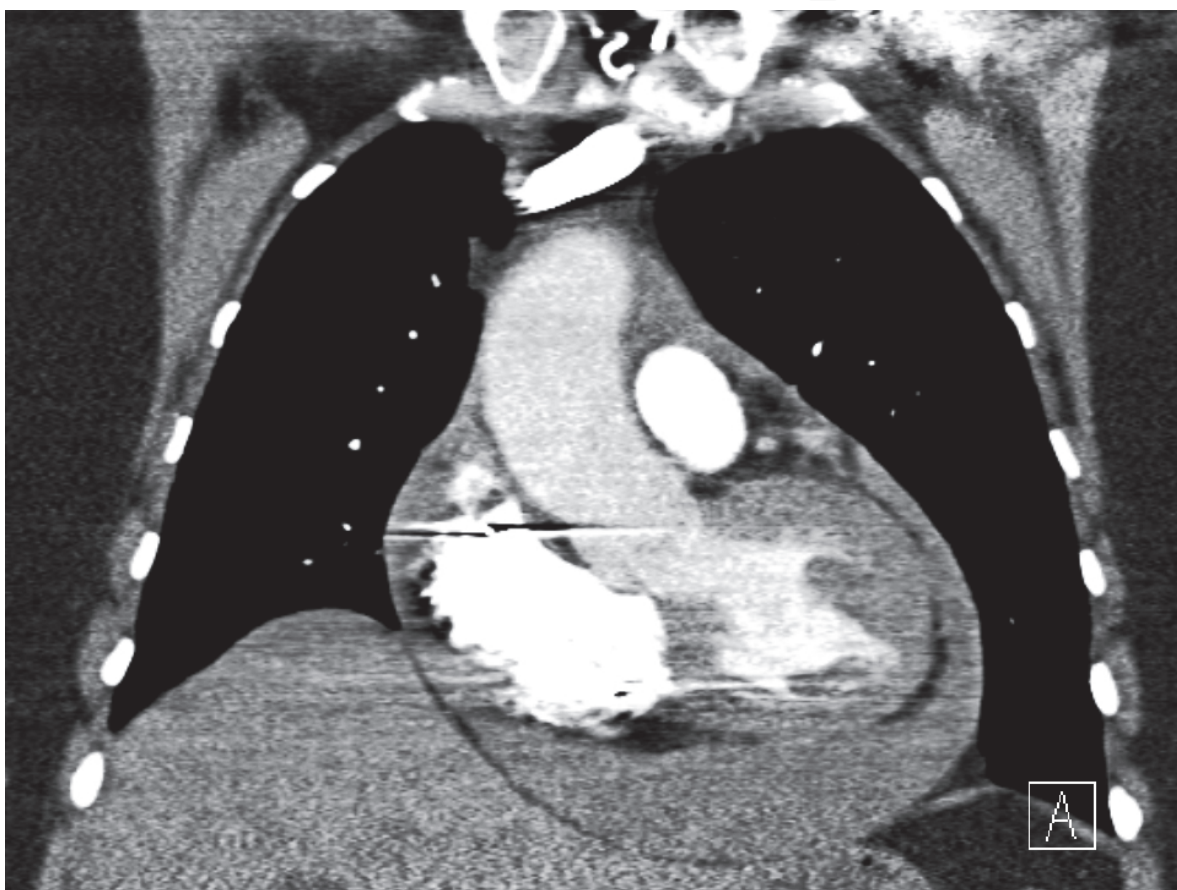
Fig. 5. Chest scan showing significant pericardial effusion, responsible for pre-tamponnade and shock.

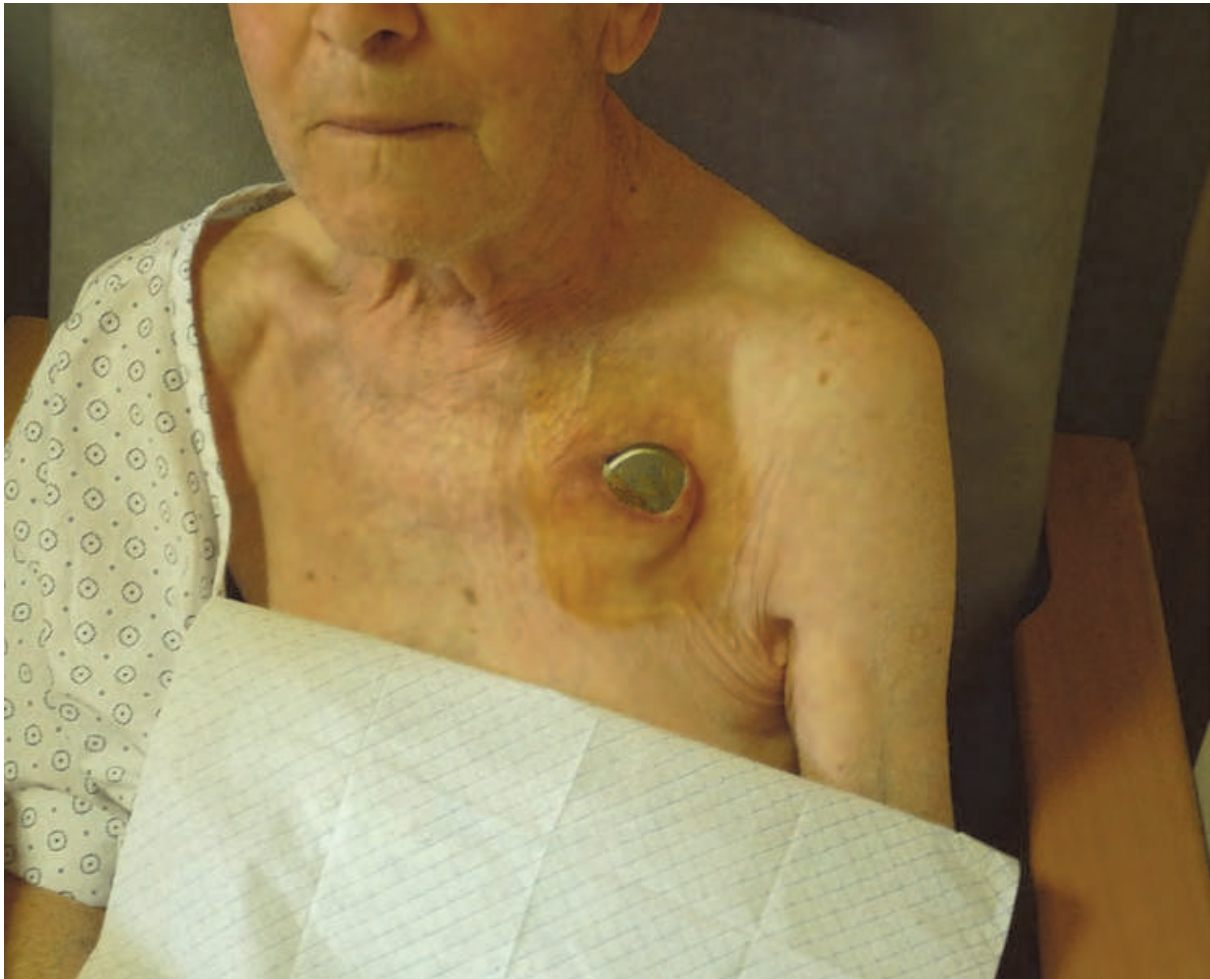
An 85 year old female patient is admitted for malaise and confusion. Medical history is positive for asthma treated regularly by corticoids and B2 mimetic aerosols. EKG shows a complete atrioventricular block and, after excluding all reversible causes, a physiological pacemaker is implanted. No complications are noted during her hospital stay. Having regained her autonomy and the confusional episode resolved, the patient returns to her old age home with instructions for routine care for the following weeks. A follow-up is programmed at six weeks and the cardiologist is confronted with a case of skin erosion and

exteriorisation of the pacemaker generator (Figure 6). Due to the high risk of infection in this case, the device is removed and a new device is implanted on the contra-lateral side after six weeks of antibiotherapy and with negative hemocultures.

Fig. 6. Erosion and exteriorisation of pacemaker generator in our elderly patient.

**Comments:** Skin erosion is caused by the pacemaker generator, and is usually a result of pocket infection. Other precipitating factors can be present, for example, the extremely fragile skin of elderly patients, a pocket that is too small, precarious subcutaneous fat, chronic use of corticoids, and use of abrasive disinfectants (Kiviniemi et al., 1999). Exteriorisation of a generator, and/or a lead, is always associated with bacterial contamination, making removal of the material an obligation, accompanied by antibiotherapy and eventually re-implantation on the contra-lateral side. Skin erosion is hence to be sort for and detected before exteriorisation. This is rarely an early complication, and incidence is estimated to be 1%.

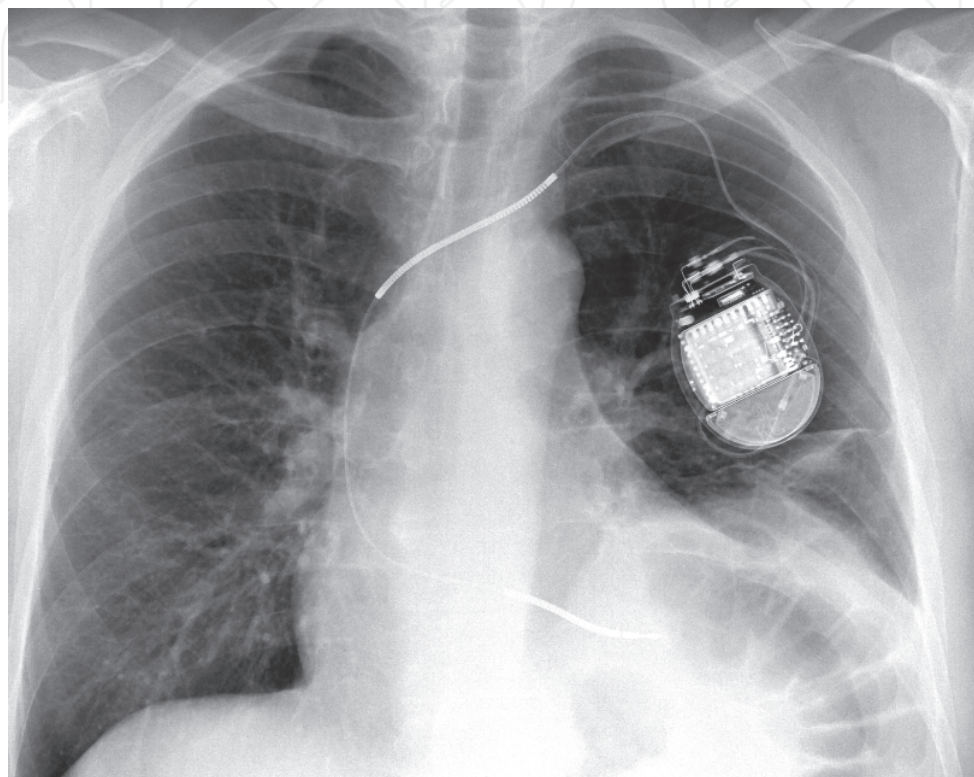
A 55 year old patient with history of hypertension, obesity, diabetes, anterior myocardial infarction and severe left ventricular dysfunction has a defibrillator implanted in primary prevention of sudden death. The follow-up is satisfactory with acceptable sensing, impedance

and threshold stimulation values on the device programmer. EKG shows a sinus rhythm with evident old anterior infarction. Chest X-ray, performed in a recumbent position and under non-optimal condition seems satisfactory and the patient is discharged. Upon follow-up one month later, the parameters of the defibrillator are still satisfactory, but the ventricular stimulation shows atypical right bundle block. Chest X-ray confirms the suspected left ventricular stimulation, via a permeable foramen ovale (Figure 7). Lead replacement is indicated seeing the high risk of thrombo-embolic complications in this young patient.

Fig. 7. Chest X-ray showing a ventricular lead that is located higher than usual; this lead is in the left ventricle, having gone through a patent foramen ovale.

**Comments:** an erroneous lead placement is extremely rare. It remains possible in patients with a patent foramen ovale or an atrial septal defect. Less than twenty cases are reported in the literature (Allie et al, 2000; Blommaert et al., 2000 ; Van Gelder al, 2000; Le Dolley et al, 2009). An EKG during stimulation and chest X-ray in an upright position (antero-posterior and lateral takes) are recommended. The risk of thrombo-embolism, including stroke, of mitral insufficiency should be evaluated. Repositioning of the lead or long term anticoagulation should be considered. When right bundle branch block pacing morphology appears in a patient with a permanent or temporary transvenous right ventricular pacemaker, myocardial perforation or malposition of the pacing lead must be ruled out, even though the patient may be asymptomatic. The overall causes of right bundle branch block morphology include:

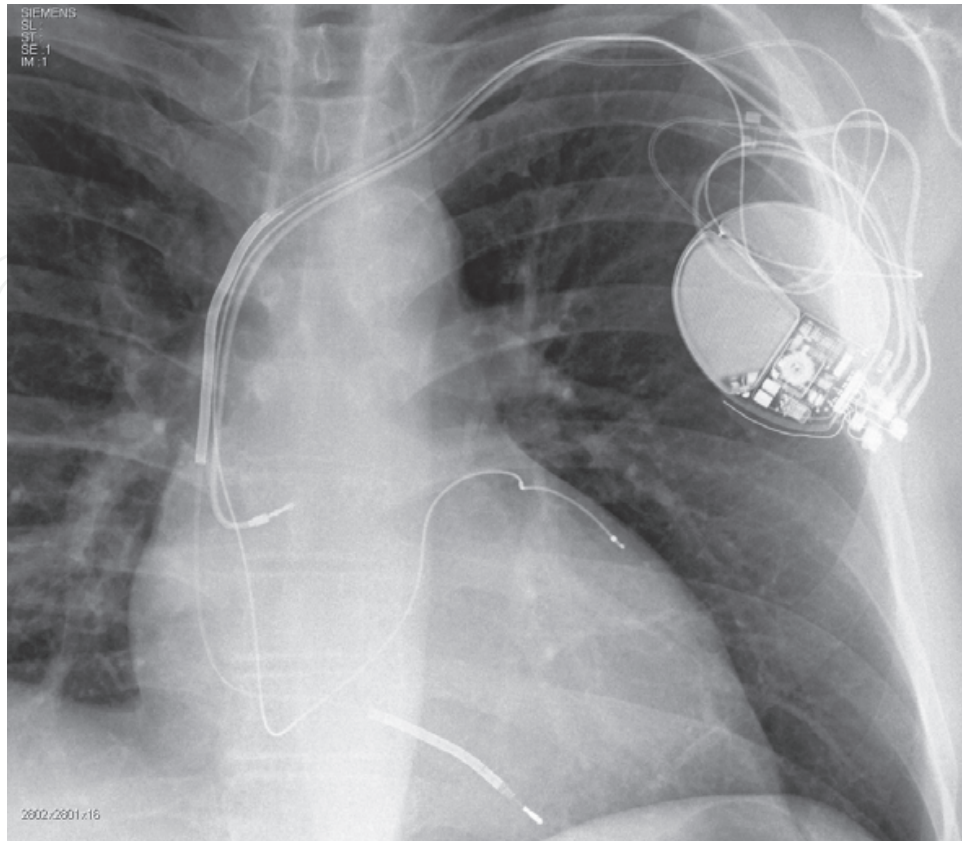
- erroneous left ventricular lead placement in patient with an atrial septal defect
- biventricular stimulation or cardiac resynchronisation therapy (CRT) (Figure 8)
- epicardial lead placement.
- some cases of “normal” right ventricular apical stimulation

Fig. 8. Chest X-ray showing implantation of 3 leads including a left ventricular lead placed in a branch of the coronary sinus (cardiac resynchronisation therapy).

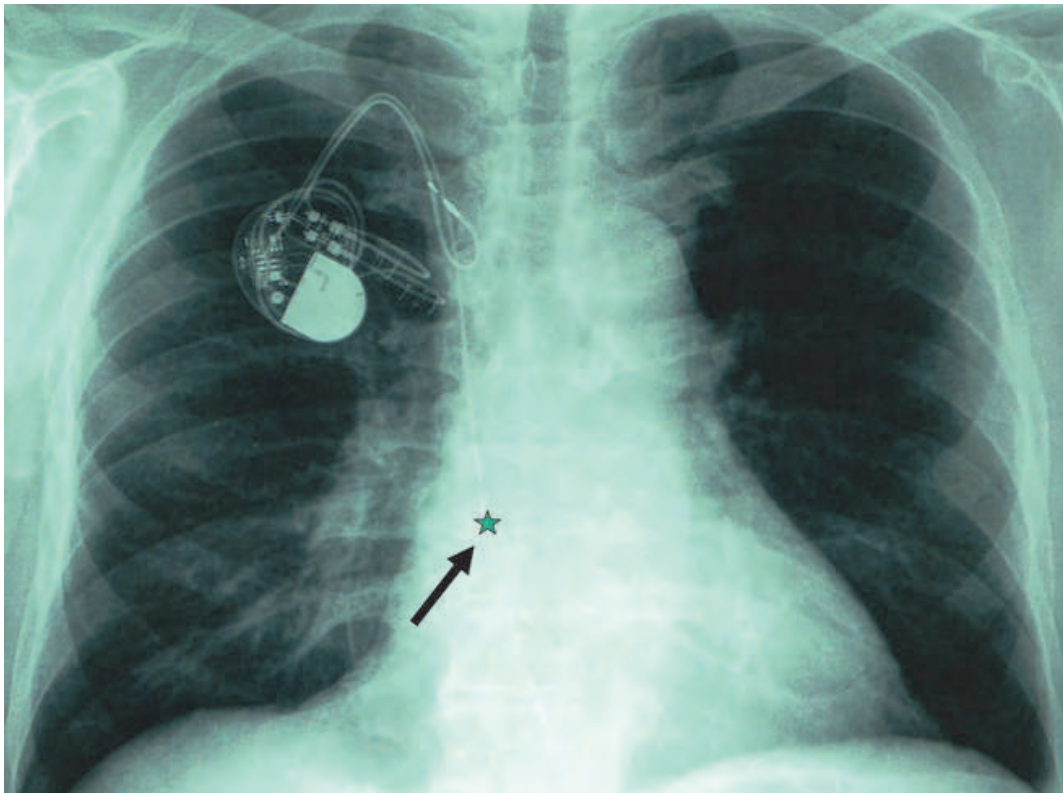
A 68 year old patient, with a history of chronic obstructive pulmonary disease and psychosis, underwent pacemaker implantation for repeated loss of consciousness due to sinus hypersensitivity. Carotid sinus massage resulted in 10 second pauses. The pacemaker was set in double chamber mode and after satisfactory programming control (P-R sensing 2.5 mV and 12.5 mV, impedance at 564 ohms and 496 ohms respectively, stimulation thresholds at 0.5 volts/0.4 msec), the patient was discharged to his psychiatric institution. At one month follow-up, the patient has no complaints, though anamnesis is laborious. Check-up of the stimulator shows absence of detection of both P and R waves, and absence of atrioventricular capture despite maximal stimulation. Displaced leads are suspected and confirmed by chest x-ray (Figure 9). The patient later admits to having manipulated the pace generator by repeatedly twisting it around. Correct repositioning and fixation of the leads were conducted.

Fig. 9. Chest X-ray showing displaced lead (ventricular lead tip indicated by the star).

**Comments:** Twiddler's syndrome is describes as the migration of cardiac stimulator leads due to repetitive rotatory movements of the generator in its pocket, secondary to manipulation by the patient himself, which may be intentional or non-intentional (for example, sportsmen). In certain cases, the stimulation of displaced leads can cause pectoral muscle contraction, or life-threatening symptoms in the case of pacemaker dependency (Nicholson et al, 2003; Castillo & Cavusoglu, 2006; Essoh et al., 2010) (Figure 10).

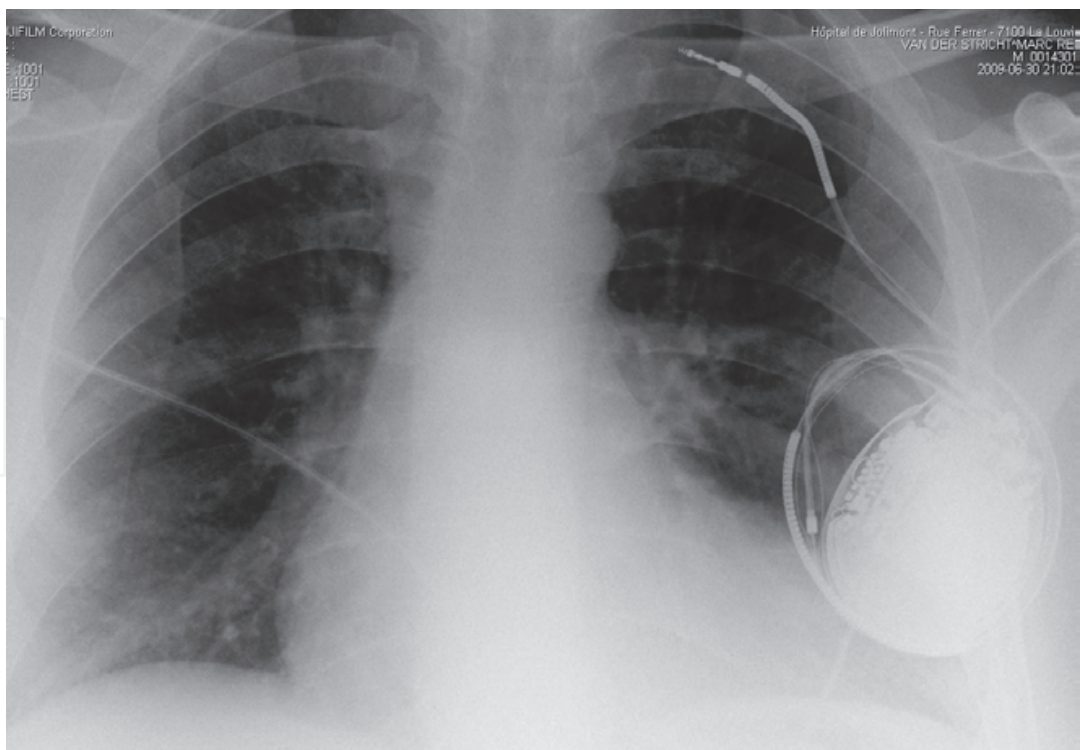
Fig. 10. Chest X-ray showing dual-coil ventricular lead displacement, causing pectoral permanent stimulation, in a case previously reported by our team (Essoh et al, 2010). Repositioning the lead was required and successfully reported.

Risk factors include obesity (adipose tissue being less firm in these patients), female sex, elderly patients, patients known as having stigmata for character disorders (obsessive compulsive tendencies, dementia). Treatment consists of repositioning the leads, and changing them in the event of fracture. Several surgical techniques have been proposed to avoid recurrence; implanting the pacemaker generator under the aponevrosis, active lead fixation (almost always the case with implantable cardioverter-defibrillators), Parsonet's dacron pouches. Patient education, and psychiatric treatment if indicated, should be proposed.

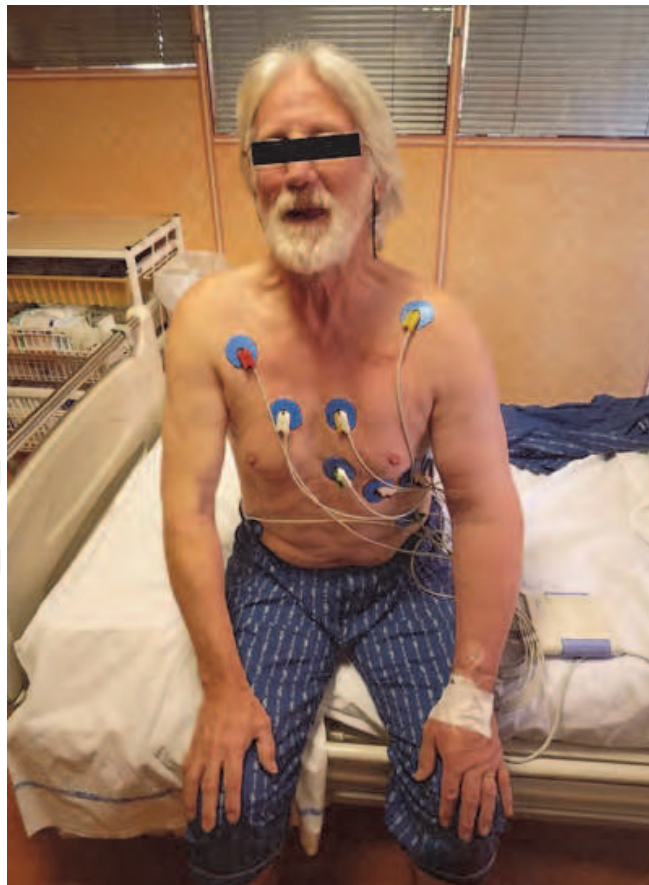
A 73 year old male has a defibrillator with resynchronisation implanted for ischemic cardiomyopathy after an anterior infarction left him with a left ventricular ejection fraction of 25%. He had presented an episode of ventricular tachycardia with syncope. Implantation of the device was by the subclavian route. There were no immediate post-operative complications and good parameters were recorded for all three leads. Three weeks later, the patient complains of discomfort in the left arm, followed by oedema of the whole arm, forearm and hand (Figure 11); ultrasound and vascular tomodensitometry confirmed complete thrombosis of the left subclavian vein, of the axillary vein, leading up until the convergence of the jugular vein. Anticoagulation therapy was commenced and evolution was slow but favourable in the following weeks.

Fig. 11. Oedema of the left arm, forearm and hand caused by massive thrombosis of the subclavian vein after defibrillator with Cardiac Resynchronisation Therapy (CRT-D).

**Comments:** Subclavian vein thrombosis is not uncommon. It can occur in about 30% of cases, but usually remains asymptomatic due to the rapid development of collateral circulation (Oginosawa et al., 2002). Less than 5% of patients are symptomatic, presenting mainly with pain or oedema of the arm closest to the implantation site. Risk is higher in cases where three leads are implanted (Cardiac Resynchronisation Therapy (CRT), when the patient is under hormonal therapy, when personal history of thrombo-embolic event is present, with temporary ipsilatérale transvenous lead, during upgrade of a simple pacemaker to a pacemaker with resynchronisation, dual coil leads, and when the ejection fraction is less than or equal to 40% (Da Costa et al., 2003 ; Rozmus et al., 2005). The risk of thrombosis does not differ for pacemakers and implantable cardioverter-defibrillators. Preventive measures may be necessary (platelet aggregation inhibiting drugs or anticoagulation therapy).

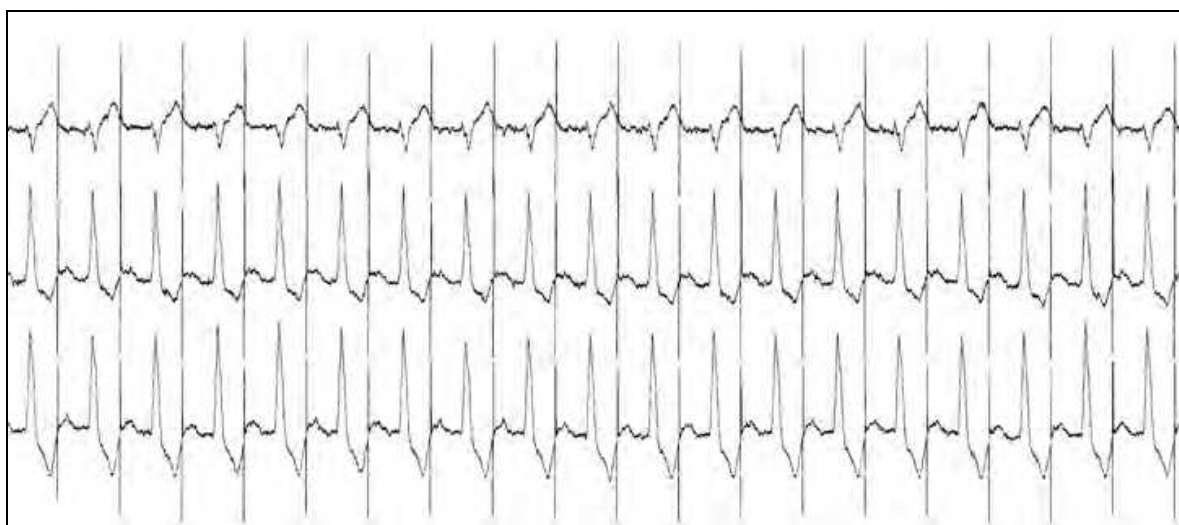
A 75 year old male is admitted for repeated fainting caused by major sinus dysfunction as shown by a 24 hour Holter monitor which revealed pauses of up to 8 seconds and paroxysmic atrial fibrillation. Medical history was negative and patient was on no current treatment. EKG at rest showed a sinus rhythm with a frequency of 68 bpm and normal repolarisation. A physiological pacemaker is implanted in the operating room. After the intervention, the patient feels palpitations and an EKG recording shows probable pacemaker-mediated tachycardia (Figure 12). Programming control shows a P-R sensing of 15.8 mV and 1.2 mV respectively, and threshold values for stimulation both inferior to 0.5 volts for 0.4 msec; a connection error is confirmed during threshold verification. Programming in AAI mode would result in VVI pacing, and programming in VVI mode would result in AAI pacing. Re-intervention allowed the correction of this connection error.

Fig. 12. Tachycardia due to an error in the connection of the atrial and ventricular leads. We note the same QRS configuration as with VVI pacing from the apex.

**Comments:** Atrial and ventricular lead connection errors are rare at implantation, but have already been documented (Barold et al, 2010). Programming verification allows rapid detection of the switch ("green wire on the green button and red wire on the red button"). A control of the programming of a stimulator is mandatory before patient discharge. It

allows detection and correction of such an error, as well as early detection of a lead displacement. Different types of tachycardia are to be excluded:

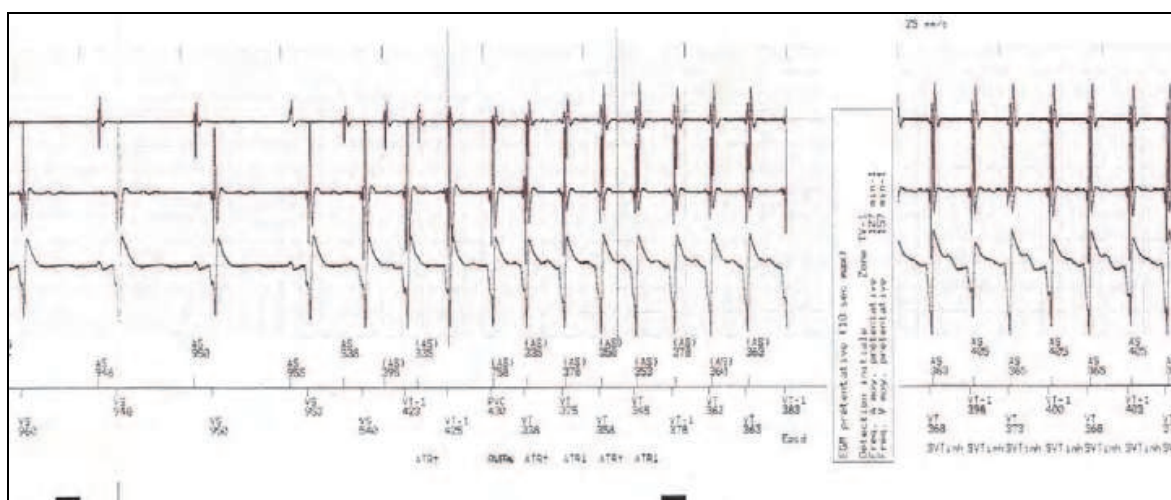
- figure 13 shows the initiation of the common type (slow-fast) of atrioventricular nodal reentrant tachycardia ; this is a typical example where the arrhythmia is triggered by an atrial extrasystole which blocks the rapid pathway of the atrioventricular node and allows flow through the slow pathway and thus initiation of the supraventricular tachycardia circuit

Fig. 13. Baseline rhythm strip showing atrial, ventricular and shock intracardiac electrogram leads, and marker atrial and ventricular channels. This is an example of initiation of common atrioventricular node reentrant tachycardia; see text.

- radiofrequency ablation is the treatment of choice.
- Other reentrant tachycardia includes
  - atrial flutter
  - orthodromic circus movement tachycardia using an accessory pathway in the retrograde direction and the AV node in the anterograde direction (concealed or not, in the Wolff-Parkinson-White syndrome)

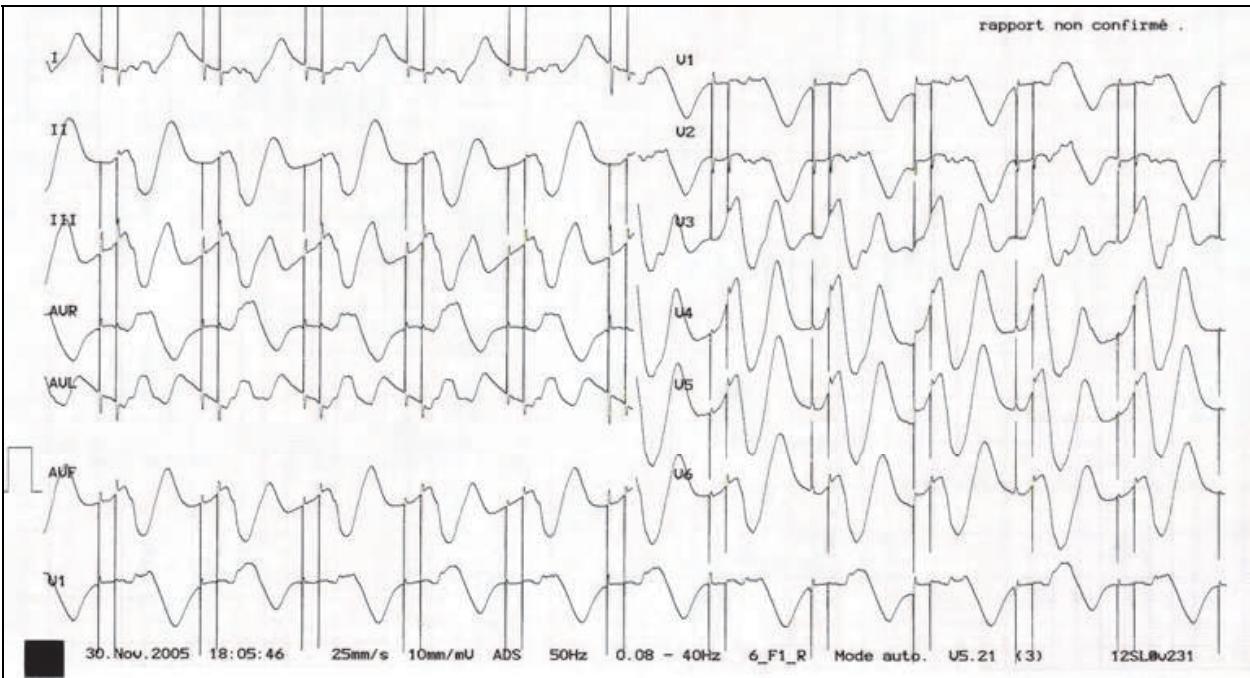
A man aged 65 with history positive for high blood pressure, diabetes and renal failure actually undergoing haemodialysis receives a pacemaker for complete atrioventricular block with syncope. His treatment includes ramipril, aspirin and insulin. No immediate post-operative complications occur. Just before a haemodialysis session a few days later, the patient complains of feeling faint. An EKG shows evident signs of hyperkalemia (very wide QRS complexes with tall peaked T waves and obliteration of the ST segment, as well as a long PR interval) and of double chamber stimulation without atrial or ventricular captures (Figure 14). Blood work-up confirms severe hyperkalemia (potassium 7.8 mEq/L). The atrioventricular underdetection and the absence of capture are caused by the high level of potassium and corrected as soon as kaliemia is normalised by haemodialysis.

Fig. 14. Twelve-lead EKG showing signs of hyperkalemia and defiant AV detection and stimulation.

**Comments:** Causes of atrioventricular underdetection and failure to capture are shown in table I. Hypokalemia is another cause of life-threatening undersensing (de Meester et al, 1996). Correction of the cause is essential for adequate pacemaker function. The risk of triggering ventricular fibrillation, due to a ventricular stimulation during the vulnerable T wave period (R-on-T phenomenon), is present, as is present in asynchronous VOO stimulation or the use of a magnet (Oupadia et al., 1998).

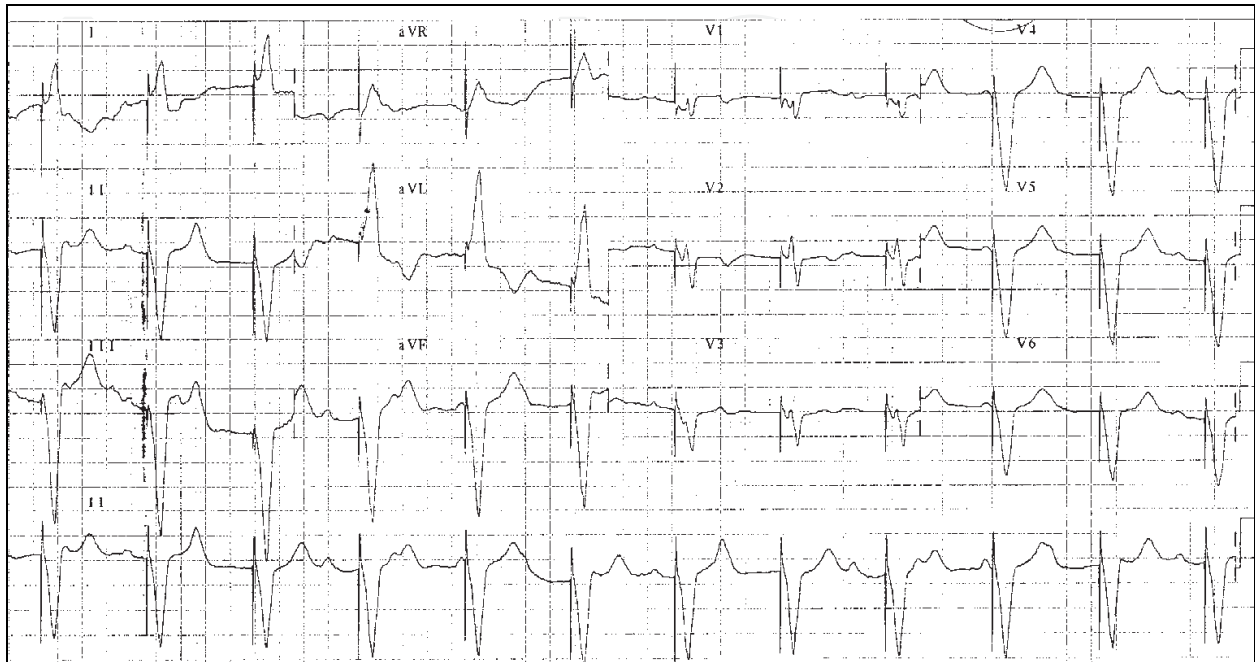
A 68 year old patient was admitted for class III dyspnoea according to the New York Heart Association (NYHA) score and repeated episodes of malaise since implantation of a single chamber pacemaker in another centre. Her personal history is positive for hypertension and sick sinus syndrome with atrial fibrillation associated with a slow ventricular rhythm and pauses of more than 8 seconds, hence the indication for cardiac pacing. Her treatment is comprised of ramipril, amlodipin and an oral anticoagulant, (acenocoumarol). Clinical

examination is unremarkable. Blood pressure was 130/80 mmHg. Twelve-lead EKG shows regular ventricular stimulation at 70 beats per minute, and a basal sinus rhythm. Dissociated P waves are seen (Figure 15). Pacemaker syndrome is suspected, and confirmed. The pacemaker was reprogrammed to VVI 30 bpm to avoid deleterious ventricular stimulation in this patient.

Fig. 15. Twelve-lead EKG showing a dissociated sinus rhythm with right ventricular stimulation.

**Comments:** This is not a veritable implantation complication but the erroneous choice of a single chamber pacemaker whereas a physiological (or double chamber) stimulator would have avoided the problem. Pacemaker syndrome is described as a combination of symptoms evoking cardiac failure and hypotension in a patient with a cardiac stimulator (Chalvidan et al., 2000). It is caused by the loss of atrioventricular synchronism leading to a drop in cardiac output, elevated atrial pressure and hypotension. The Mode Selection Trial (MOST) investigators defined pacemaker syndrome as occurring if either one of two different criteria occurred (Link et al., 2004). The first criterion was new or worsened dyspnea, orthopnea, elevated jugular venous pressure, rales, and oedema with ventricular (VA) conduction during ventricular pacing. The second criterion was symptoms of dizziness, weakness, presyncope, or syncope, and a >20 mmHg reduction of systolic blood pressure when the patient had VVIR pacing compared with atrial pacing or sinus rhythm. Its incidence is 7-20% of stimulators in VVI mode with a sinus rhythm. Pacemaker syndrome can also be seen in AAIR mode and in double chamber modes (VDD, DDI, DDD) if the stimulator if programming is sub-optimal or the stimulation mode is incorrectly selected. Dyspnoea should, besides pacemaker syndrome, evoke:

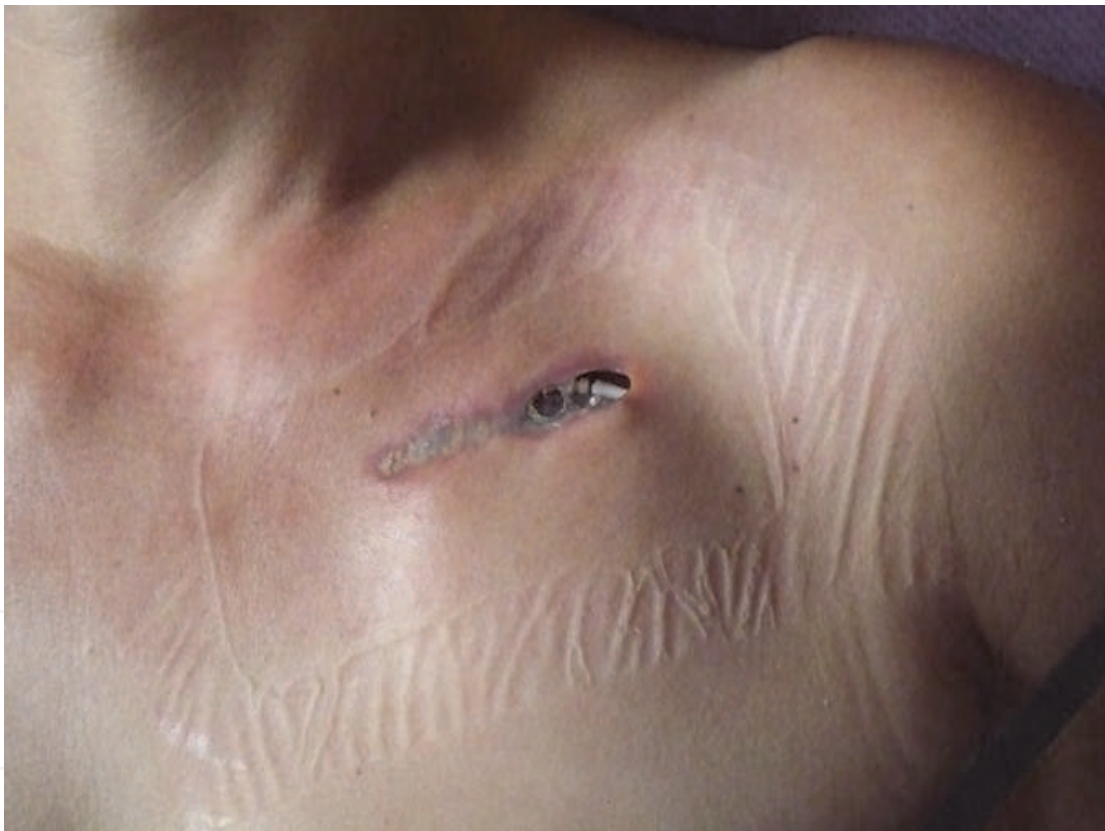
A 45 year old female patient suffering from idiopathic congestive cardiomyopathy with a left ventricular ejection fraction of 35%, class III dyspnoea on the New York Heart Association (NYHA) scale, left bundle branch block morphology, with a QRS duration of 175 msec, on EKG and under optimal medical treatment for over three months receives a pacemaker with left ventricular resynchronisation. Implantation was complicated immediately by left ventricular lead displacement. A Starfix Attain OTW 4194 (Medtronic Inc., Minneapolis, MN, USA) was necessary for stability (The Attain Starfix's design includes three soft, polyurethane lobes near the lead tip that, when expanded, enable stable lead placement in the target location) (de Meester, 2010). After one month, the implantation site becomes suppurative (Figure 16). Local wound care and 10 day antibiotherapy did not help. Bacteriological studies revealed the presence of *pseudomonas aeruginosa*. Treatment required complete ablation of the material and prolonged antibiotherapy. Re-implantation on the counter-lateral side in this case was performed two months after the end of the antibiotic course.

Fig. 16. Photograph showing suppurative wound with visible pacemaker leads. Ablation of all material was necessary.

**Comments:** Suture or pocket infection is not a rarity during the first month and incidence is estimated to be 1% (del Rio et al., 2003 ; Klug et al., 2007). Principal risk factors are re-intervention, diabetes, old age, corticoids, operator inexperience, and renal failure. Antibiotic prophylaxis prior to pacemaker implantation has a protective effect. In the case of very early infection, a per-operative contamination by cutaneous flora (*staphylococcus aureus*) is the principal source of infection (Kearney et al., 1994 ; Da Costa et al., 1998).

Successful treatment of an infected device requires removal of the entire system and administration of antimicrobials. Infection after one month usually originates from the lead (and not the pocket). Sepsis is uncommon and diagnosis includes positive blood cultures (80% of cases) and transesophageal echography showing lead anomalies. Skin erosion at pocket site and other local signs of infection are common. *Staphylococcus epidermidis* or other gram negative bacteria are most commonly found.
