Material Characterization and Failure Analysis for Microelectronics Assembly Processes

Chien-Yi Huang^{1,2}, Ming-Shu Li¹,
 Shan-Yu Huang¹, Cheng-I Chang¹ and Min-Hui Huang¹
¹*Process Technology Enabling & Materials Characterization Div. Operations,*
Wistron Corporation, Hsinchu 300, Taiwan,
²*Department of Industrial Engineering and Management,*
National Taipei University of Technology, Taipei 106, Taiwan,
R.O.C.

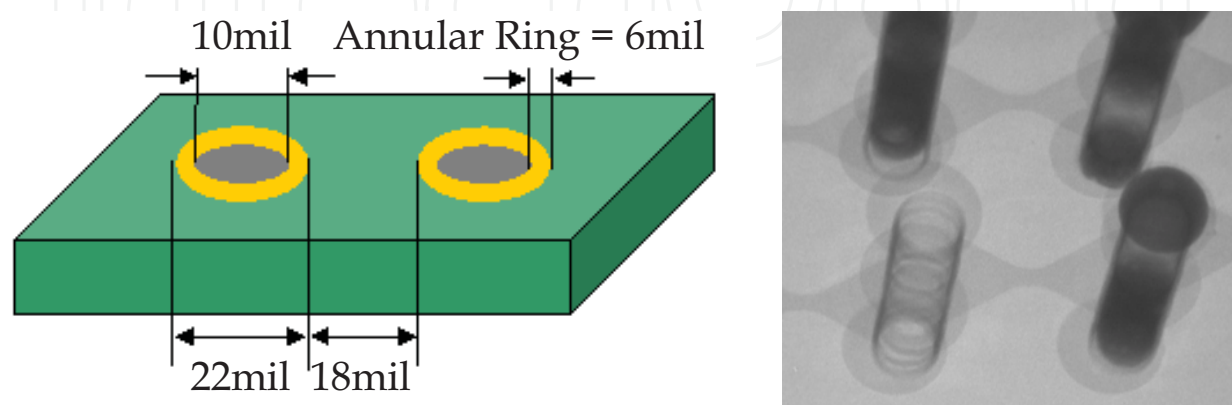
Fig. 1. PTH on the test board

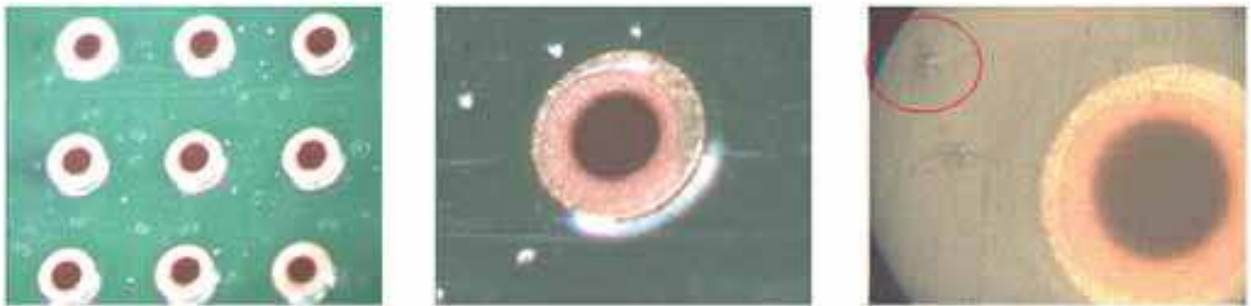
Fig. 2. Surface of the HD samples

The test boards are subjected to the Standard Inspection Process (SIP) which includes the incoming quality control (IQC) for inspection of trace, solder mask, labelling, board thickness, warpage, electrical resistance, and PTH dimension. The HD (high Tg / Dicy, HD) sample shows blisters on the board surface (Fig. 2).

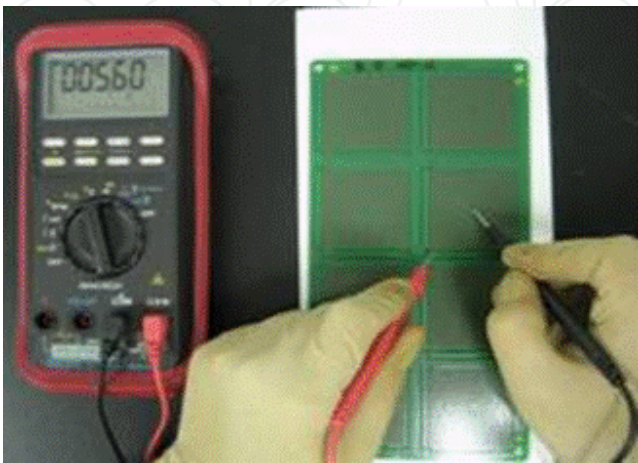
Fig. 3. Resistance measurements for the test vehicles

The meter used for measuring the resistance is correct within 0.02% (Fig. 3). The average resistances are: ND= 5.77 Ω , NP= 5.66 Ω , HD= 5.55 Ω , HP= 5.50 Ω . The normal Tg (ND, NP) material shows a higher resistance compared to the high Tg material (HD, HP). Failure is defined as: the value of resistance increased by 15%. Failed samples are then cross-sectioned for failure analysis. Samples are then subject to two tests. In the first test, heat resist-abilities of different PCB materials are evaluated. The second test involves the simulation of potential environments through thermal shock testing followed by a failure analysis.

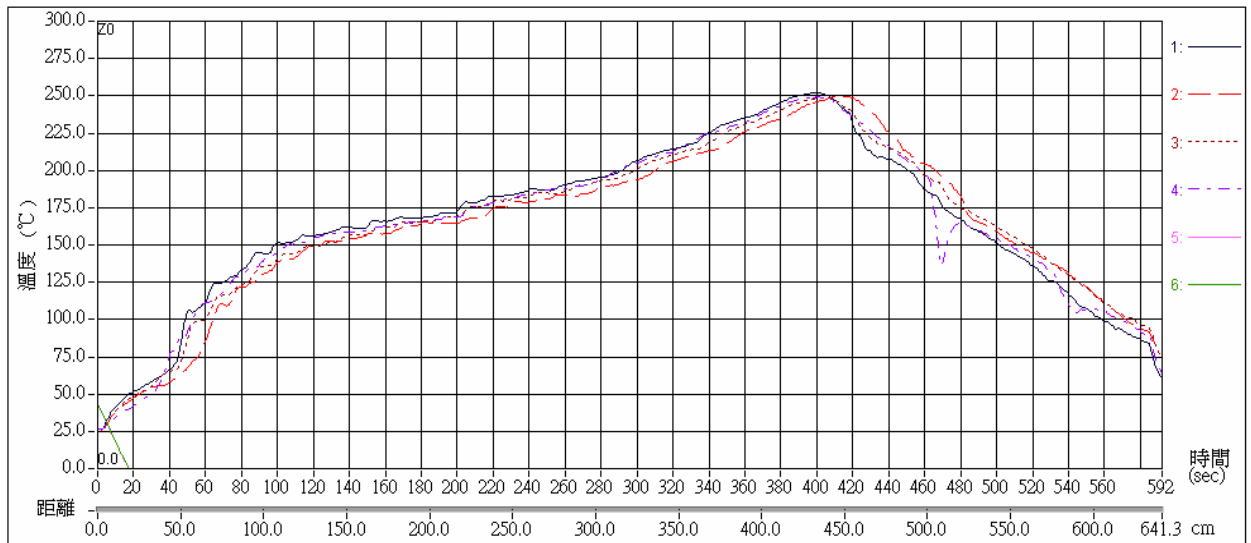
Fig. 4. Reflow temperature profile

The assembly process includes two reflow cycles (for two sided PCBs) and one wave soldering. The reflow oven has nine temperature zones. The conveyor velocity is 65 cm/min. TAL (time above liquid) is 90 s while process spec is between 40 s and 90 s (Fig. 4). The oxygen level is 350 ppm. During the wave soldering process, the conveyor velocity is 50 cm/min. The dwell time is 10 s while process spec is between 4 s and 6 s. The soldering temperature is 265°C. The preheat temperatures are 170°C, 190°C and 210°C (Fig. 5).

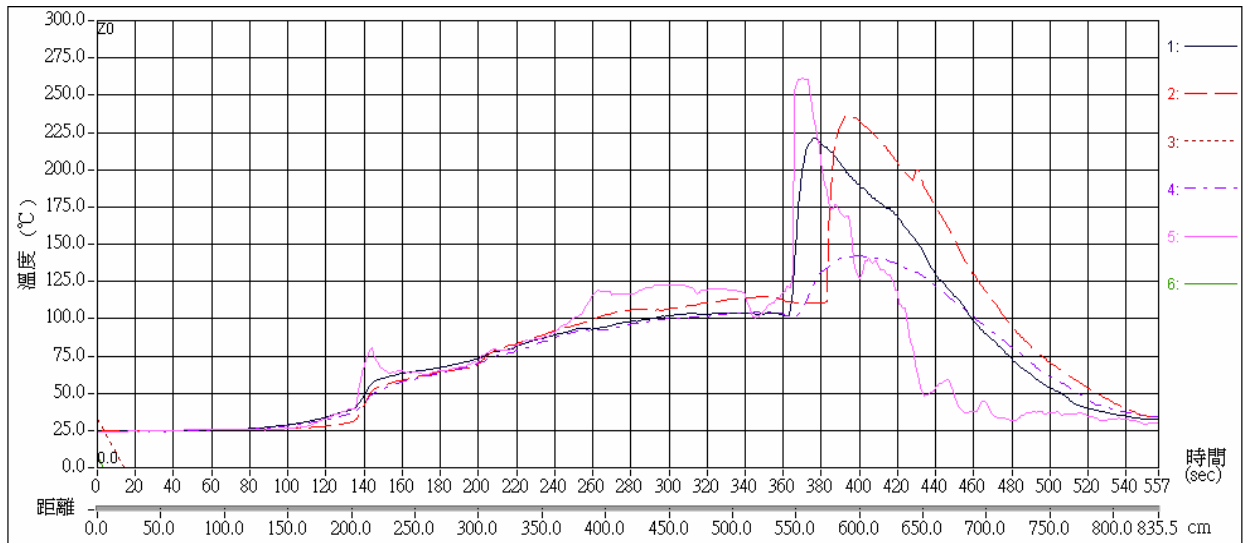
Fig. 5. Wave soldering profile

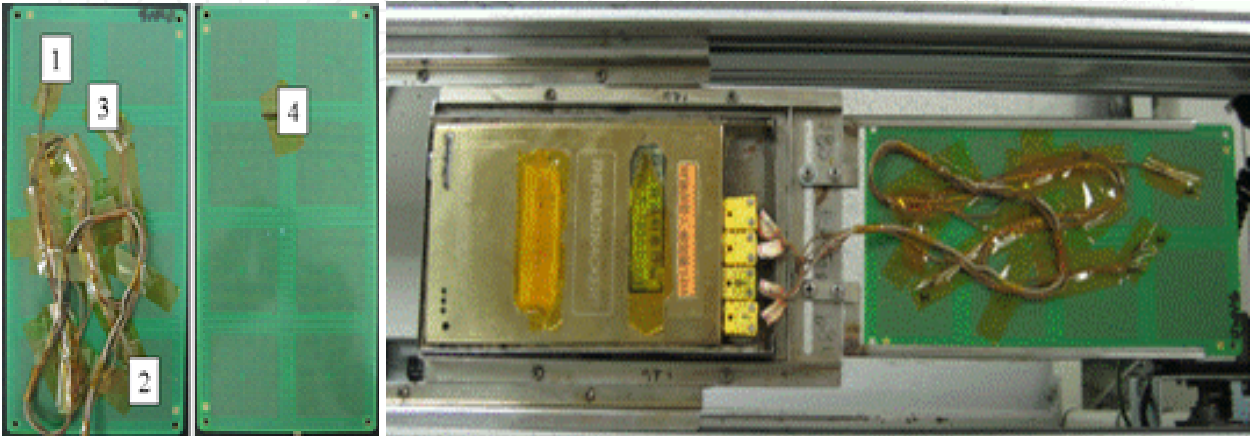
Fig. 6. Profile board and temperature recorder

A profile board is made to ensure that the desired temperature profile is achieved (Fig. 6). Thermal couples are attached at locations near the conveyor edge, the center of the oven, the PCB top side, and the PCB bottom side. The temperature variation across the board is within 10°C.

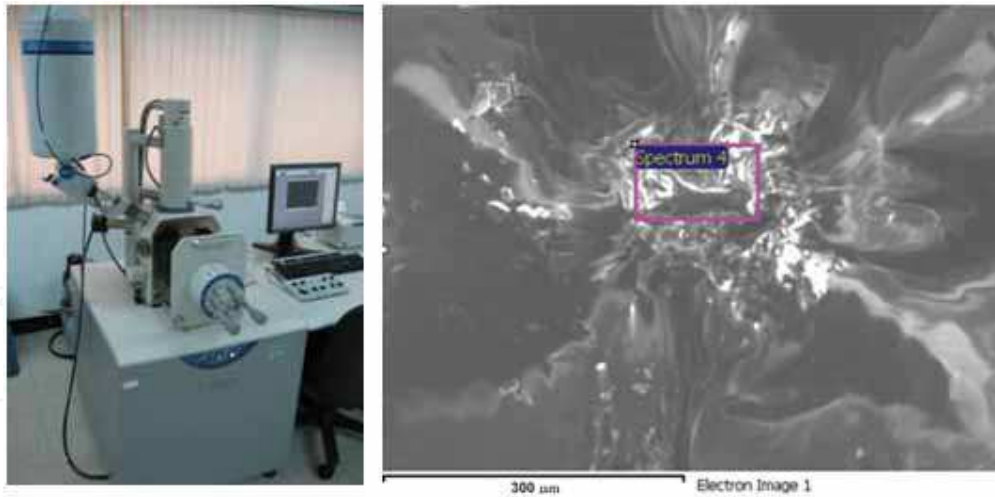
Fig. 7. SEM analysis

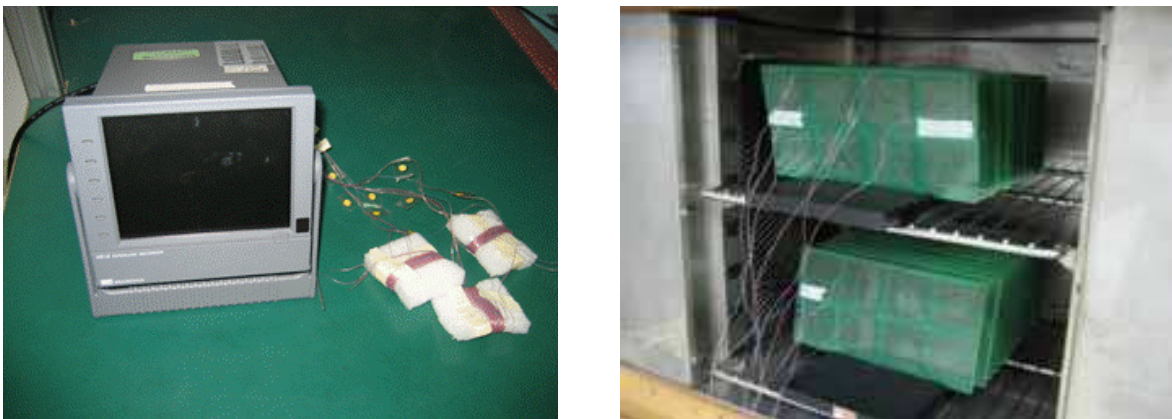
Fig. 8. Real time monitoring system

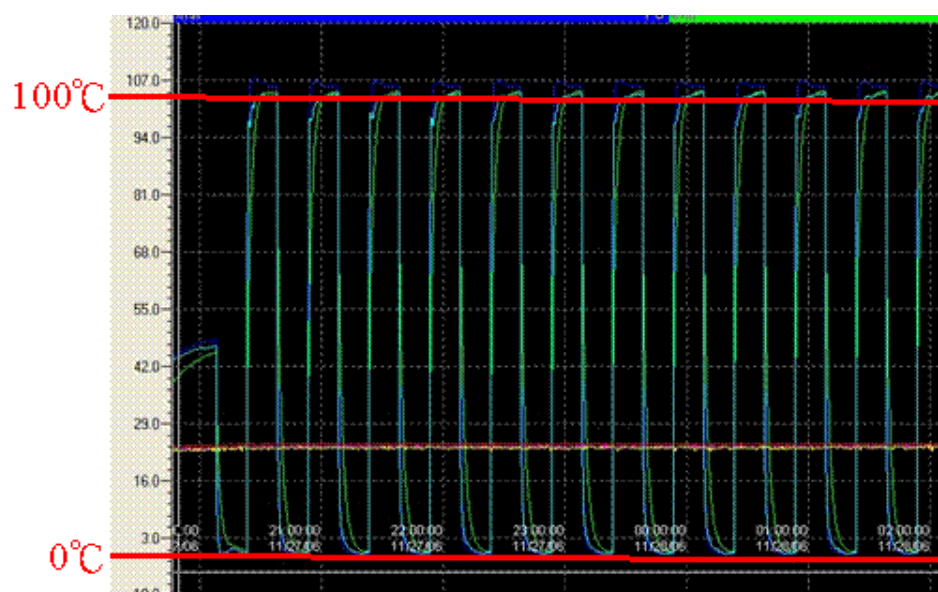
Fig. 9. Temperature profile during thermal shock test

The thermal shock test simulates the change of environmental temperatures that the electronics products may encounter during field service (Bevilacqua, 2004; Jayatilleka, 2003; Zhao, 2004). Each material is represented by a total of 48 samples (6 test boards). Samples are subject to the two reflow and one wave soldering profiles prior to the thermal shock test. The temperature ranges from 0°C to +100°C (temperature change within 3 min) and the time at both extreme temperatures is 12 min. A total of 900 cycles with real time temperature monitoring systems are used (Fig. 8). Samples are removed from the chamber after every 12 temperature cycles for resistance measurement (Fig. 9).

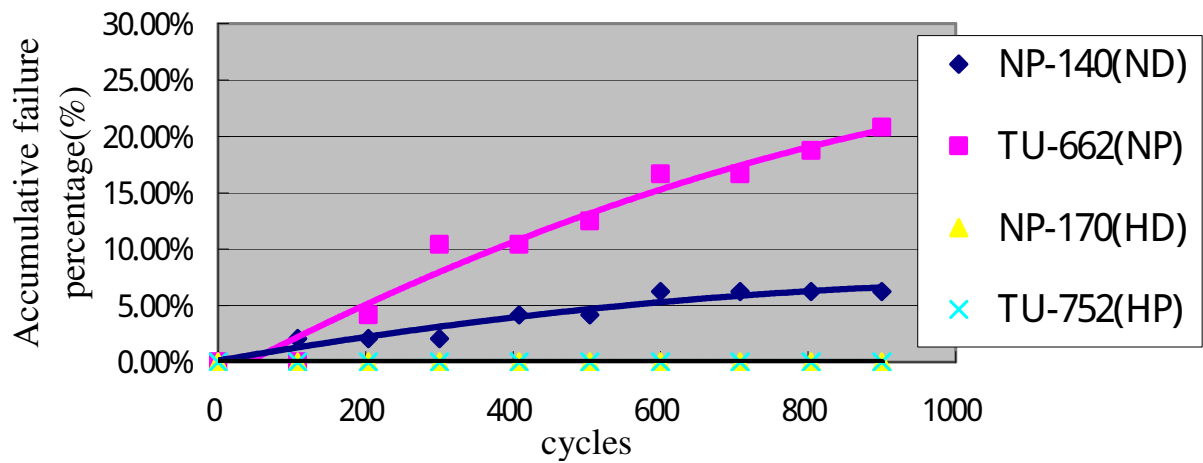
Fig. 10. Accumulative failure percentages after 900 thermal shock cycles

Solder mask cracking is the only symptom observed during the appearance check within the 900 temperature cycles. The measured resistance shows that failure only obtained in the normal Tg PCB (ND = 6.25%, NP = 20.83%). High Tg PCB shows better performance during the thermal shock test (Fig. 10). Cross-sectional analysis of the normal Tg PCB also shows that delamination and cracking occurred at the ND inner layers (Fig. 11). These defective scenarios did not occur to either Dicy or Phenolic of the high Tg PCBs.

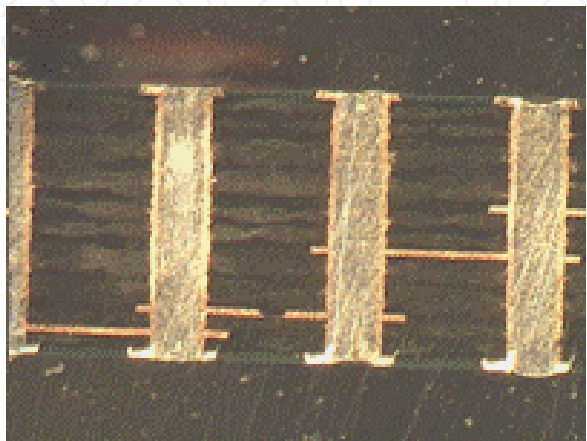
Fig. 11. Inner layers of the ND samples

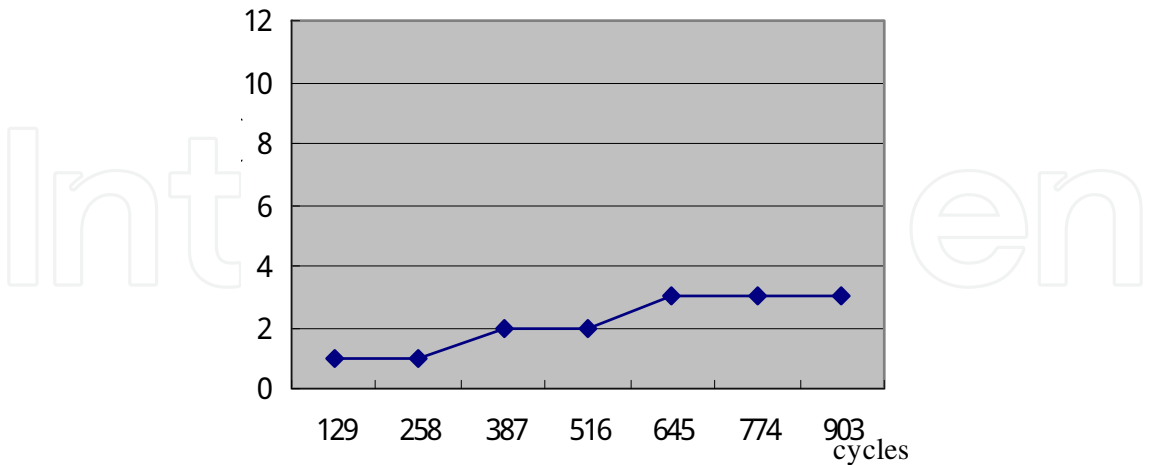
Fig. 12. Accumulative failure data for the ND PCBs

There are three and ten failed samples for the ND and NP PCBs, respectively. The accumulative failure data are shown in Figs. 12 and 13. The Weibull probability plots are used to estimate the parameters of the failure distributions (Figs. 14 and 15).

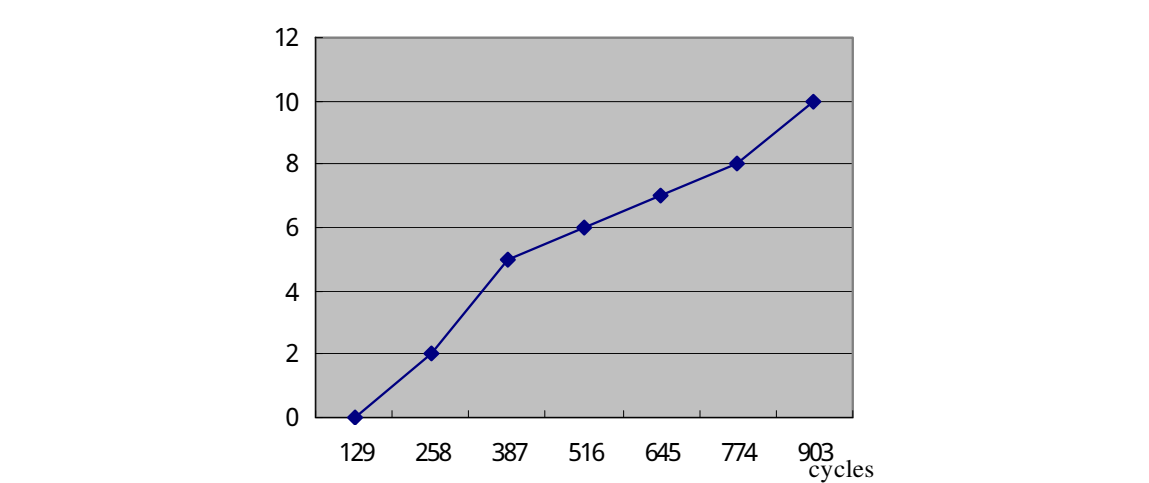
Fig. 13. Accumulative failure data for the NP PCBs

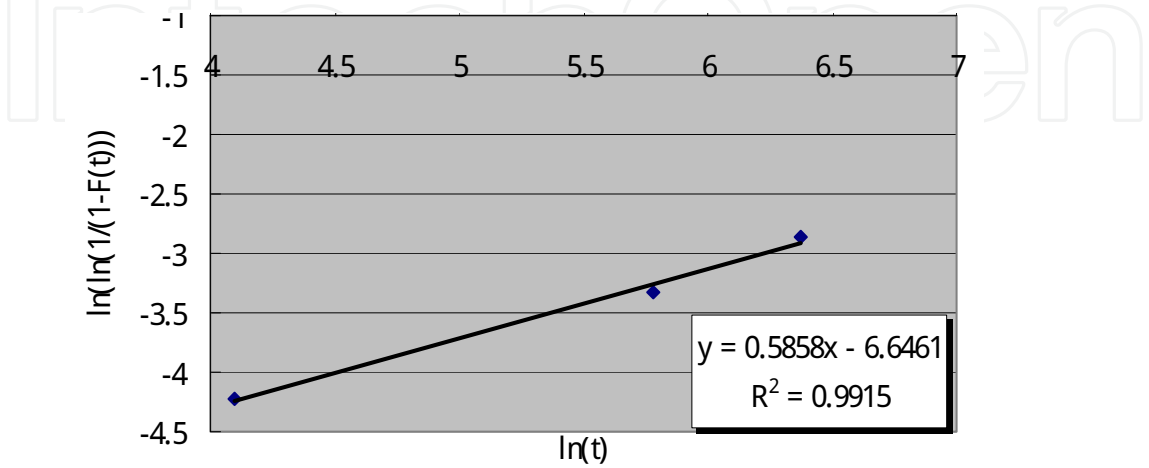
Fig. 14. Weibull probability plots of ND PCBs

The shape parameters β and characteristic life θ of the ND PCBs are found to be 0.5858 and 84570 cycles, respectively. For the NP PCBs, β and θ of the ND PCBs are 1.1955 and 2770 cycles, respectively. Through the use of Gamma function, the expected life for ND and NP PCBs are 129,027 cycles and 2,603 cycles of testing. Finally, the modified Coffin Mason formula is used to calculate the accelerated factor (AF). Assuming that the normal-use environment is within the temperature range of 25°C~40°C, and the frequency of temperature change is five, the AF is found to be 40. As a result, the expected life for ND and NP PCBs are 2,557,142 h and 51,580 h during their normal service environment.

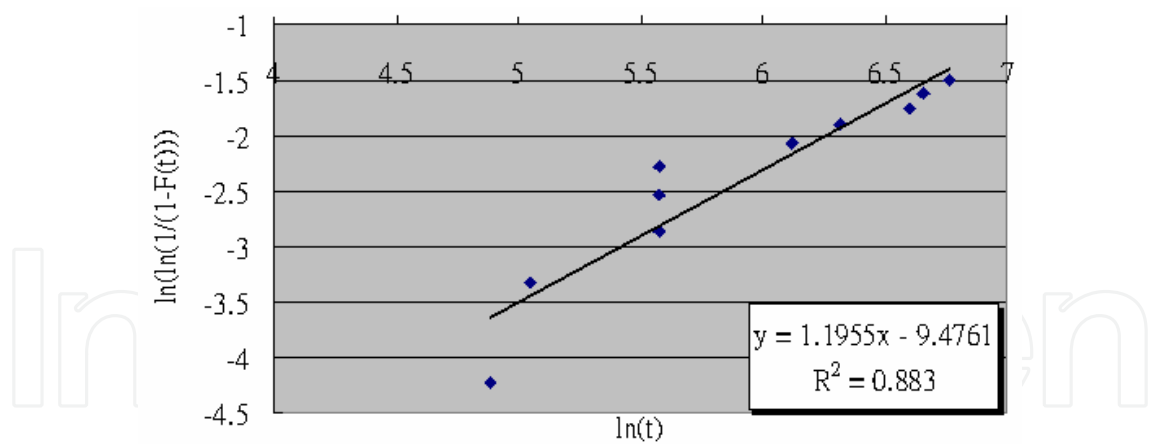
Fig. 15. Weibull probability plots of the NP PCBs

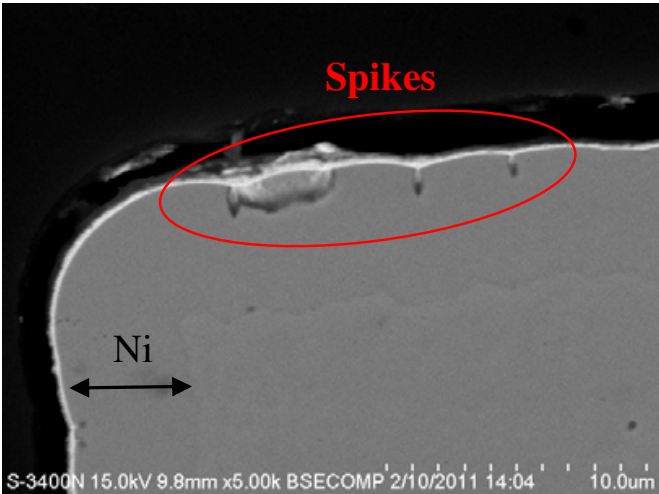
Fig. 16. Black pad symptom, cross-section view

Figure 16 presents the black pad symptom occurring on the ENIG surface finished from raw materials. Through a cross-sectional analysis using scanning electron microscopy (SEM) equipment, several spikes can be observed on the Ni layer and which have penetrated into the Ni layer around 25% of the total thickness. Based on author's experience, ENIG soldering pads with this symptom can be wetted by solder, but their reliability performance may have been decreased to one-half or one-third of its original. As it stands, there are no criteria with which to judge this symptom. A careful company usually screens out the potential risk factors through reliability tests before mass production.

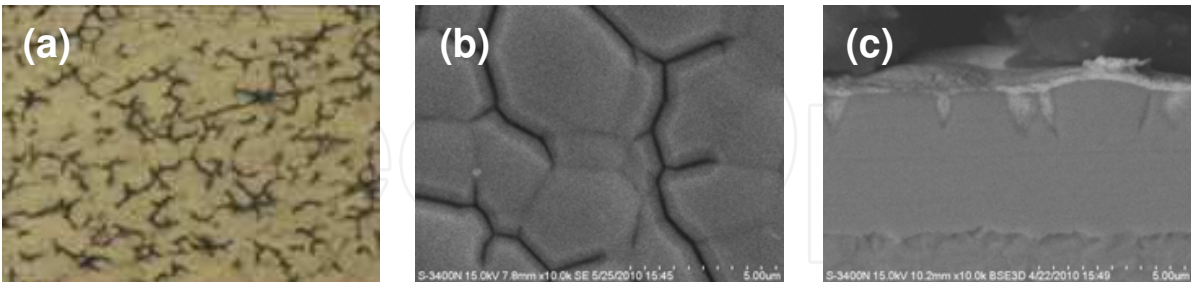
Fig. 17. (a) Plane view, Ni layer (b) plane view, Ni layer (c) cross-section view

Figure 17(a) presents the Ni surface after removal of the Au layer using a chemical etching method. Several dark lines can be seen on the Ni surface. A more detailed magnification is shown in Fig. 17(b). Compared with the cross-sectional view of raw material shown in Fig. 17(c), these dark lines were groove structured and penetrated into the Ni layer. Several studies have indicated that this symptom was caused by corrosion during the Au plating process (Bulwith et al., 2002; Xu et al., 2008). PCB vendors claim that a Ni layer without this spike symptom is not achievable. Based on the literature as well as our practical experience,

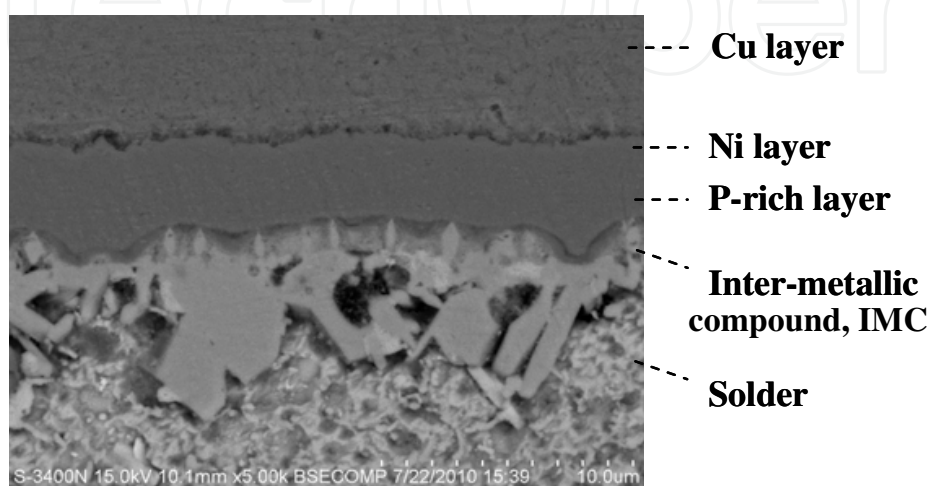
Fig. 18. Solder joint structure, cross-section view

A typical cross-sectional view of the solder joint structure is shown in Fig. 18. The microstructures from top to bottom and sides were the Cu soldering pad, the Ni layer, and the IMC layer, respectively. These spikes observed from raw material remained on the Ni layer after the soldering process. Additionally, a thin dark layer between the Ni layer and inter-metallic compound (IMC) was observed; this layer was a P-rich layer. A P-rich layer was actually developed during the Au plating process due to Ni atoms nearby. The Ni layer surface was replaced by Au atoms, but P atoms within the Ni layer did not act in the Au

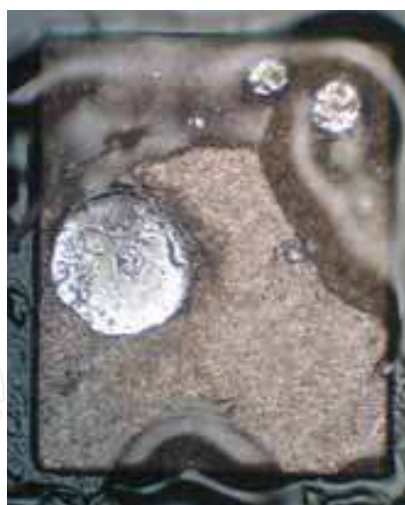
Fig. 19. Fracture appearance

Figure 20 shows a more detailed view than Figure 19. We can observe several moiré on the soldering pad. This phenomenon may be attributed to deeper spikes forming on the Ni layer during the Au plating process.

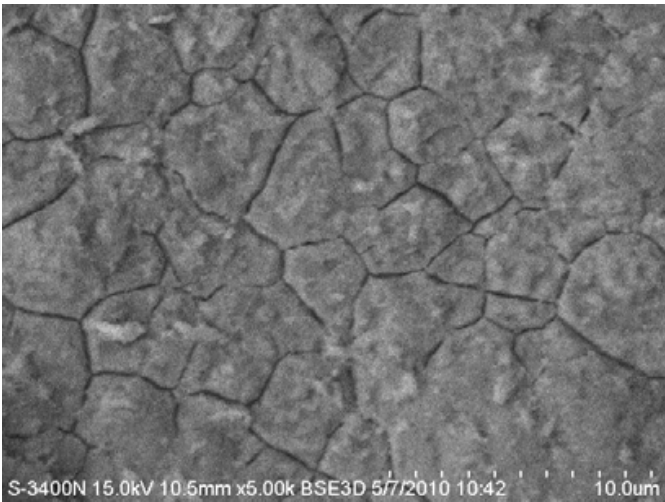
Fig. 20. Fracture morphology, SEM view (5000 x)

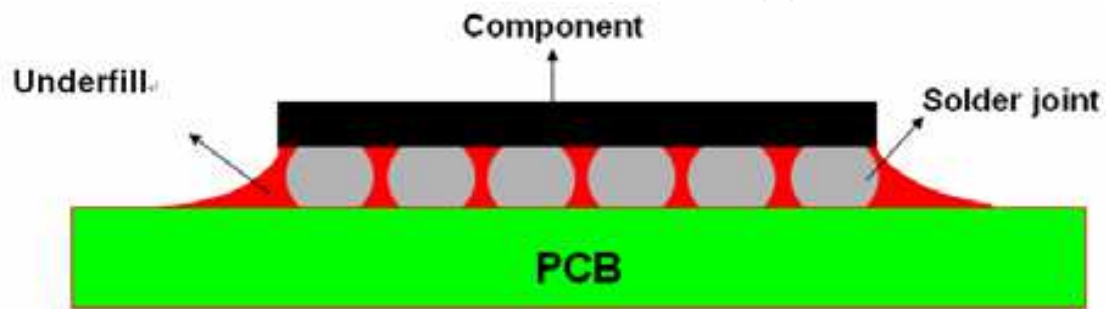
Fig. 21. Illustration of underfill enhancement

Figure 21 illustrates a method for enhancing solder joint strength. The free space between the component and the PCB were filled with an underfill material which becomes solid after the baking process. This kind of reinforced method is commonly used in PCB assembly for enhanced bonding strength in bigger components. So far, there has been no published academic research related to using underfill enhancement for improved solder joint strength when assembly plants encounter black pad symptoms. Hence, we have performed the test to understand whether underfill enhancement is suited to mitigate the influence of the black pad phenomenon. The testing component for the drop-test was prior diagnosed as the black pad symptom, and the defect rate was almost 100%. Before drop-testing, we enhanced the bonding strength for this component by pouring underfill material into the free space between the component and the PCB.

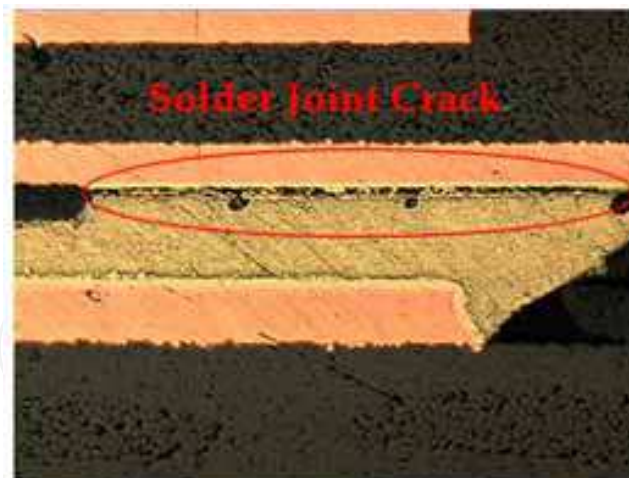
Fig. 22. Solder joint crack after drop-test

The drop-test resulted in failure; the suspected component was still attached to the PCB during drop-testing. Through cross-section analysis, we could found that the crack penetrated the entire solder joint at the component side, Fig. 22. This implied that the underfill enhancement was unable to eliminate the black pad threat.

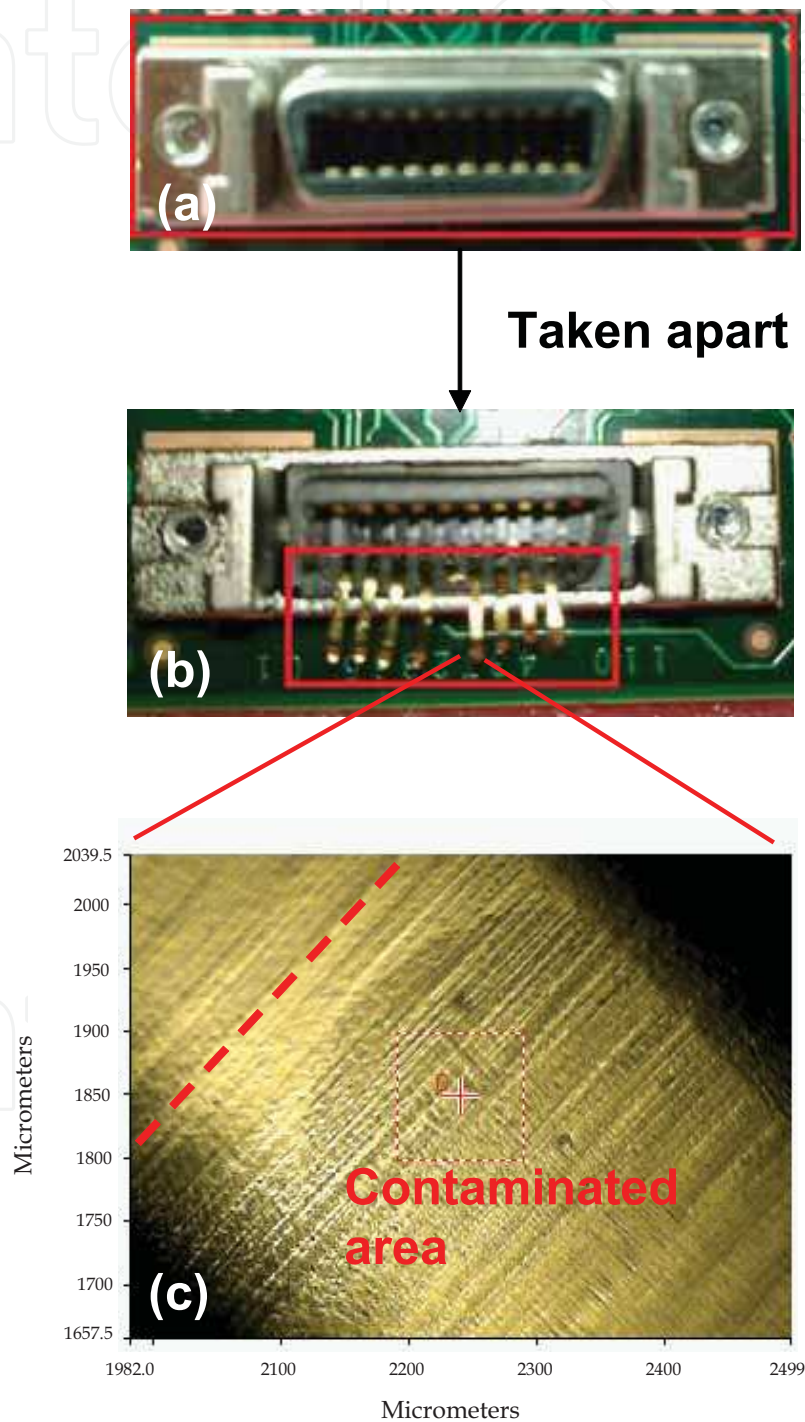
Fig. 23. JPSPK connector (a) plastic holding with metal housing, (b) pins unit, (c) contaminated area on pin for micro FTIR analysis

A failure symptom of open contact was found to the JPSPK connector of the audio station bed connector (ASBC) main board. This had resulted in in-circuit test (ICT)/automatic test equipment (ATE) testing failure after the test fixture was attached (or during the basic electric conduction and functional tests). The failure rate for the connector test is about 15%. The connector pin unit can be dislocated from the plastic holding and metal housing (outer layer), as shown in Figs. 23(a) and (b). The appearance observation by OM and CCD shows severe residues on the connector pins. This also indicates the obvious difference in color between the clean and the contaminated areas in Fig. 23(c).

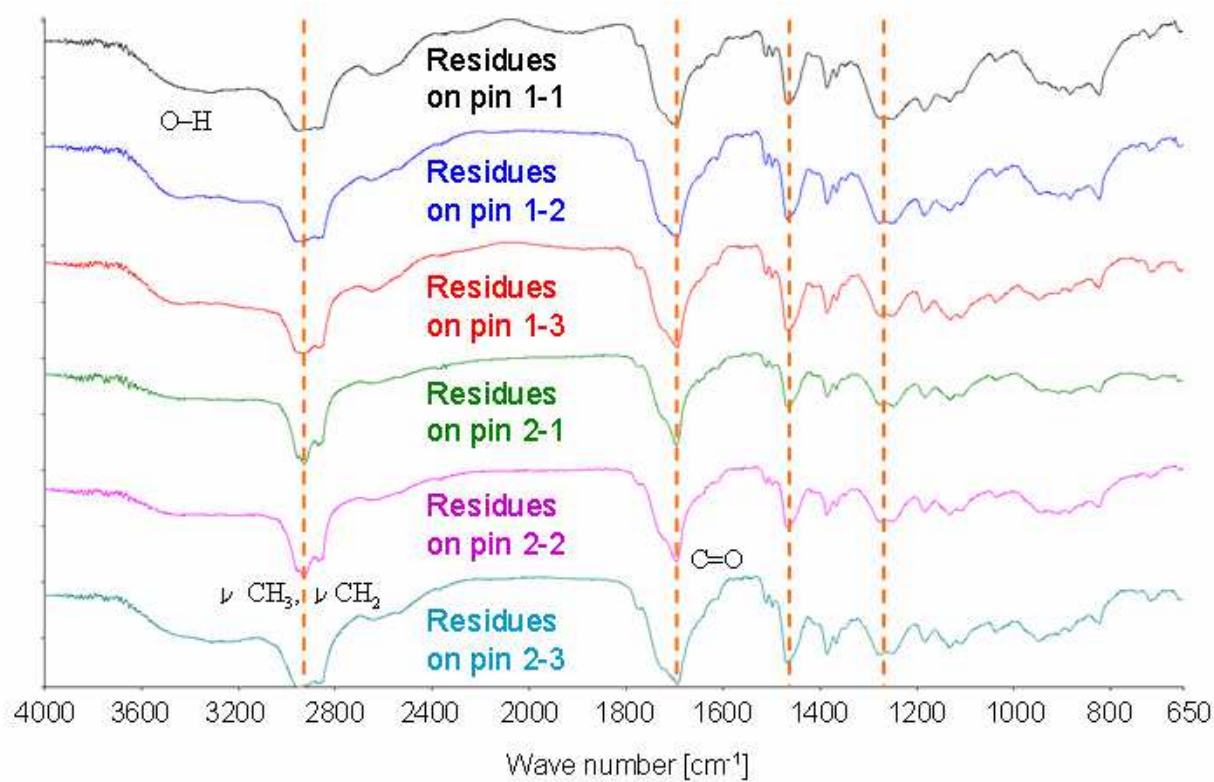
Fig. 24. Micro FTIR spectra of the contaminated connector pin 1 and 2 from different locations (marked dash -1 to -3)

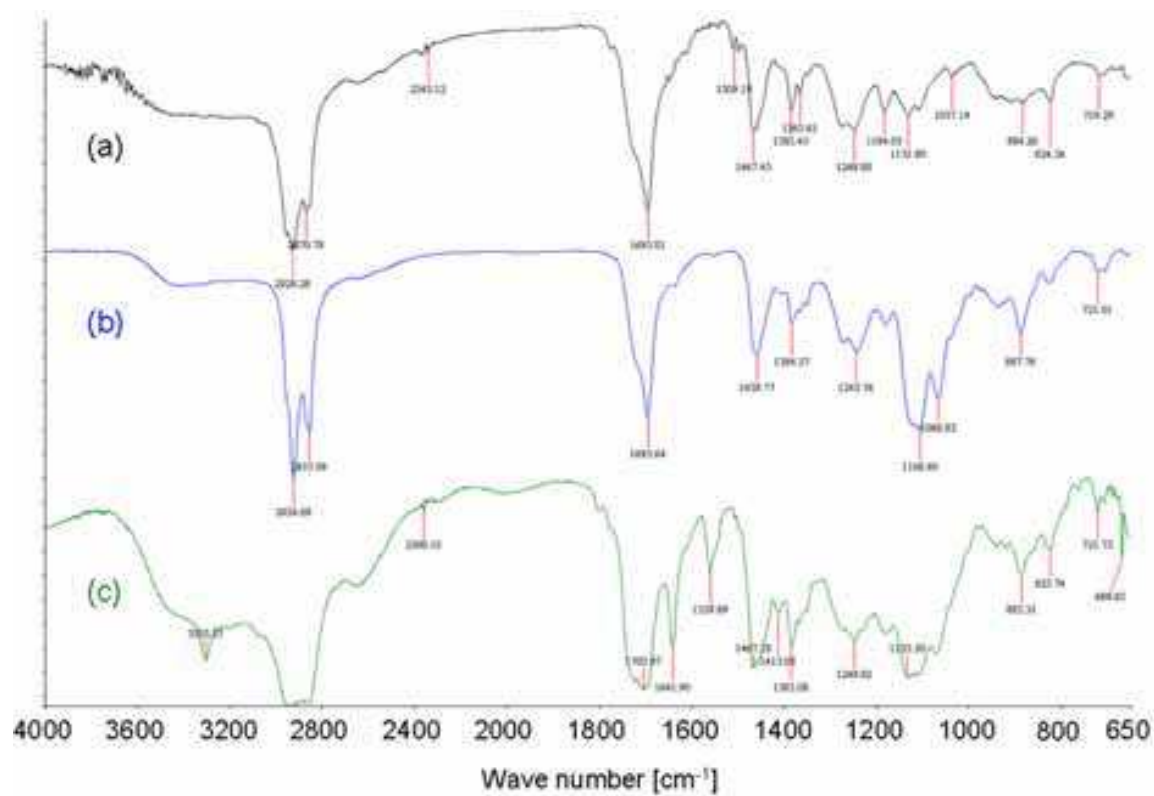
Fig. 25. Micro FTIR spectra of the (a) contaminated connector pin, (b) paste P1, and (c) paste P2

Two different solder pastes (a sticky mixture of powdered solder and flux) were used in reflow soldering during the assembly process, namely paste P1 and P2, respectively. Contrary to metal solders, organic fluxes have the absorption characteristics of molecules with respect to IR radiation. After comparing with the FTIR spectra database, the spectra of the contaminated areas seem to be consistent with that of the paste P1 in Figs. 25(a) and (b)

(sorted by the similarity of chemical structures). Their characteristic functional groups appeared at the same absorption peaks. The paste P2 showed similar structures, but showed few differences compared with the paste P1 (Fig. 25(c)). This suggests that the residues on the connector pins are attributed to the flux from the solder paste used in the assembly processes. Therefore, the micro FTIR was found to be an effective tool to identify the root cause of the micro residue left on the connector pins (Huang et al., 2009).

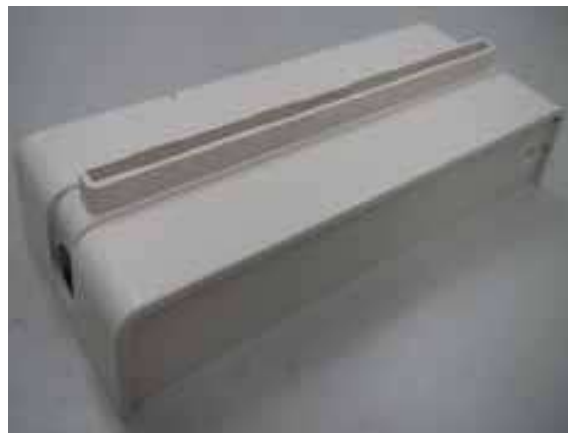
Fig. 26. The appearance of the plastic housing

Incoming quality control (IQC) and supplier quality management (SQM) found that the suspected spray-painted plastic housings had mixed in, with the raw materials, primary colors. The defect rate is about 6% for this discoloration issue after sorting. The suspected housings presented darker surfaces than the normal incoming conditions. It is difficult to recognize the difference in color between the two kinds of housings through visual inspection. Therefore, an instrumentation analysis was applied to help confirm the properties and compositions that caused the cosmetic variation. An FTIR analysis was performed to investigate the chemical structures and compositions from the housing surfaces. It is important to find out whether improper or unnecessary processes were done for the incoming materials. Clients usually attach great importance to the surface textures and dispositions of their products. The appearance of the plastic housing is shown in Fig. 26.

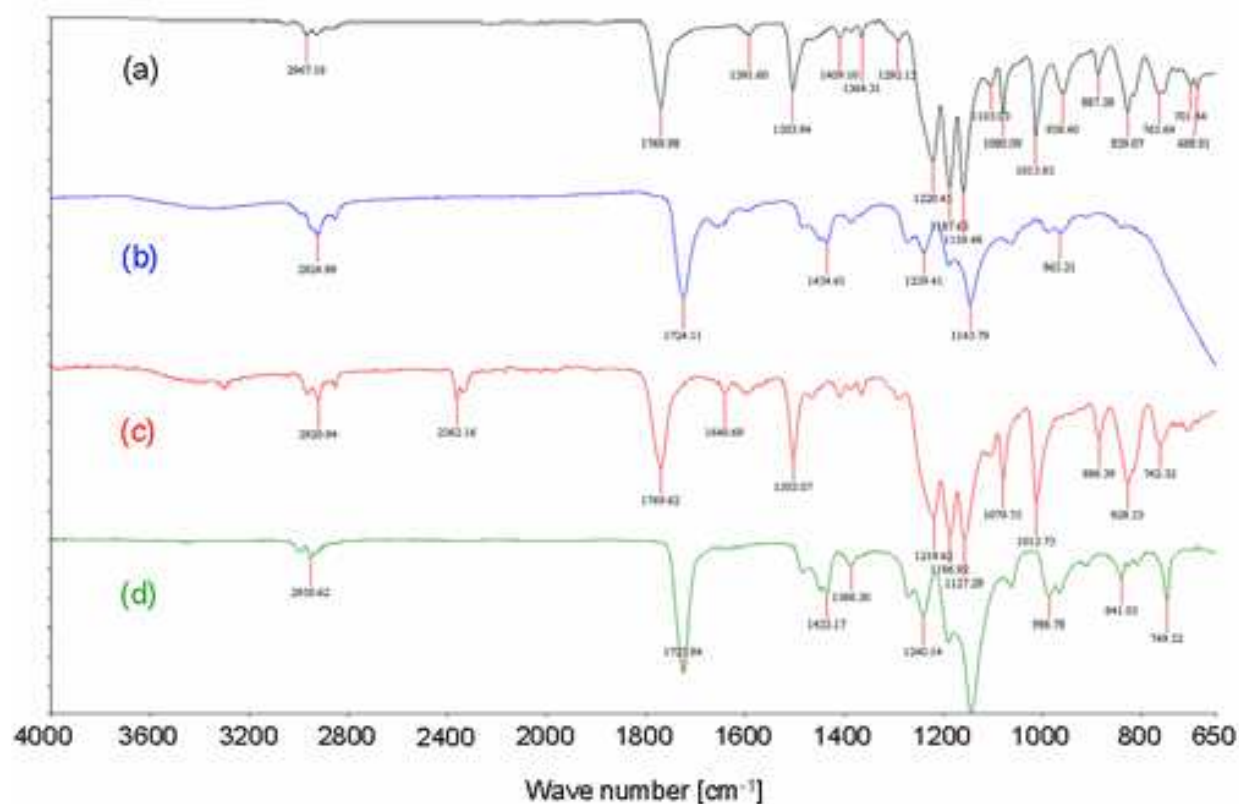
Fig. 27. FTIR spectra of the (a) raw plastic housing surface, (b) suspected spray-painted plastic housing surface, (c) PC (polycarbonate), and (d) acrylic ester

The FTIR spectra under analysis with ATR mode from two different plastic housing surfaces are shown in Fig. 27. IR analysis was carried out at three adjacent locations for each surface to confirm the uniformity of the chemical structures. This showed very similar results from the various locations. The spectra were then compared to the FTIR built-in standard database (Fig. 27). The raw plastic housings with primary colors showed a bright surface and consistent spectrum (chemical structures) with PC (polycarbonate). The spray-painted plastic housings showed a little dark surface and consistent spectrum with acrylic ester.

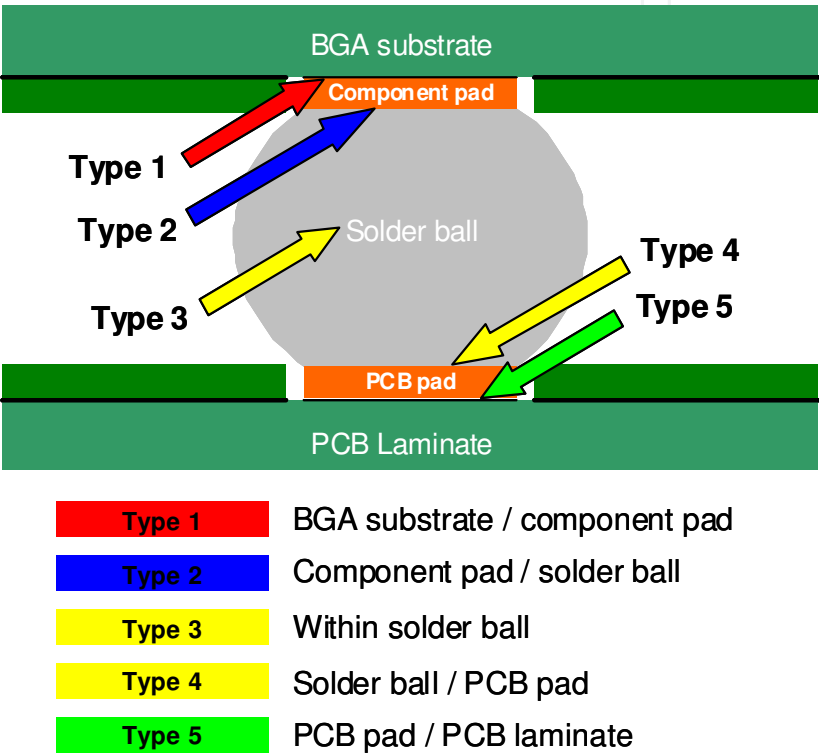
Fig. 28. Failure mode classification for a solder joint

The failure mode of a solder joint can be classified into five types, as illustrated in Fig. 28. Type 1 indicates that the fracture is between the BGA substrate and the component pad. Type 2 shows that the fracture is between the component pad and the solder ball. Types 3 and 4 both show that the fracture is within the solder ball and the solder ball/PCB pad, respectively. A fracture between the PCB pad and the PCB laminate indicates Type 5. The magnitude of the dye penetration for each solder ball shows the degree of the crack propagation and can be classified into four types. Type A is such that the magnitude of dye penetration for a solder ball is below 25%. Type B falls between 26% and 50%. 51% to 75% indicates Type C. Type D has over 76% dye penetration.

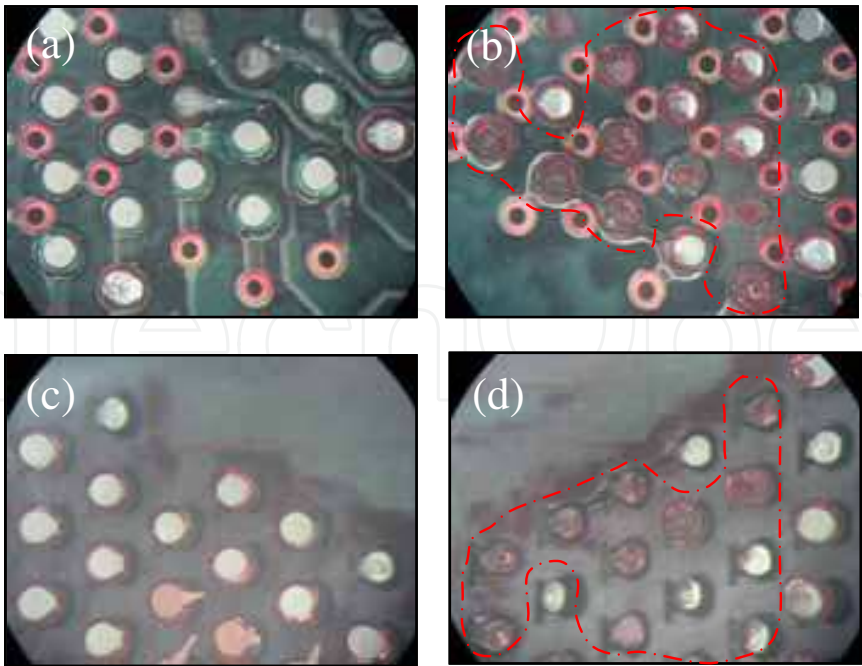
Fig. 29. Optical picture of (a) PCB pad side of 1st corner (b) PCB pad side of 2nd corner (c) component BGA side of 1st corner (d) component BGA side of 2nd corner after dye staining process

Figure 29 is an optical picture taken after the dye staining process. In order to accurately interpret the dye staining results, two photos from the PCB pad side and component BGA side are compared together to find out the right failure mode of the dyed areas. For example, Fig. 29(a) corresponds with Fig. 29(c). Dye propagation and magnitude from both sides provide the main judgment criteria regarding whether cracks occur. Following the dyeing process, the failed solder joints are identified and the failure mode classification can be defined.

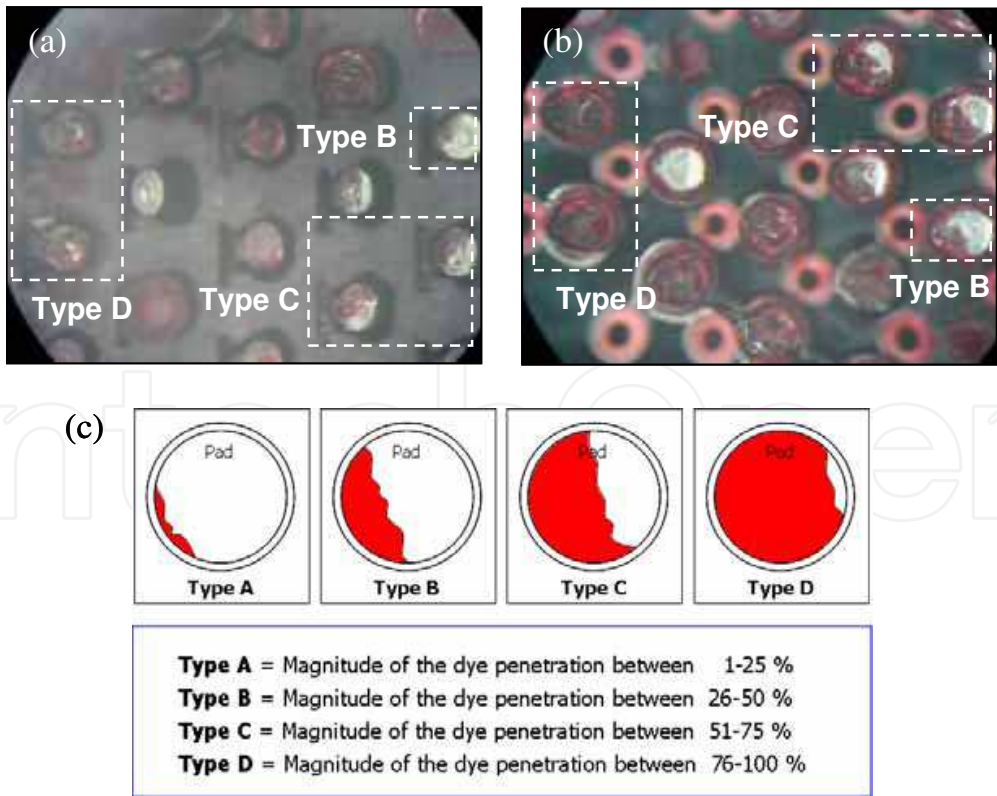
Fig. 30. (a) Enlarged picture of PCB pad side of 2nd corner (b) enlarged picture of component BGA side of 2nd corner (c) the classification of magnitude regarding dye penetration for each solder balls (crack size)

Figs. 30(a) and (b) are enlarged photos showing several failed solder joints. The failure mode of these solder joint cracks is between the component pad and the solder ball, which is Type 2, based on the classification of failure mode. Figure 30(c) shows the classification of the magnitude of the dye penetration. With respect to the magnitude of the dye penetration, Types B, C, and D of high percentage crack sizes can be seen in the photos indicating severe solder joint cracks occurring after a slight variation to the ICT fixture.
