Seismic Potential Improvement of Road Embankment

Ken-ichi Tokida
Osaka University
Japan

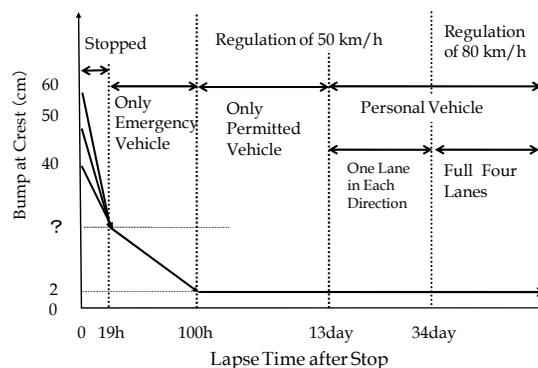
Fig. 1 shows the time history just after the main shock occurrence for opening Kanetsu Highway and Hokuriku Highway which were stopped mainly by the damages relating to not the bridges but the embankments to the emergency vehicles such as ambulances etc. and the public cars. It can be seen it took about 13 days to open the highways for the personal vehicles under the speed regulation. As mentioned above, we can realize the importance of seismic design and reinforcement for road embankments in the future.

Fig. 1. Recovery of traffic performance after stopping caused by earthquake

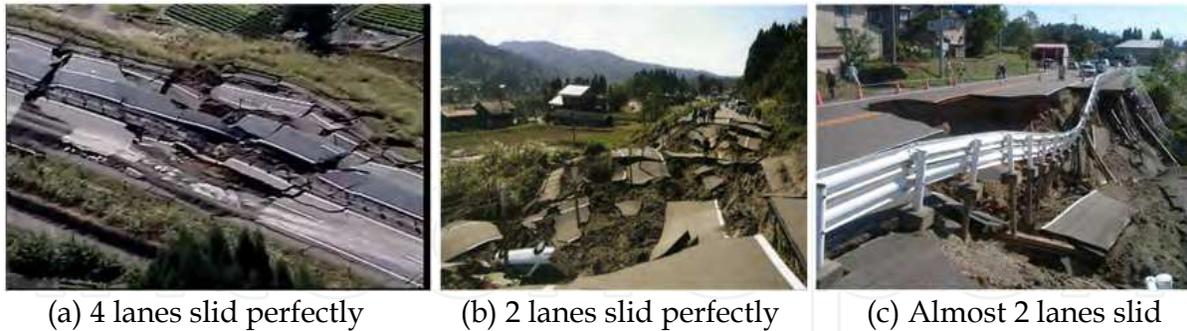
The typical examples of severe or large-scaled damages and slight or small-scaled damages of road embankments can be shown as Photo. 1 and Photo. 2, respectively. The former indicates three examples, i.e. (a) very severely damaged site reported by Higashi Nippon Highway Co. Ltd. where all 4 lanes were slid perfectly, (b) severely damaged site reported by Hokuriku Regional Bureau of Ministry of Land and Transportation where all 2 lanes were slid perfectly and (c) a little severely damaged site also reported by Hokuriku Regional Bureau where almost 2 lanes were slid partially and each traffic performance was lost perfectly. While, the latter indicates two examples, i.e. (a) partially slid site also reported by Hokuriku Regional Bureau where the sliding occurred only at the shoulder of the embankment and was retrieved easily with large-scaled sand bags as shown in Photo. 2, and (b) cracked site reported by Higashi Nippon Highway Co. Ltd. where only the shoulder was cracked a little and dump trucks can run without urgent retrieval, then their loss of traffic

Photo 1. Large-scaled damage of road embankment without traffic performance

Comparing the severe damage of road embankment shown in Photo. 1(b) with the slight damage shown in Photo. 2(a), it can be hinted to control the position of the sliding plane occurred not to reach to the traffic lane, then to keep the traffic performance at a certain level just after an earthquake. This fundamental design concept was proposed by Tokida et al. (2007) and named "Sliding Failure Control Method". The control of the sliding failure aims to change the position of sliding plane and/or to decrease the sliding displacement occurred during earthquakes not to disturb the traffic performance perfectly. Furthermore, as shown in Fig. 5, four specific design concepts such as "Crest Reinforcement Structure", "Barrier Reinforcement Structure", "Artificial Reinforcement Structure" and "Toe Reinforcement Structure" can be proposed to achieve the fundamental design concept. The performance of each reinforcement structure is as follows.

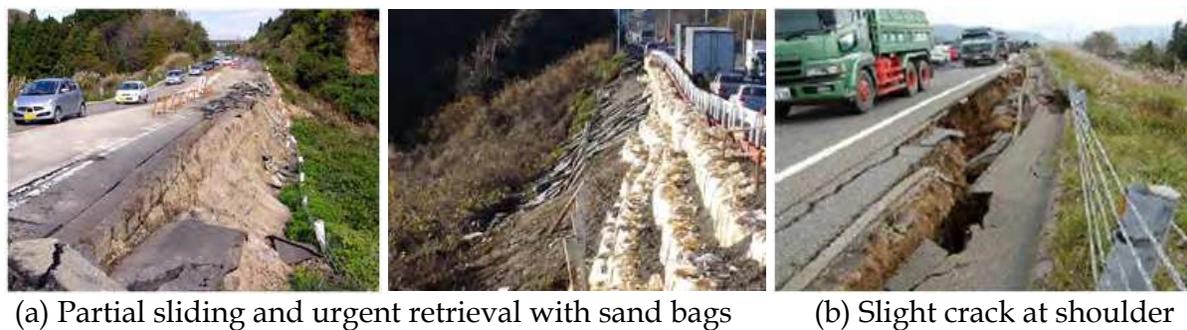
performance were small and the road could be used just after the earthquake by small-scale and short-time restoration or not.

Photo 2. Small-scaled damage of road embankment with a certain traffic performance

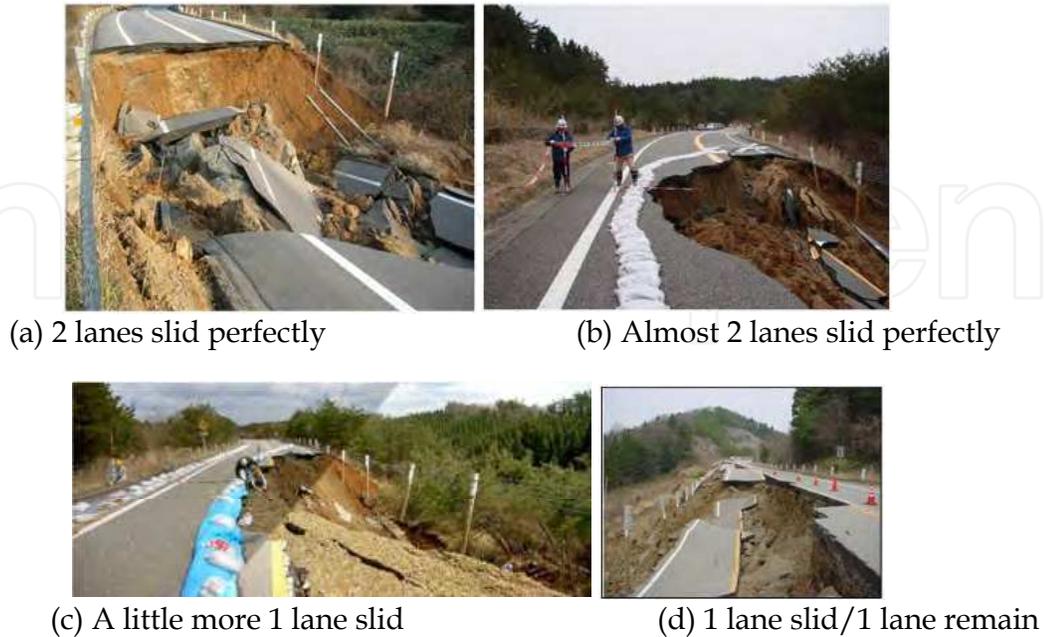
Photo.3 reported by Ishikawa Prefecture shows four examples of the slid road embankments which locate at Noto Toll Road at the mountainous area of Noto Peninsula. These photos indicate (a) severe damaged site where 2 lanes were slid perfectly, (b) severe damaged site where almost 2 lanes were slid, (c) severe damaged site where slight 2 lanes were slid and (d) severe damaged site where one side of 2 lanes slid and each traffic performance was lost perfectly.

The severe sliding damages such as Photo. 3 which resulted in the perfect stopping of traffic performance occurred at 13 sites located along the road of about 48.2 km. The site shown in Photo. 3(c) is selected to apply the analytical method named Newmark Method to simulate the sliding plane and its displacement in Chapter 5.

Photo 3. Large-scaled damage of road embankment without traffic performance

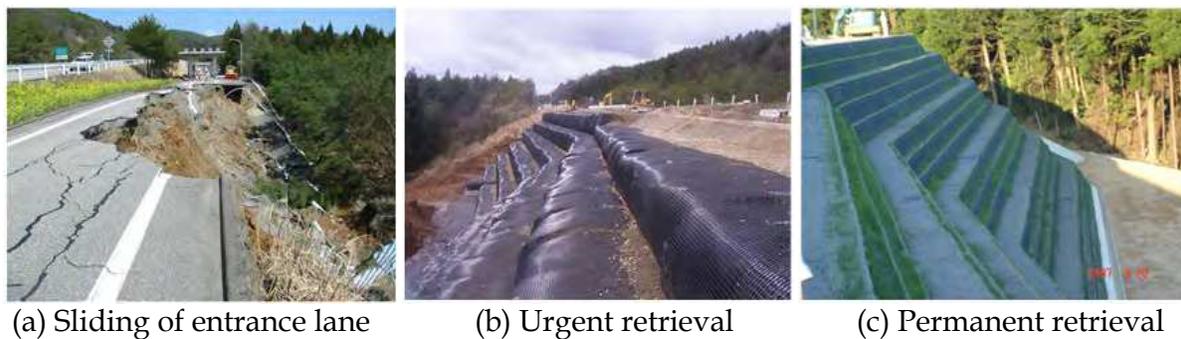
In Photo. 4 reported by Ishikawa Prefecture, Photo. 4(a) shows the severe damaged on ramp close to the toll gate. Most damaged embankments were retrieved urgently and permanently with use of the geotextile which can be shown in Photos. 4(b) and 4(c), respectively. Noto Toll Road was opened to the public urgently in about one month later

after the earthquake and the permanent retrieval of all damaged embankments was completed in about five months later after the urgent retrieval.

Photo 4. Damage and seismic retrieval with geotextile

It can be indicated that the seismic design with the seismic coefficient of 0.2 was applied to reinforce the retrieved embankments strongly more than that before the earthquake for the future earthquakes. Such seismic retrieval for the road embankments at Noto Toll Road may be the first case in Japan and can be referred for other embankments in the future.

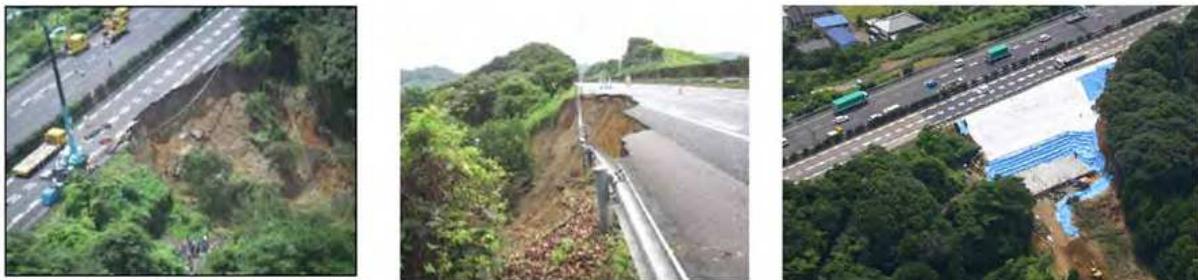
economical influences and so on were very large for Japan. However the urgent and extended retrieval was executed, it took 5 days to recover the limited traffic performance for the personal vehicles as shown in Photo. 5(c). The permanent retrieval ended on June 10, 2010, i.e. in about ten months and the traffic performance was recovered perfectly.

(a) Overview of sliding

(b) Shoulder and slope slid

Photo 5. Partially damaged site without traffic performance and urgent retrieval

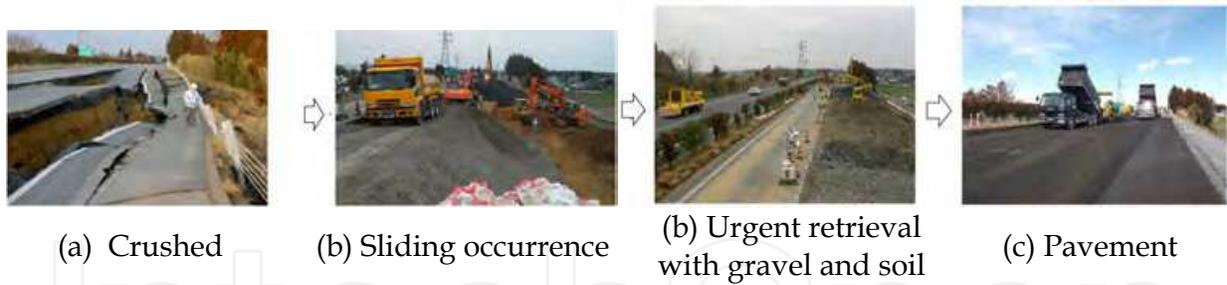
However the damages by tsunami occurred widely and severely, other damages of civil engineering structures such as road bridges, road embankments, river dykes and so on were not so remarkable because the epicenter of the main-shock is rather far and the damages occurred along the coasts may be washed away by tsunami attacks. The most severely damaged embankment of all ones at Tohoku Highway and Joban Highway which are the main trunk routes to connect Tokyo with Tohoku Region, where the earthquake occurred can be introduced as shown in Photo. 6 reported by Kanto Branch Office of Higashi Nippon Highway Co. Ltd. As shown in Photo. 6(a), the one side of 2 lanes in one direction slid. However the thickness of the soft ground beneath the embankment body is about 3.6m, the type of the failure is a toe sliding failure and a little small failure. The work flow of the urgent retrieval for this embankment can be shown as Photo. 6(b), 6(c) and 6(d), respectively. As shown in Photo. 7 under urgent retrieval work, the height and the damaged length of the embankment are about 8m and 150m, respectively. The traffic performance for the personal vehicles was recovered urgently on March 21, 2011. Then it takes about 10 days to complete the urgent retrieval and open the highway to the public.

Photo 6. One side of two lanes damaged and urgent retrieval

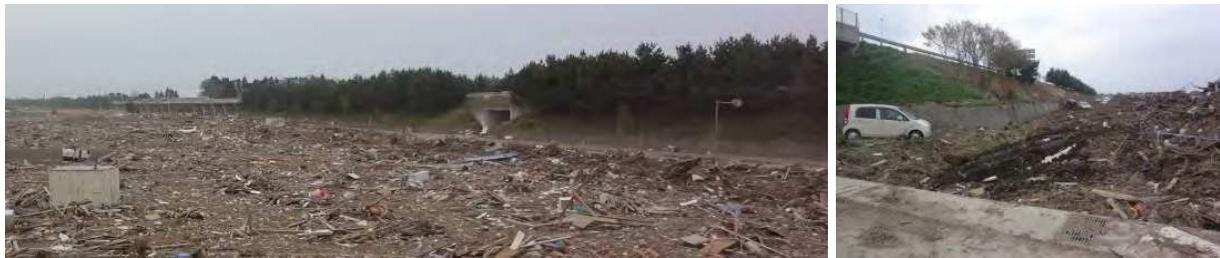
(a) Opposite side from sea

(b) Sea side

Photo 9. Comparison of damages at both sides of highway embankment

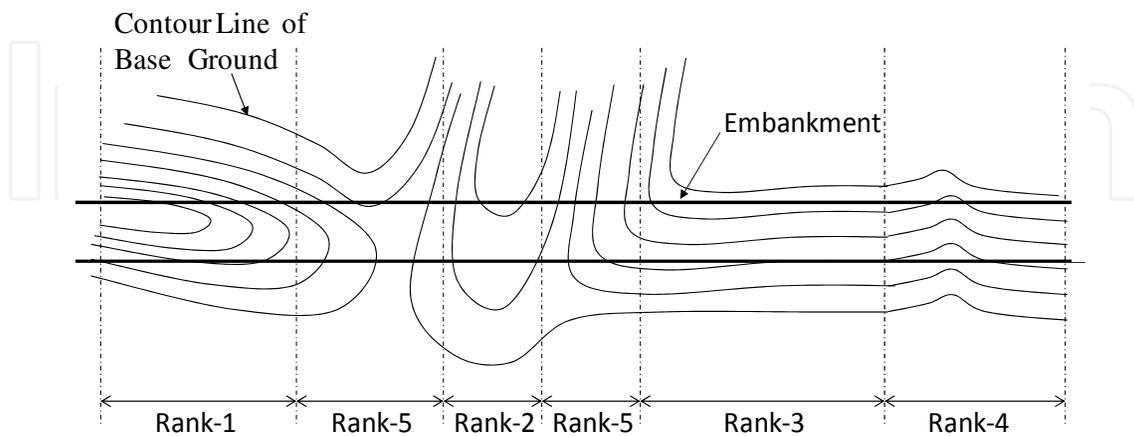
Item 1 on the topographical conditions below embankments can be selected because the damage risk relates to the original terrain condition under the embankment such as ridge slope or stream. For example, the assessment rank and each relating score are assumed as shown in Fig. 2.

Fig. 2. Identification of topographical ranks for Item 1

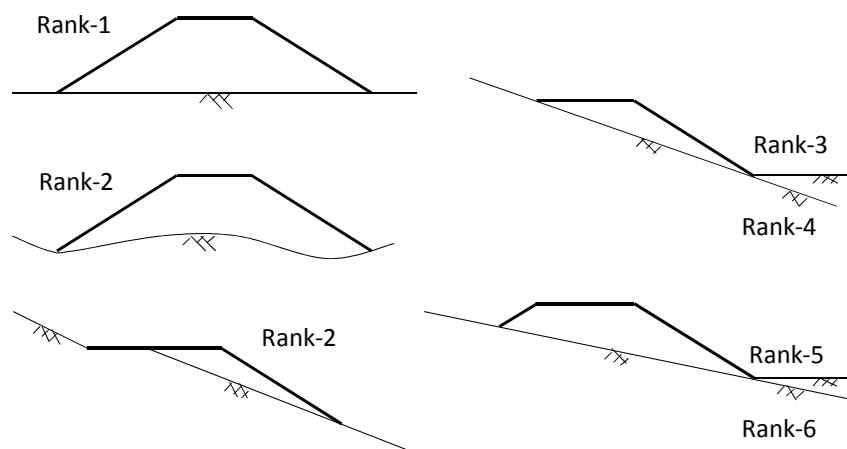
Item 4 on the traverse structure of embankment can be selected because the damage risk relates to the traverse structure of the embankment, including the incline of the foundation ground, the configuration of the embankment, as shown in Fig. 3.

Fig. 3. Identification of traverse structures for Item 4

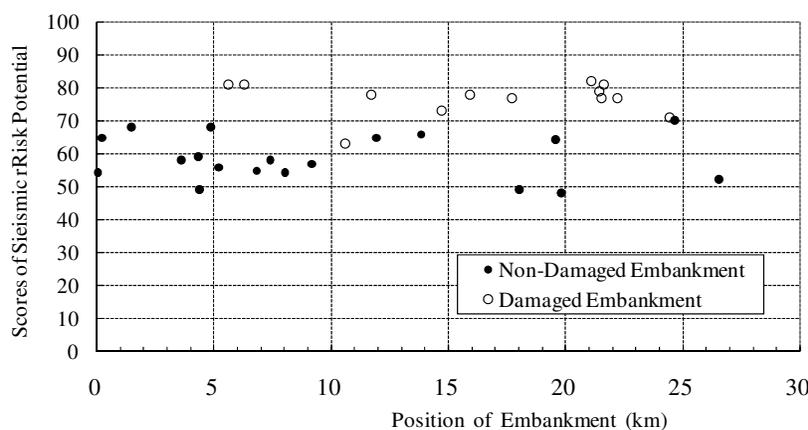
The example of application of the macroscopic assessment method with the value of SRP can be obtained as shown in Fig. 4 where 13 damaged and 19 non-damaged embankments in the 2007 Noto Peninsula Earthquake are selected and compared each other.

The average score μ and standard deviation σ are 60.7 and 8.2, respectively on the 19 non-damaged embankments. Then the score range of $\mu \pm \sigma$ is from 52.5 to 68.9. The average score and standard deviation are 75.2 and 4.8, respectively on the 13 damaged embankments and then the score range of $\mu \pm \sigma$ is from 70.4 to 80.0.

Fig. 4. Scores of seismic risk potential between non-damaged and damaged embankments in the 2007 Noto Peninsula Earthquake

Based on the results as shown in Fig. 4, the following lessons can be drawn to use the evaluation value of seismic risk potential practically.

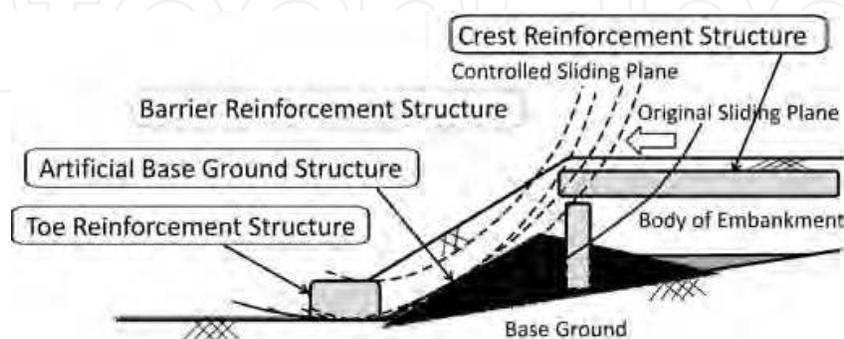
Crest Reinforcement Structure aims to reinforce the crest of embankment partially with use of geotextile etc. and not to occur the sliding plane and decrease the sliding displacement on the top of the embankment, then maintain the traffic performance enough just after an earthquake. Toe Reinforcement Structure aims to reinforce the toe of embankment to control the sliding plane and decrease the sliding displacement. Artificial Reinforcement Structure aims to control the sliding plane by improving the embankment body stiffly as shown in Fig. 5 to control the sliding plane not to reach the traffic lane. Barrier Reinforcement Structure aims to control the position of the sliding plane with use of sheet piles etc. and not to occur at the traffic lane, then maintain the traffic performance enough just after an earthquake.

Fig. 5. Typical concepts proposed for performance-based design of road embankment

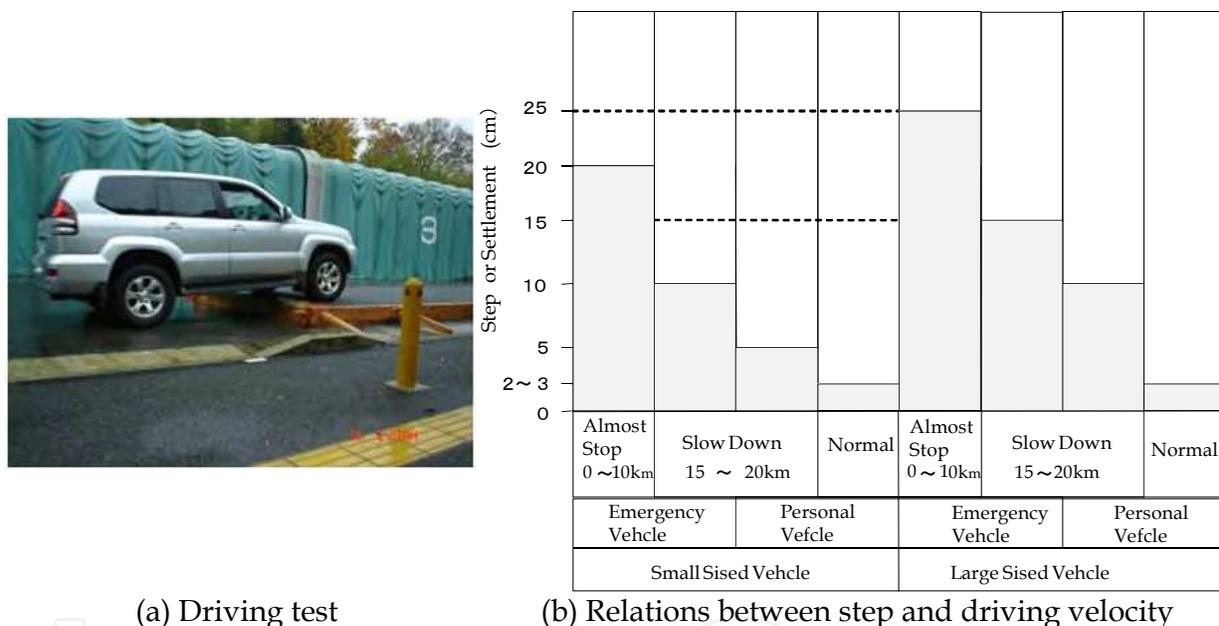
The test results are summarized in Fig. 6(b) which shows the limit height of steps able to drive through without repair, relating to some conditions of the small or large vehicle size, the emergency or personal vehicle and the velocity of vehicles driving through the steps such as almost stop (0 to 10 km/h), slow down (15 to 20km/h) and normal (for example, 60 to 80km/h).

Fig. 6. Driving tests and results

Based on the driving test results such as in Fig.6(b), the performance level considering traffic performance just after an earthquake can be proposed as shown Table 2. The performance levels are classified into four types as follows.

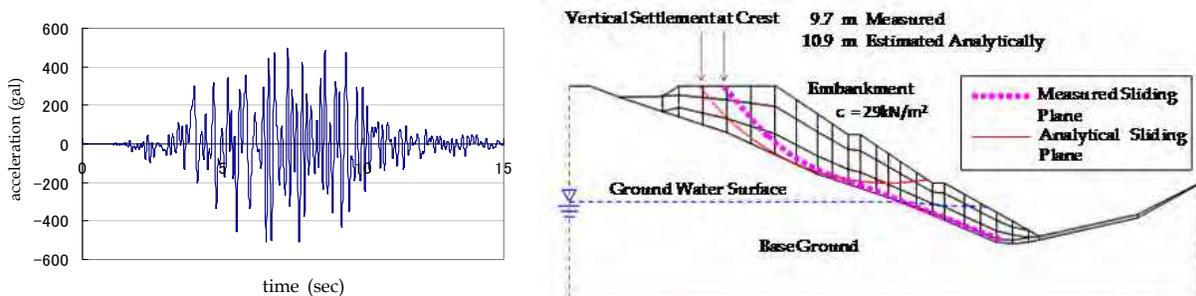
Fig. 7 is the example applying the Newmark Method to the embankment damaged during the Noto Peninsula Earthquake in 2007. The ground motion inputted at the bottom of the embankment model shown in Fig. 7(b) is revised the maximum acceleration from the ground acceleration of 580gal in the East-West direction shown in Fig. 7(a) which was observed at Togi City set by National Research Institute for Earth Science and Disaster Prevention (NIED) to the one of 500gal. As known in Fig. 7(b), the position of the sliding plane measured after the earthquake is almost similar to the analytical one. Furthermore, the measured sliding displacement at the crest of the embankment is 10.9m and similar to the 9.7m measured.

(a) Observed E-W ground motion at Togi (b) Measured and analytical sliding failure
Fig. 7. Example of application of Newmark Method

In this case study, the sliding failure such as the position of the sliding plane and the sliding displacement estimated with use of the Newmark Method is well estimated analytically.

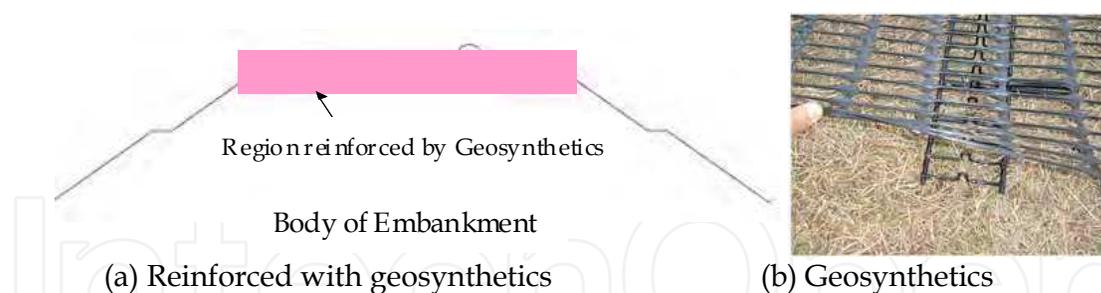
Fig. 8 shows the example of the Crest Reinforcement Structure with use of the geosynthetics. This structure can be applied to both existing and newly constructed embankments. In the case of the existing embankment, the sheets of geosynthetics are installed at the overall crest of the embankment as shown in Fig. 8 based on the excavation and the re-pavement, or around the shoulder of the embankment partially. The reinforcing work is necessary to be paid attention to reduce the effects on the traffic performance as little as possible. On the other hand, in the case of newly construction, the sheets of geosynthetics can be easily set inside of the embankment. The practical applications of the crest reinforcement structure with use of geosynthetics have been discussed and clarified as follows.

Fig. 8. Example of crest reinforcement structure

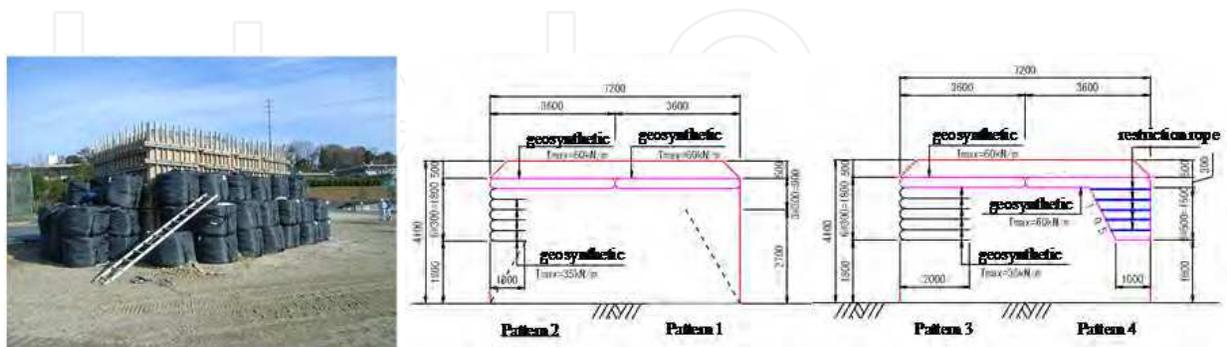
ropes. The soil properties are shown in Table 3 and the fine aggregate without fine-grained fraction of the wet density of $\gamma_t = 18\text{kN/m}^3$ which tends to occur a collapse easily. The static failure of the reinforced embankment model is planned to be occurred by removing the panels and sandbags.

(a) View of embankment model

(b) 4 patterns of reinforced embankment models (unit: mm)

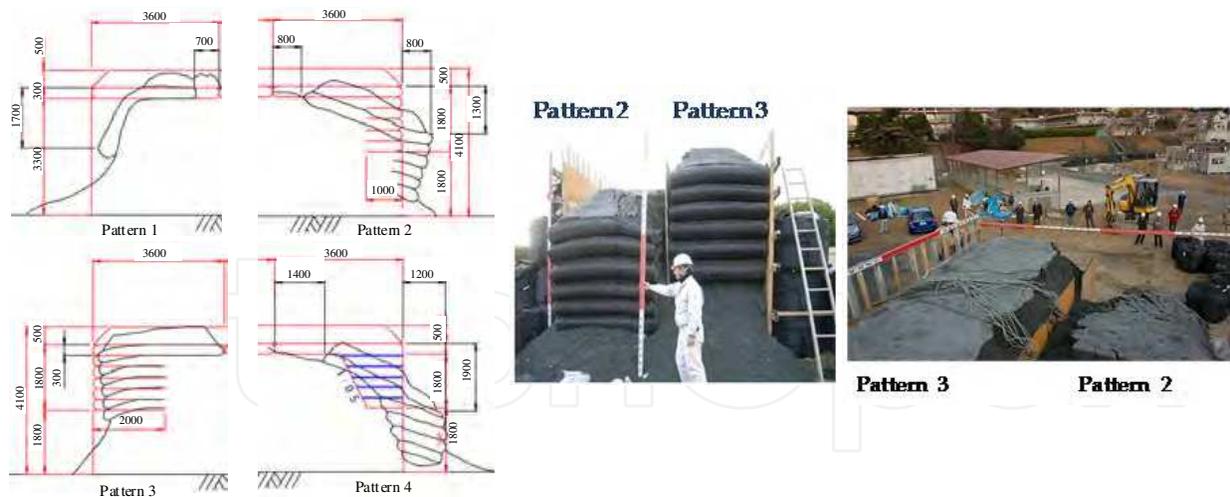
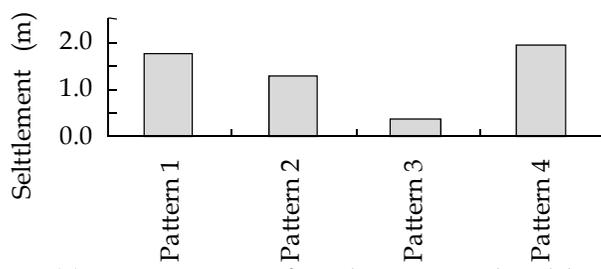
(a) Deformation of models (unit: mm)

(b) Difference of Settlement Level

(c) Comparison of settlement at shoulder

Fig. 10. Comparison of damage level between different reinforcement patterns

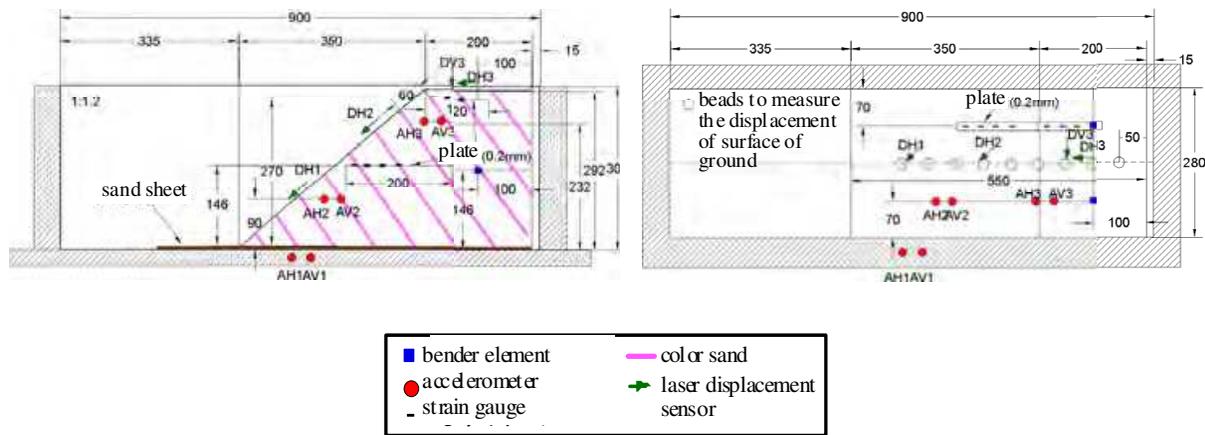
which the strain gauges are pasted on both sides are placed in the upper and central parts of embankment to investigate the failure mechanism.

(a) Cross section (unit: mm)

(b) Plane section (unit: mm)

Fig. 11. Embankment model and measurement for dynamic centrifuge test

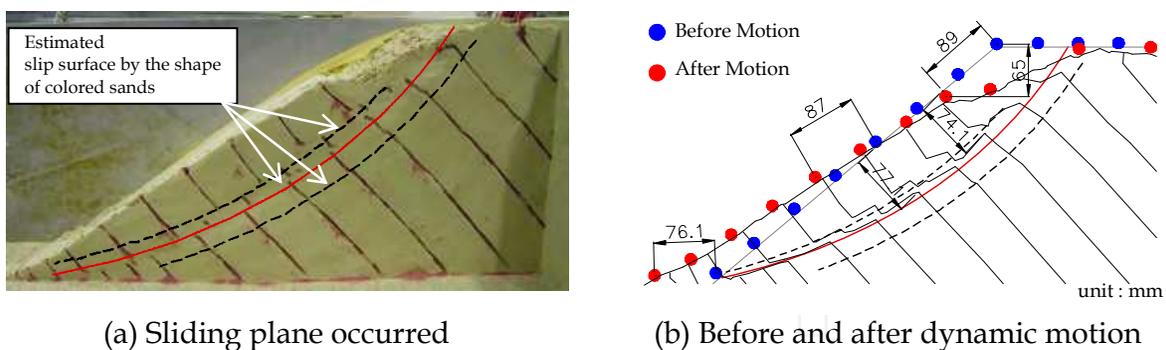
Fig. 12(a) shows the cross section cut at the center of the embankment model which is not reinforced and slid largely by the inputted motion with the maximum acceleration of 488gal. Fig. 12(b) compares the initial and slid shapes of the embankment model drawn by markers located at the surface and the colored sands columns. Comparing the positions of markers before and after dynamic motions in Fig. 12(b), it can be seen that however the embankment body around the shoulder is disturbed according to the sliding, the sliding body is driven over all because the displacement of markers at the shoulder of 89mm and the one along the slope of 87mm are almost same. On the other hand, the vertical settlement at the shoulder is 65mm which is converted to 1.95m at the field. As mentioned above, it can be clarified that it's possible to reproduce the dynamic sliding plane artificially by the centrifuge test.

(a) Sliding plane occurred

(b) Before and after dynamic motion

Fig. 12. Sliding failure in case of non-reinforced model

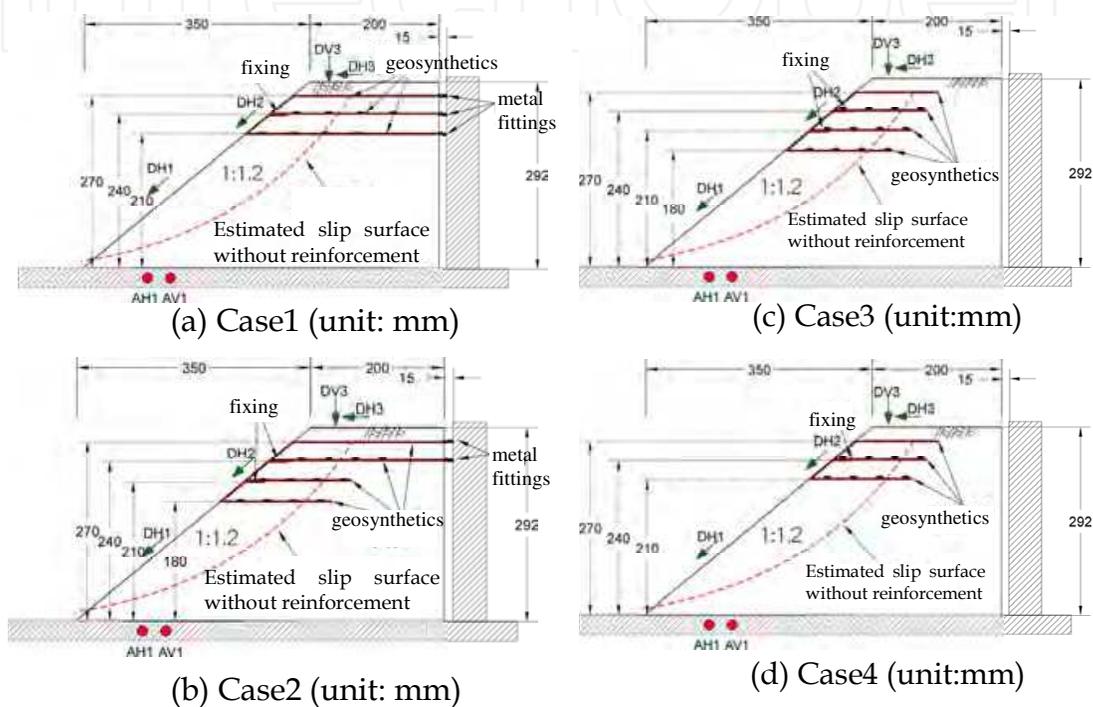
In the above four cases, the thickness of both long and short reinforced layer is set to be 30mm which scale is 0.9m in the field. To ensure the total performance of reinforced zone, geosynthetics sheets are connected with each other at the surface of slope.

Fig. 13. Embankment Model Reinforced with Geosynthetics

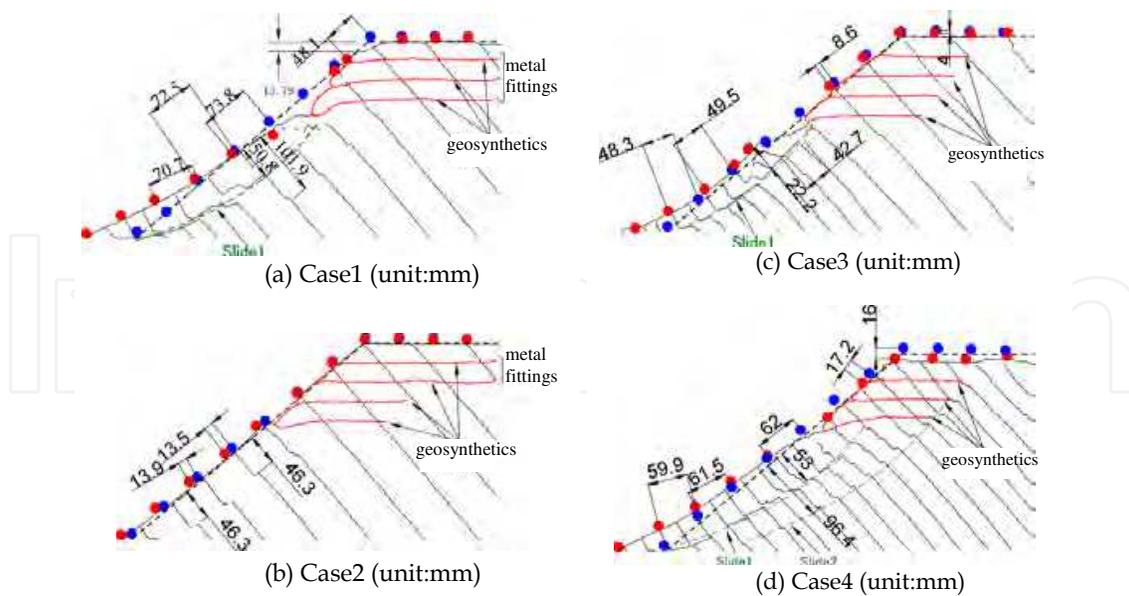
Fig. 14 compares the slid conditions between four cases measured at the central cross section after inputting the sinusoidal motion with the maximum acceleration of about 500gal. It can be indicated qualitatively as follows based on the results of Fig. 14.

Case 4: The deformation on the crest of embankment is occurred a little and the sliding occurs not only at the area lower than the reinforced zone but also at the boundary of reinforced zone which is reached to the surface of the crest.

Fig. 14. Sliding failure in case of reinforced model with geosynthetics

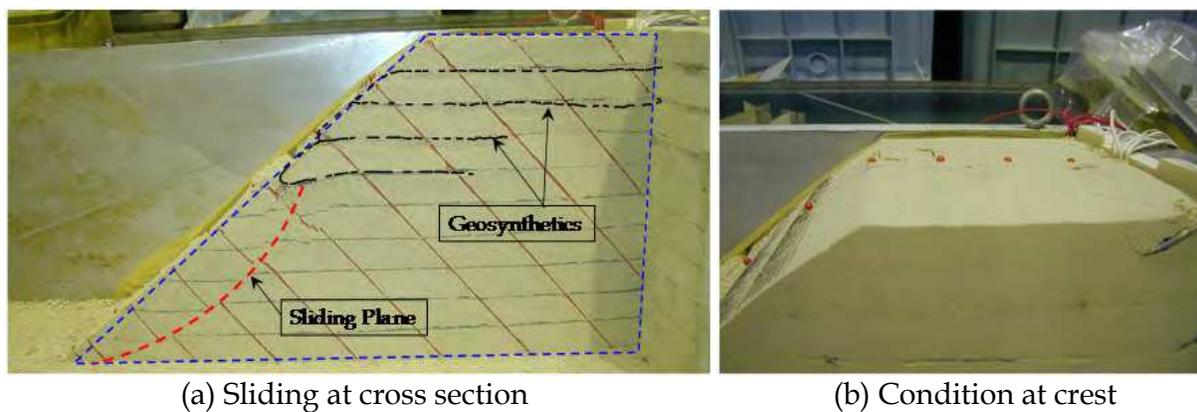
Photo 10. Overview of deformation of reinforced embankment model in Case 2

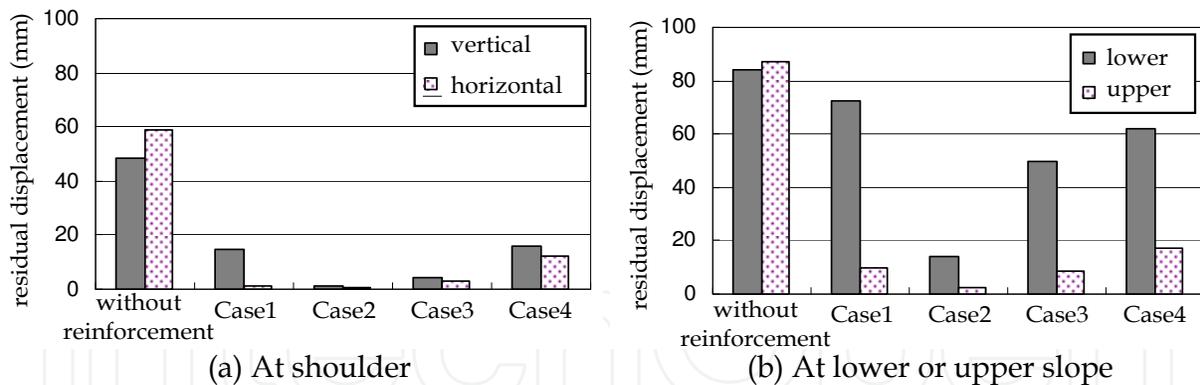
The residual displacements measured at the shoulder and upper and lower slope of the four reinforced models comparing with the non-reinforced one in Fig. 12 are summarized in Fig. 15. Compared the reinforced models with the one without reinforcement, both horizontal and vertical residual displacements at the shoulder of the embankment model are decreased greatly in the whole reinforced models as shown in Fig. 15(a). Furthermore, the residual displacements along the upper-side slope are also decreased greatly as shown in Fig. 15(b).

Fig. 15. Comparison of Residual Displacement

As mentioned above, it can be indicated that the Crest Reinforcement Method with geosynthetics sheets is very effective for both newly constructed embankment and existing ones to get minimum traffic performance just after earthquakes. Some lessons can be obtained that the number of reinforced layers is very important for both long sheets and short sheets and the short sheets should be set deeper than the estimated sliding plane and almost fixed at the inside end.

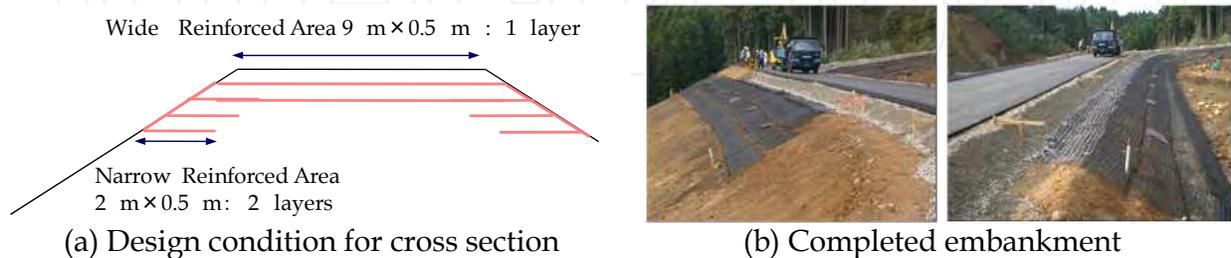
As shown in Fig. 16(a), one reinforced layer with two long sheets of 9m and two reinforced layers with two short sheets of 2m which are similar to the Case 2 in the centrifuge test in Fig. 13. The thickness of each layer is 0.5m. However the seismic design hasn't been applied in this case, it's very important that this case is the first trial to apply the Crest Reinforcement Structure in Japan as shown in Fig. 16(b) and can be obtained important lessons to construct the structures in the field.

Fig. 16. Application of crest reinforcement structure to actual road

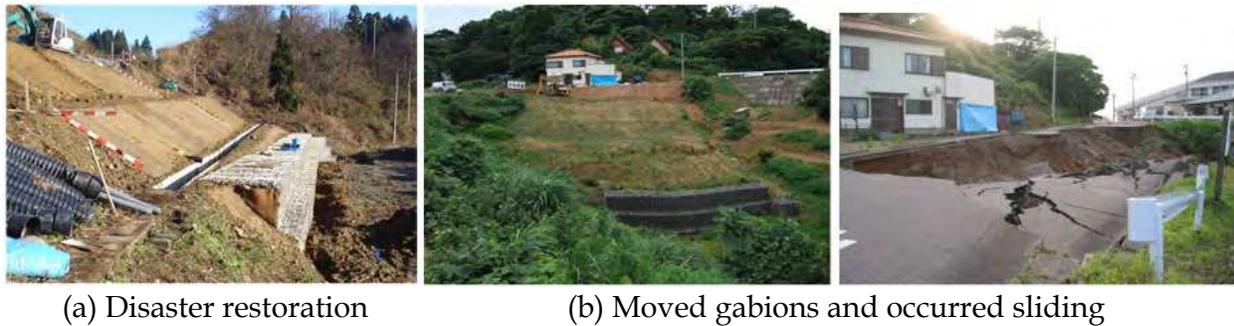
reported in recent years. A large-scale gabion is given as a typical structure of the Toe Reinforcement Structure in this Chapter. As for the large-scale gabion, the merits to apply it are low-cost, good construction workability, and there are a lot of actual results in the field as the disaster restoration method for the purpose of drainage as shown in Photo.11 (a).

Photo 11. Application of large-scaled gabion at present

However the gabions were set only for drainage in advance, they could not work against the seismic motion as shown in Fig. 11(b). Then it is necessary and effective to apply the large-scale gabions for not only drainage but also reinforcement of the embankment.

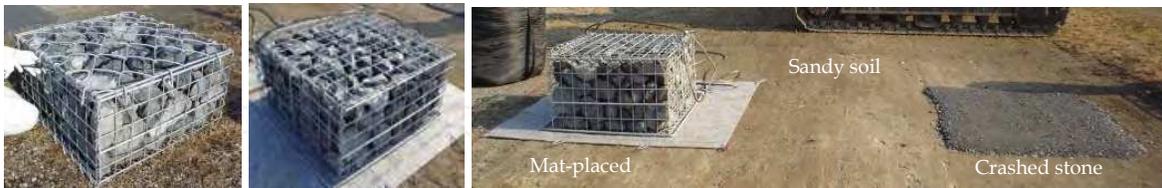
are discussed. Photo. 12 shows the three types of the conditions at the ground surface where the gabions are placed: a mat-placed ground, a sandy ground and a crushed-stone-layered ground, respectively. The sheet of a mat is permeable and possible to be set at the bottom of gabions to prevent fine soil particles to be flown out from the beneath the ground.

(a) Diamond-shaped (b) Grid-shaped (c) Ground surface condition to place gabions

Photo 12. Structure of gabion and ground surface condition

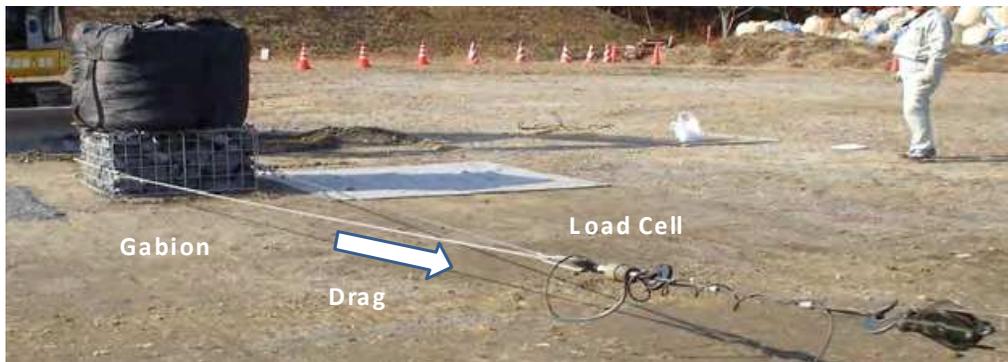
Photo 13. Typical method to drag gabion and measure drag-Load

Furthermore, three types of the weight and/or load condition are considered. The weight at Stage 1: 7.487kN are the same with that of the practical gabion and each weight at Stage 2: 15.249kN and at Stage 3: 21.619kN is about twice and three times the weight of the practical one, respectively. Photo.13 shows the typical method to drag a gabion and to measure the drag-load where the steel wire connected to the gabion is pulled by the winch which is set on the right side in Photo. 13.

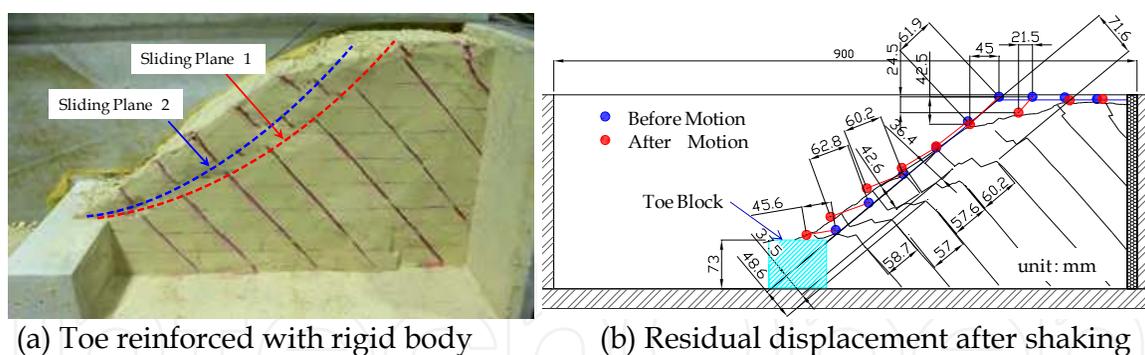
The centrifuge test is conducted on the effects by the Toe Reinforcement Structure with a rigid body shown in Fig. 17(a). The test conditions and measurement system are same with the former tests in Fig. 11. The toe structure set on the bottom of the container is not fixed. However the friction coefficient between the rigid body and the surface of the bottom is measured to be 0.78 in 30g, the rigid body isn't moved by dynamic motion with the maximum acceleration of 485 gal. Fig. 17(b) shows the displacements of the embankment model after shaking. It can be seen that the sliding plane is shallower and each displacement measured is smaller than that without reinforcement in Fig. 12. Furthermore, it can be indicated that it isn't necessary to fix the toe structure on the ground surface and it's enough to keep the high friction coefficient not to be slid. As the rigid body, the retaining wall and the large-scaled gabion etc. can be considered as the practical toe reinforcement structures.

Fig. 17. Centrifuge test on toe reinforcement structure

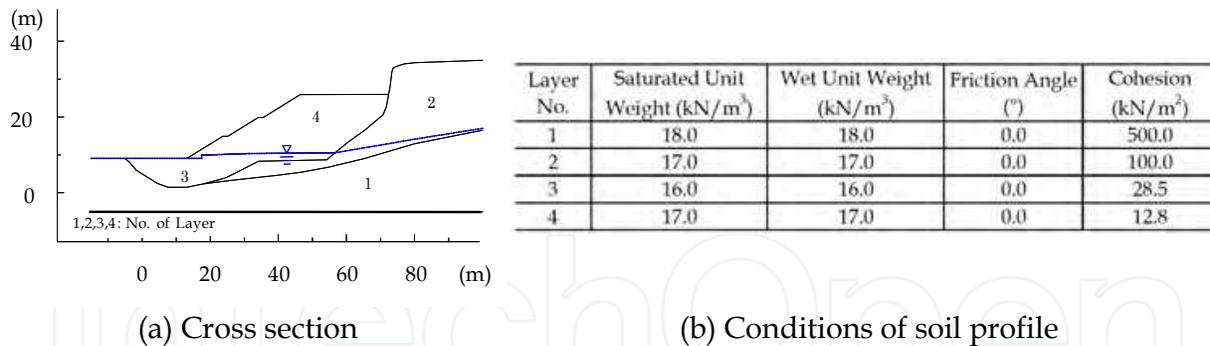
The practical examples on the application of the Artificial Base-ground Structure and the Crest Reinforcement Structure with geosynthetics are introduced as follows. Fig. 18 shows a certain site same with Fig. 16 where the road embankment indicated by Layer 4 shown in Fig. 18(a) approaching to the other construction site is constructed temporarily. Fig. 18(a) shows the soil conditions in each layer, i.e. Layer 1 and Layer 2 are natural rigid base grounds, and Layer 3 is a little soft clayey deposit. The groundwater table is shown as the blue line. The soil conditions of each layer are estimated in Fig. 18(b) based on the soil investigation.

Fig. 18. Analytical model of in-situ field shown in Fig. 16

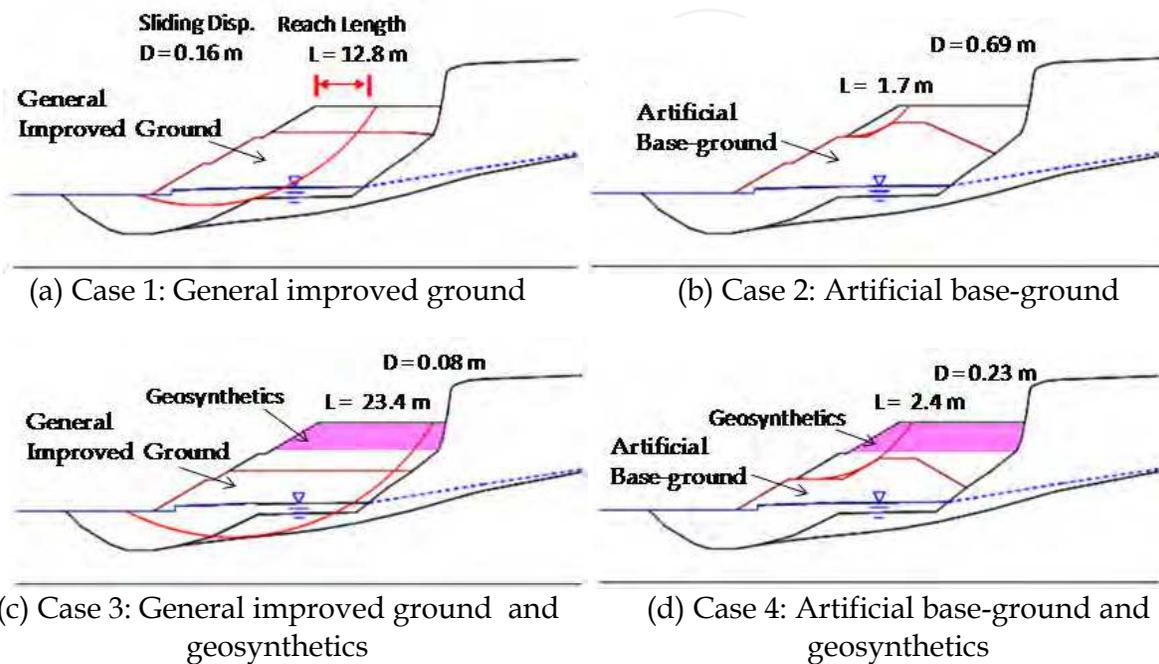
Four analytical cases of the reinforced embankment model are prepared as shown in Fig. 19. Table 6 shows the design conditions for the geosynthetics to reinforce the crest of the embankment and/or the improved strength of the embankment body as the artificial base-ground where the sliding plane don't pass through.

Fig. 19. Sliding characteristics according to reinforcement structures

The construction costs corresponding to the unit length in the longitudinal direction of the embankment among these four cases can be ordered in Case 4, Case 1, Case 2 and Case 3 from the low cost to the high one. Because the cost ratio of Case 3 against Case 4 is about 1.13, Case 4 can be indicated to be the best reinforcement plan based on the seismic performance-based design.

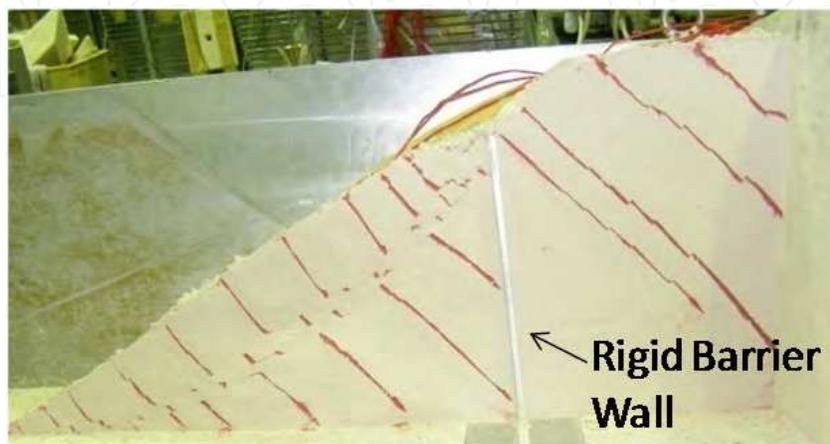
The centrifuge test is conducted on the effects by Barrier Reinforcement Structure with a rigid plate shown in Photo. 14. The test conditions and measurement system are same with the former tests in Fig. 11. The under edge of the barrier structure is set to be rotated and not to be moved horizontally, i.e. assumed to be a hinge. The upper edge of the one is free and not to be connected with the side wall of the container.

Photo 14. Centrifuge test on the Barrier Reinforcement Structure

It can be known that however the rigid plate is inclined a little toward the slope, the sliding plane can be controlled toward the shoulder of the crest where the traffic performance isn't affected severely. If the upper edge is fixed, the effectiveness of the barrier may become larger. The Barrier Reinforcement Structure can be assumed to be effective to decrease the residual displacement at the crest of road embankments. As the rigid plate, the sheet piles and the reinforced concrete wall etc. can be considered as the practical barrier reinforcement structures.
