# **Landslide Inventory and Susceptibility Assessment for the Ntchenachena Area, Northern Malawi (East Africa)**

Golden Msilimba

*Mzuzu University, Department of Geography,  
Mzuzu 2,  
Malawi*

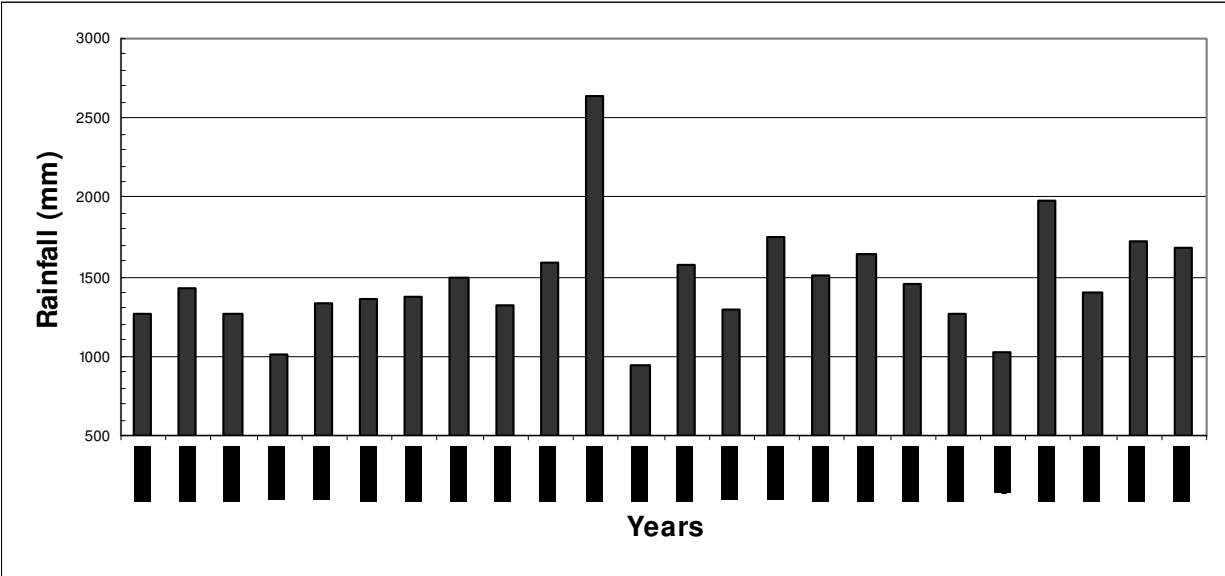
Fig. 3. Annual Rainfall Totals for the Ntchenachena Area from 1977 to 2001 (Note annual totals for years after 2001 were not available)

The contribution of rainfall to slope instability has been analysed by several authors (Crozier 1984; Aryamanya-Mugisha 2001; Ingag'a and Ecauwun 2001; Msilimba 2002; Msilimba and Holmes 2005; Knapen et al. 2006). Rainfall measurements (**Figs 3 and 4**) indicate that the Ntchenachena area receives high precipitation. Annual rainfall ranges from 949mm (1988/9) to 2631mm (1987/8) with an average of 1472mm. Although annual totals for the 2003 period for the area are not available, the study area is one of the wettest areas in Malawi (Linceham 1972; Msilimba 2007). Daily rainfall analysis (Fig 4) shows that the landslides areas occurred after prolonged rainfall of 21mm on 26/27 March and 185mm on 27/28 March, 2003. Total rainfall for the two days was 206mm which was more than half the total for the month of March which was 402mm. Before these rainfall events, the area had received 192mm of rainfall during the month of March. This was also towards the end of the rainy season when the antecedent soil moisture was already high. The landslides occurred in March when the recorded rainfall of 402mm was significantly higher than the normal monthly average of 301.9mm. Eyewitnesses attest to prolonged rainfall of low intensity prior to the landslide events, suggesting inflow exceeded discharge, resulting in higher pore pressure and liquefaction.

The mechanism of pore pressure accumulation is well discussed (Crozier 1973; 1984). The rainfall data show that the Ntchenachena area receives high annual precipitation (>1600mm per year). The antecedent moisture content prior to the landslide events was probably high. The 206mm of rain which fell in the Ntchenachana area, was unusual and above average. This unusually high rainfall coupled with high sand content, moderately high porosity, and moderately rapid hydraulic conductivity increased pore pressure between the soil particles contributing to the liquefaction.

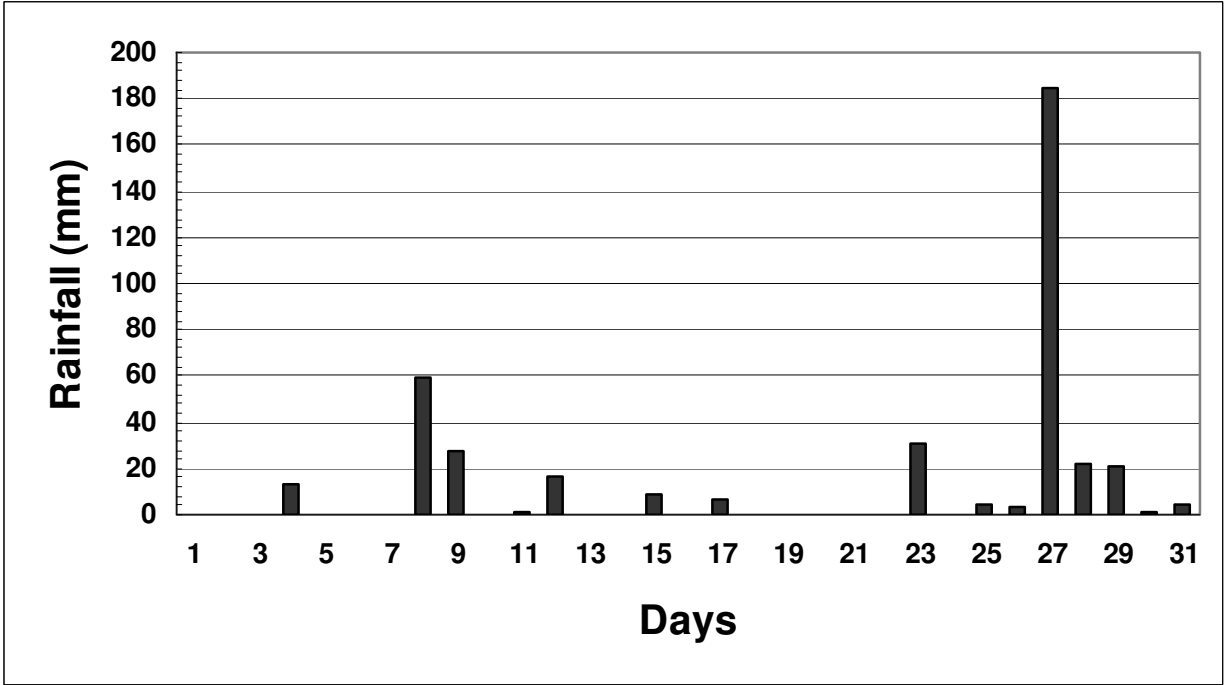
Fig. 4. Daily rainfall for March 2003 for the Ntchenachena Area. Note the critical rainfall that triggered the landslides

While high mean annual rainfall figures and moderate rapid hydraulic conductivity (>7 cm/hr) act as a prerequisite to occurrence by raising ground water tables and pore pressure, the critical factor in the case of 2003 landslides appear to have been prolonged, low intensity rainfall. It is important to note that out of six topographic units of Ntchenachena area (**Table 2A**), five registered hydraulic conductivity of greater than 7 cm/hr (moderate rapid hydraulic conductivity).
