Resolving the Difficulties Encountered by JPL Interplanetary Robotic Spacecraft in Flight

Paula S. Morgan

*Jet Propulsion Laboratory, California Institute of Technology,
USA*

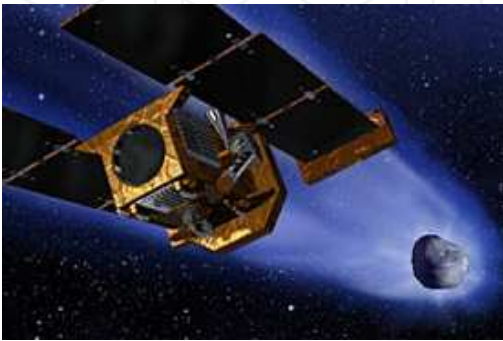
Fig. (4a). CloudSat Spacecraft FP Allocation. Fig. (4b). Stardust Spacecraft FP Allocation.

Fig. (4c). Cassini Spacecraft FP Allocation.

Fig. (4d). Voyager Spacecraft FP Allocation.

Figures (4a) through (4d) depict four JPL spacecraft designs with quite different mission objectives, which employ typical and mission unique FP (Ball Corp., 2001; JPL, 1997, 2005).

CloudSat: Earth Orbiting Satellite
Standard FP: 3 Safe-Mode Responses
5 Under-voltage Responses
Memory Scrubber & Bus FP

Stardust Spacecraft: Inner Solar System;
Comet Explorer
Standard FP: 1 Safe-Mode Response
1 Under-voltage Response
1 Command Loss Response
Memory Scrubber & Bus FP
Unique FP: Some computer & thermal FP

Cassini Spacecraft: Outer Solar System Explorer	Voyager Spacecraft: <i>Interstellar Explorer</i>
Standard FP: 1 Safe-Mode Response	Standard FP: 1 Under-voltage Response
1 Post-Safe Mode Response	1 Command Loss Response
1 Under-voltage Response	Unique FP: Computer FP, attitude articulation and control computer FP, and radio unit FP
1 Command Loss Response	
Memory Scrubber & Bus FP	
Unique FP: Significant command & data processing computer FP, radio unit FP, thermal FP, fuel tank pressure FP, attitude articulation and control computer FP

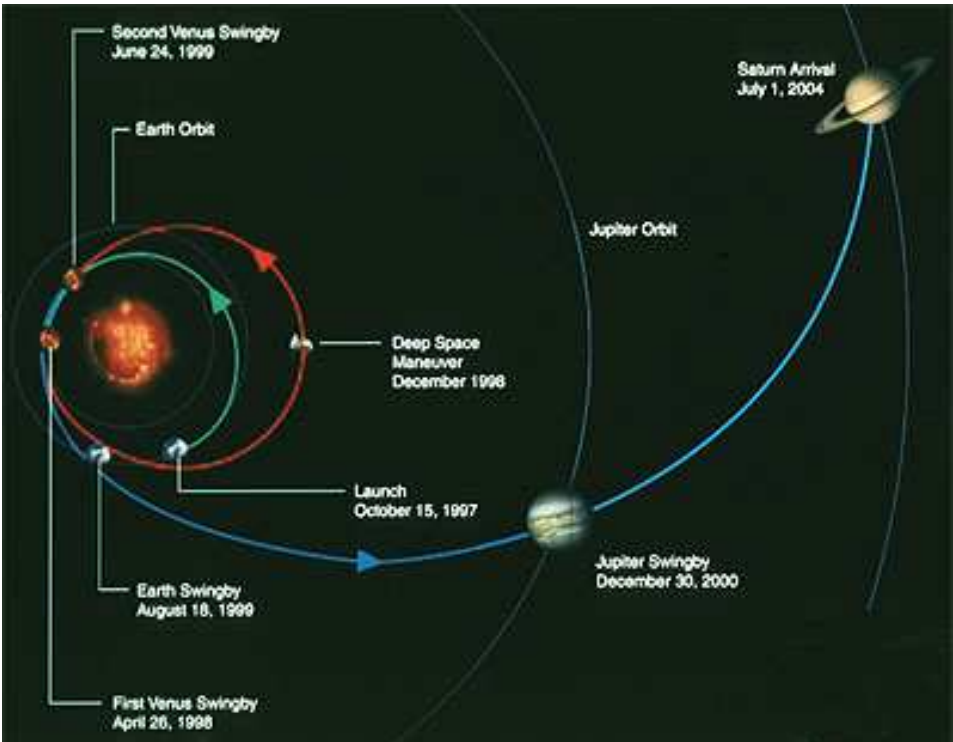
Fig. 5. Cassini’s Inner Planet Flyby Schedule.

During the 6.7 year cruise phase, several Trajectory Control Maneuvers (TCM) were performed using Cassini’s Main Engine (ME) and Reaction Control System (RCS) jets to guide the Spacecraft to its intended destination. Once near the Saturnian system, the “Saturn Orbit Insertion (SOI)” burn maneuver was implemented to slow the craft down so that it could be captured into Saturn’s orbit. This marked the beginning of its four-year Orbital Tour phase around Saturn’s complex system of moons which is shown in Figure 6. The probe was separated on Christmas Eve 2004, landing on the Titan moon in January 2005. The current end-of-mission plan is for a controlled 2017 Saturn impact (Smith & TPS, 2009).

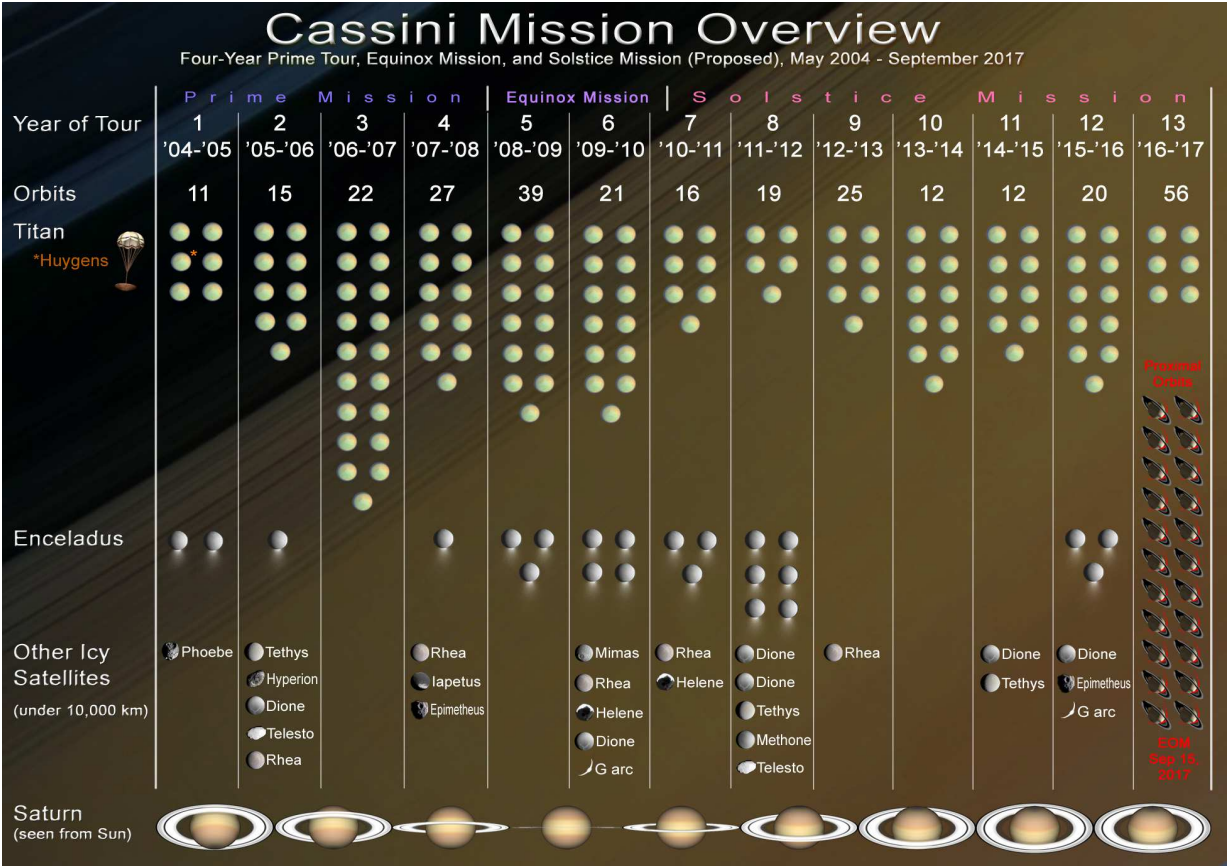
Fig. 6. Cassini’s Prime Mission, Extended Mission (XM), and Extended-Extended (XXM) Mission.

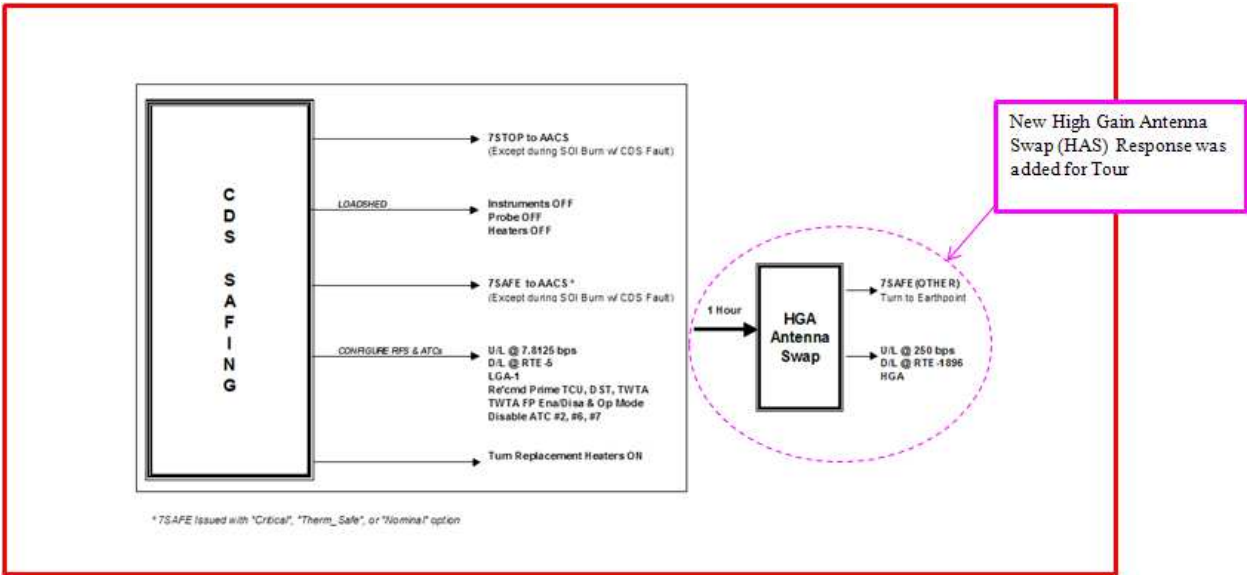
Fig. 9. New HGA Response was added in 2003; Configured to Run 1 hr. after Safing Response Executes.

As stated previously, the Safing Response (and internal FP routines) provide a safe spacecraft state with low uplink & downlink rates for the SOFS team to diagnose the fault condition, recover the spacecraft systems, and reactive the onboard sequence. Two weeks was originally allocated for this recovery period. But once the Cassini spacecraft reached the Saturnian system and began its mission Tour phase in 2004, three Orbital Trim Maneuvers (OTMs) were now required for each loop around Saturn-Titan, making the two-week-turnaround period infeasible since a lengthy spacecraft recovery period could cause Cassini to fall off the Tour trajectory. A High Gain Antenna Swap (HAS) Response was therefore designed into the FSW to help the SOFS team improve recovery time. This HAS response executes one hour after the Safing Response activation to increase the downlink rate from 5bps (bits per second) => 1896bps, and the uplink rate from 7.8125bps => 250bps. Figure 9 shows the HAS Response following the Safing Response activation.

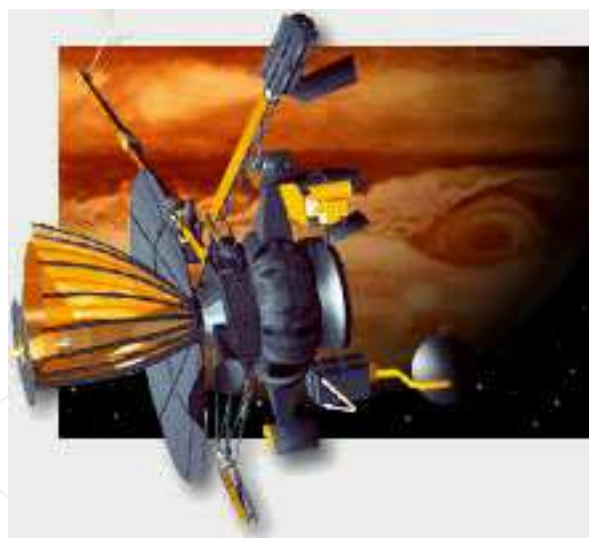
Fig. 16. Galileo's Undeployed HGA.

away (after the first Earth flyby). The SOFS Team communicated with Galileo through its two Low Gain Antennas (LGA). When commanded to deploy on April 11, 1991, the HGA only partially deployed, leaving the HGA mission in jeopardy. An investigation team was organized to rectify the problem where numerous attempts were made to fully deploy the antenna over the next two years, while investigating the alternative of using the LGA to support the Jovian operations segment of the mission. All attempts to fully deploy the HGA were unsuccessful, leaving the HGA antenna nearly useless.
