General Principles Regarding the Rehabilitation of Existing Railway Bridges

Petzek Edward and Radu Băncilă
"Politehnica" University of Timișoara & SSF-RO Ltd
 Romania

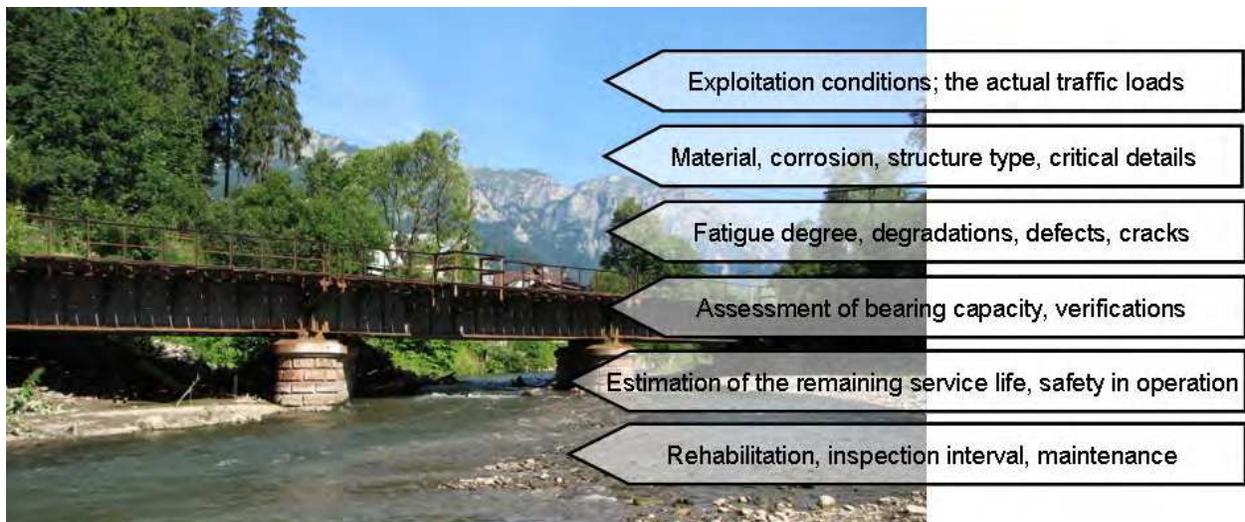
Fig. 2. Assessment and control of existing steel bridges

During service, bridges are subject to wear. In the last decades the initial volume of traffic has increased. Therefore many bridges require a detailed investigation and control. The examination should consider the age of the bridge and all repairs, the extent and location of any defects etc (Figure 2).

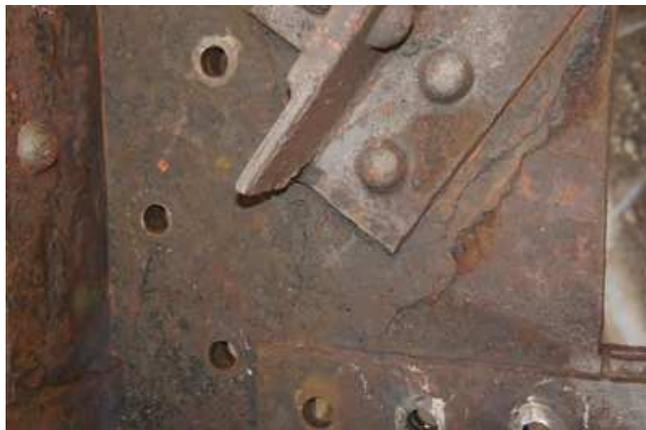
Fig. 3. Crack in the joint plate

In figure 3 there is presented a crack of a joint plate from a wind bracing and in figure 4 also cracks in the lower flange joint of a double T girder, near to the bearing.

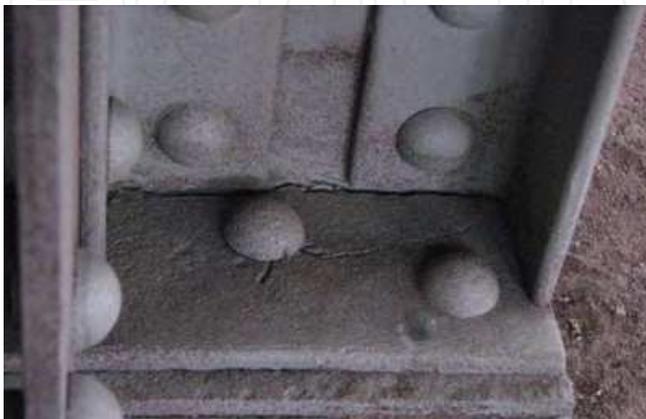
Fig. 4. Crack in the lower flange near to the bearing

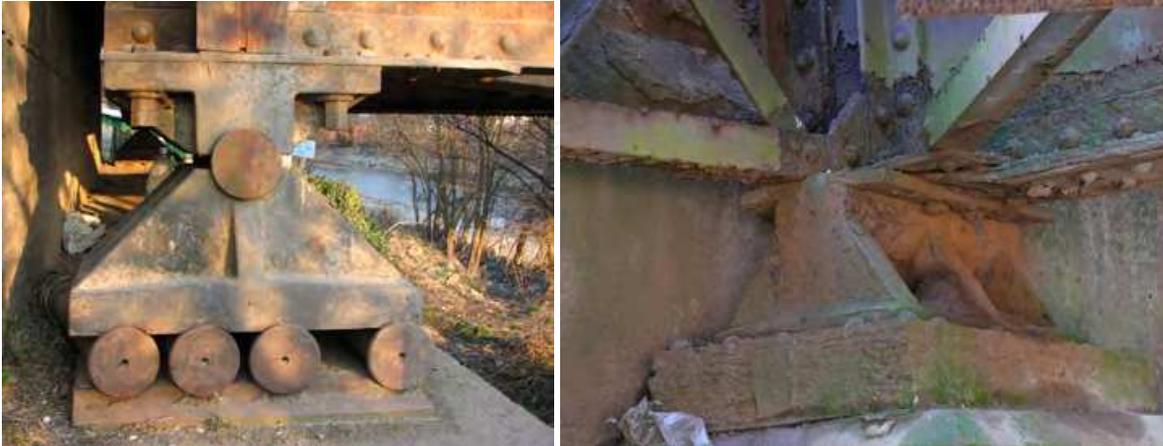
Fig. 5. Defects on bearings

Defects of the bearings are frequent as well. In figure 5 there are presented two examples.

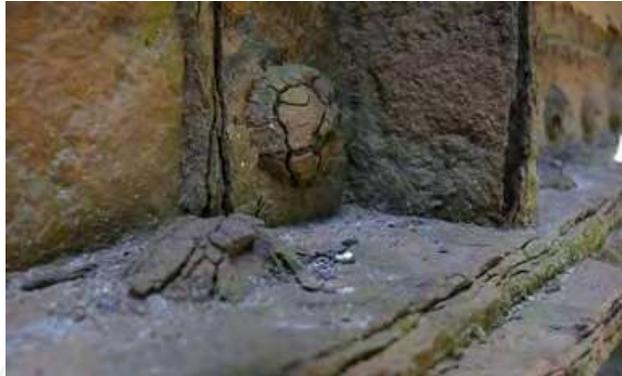
Fig. 6. Strong corrosion at the lower flange – railway bridge on a main line

Due to deficient maintenance the riveted structures are strongly corroded, especially in the lower zones (figure 6). These corroded surfaces represent also a critical detail for fatigue. Fatigue under corrosion factor is an aspect treated only qualitatively and not quantitatively. The interaction between the two aspects is obvious. There can also be found inefficient joints, like weakened rivets (figure 7).

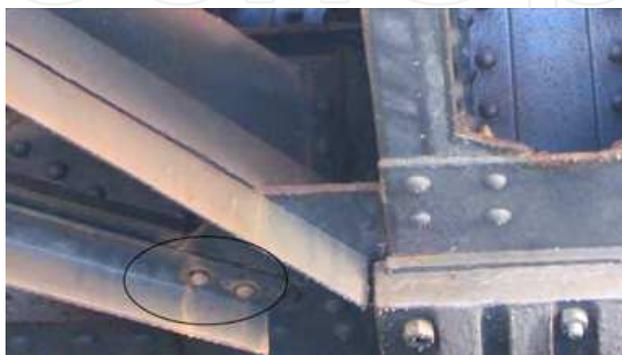
Fig. 7. Inefficient joints – railway bridge on a main line

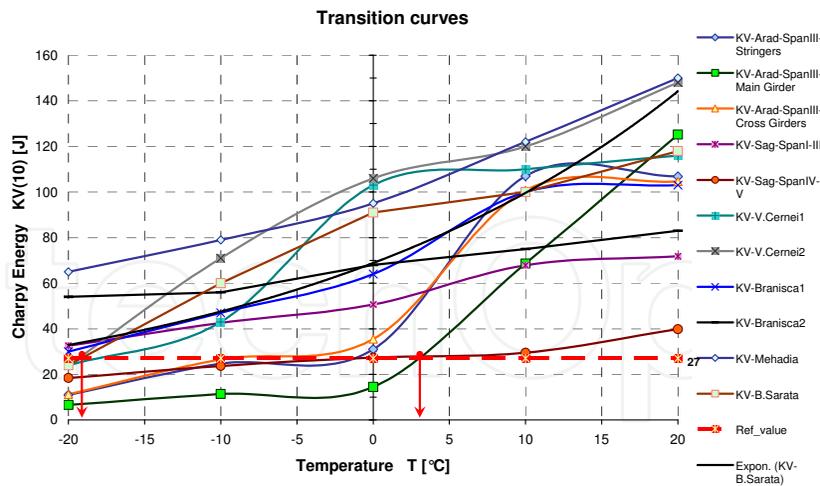
Fig. 8. Transition curves for the analyzed bridge structures

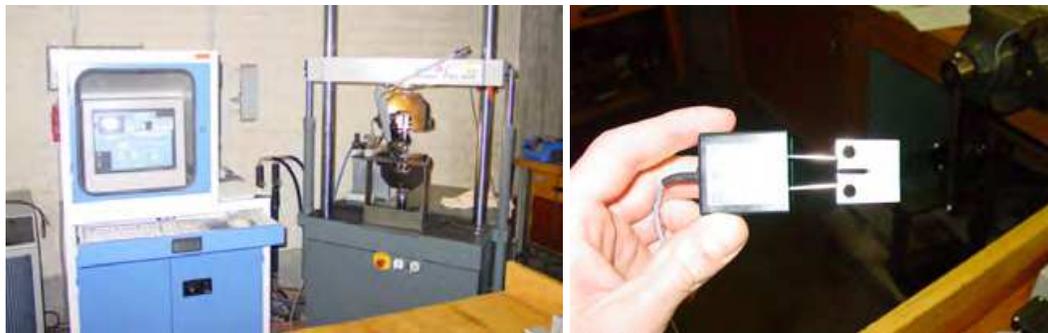
Fig. 9. Experimental tests for determining of J values

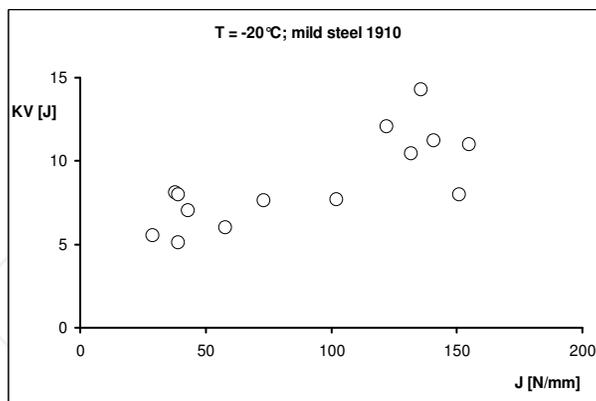
Fig. 10. Charpy V Notch Energy vs. material toughness J_c (Arad Bridge 1912)

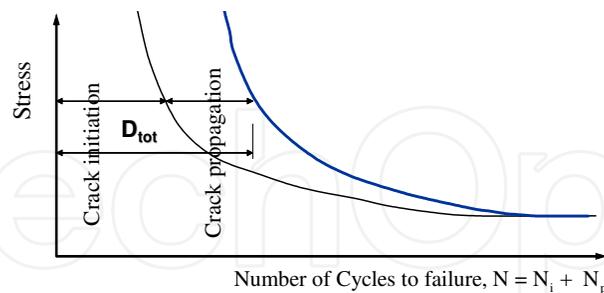
Fig. 11. Fatigue life of structural elements

In the present state of knowledge it is generally accepted that the fatigue failure of materials is a process containing three distinct steps: (1) initiation of defect (crack), (2) crack propagation in material, (3) separation through complete failure of the material in two or more pieces. Practically, the safety service life of an element under fatigue conditions can be expressed as follows (figure 11):

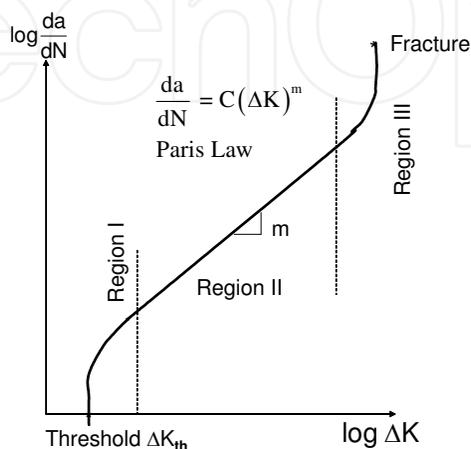
Fig. 12. Logarithmic representation of the fatigue crack growth in steel

The crack growth rate da/dN , defined as a crack extension - da obtained through a load cycle dN (it can also be defined as da/dt , in which case the crack extension is related to a time interval), represents a value characteristic of the initiation phases respectively the stable crack propagation. It has been experimentally observed that the connection between the crack growth rate and stress intensity factor variation represents a suitable solution for the description of the behavior of a metallic material containing a crack, as in the case of steel. In a logarithmic graphical representation of the crack growth rate da/dN versus the stress intensity range ΔK a curve as the one in the following figure (Fig. 12), is obtained.

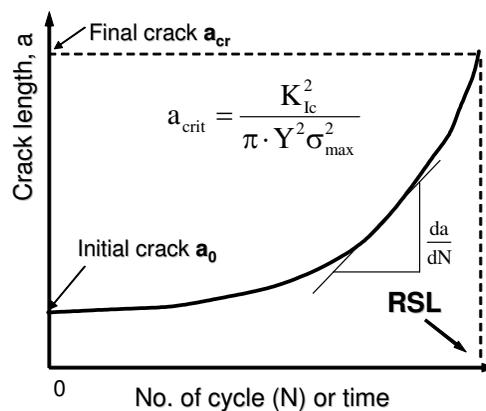
Fig. 13. Principles for determining the remaining service life

The number of cycles N_i obtained with the help of relation (4) represents the remaining service life of the detail, by regarding the initial length a_0 up to the critical length a_{crit} , by admitting stable crack propagation (Figure 13).

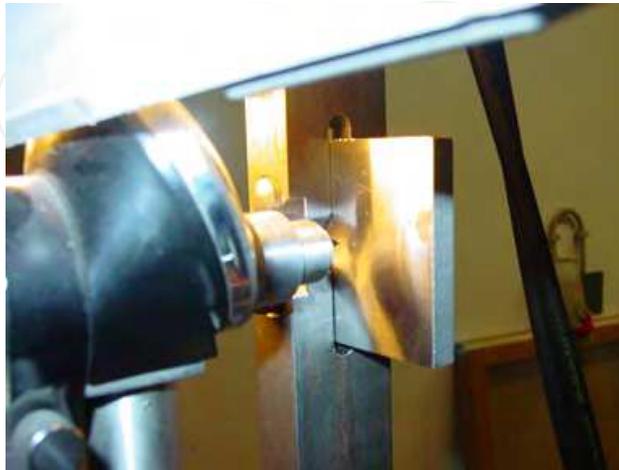
Fig. 14. Experimental tests in order to establish the material constants C and m

The experimental tests on 26 CT specimens from two old bridges have shown that for the oldest mild steels the values of the material constants from the Paris relation are in the following intervals: $m = 2,05 \dots 5,65$ and $C = 2,2 \times 10^{-11} \dots 10^{-18}$.

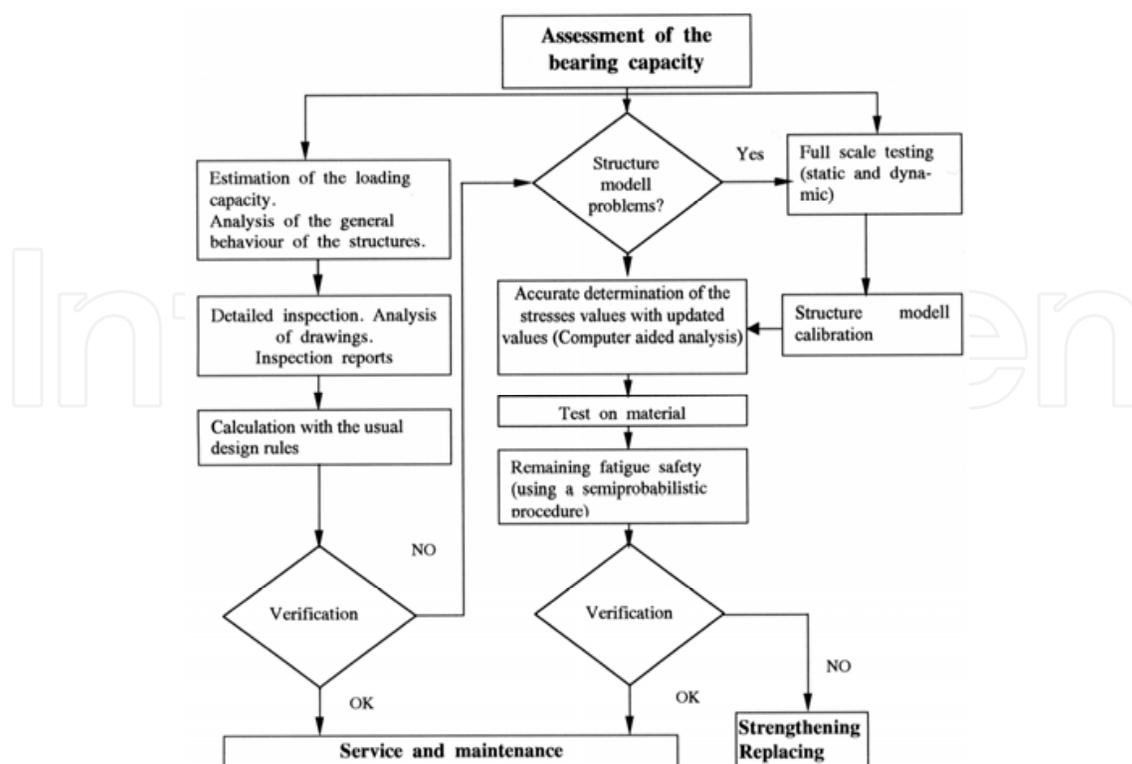
Fig. 15. Methodology of the Romanian standard SR 1911-98 [3]

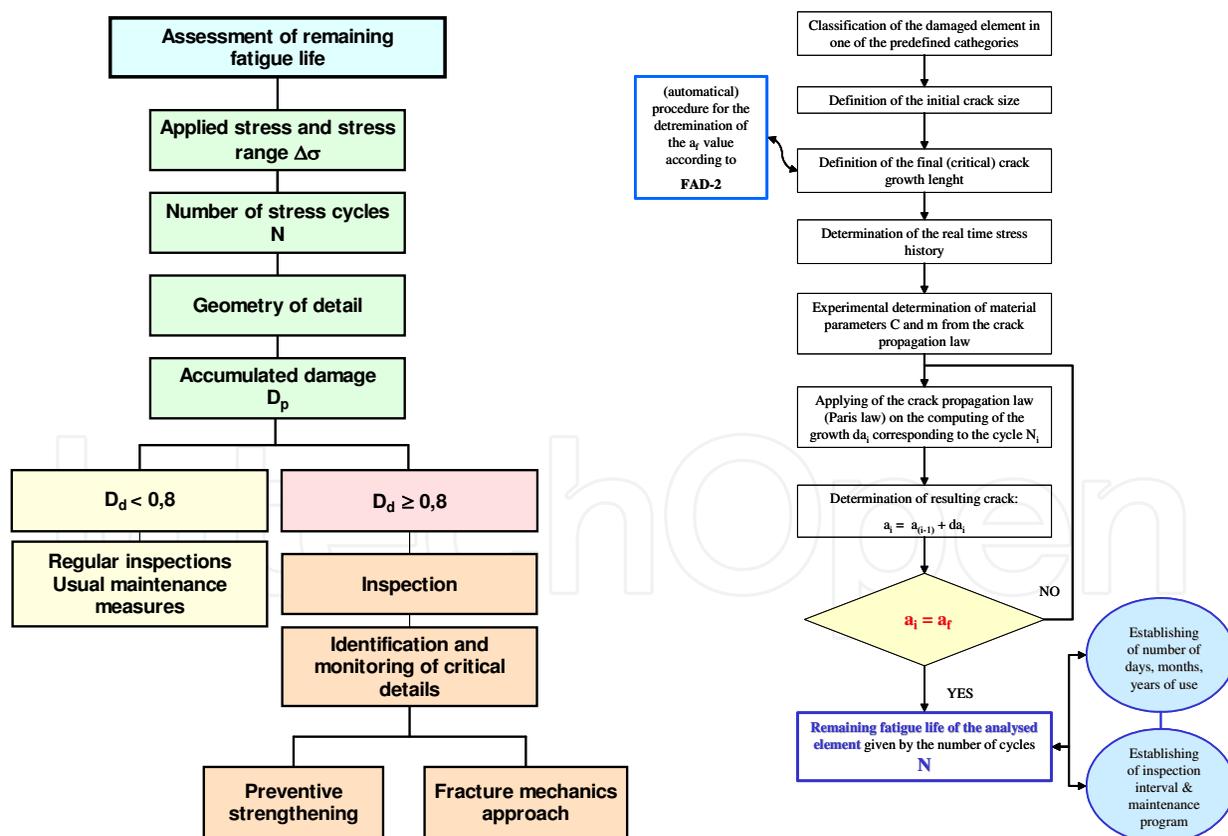
Fig. 16. Assessment of the remaining fatigue life and the crack growth procedure

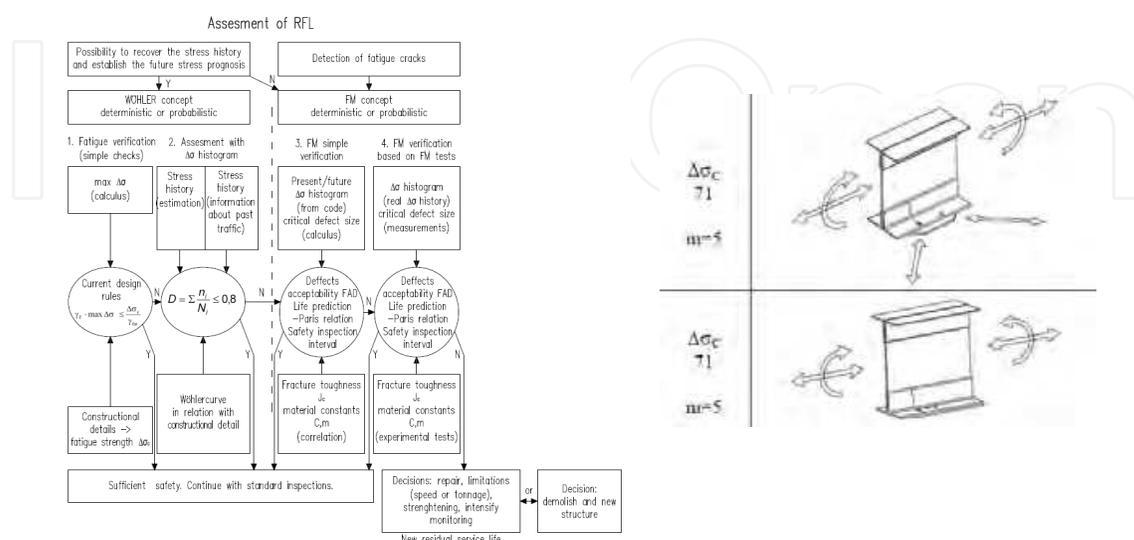
Fig. 19. The methodology and the constructive details for the evaluation of the RFL

All these structures were verified. In the following some aspects regarding the verification of the steel bridges are presented. The methodology which was adopted is showed in the figure 19.

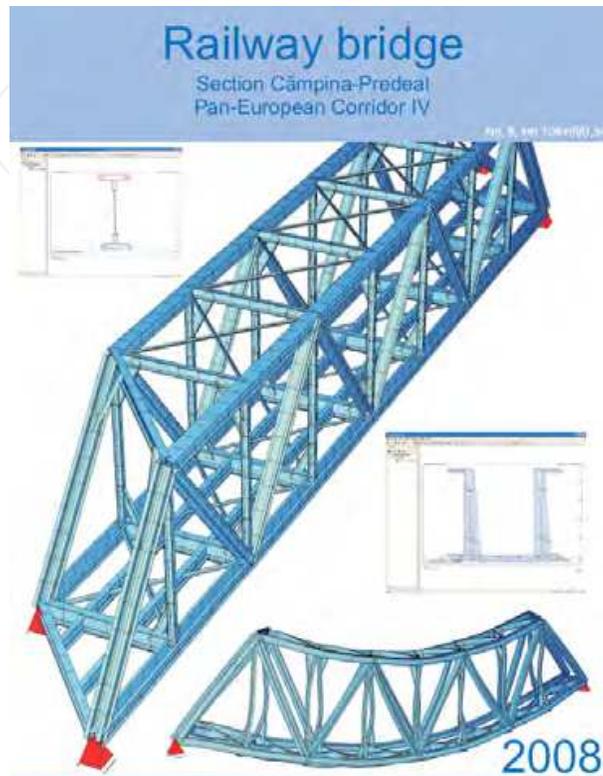
Fig. 20. The static model of the structure no. 6, km 108+690,34

After the stress analysis (Figure 20) and the fatigue verifications based on the Wöhler concept which were made in relation with the prescriptions of the Romanian standard SR 1911-1998, Swiss code 161 & SBB Richtlinie 2002 and the German code DS 805-2002, a life prediction analysis based on fracture mechanics principles was performed in order to evaluate the remaining fatigue life for these structures for the new traffic UIC conditions.

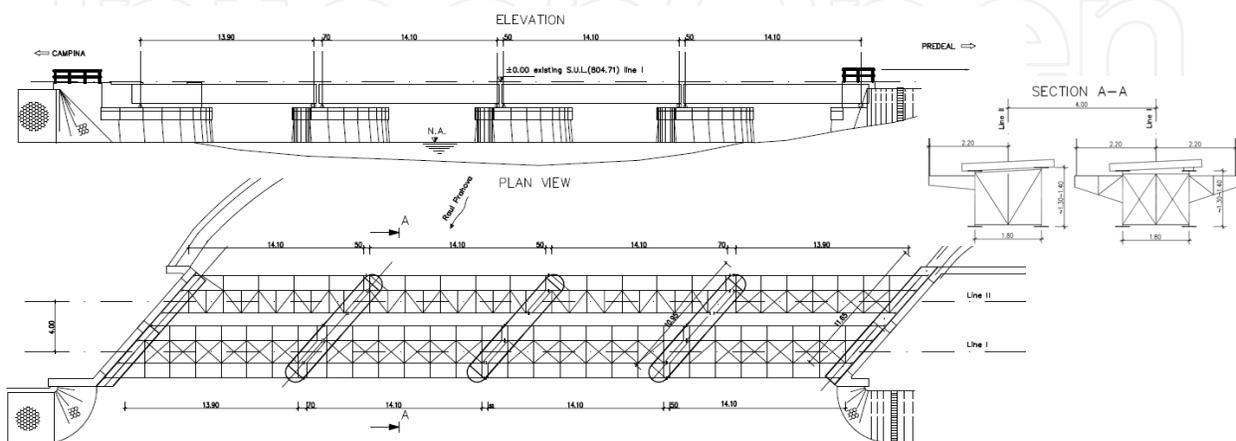
Fig. 21. The general disposition of the bridge no. 28

For example, a plate girder bridge (no. 28, at km 125+323.25) is presented, which is a riveted structures crossing the Prahova River. The structure has four spans, one of 13.90 m and three of 14.10 m each and is skew (skew to the right - $48^{\circ}37'$) and its superstructure is made out of independent plate girder decks.

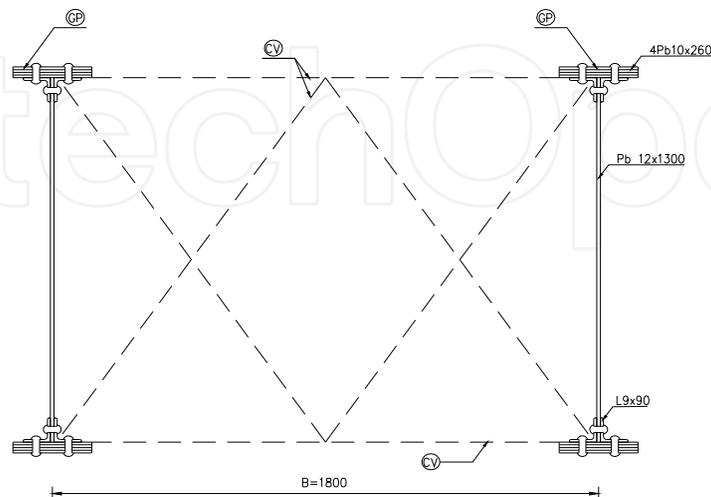
Fig. 22. Dimensions of the steel elements - Main girders

- Construction year - 1940.
- Due to lack of any documentation, the dimensions of the main girders elements were measured in the emplacement (Figure 22).

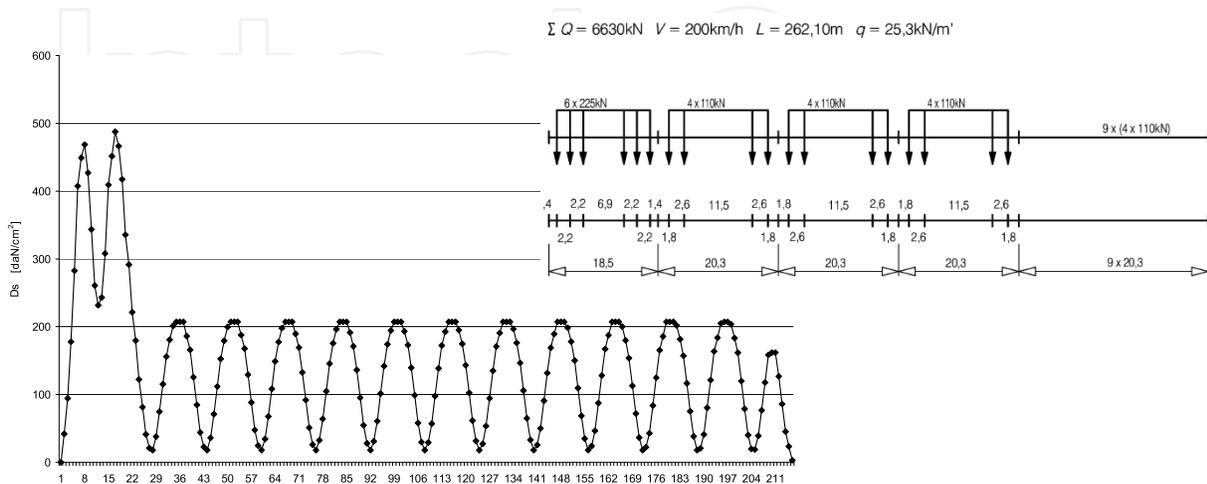
Fig. 23. The stress range diagram $\Delta\sigma$ for train type 1

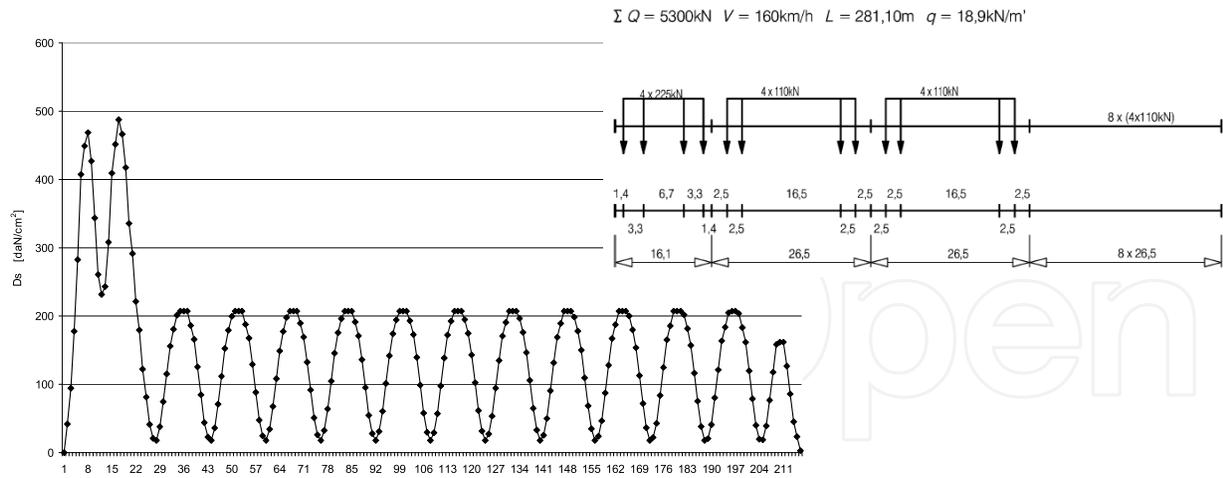
Fig. 24. The stress range diagram $\Delta\sigma$ for train type 2

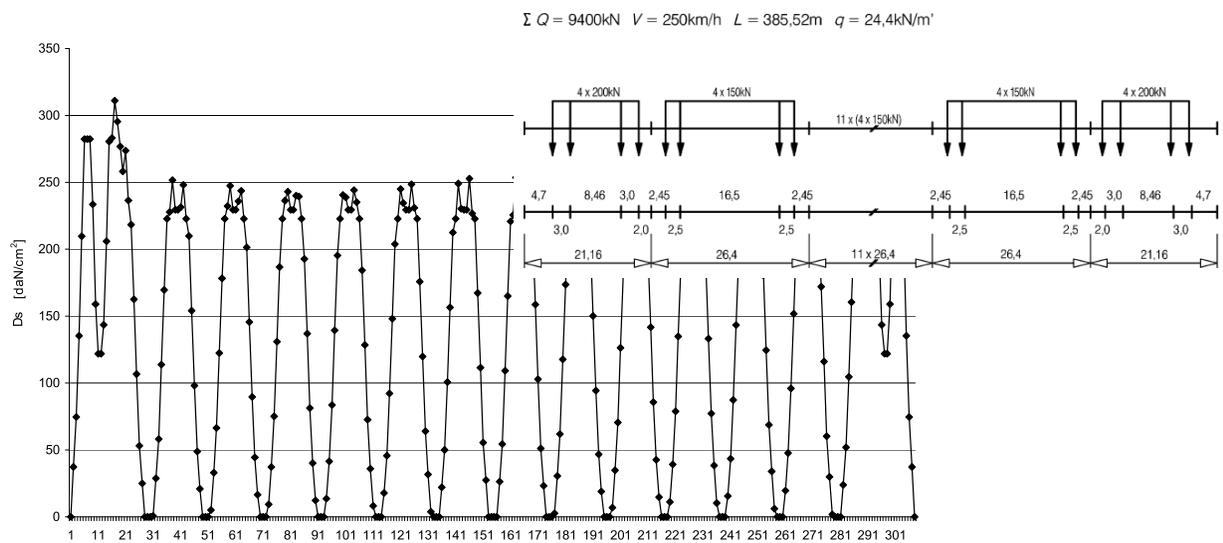
Fig. 25. The stress range diagram $\Delta\sigma$ for train type 3

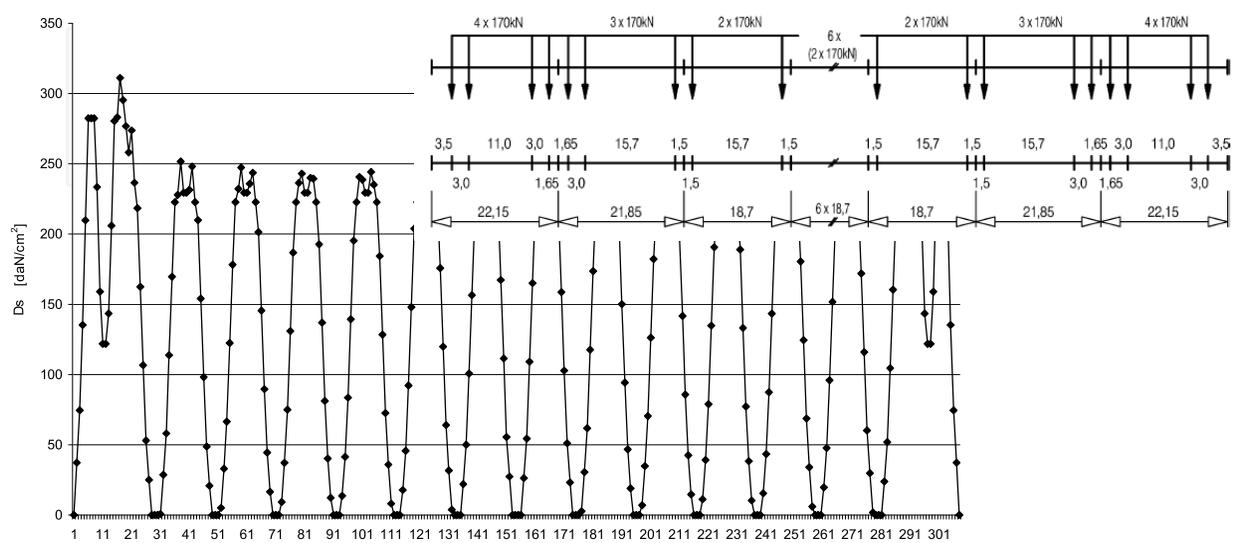
Fig. 26. The stress range diagram $\Delta\sigma$ for train type 4

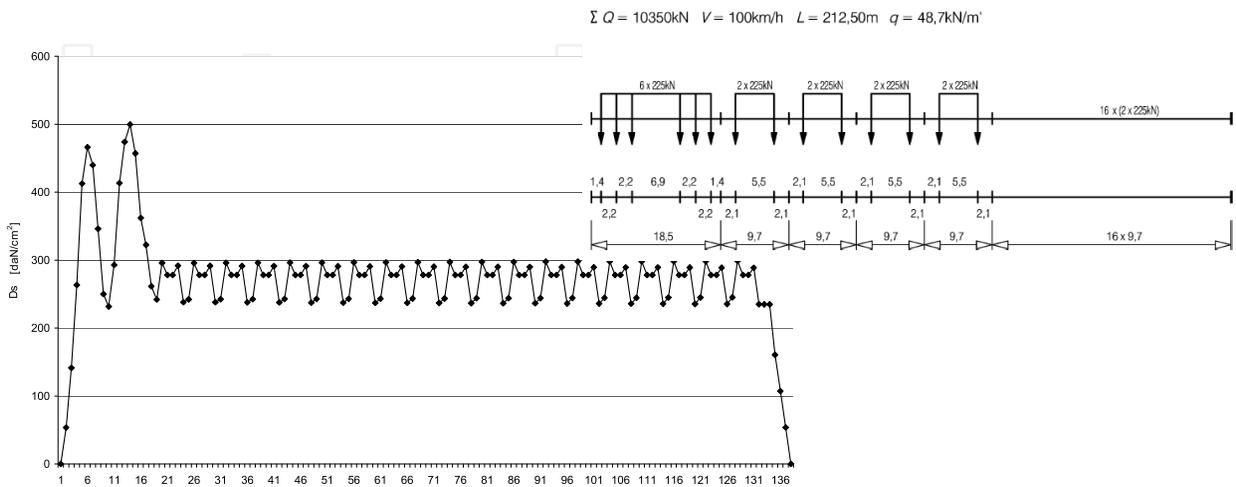
Fig. 30. The stress range diagram $\Delta\sigma$ for train type 8

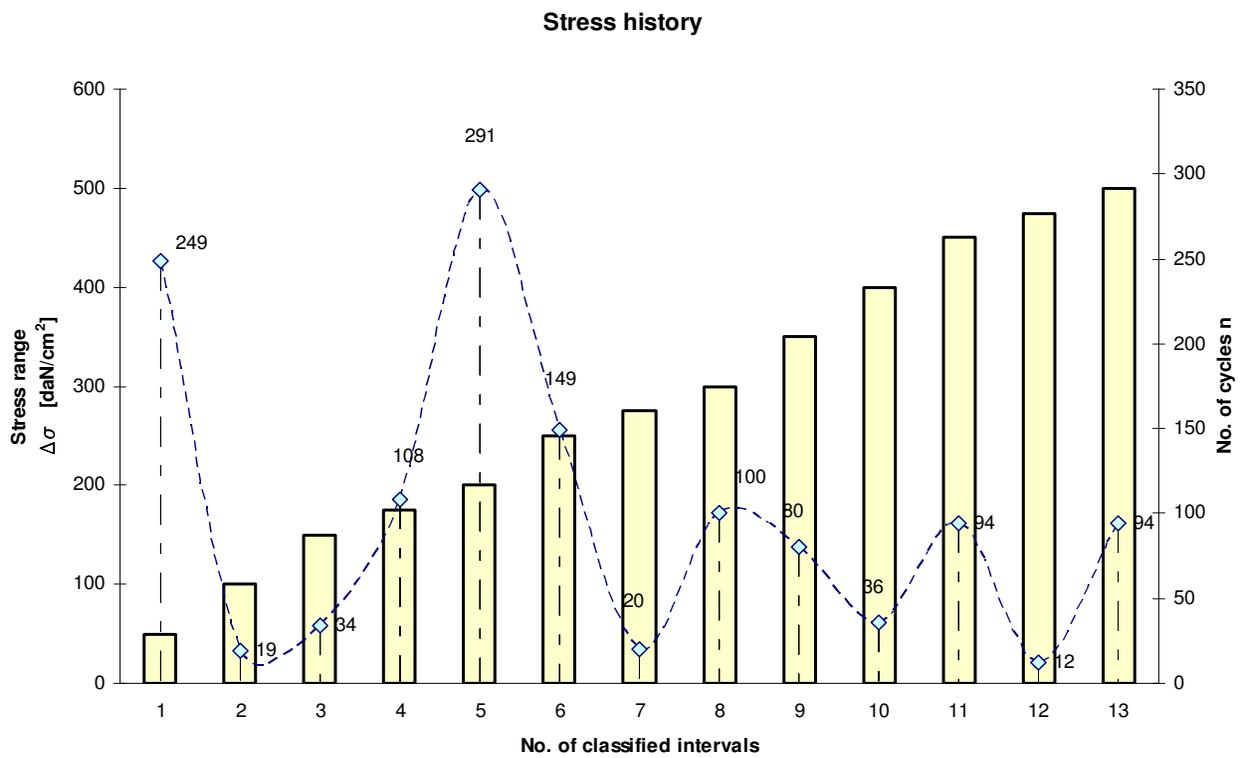
Fig. 31. Stress history

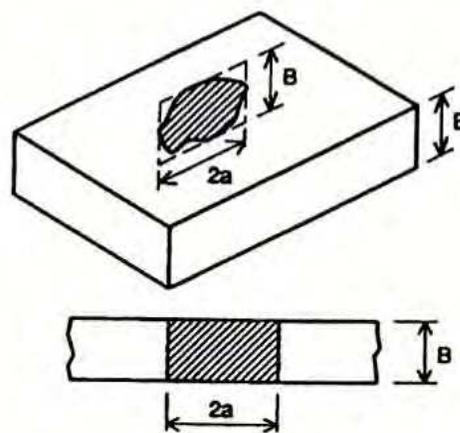
Fig. 32. Theoretical crack models

The crack case assumed for these structures (riveted bridges) is illustrated in figures 32; it is a trough thickness defect.

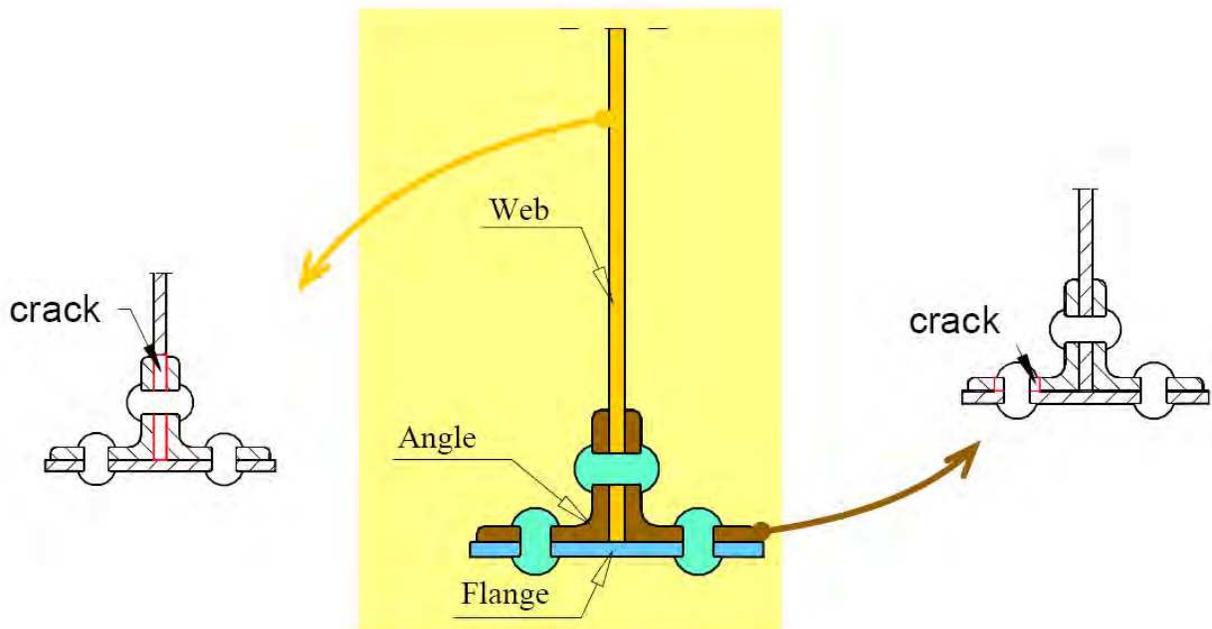
Fig. 33. The two studied defect cases

- through thickness flaw with initial size $a_0 = 2.0$ mm which is undetectable because it is situated under rivet head in the web steel plate, and
- through thickness flaw with initial size $a_0 = 2.0$ mm which is also undetectable during a visual inspection appearing in the corner (lower flange).

In the first case the remaining fatigue life is estimated at a value of 8.31 years (corresponding to a number of cycles of 1 566 000). In the second case the administrator must be acquainted with the fact, that propagation of the crack to the critical value will occur in 8.89 years ($N=1\ 676\ 000$ cycles).

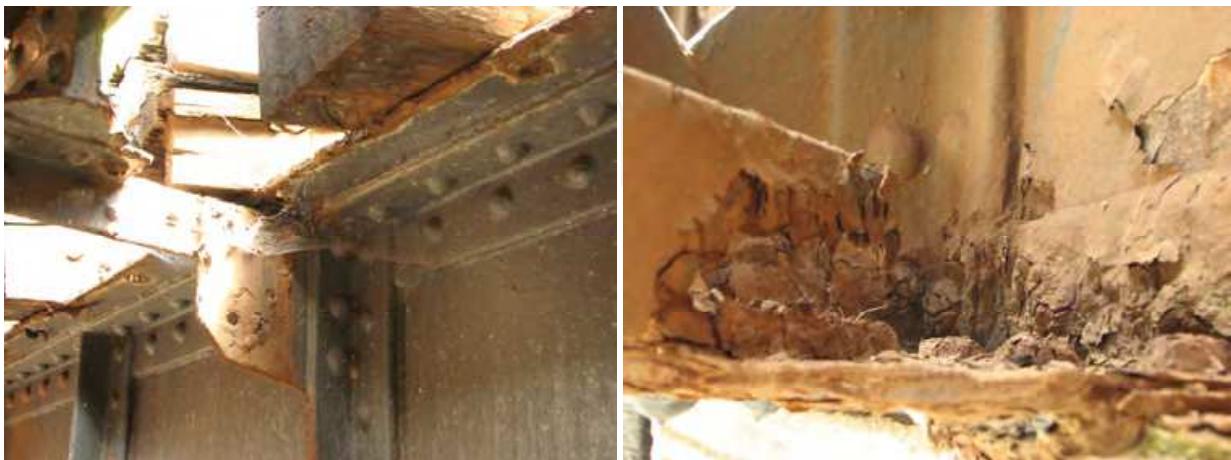
Fig. 34. Corrosion attack details

Finally due to the high corrosion level (Figure 34) and also based on the fatigue assessment, the superstructure was proposed for the replacement.

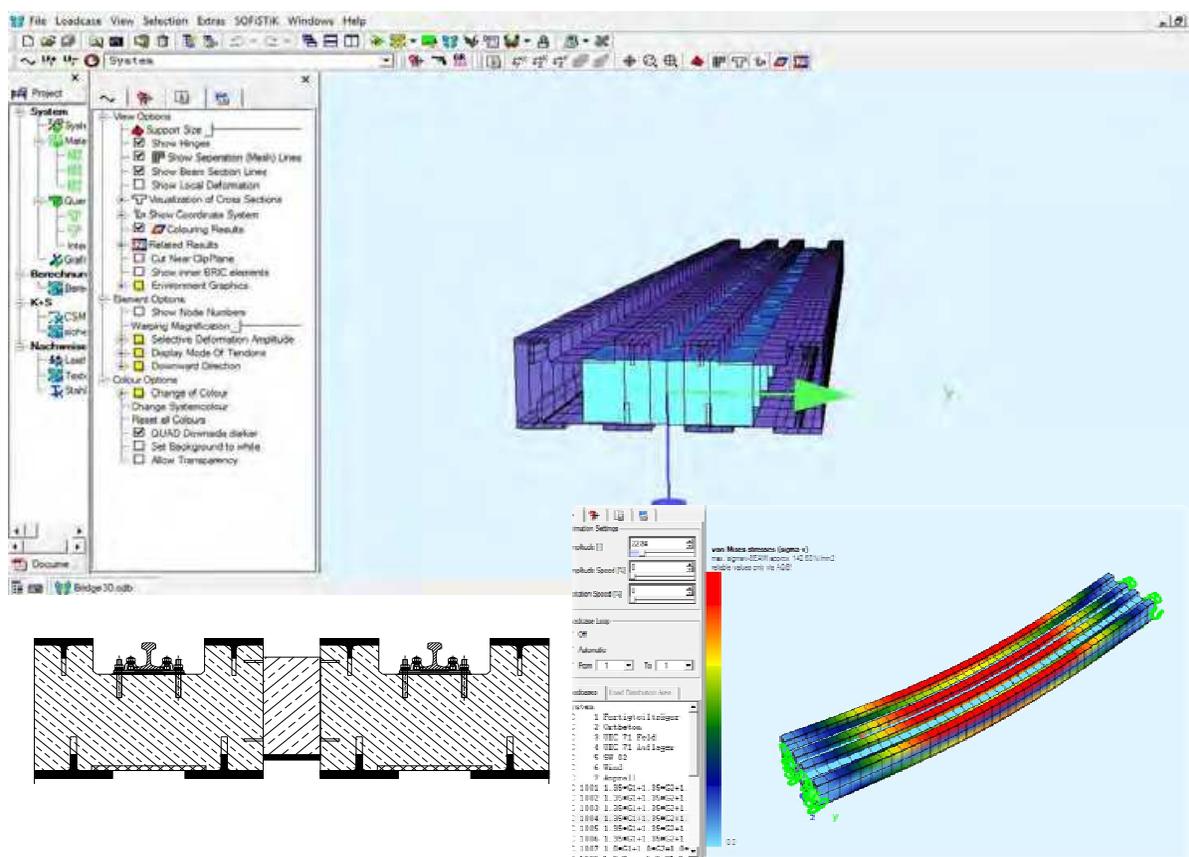
Fig. 35. Cross section of the new structure and calculation model
