# TEM Investigations of Wear Mechanisms of Single and Multilayer Coatings

Łukasz Major<sup>1</sup>, Jürgen M. Lackner<sup>2</sup> and Jerzy Morgiel<sup>1</sup>

<sup>1</sup>*Institute of Metallurgy and Materials Science Polish Academy of Sciences,*

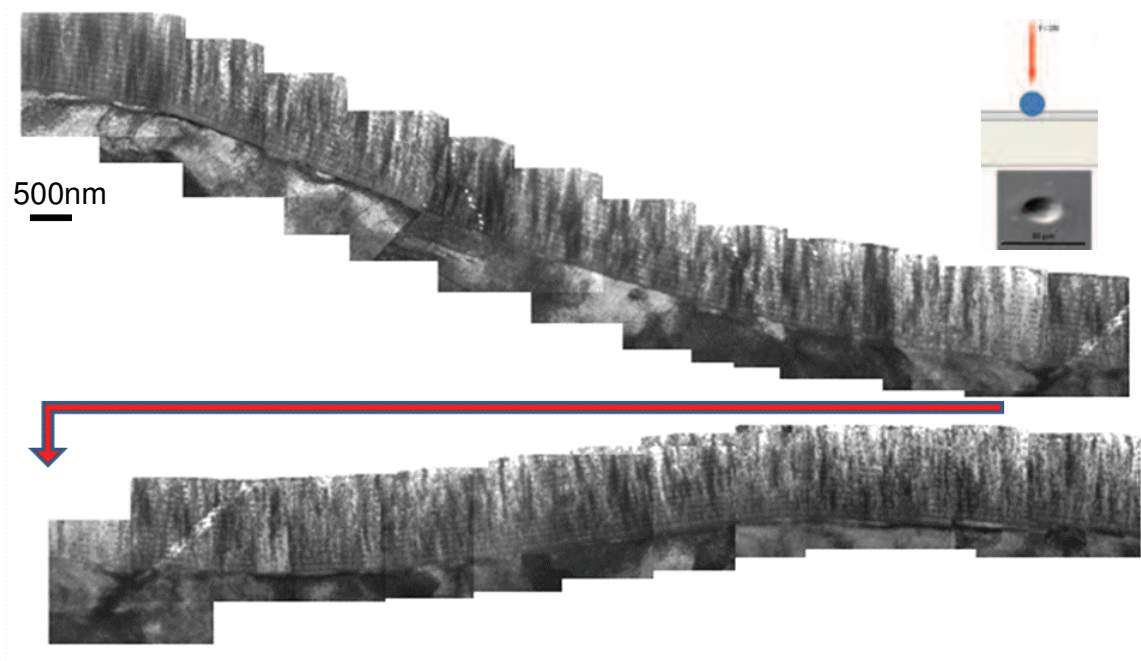
Fig. 12. Microstructure analysis of multilayered Ti/TiN coatings after static mechanical test done on a cross- section by TEM technique.

Both types of multilayer coatings were subjected to static mechanical tests. The tests were based on pushing diamond spherical indenter into the coatings with 1N of the applied load. Ti/TiN multilayer coatings after mechanical test were taken first under consideration focusing on microstructure change after mechanical test (Fig. 12).

The multilayer Ti/TiN coating was strongly deformed. Deformation lines appeared at an constant angle to the crystallites growth. Deformation lines were formed at 45° to the crystallites growth, which is a typical angle of plastic deformation for metallic polycrystalline materials (Fig. 13).
