High Resolution Remote Sensing Images Based Catastrophe Assessment Method

Qi Wen et al.*

*National Disaster Reduction Center of China
China*

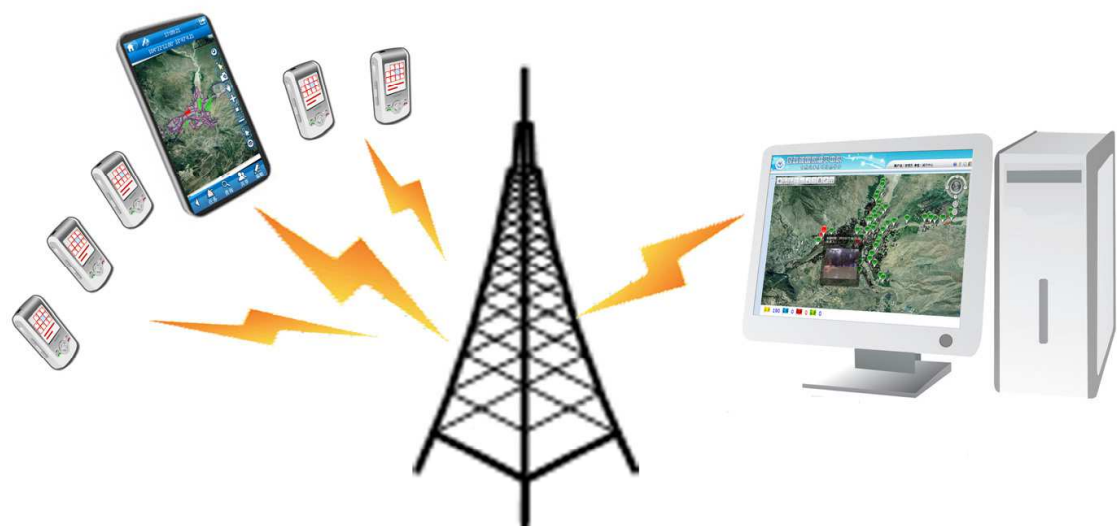
Fig. 2. Ground Disaster Information Collection System

Ground Disaster Information Collection System is a GIS software with the client-server architecture. The client side implemented in mobile phone is used to collect text and picture disaster information, label the position and send information to the sever side. The server side receives information from client side, interprets it and stores it to database.

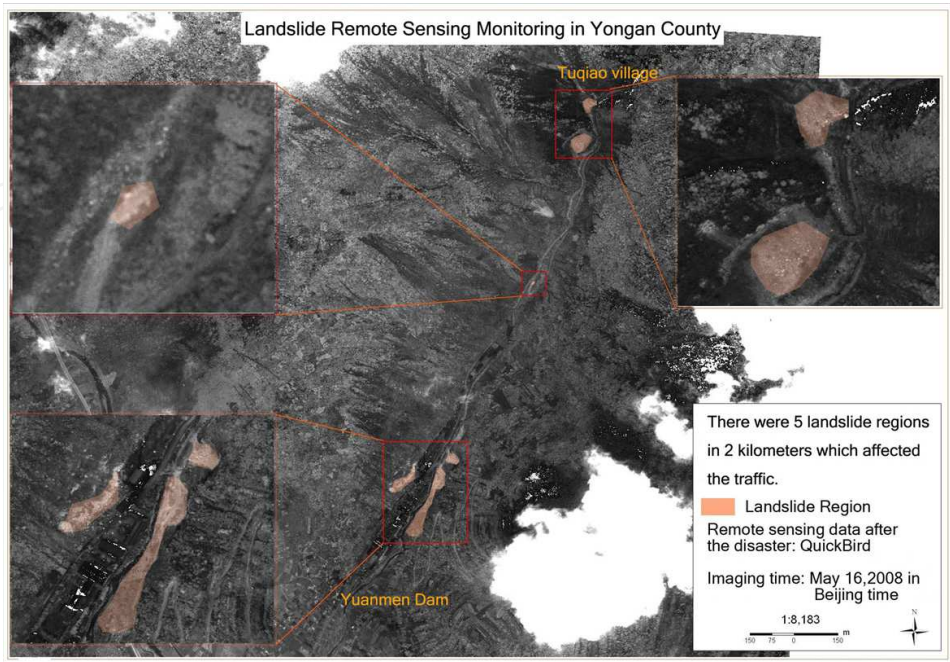
Fig. 10. Remote sensing image from Quickbird satellite about landslide around Yongan County

Quickbird satellite image on May 16th illustrates 5 landslides happened in a 2-kilometre diameter area around Yongan County, which seriously interrupted traffic (Figure 10).

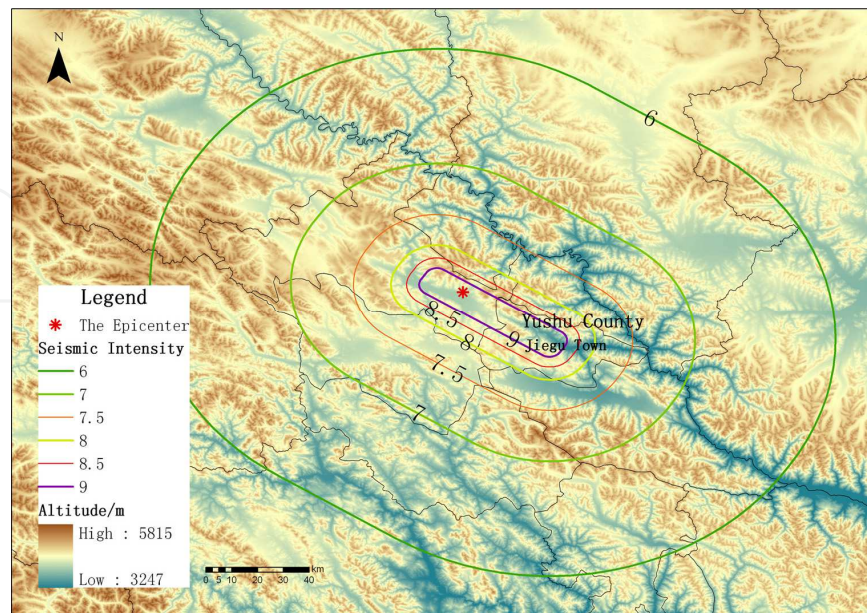
Fig. 13. Seismic intensity and terrain distribution map

distribution. Jiegu Town, Yushu County was in the hard-hit area with IX degree. Figure 13 illustrates contour of seismic intensity and terrain distribution.

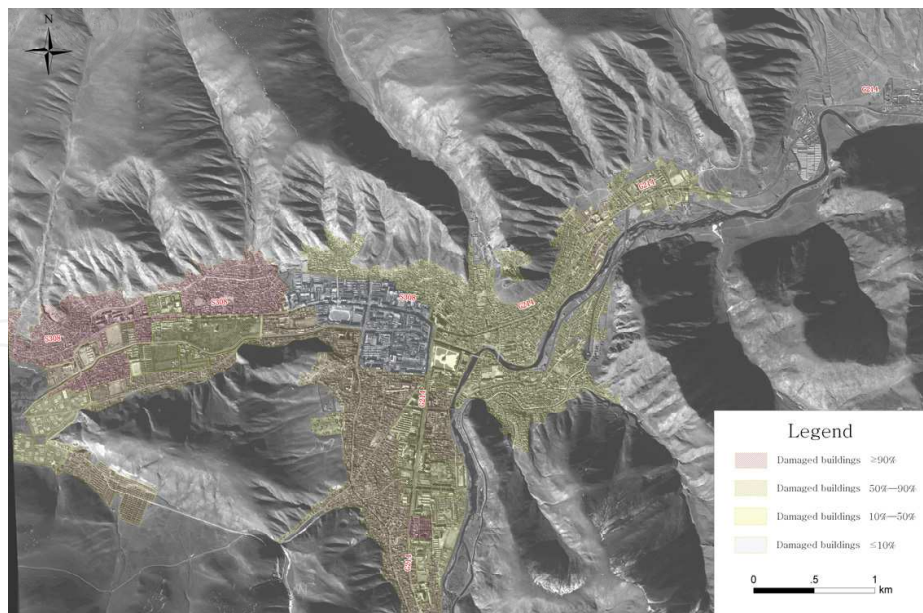
Fig. 14. Rapid assessment of disaster scope and extent of houses damage

By comparing pre-disaster airborne remote sensing images and post-disaster EROS-B high resolution satellite images, we analyzed the damage condition of housings, and estimated disaster scope and damage extent rapidly. Figure 14 illustrates the assessment result.

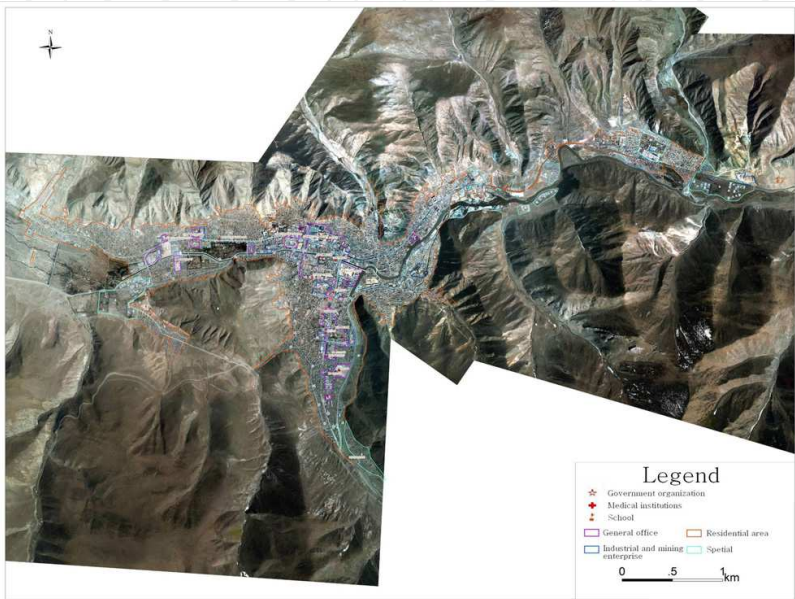
Fig. 15. Grids of first level

First level (Figure 15) includes 4 categories: government office, community, industry area, and restricted area; second level (Figure 16) includes 6 categories: government office, school, general office, community, industry area, and restricted area; third level (Figure 17) includes 5 categories: building, bungalow, greenhouse, square, and stadium.

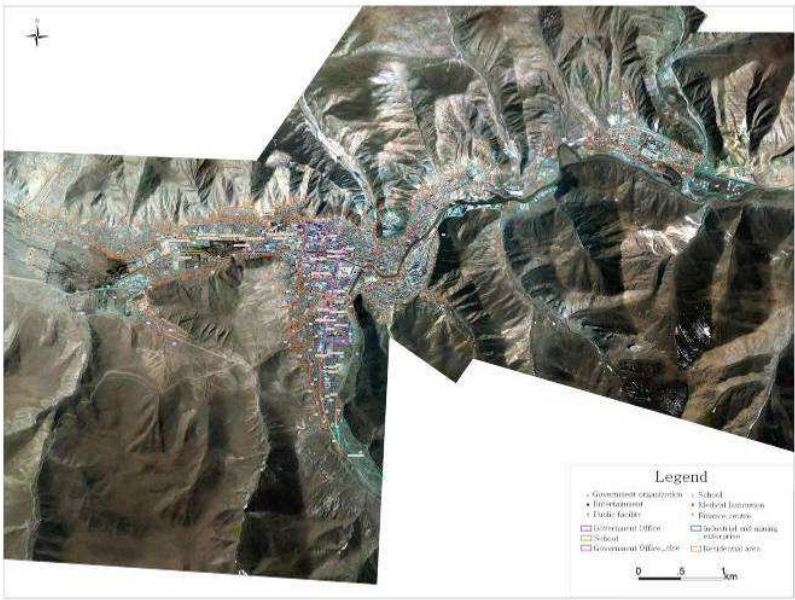
Fig. 16. Grids of second level

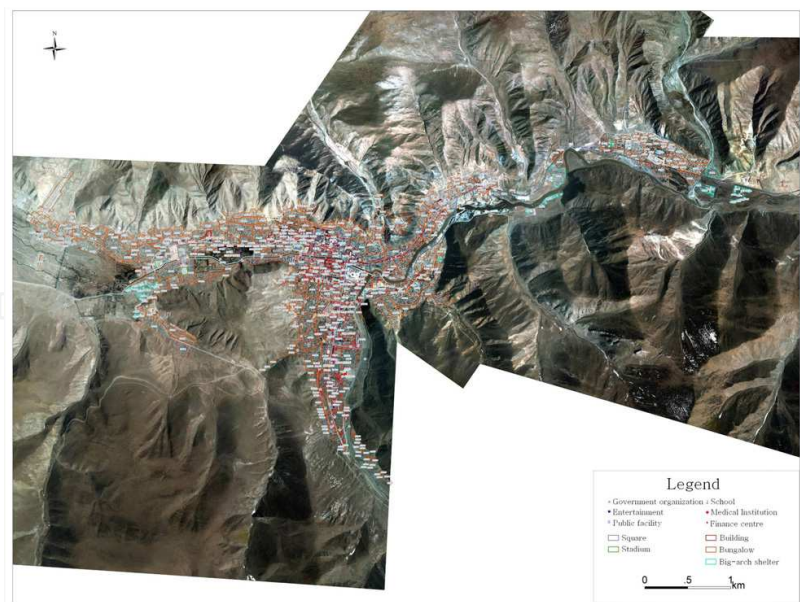
Fig. 17. Grids of third level

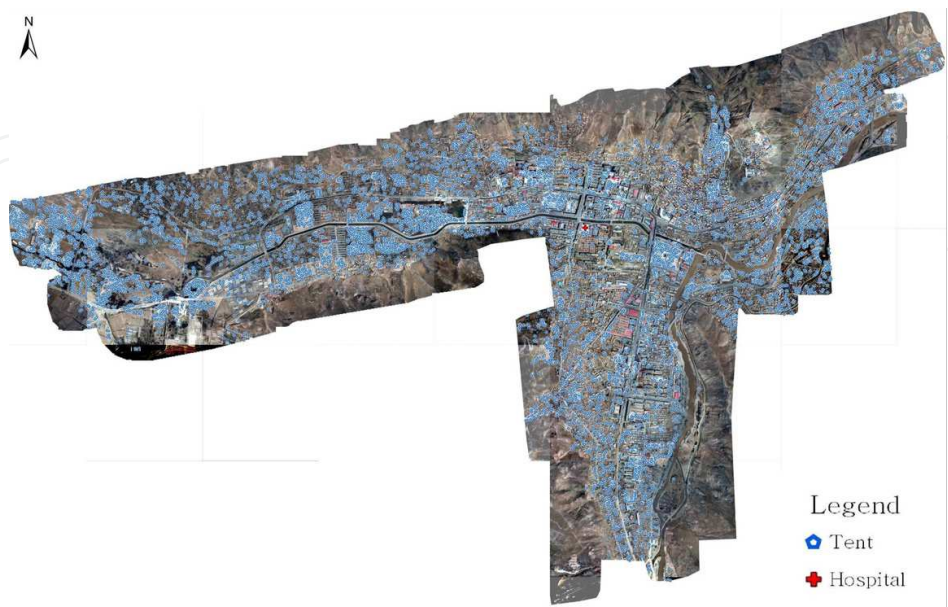
Fig. 18. Tent settlement monitoring

According to UAV monitoring images of 0.2m in Figure 18, 9861 refugee tents were placed in Jiegu urban region by April 19th, 5 days after the quake.

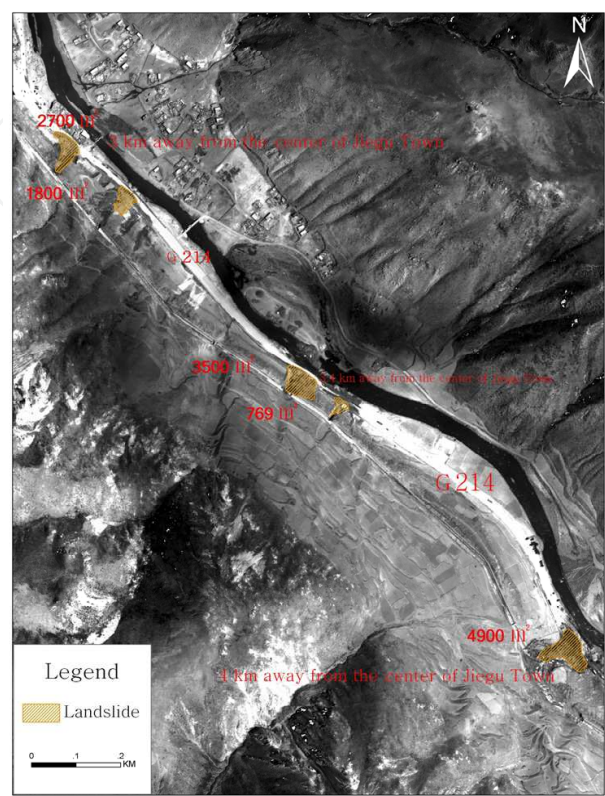
Fig. 19. Traffic jam monitoring and assessment in landslide regions

26 landslide regions were spotted, among which 5 were along Road 214 in the south of Jiegu town, which resulted in traffic jam. The other 21 were mainly located in mountain region and had little affect to traffic. Figure 19 illustrates traffic jam caused by landslide along Road 214.

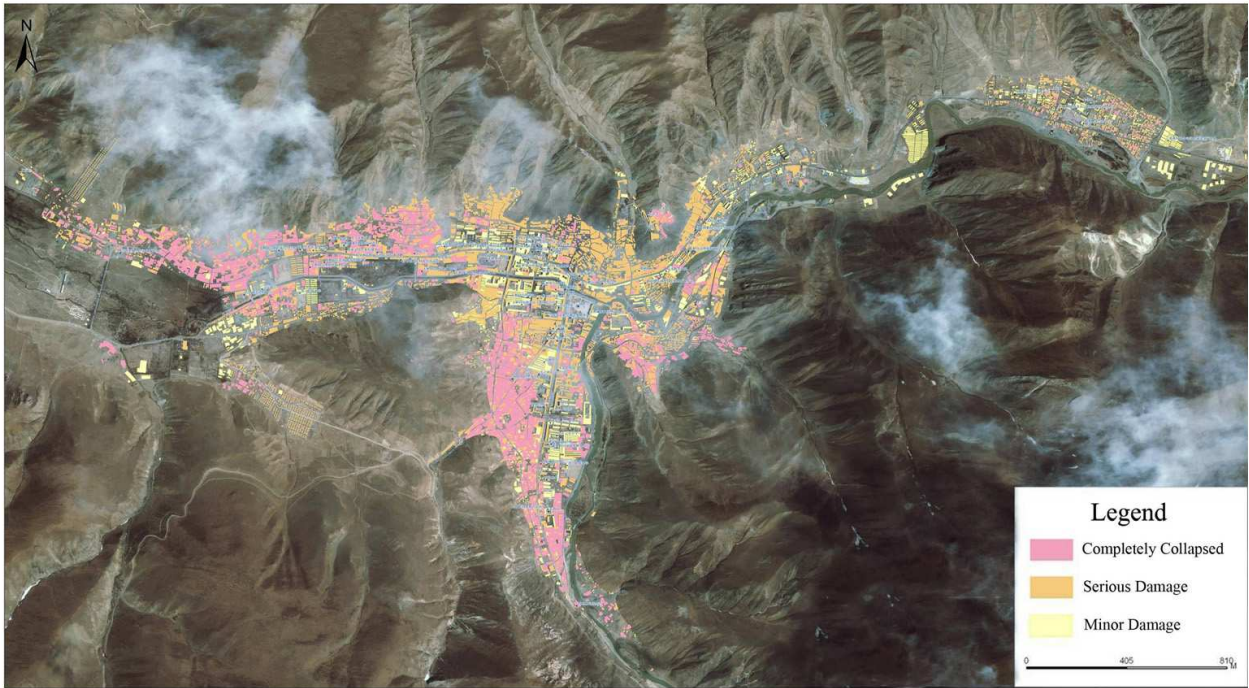
Fig. 21. Housing damage assessment results

The housing damage scope and extent of loss were defined again by integrating field investigation data, data reported by local government (Figure 21). This is the first time satellite-airplane-ground integration assessment mode used in national disaster assessment. The damage scope was partitioned into three parts: collapsed building area, about 1,314,000m²; serious damaged building area, about 2,332,000 m²; and minor damaged building area, about 680,000 m². Collapsed building is defined as houses collapsed into ruins; serious damaged building as structures of houses been destroyed, thus it must be reconstructed; minor damaged building as structure been slightly affected, and it can still be used after reinforcement. Figure 8 and table 1 show housing damage assessment results. Figure 22 illustrates the remote sensing hazard monitoring and assessment flow in Yushu Earthquake.

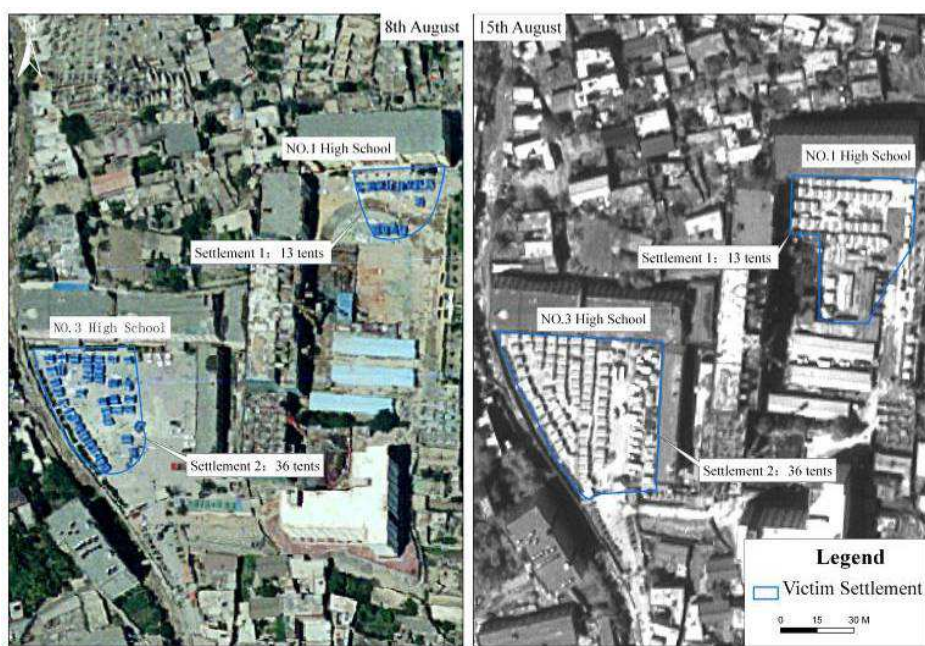
Fig. 25. Settlement monitoring map

Figure 25 and Table 3 shows refugee settlement monitoring result. Tents number increased a lot from August 15th to August 8th.

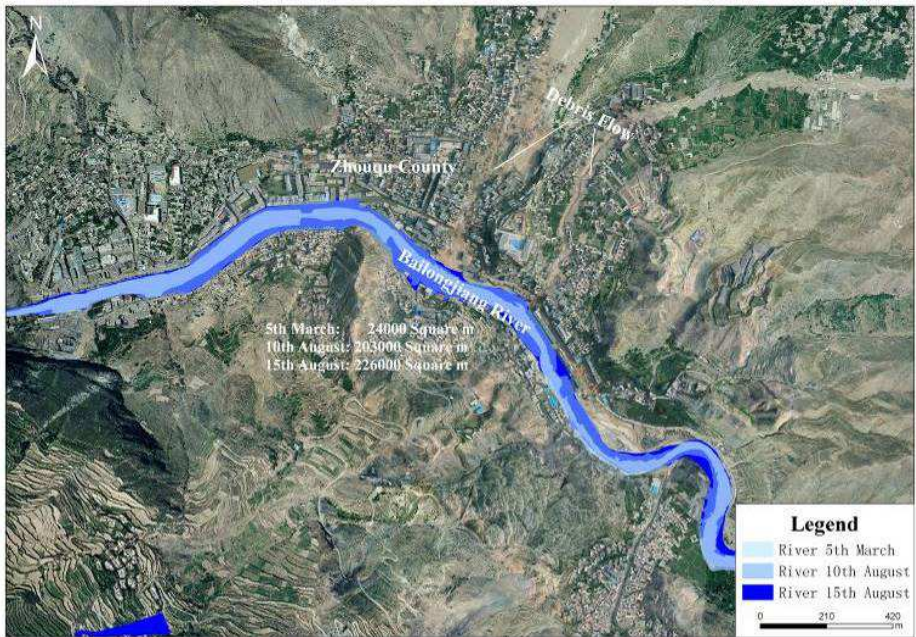
Fig. 26. Water area monitoring map

The flooded area expanded obviously (Figure 26), with about 226,000 m² in August 15th, 23,000 m² more compared with that in August 10th, and 102,000 m² more compared with that in May 5th.
