The Use of Fiber Reinforced Plastic for The Repair and Strengthening of Existing Reinforced Concrete Structural Elements Damaged by Earthquakes

George C. Manos and Kostas V. Katakalos

<http://dx.doi.org/10.5772/51326>

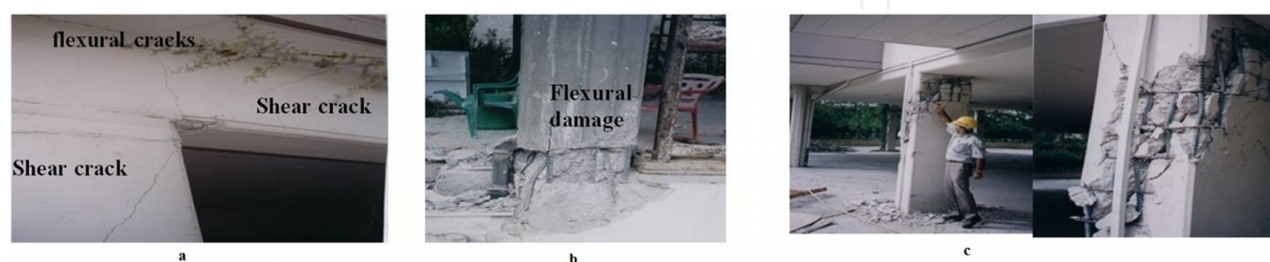
Figure 2. a Typical damage of beam at the joint with the nearby column (6th story building, Aharnes, Athens earthquake 1995), [2]. b Typical damage of the toe of a column at ground floor (two-story building, Nea Kifisia,, Athens earthquake 1995), [2]. c Typical shear damage at the columns of a “soft story” (4-story Metamorfofi building, Athens earthquake 1995), [2].

ance of shear damage in the form of diagonal cracks (figure 2a). The presence of large bending moments mainly from the seismic load together with large axial forces will cause the formation of flexural damage at the top and the toe of columns (see figure 2b) whereas the presence of shear forces from the seismic loads together with axial forces will lead to the formation of shear damage at the columns (see figure 2c). The presence of large shear forces from seismic loads together with relatively low level axial forces will lead to the development of shear damage in the shear walls (see figure 3a) whereas the presence of short columns will lead to the development of large shear forces from seismic loads and the development of shear damage as shown in figure 3b.

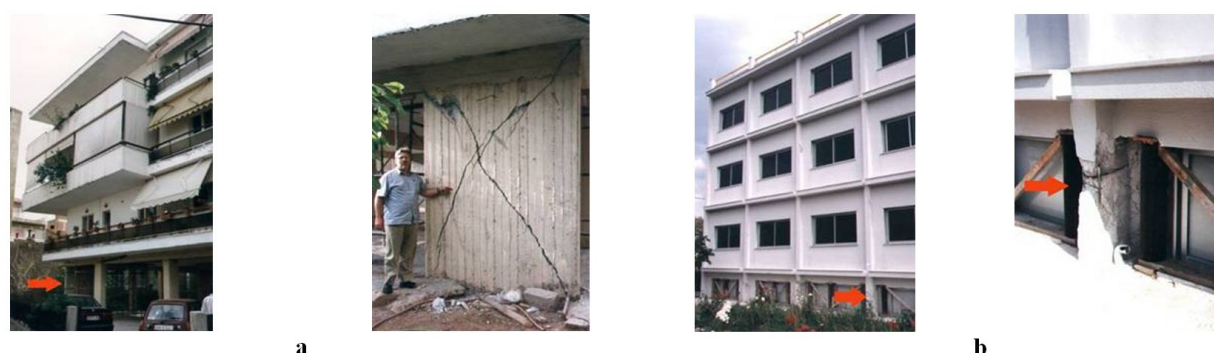
Figure 3. a Typical damage of shear walls at the “soft story” during The Kozani 1995 Earthquake in Greece. b. Typical damage of “short” columns during The Kozani 1995 Earthquake in Greece.

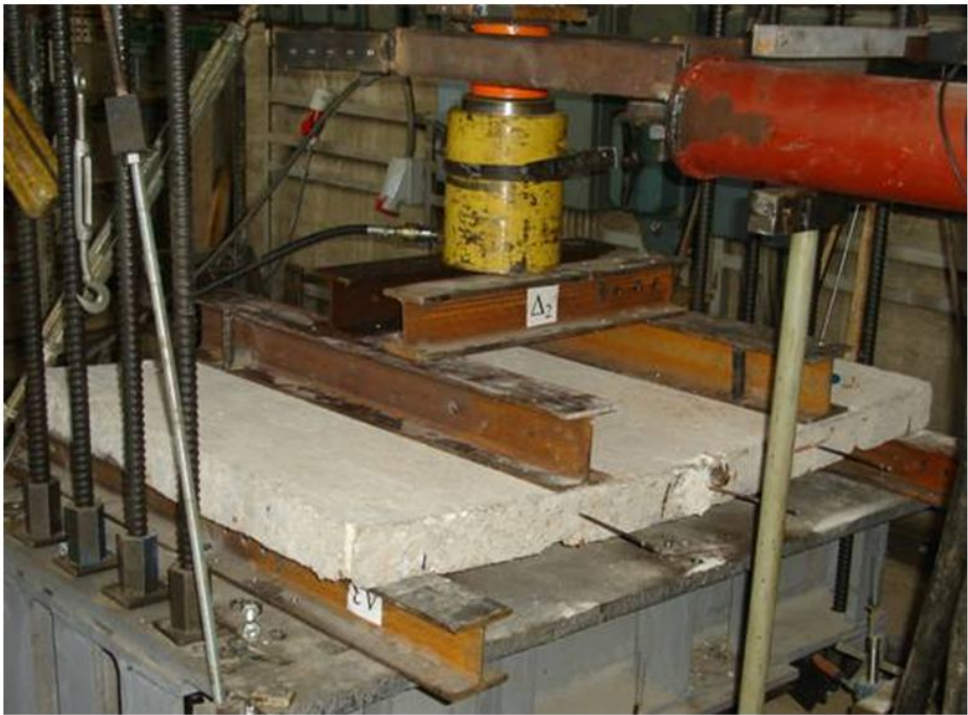
Figure 7. Loading arrangement of the slab specimens in flexure.

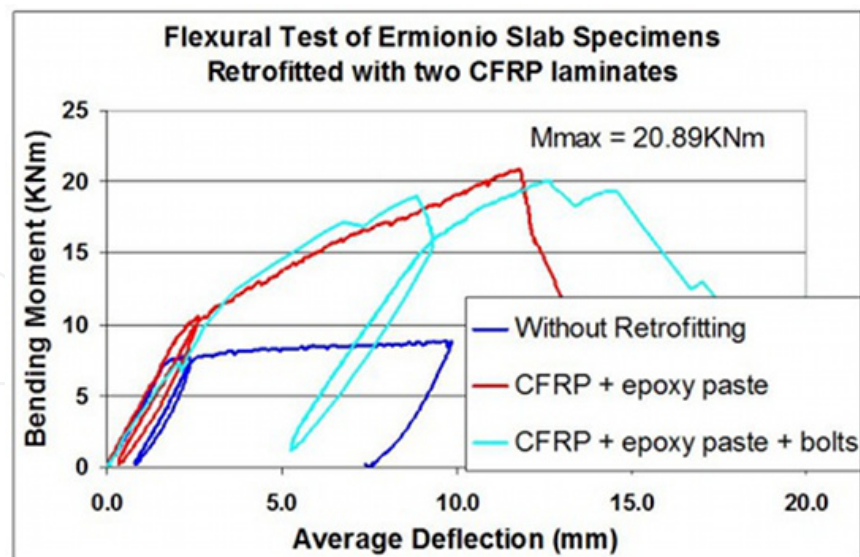
Figure 8. Flexural behavior of Ermionio slab specimen retrofitted with two CFRP laminates either bonded only with epoxy paste or with epoxy paste and bolts.

136% when compared to the maximum bending moment value of the un-retrofitted slab. This retrofitted slab failed in the form of the debonding of the CFRP laminates (figure 9). The debonding of the two CFRP laminates was followed by a sharp decrease in the flexural bearing capacity together with the formation of a plastic hinge at mid-span in the form of excessive plastic deformations of the old steel reinforcing bars at the bottom of the slab as well as crushing of the concrete at the top of the slab. Next, two new CFRP laminates were reattached to the same slab specimen; this time epoxy paste was used again together with bolts penetrating through the slab and securing the attachment of these CFRP laminates. The flexural bearing capacity of the slab this time reached the same maximum bending moment value as the one observed when only epoxy paste was used for the attachment of the laminates; they exhibited satisfactory performance without any signs of failure either in the form of debonding or fracture. This is shown by the bending moment versus mid-span deflection curve plotted for this test in figure 8. Despite the satisfactory performance of the CFRP laminates, no increase in the flexural bending capacity could be achieved due to the slab damage from its previous loading history; however, the performance of the anchors for the attachment of the CFRP laminates was satisfactory and the flexural behavior of the slab exhibited a much larger range of deformability (figure 8).

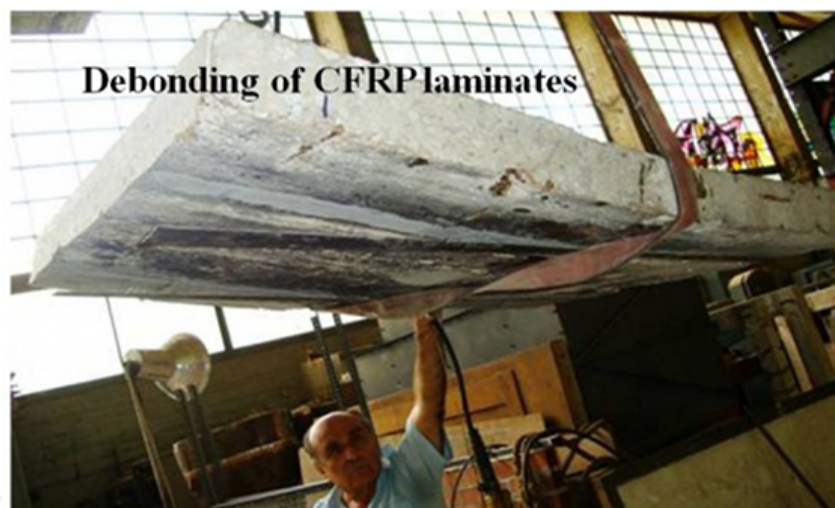
Figure 9. Flexural failure of the Ermionio slab specimen retrofitted with two CFRP laminates bonded only with epoxy paste. The CFRP laminates were debonded from the concrete slab in this case.

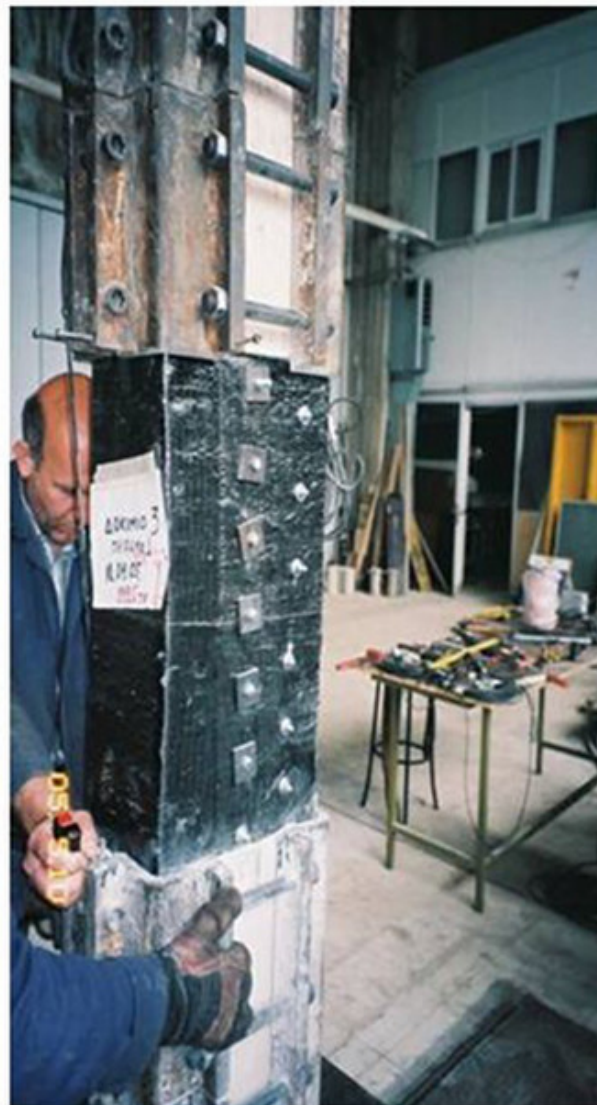
Figure 27. Specimen with confining steel brackets at the edges and partial CFRP confinement at the mid-part

The reinforcing details are depicted in figure 26. As can be seen, the total height of the specimens was 1600mm. They had a mid-part height of 580mm that was left to develop the compression failure (figure 26, part denoted as CROSS SECTION A). The cross section of this mid-part was the one shown in figure 25b, including the two distinct parts (the weak and the strong). The two edges of the specimens, with a height of 510mm each, were confined during the experiment with strong steel brackets covering these parts from all sides thus prohibiting any compressive failure developing at those two edges (see figure 27).

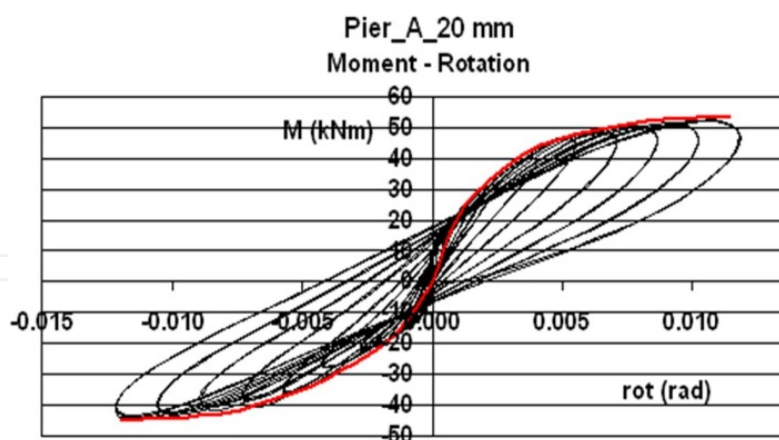
Figure 38. The measured flexural response of Pier A in terms of bending moment - plastic rotation.

The yield stress of the longitudinal reinforcements was equal to 344.8MPa whereas the concrete strength was equal to 21.2MPa. Based on these mechanical characteristics and the cross-section reinforcing detailing, predictions of the limit-state flexural behavior for this virgin specimen (without CFRP) were obtained in terms of the M-N interaction. The limit-state flexural behavior of a specimen with 2 layers of CFRP attached to both vertical sides of a repaired specimen is also obtained, based on the assumption that the cross-sections under flexure remain plane even with the attachment of the CFRP layers. The development of flexural cracks took place as shown in figure 37. At this horizontal cross-section the measured flexural behavior of Pier A is depicted in figure 38, which presents the variation of the resulting bending moment at this cross-section of the specimen against the rotation of the same cross section,. The rotation was obtained from measurements made by displacement transducers that were placed at the two sides of the pier monitoring the relative vertical displacement between the upper part of the specimen and its foundation block. Additional instrumentation was provided to monitor the rocking or the sliding of the foundation block itself, which proved to be non-significant. The observed maximum bending moment value compares quite well with the corresponding predictions of the limit-state flexure for this cross-section. The red line in these plots represents the corresponding envelope curve.

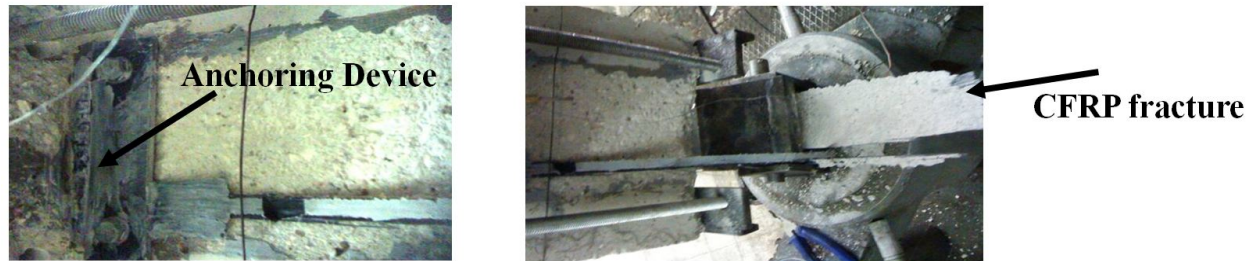
Figure 48. Detail of the anchoring device and the fracture of the CFRP strip when such an anchoring device is employed.
