Acoustic Emission of Composite Vessel

Hyun-Sup Jee and Jong-O Lee

1. Introduction

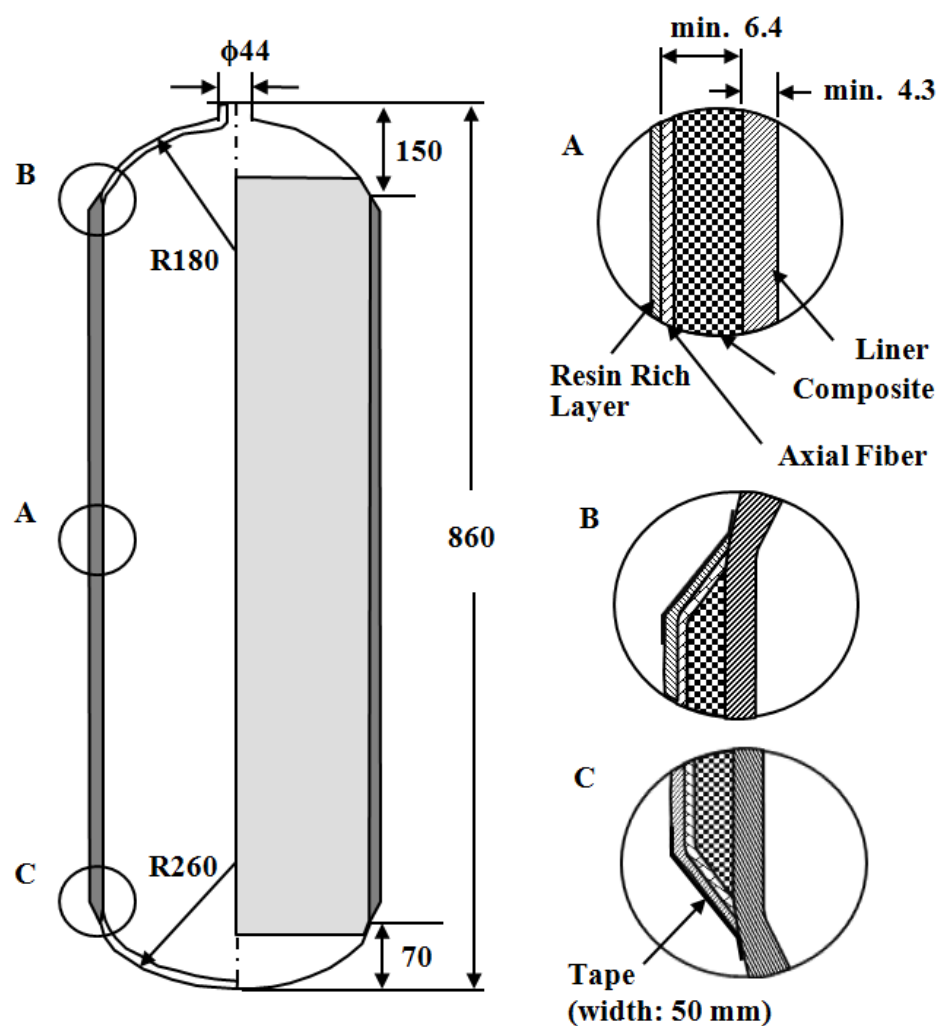
Figure 1. Schematic diagram of experimental vessel

Experiment vessel used in this research is a 64 Liter CNG fuel tank used in vehicles. The thickness of the liner in the shell is about 6 mm and was made using the DDI (Deep Drawing Ironing) method[12,13] using 34CrMo4 steel plate, and is a type-II vessel in which glass fiber is hoop-wrapped on the shell of the liner.

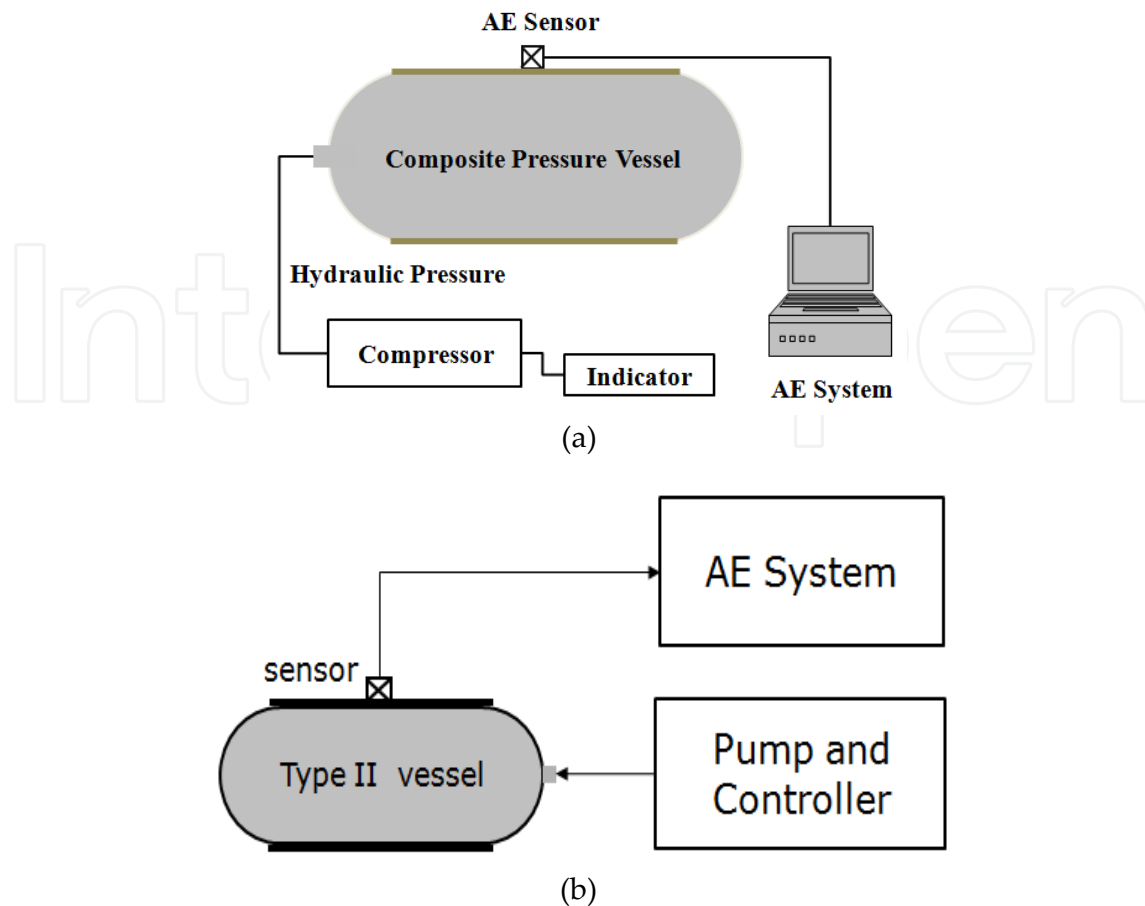
Figure 2. Diagram of Experimentation : (a) Burst and (b) fatigue test of the composite vessel

For the test, the acoustic emission sensor is R15I (PAC) with the resonance frequency of 150 kHz and cable of RG58A/U (10m) is put on the middle of shell using the vacuum grease.

The detected AE signal is put into the DiSP-52 Acoustic emission workstation (PAC) for processing. In addition, the water was used as medium for burst test. The threshold value of test was set at 45dB. The source of simulated sound was the destruction of the 2H Pentel pencil lead. The average sensitivity of sensor was 98dB within 1 inch from sensor.

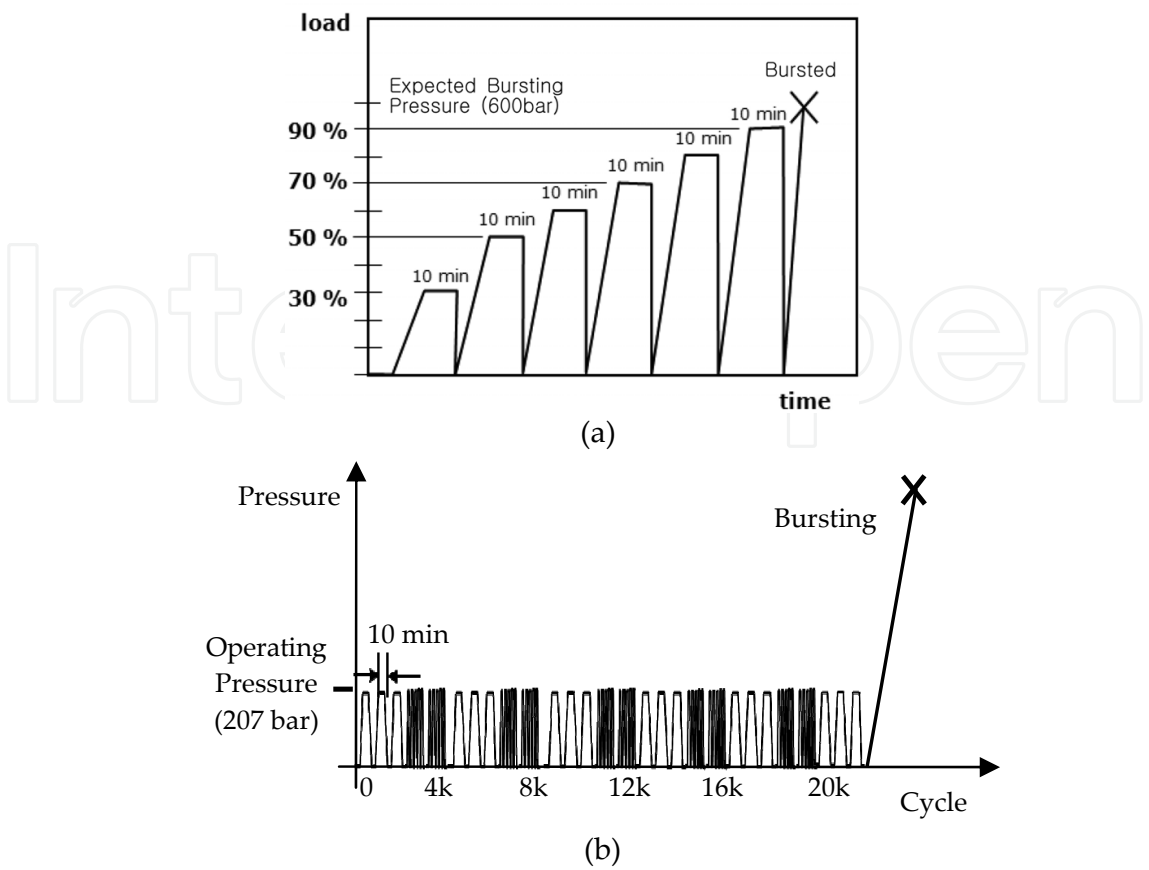
Figure 3. Loading sequence : (a) Burst and (b) fatigue test

The burst pressure was estimated to be 600 bar under the pressured conditions. By raising the pressure to 30%, 50%, 60%, 70%, 80% and 90% of estimated burst pressure and keeping each pressure stage for 10 minutes as in Figure 3(a), we acquired the AE signal from each stage. As can be seen in the figure, pressure was put on the vessel with a pump to control the pressure and acoustic emission signals were detected using acoustic emission sensors attached to the vessel. And the signal were processed and analyzed after fed into AE equipment. The fatigue test repeated 20000 cycles between 0 and 207 bar, afterwards which has a used pressure of 0 and afterwards, the pressure was continuously increased and the burst test was carried out. Figure 3(b) shows the conditions for pressurization.

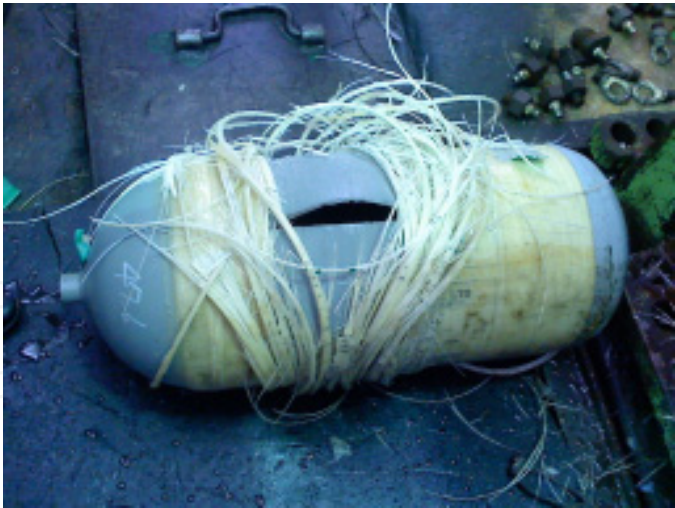
Figure 4. Composite vessel after burst test

First, the composite materials wrapped in the metal liner were separated due to the matrix crack and then each layer was separated from each other. Then, some section of the fuel tank was weakened due to the cutting of some reinforced fiber, causing the destruction of metal liner of that part and finally destroying the vessel.

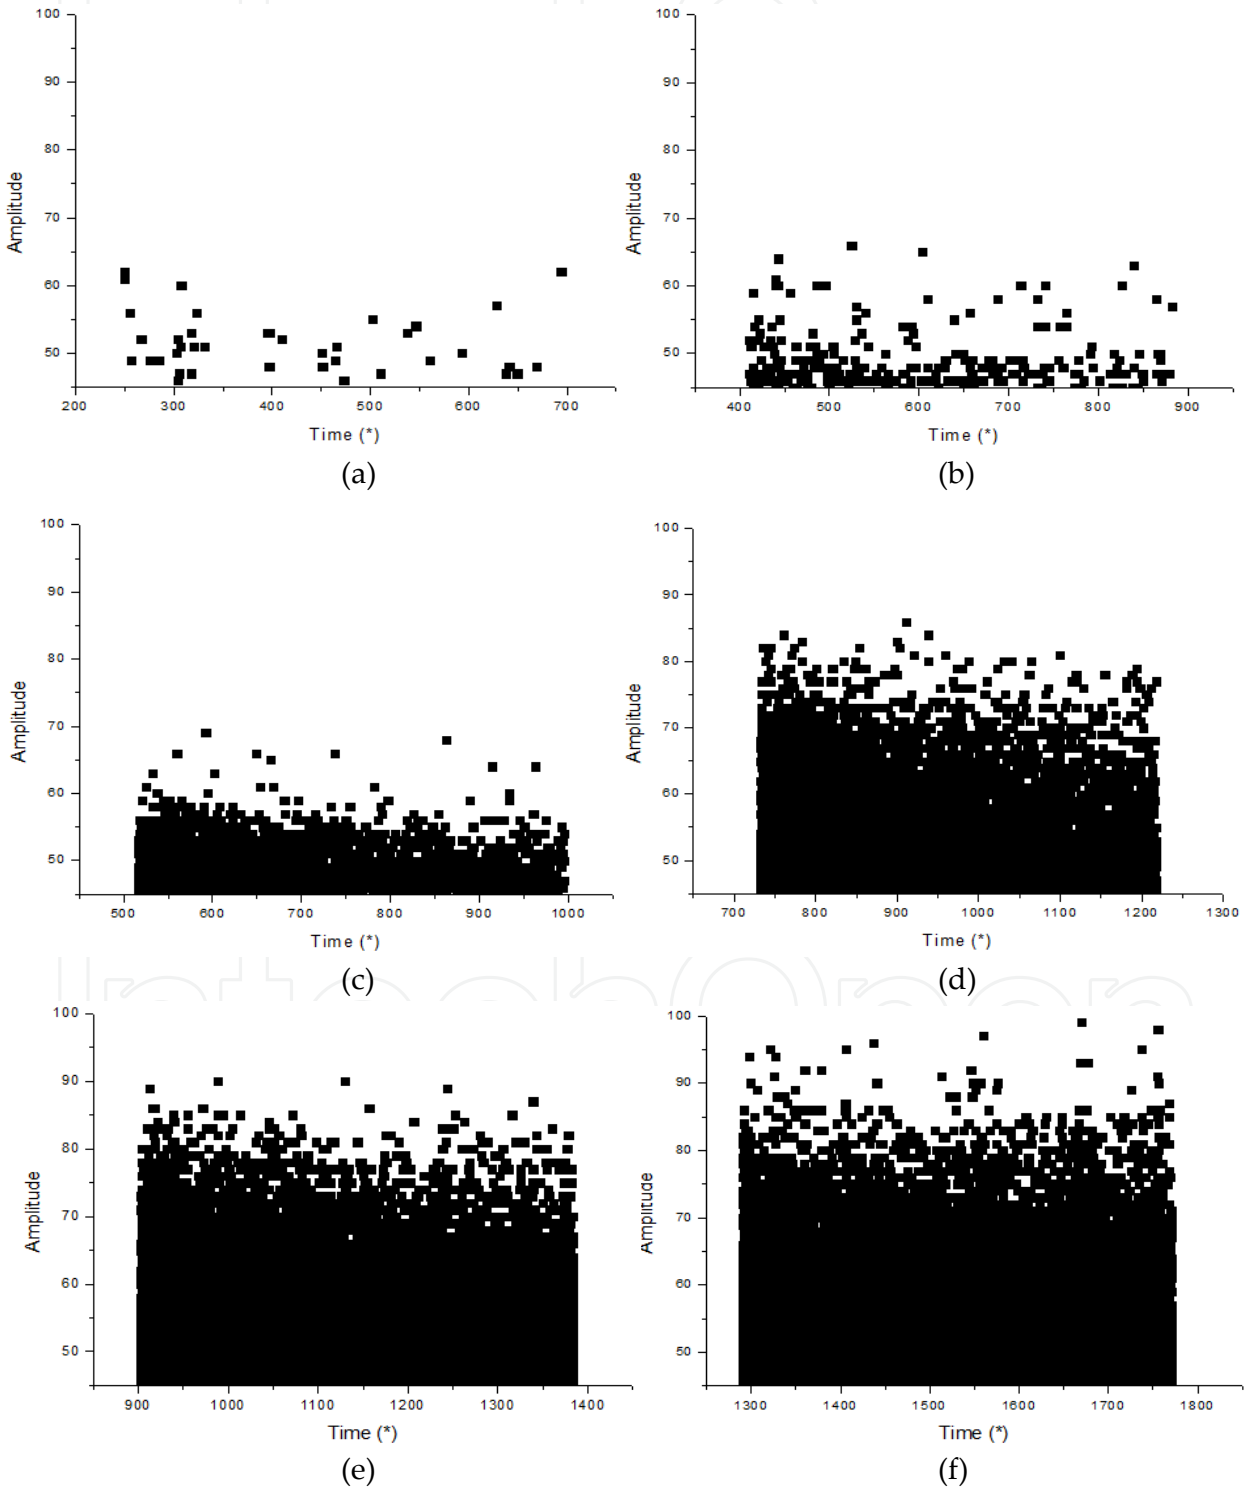
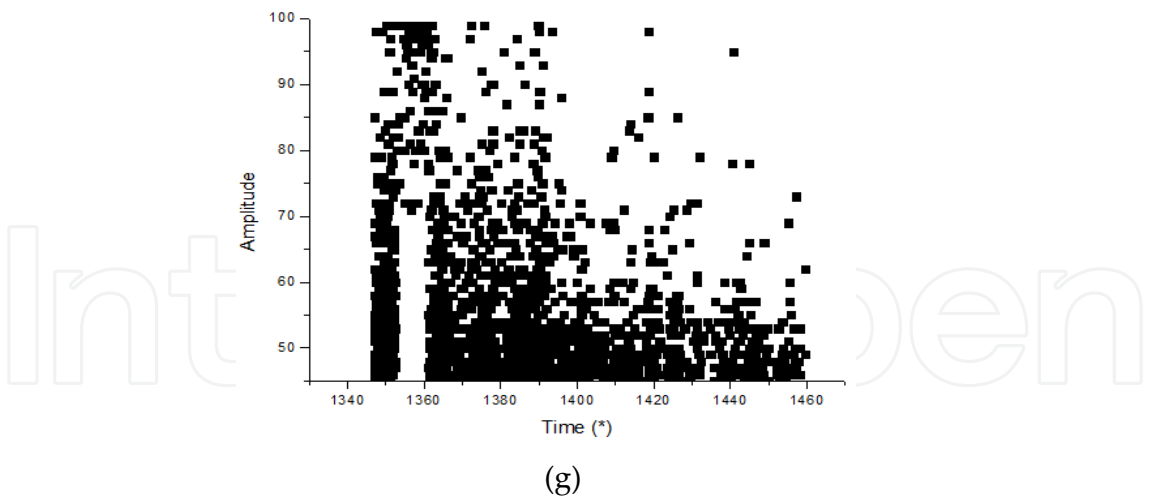
Figure 5. Amplitude vs Time plot during load holding : (a)30% (b)50% (c)60% (d)70% (e)80% (f)90% and (g)fractured

pressure on the vessel and keeps the pressure for some time until some sound emits from it. This is called the analysis of creep effect. The values in Figure 5 show that the pressure up to 360 bar, or 60% of the expected burst press is weak, showing that the vessel is not likely to receive significant damages. But after 70% of the expected pressure, the signals of 60dB or more are often shown, which may mean that there is a lot of creep effect and that the significant damages have been done to the vessel.

The pressure rise to the 80 % and 90 % of the expected burst pressure shows a lot of signals with high amplitudes. At the pressure stage of 540 bar or higher, where the burst is likely to occur, the signals with the amplitude of 80-100 dB continue to occur while giving the continuous leak signal from 1352 seconds to 1361 seconds. The burst occurred when the pressure rapidly went down to 400 bar. Figure 6 shows the total hits from 2 minutes after the start of each load. There is a rapid increase in the number of hits when the load pressure goes over 70 % of the expected burst pressure where the significant damage is likely to happen. In the final destruction, the number of total hits is low because the time to destruction was short, considering the felicity ratio and the pressure rising up to the fracture.

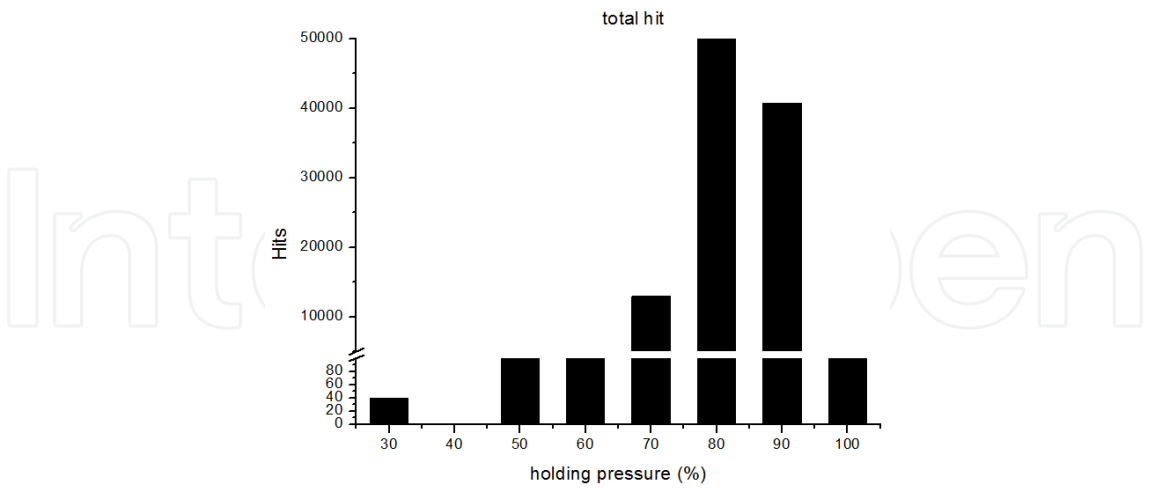
Figure 6. Total hits during load holding

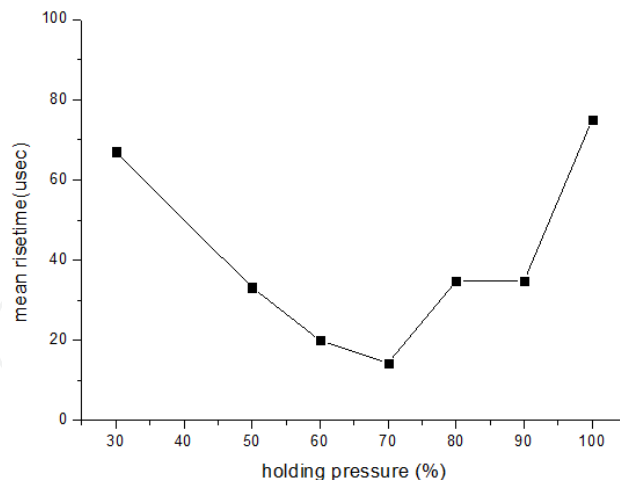
Figure 7. Mean rise time during load holding

Figure 7 and 8 show that the average rise time and duration for the signals occurred during the holding time of each load. The rise time and duration become shorter up to loads up to 70 % while those from time of 80 % to the time of burst get longer, during which the damage is likely to be greater.

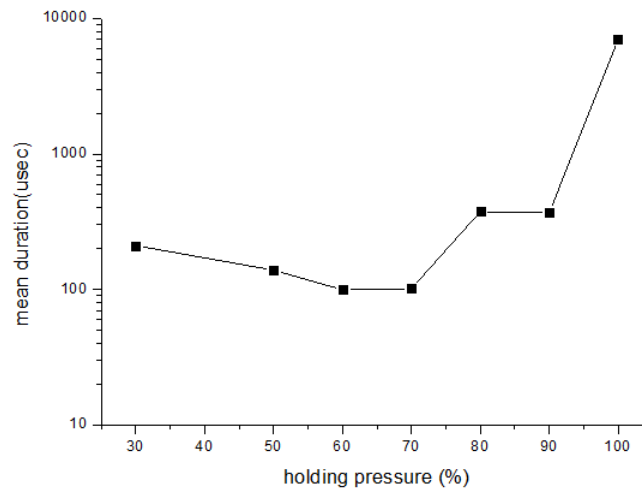
Figure 8. Mean duration during load holding

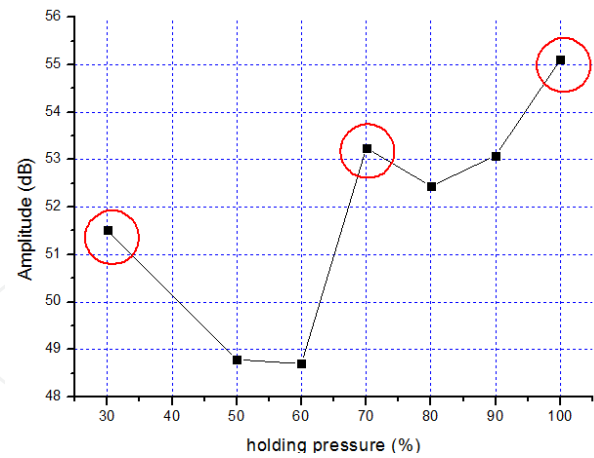
Figure 9. Mean amplitude during load holding

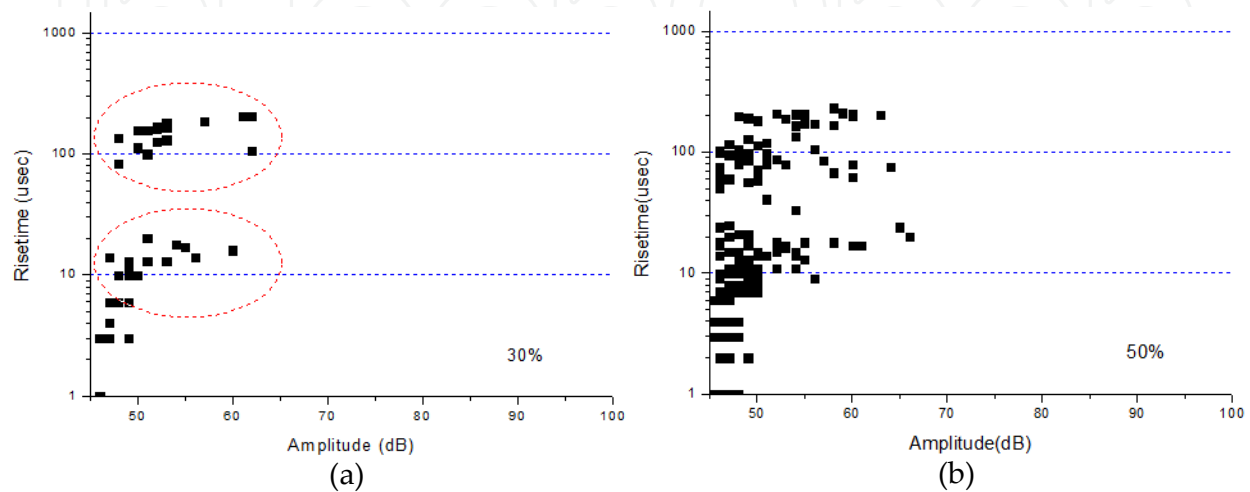
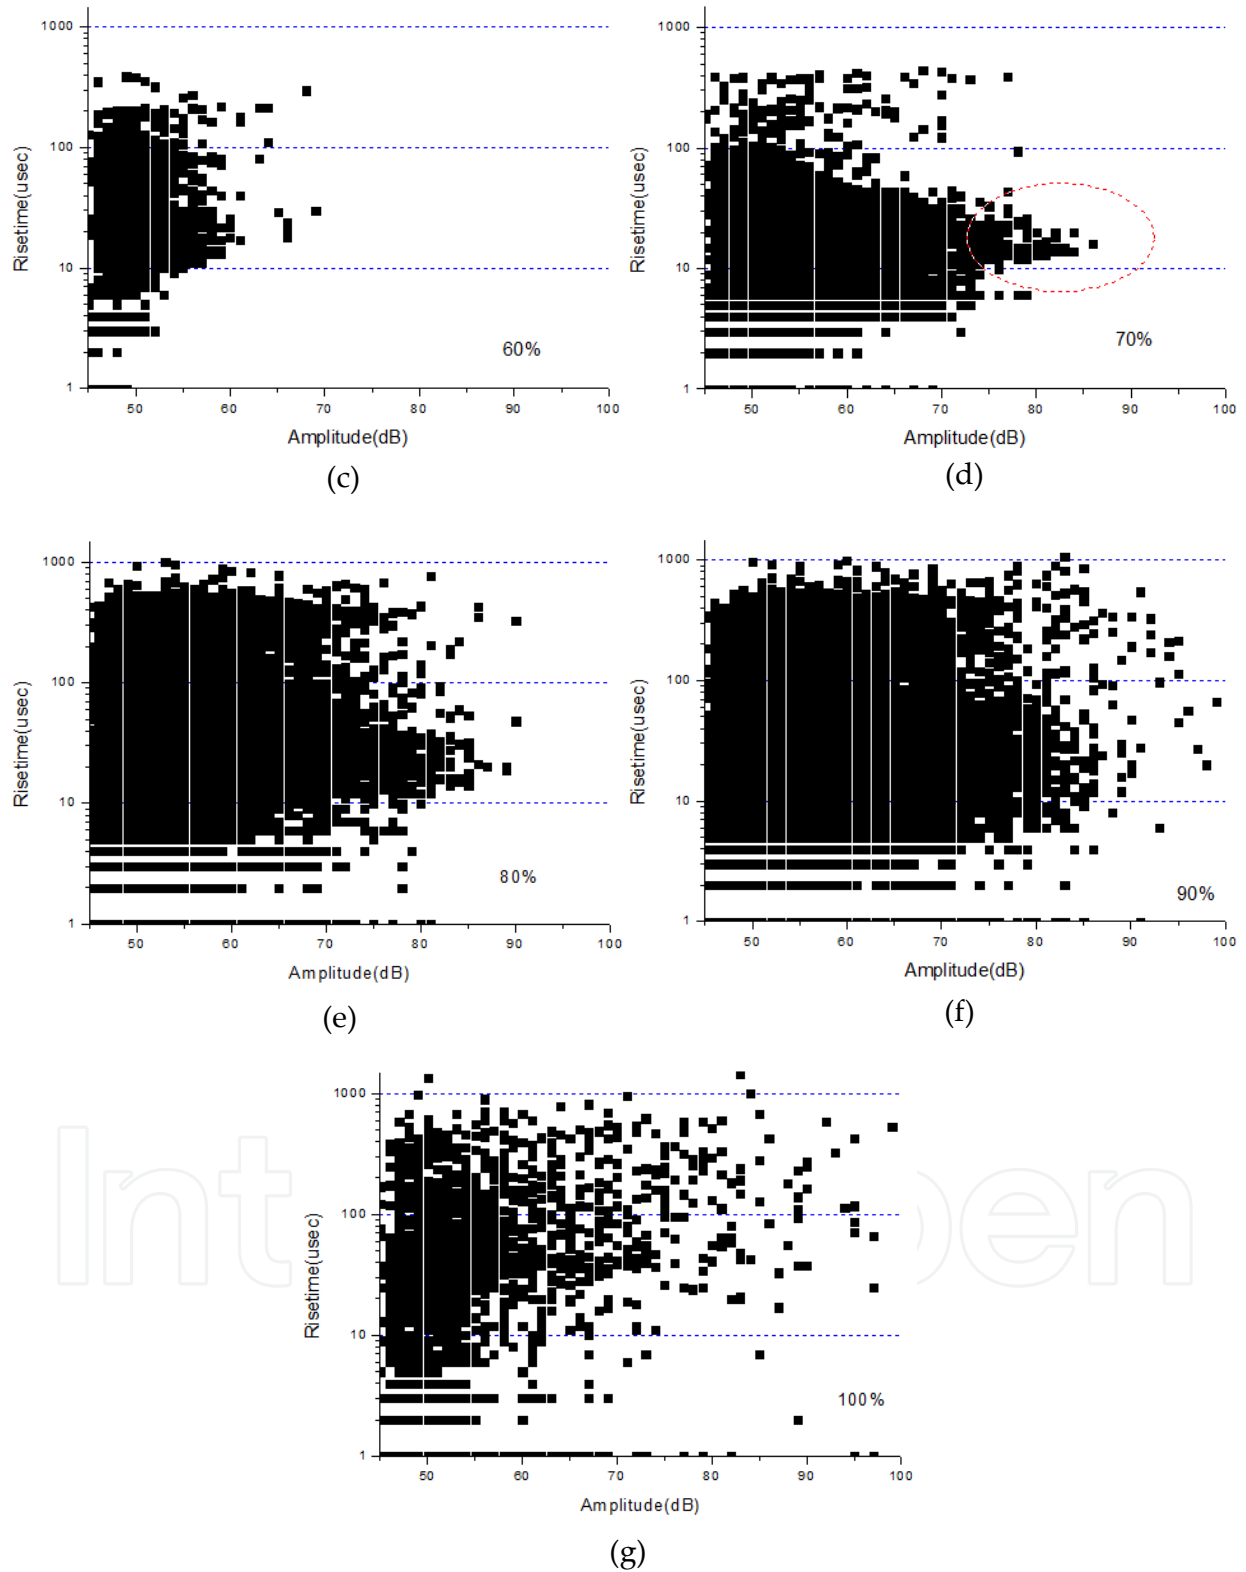
Figure 10. Rise time vs amplitude plot during load holding : (a)30% (b)50% (c)60% (d)70% (e)80% (f)90% and (g)fractured

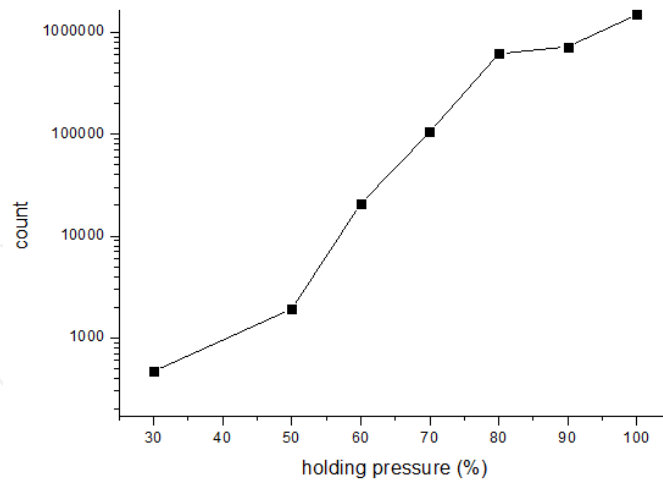
Figure 11. Total count during load holding

Figure 11 shows the total count of sound emission signals which occur during the 2 minutes of holding time. These variables are better indications than mean rise time in Figure 7, mean duration of Figure 8 or mean amplitude of Figure 9. It was discovered that it was difficult to assess the damage against the vessel with variables such as mean amplitude, total hit, mean rise time, or mean duration but the total count and the total signal strength of the sound emitted when the load is pressed on, activation and vessel's damage were better indications for damages on the vessel.

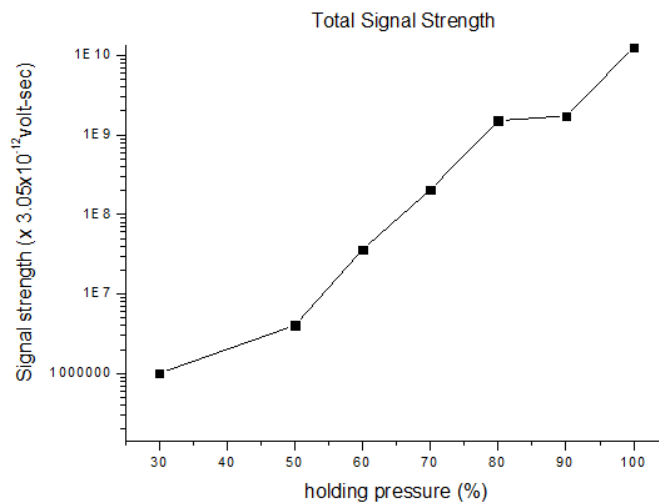
Figure 12. Total signal strength during load holding

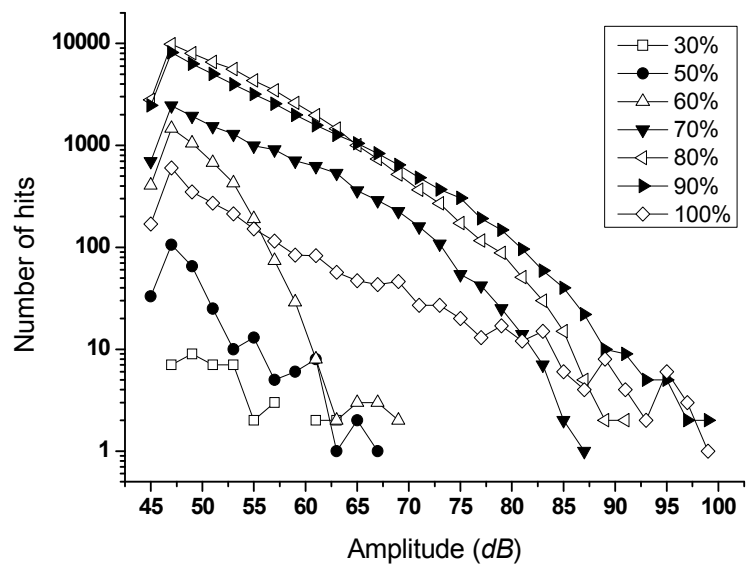
Figure 13. Amplitude distribution during load holding

load of 30 % to 60 %, even though there was increase in the number of signals, there was not a big increase in amplitude. Accordingly, we now that up to 60 %, there is not much of a creep affect but just the low amplitude of signals. I think that this is mainly caused by the creation and growth of cracks of substrate. After pressing, there were the creep effects, which show the significant increase in AE signal and the signals with the amplitude of 85 dB. In addition, as the distribution of amplitude appears different from the previous one, I think that the damages on the vessel are significant. It seems that there are more creations and growths of cracks in the composite materials and the cutting of reinforcement fiber and peeling of substrate cause the damage mechanism. In addition, the slope of the distribution of amplitude is known to be related to the mechanism of the signals[8], In the load of 70 % or higher, the slop looks similar, meaning that the damage is caused by the similar damage mechanism.

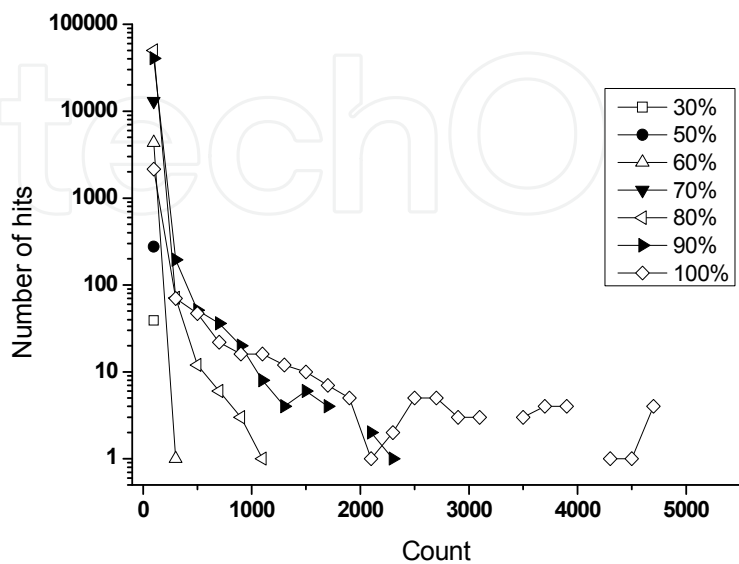
Figure 14. Count distribution during load holding

Figure 14 shows the distribution of counts of AE signals coming from each load of pressure. When the signal with counts of 500 or less occurred under the load of 60 %, the damage was caused by the creation of growth of substrate crack under the load of 60 % pressure. At the pressure of 80-90 % where the significant damage is done to vessel, the number of counts was 1000 or more. At the burst stage the number of counts was 2,500 or more.

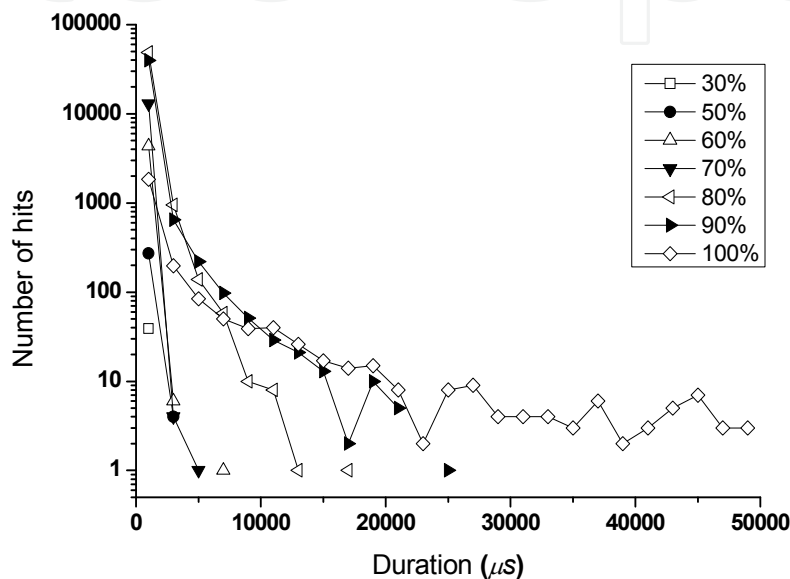
Figure 15. Duration distribution during load holding

Figure 15 shows that the duration of signal occurs with the range of 500 μs at the load of up to 70 % and that the signal of over 10000 μs started to appear at the load of 80 % or higher. At the load of 90 %, the 20000 μs appears during the final burst stage where the signals of 25000 ~ 50000 μs appeared.

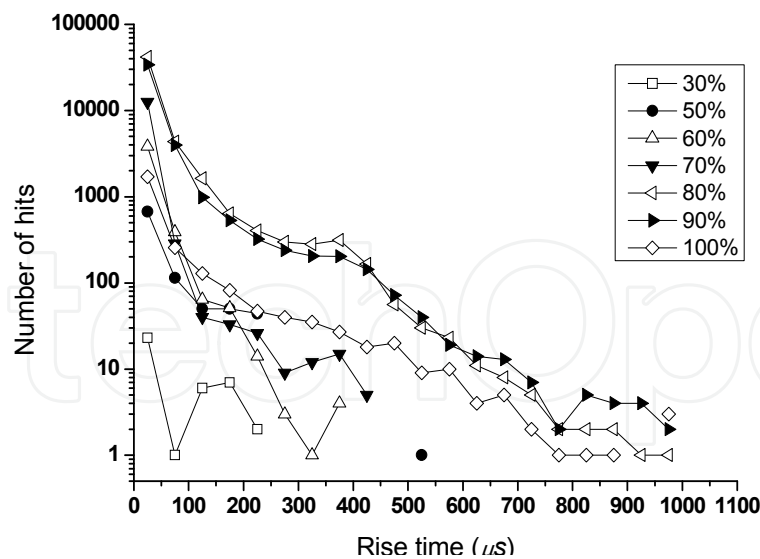
Figure 16. Rise time distribution during load holding

Figure 16 shows the rise time of 100 μs or less and the signal of 100-200 μs at the load of up to the initial 30 %. As we understand the distribution of the amplitude from the fatigue test of 20,000 cycles, there may be no mechanism other than the creation and growth of cracks at the load of 30 % pressure. It means that the signal of 200 μs or less is caused by the creation and growth of cracks of the vessel materials. Even though there were 1 and 4 signals of 300 μs or higher at the load of 50-60 %, they are negligible considering the total number of signals. It seems that the damage was mainly caused by creation and growth of cracks on composite materials rather than by new damage mechanisms. At the load of 70 % pressure, the signal of 250-450 μs , which is longer than at previous load stage appeared, meaning that there may be new damage mechanism. It seems that it was caused by the additional damage mechanism such as the cutting of reinforcement fibers and interlayer peeling due to the increase in internal pressures. At the load of 80-90 %, the rise time of 500 μs or more is observed. It may be affected by the composite damage mechanism such as the growth of existing cracks, cutting of reinforcement fiber and inter-layer separation happening at the neighboring location. This trend is true of the distribution of counts and durations as specified above. The observation of the sound emission signals coming out of the neighboring location through the composite damage mechanism would be a good tool to assess the vessel.

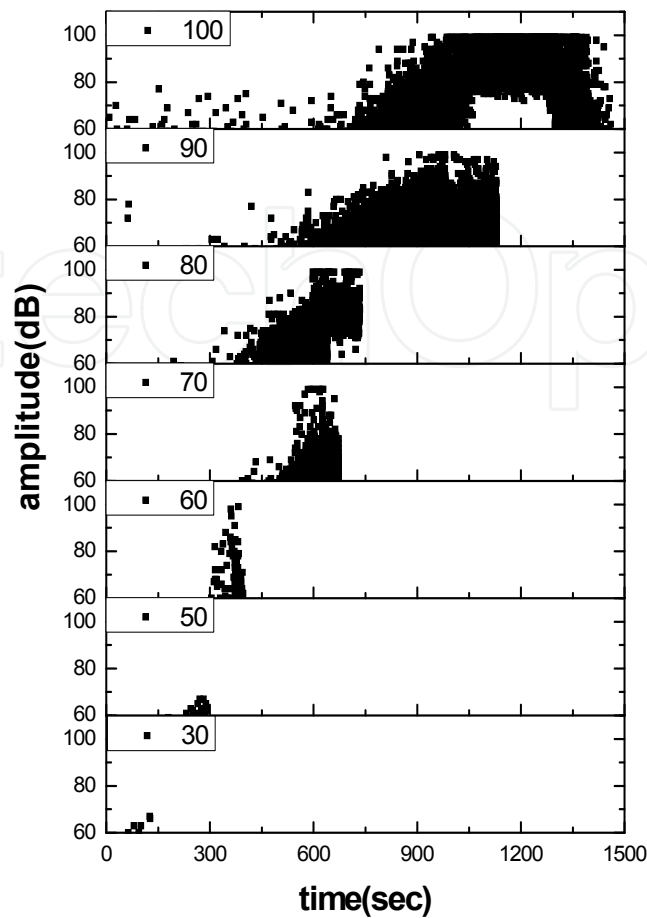
Figure 17. Amplitude distribution during loading at each loading stage (over 60 dB)

To estimate the damage with the sound emission signal, the signal of 60 dB or higher is used. Figure 17 shows the distribution of amplitude for hits of 60 dB or higher for each load of pressure. AE time becomes lower until the pressure of 70 % but at 80 %, it becomes faster. As the pressure rises at constant pace during the test, at 70 % pressure, there is no AE signal until 60 % pressures, showing the Kaiser effect. Accordingly, up to 60 % pressure, it looks like that there was no significant damage to the vessel. As the pressure rises up to 70 % that may have damaged the vessel, it looks like that AE happened due to the Felicity effect when the pressure goes up to 80 % as the vessel was damaged during the rise up to 80 %. At the 90 and 100 % pressure, there is the Felicity effect. Particularly, in the pressure range of up to 100 %, which experienced the load of 90 % or higher, there is AE signals of 60 dB or more from the beginning, showing that the damage is significant. In the actual burst test, the damage mechanism of Type II vessel, or the matrix crack in the direction of initial hoop occurs and then the creation of cracks and its growth and the interlayer separation (which belongs to matrix crack but has different damage mode) occur [4]. At the load of 60 %, the matrix crack in the direction of hoop was shown. But, the matrix crack in the direction of hoop did not affect the burst pressure of the vessel [8].

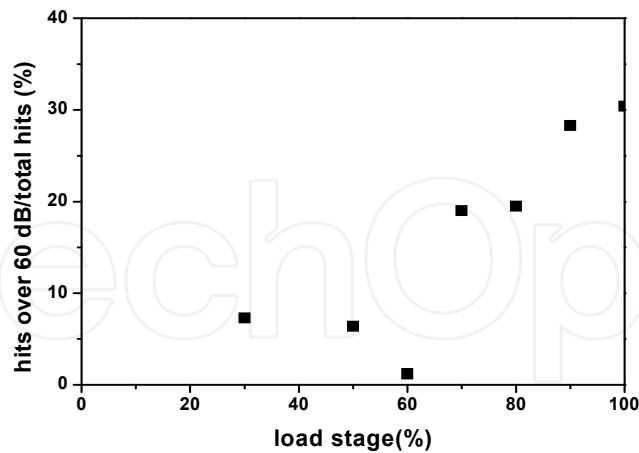
Figure 18. Ratio of hits over 60 dB / total hits during each loading stage

Figure 18 shows the count of hits where sound exceeds 60 dB at each stage of burst test. The rate decreases from 7 % to 1 % during the pressure of 30 % to 60 %. Then, the signals of 60 dB or higher rapidly go up to 2.0 % at the load of 70 %. The rate goes up to 30 % at the load of 100 %. The signals of 60 dB or higher at an early stage may be caused by the creation of matrix crack on the composite materials. The reduction thereafter may be caused by the low amplitude (60 dB or less) rather than the creation of crack. At the load of 70 % or higher, there are not only the matrix cracks but also the damages by the new damage mechanism such as the cut of fibers, increasing the signals of 60 dB or higher. The measurement of the count of hits which are 60 dB or higher is a good tool to assess the damage.

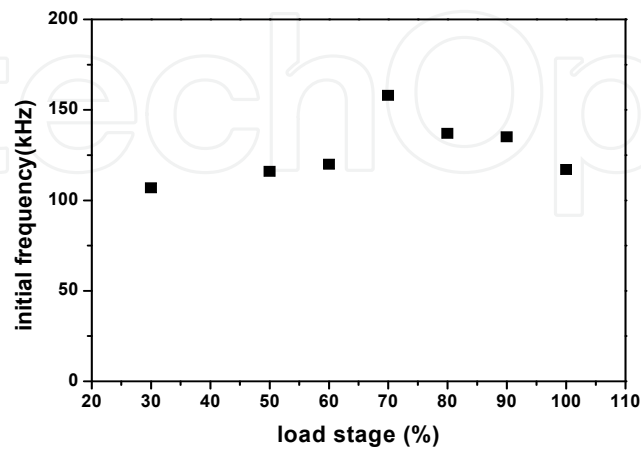
Figure 19. Mean initial frequency during each loading stage

Figure 19-21 show the mean initial, reverberation and average frequency of AE signal at each load stage. The frequency is obtained not from the analysis of wave form but from the duration and counts. The frequency shows the difference between above and below 70 % load. As for the initial frequency, it did not show a big change at the load of up to 60 % or 100 kHz but it goes up at the load of 70 % until going down a little. This is likely to be

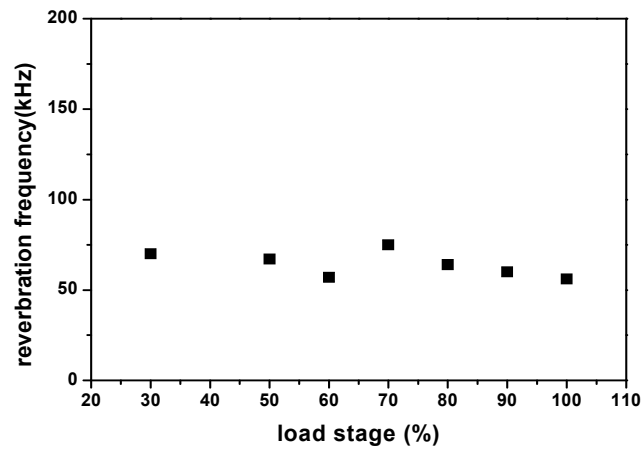
Figure 20. Mean reverberation frequency during each loading stage

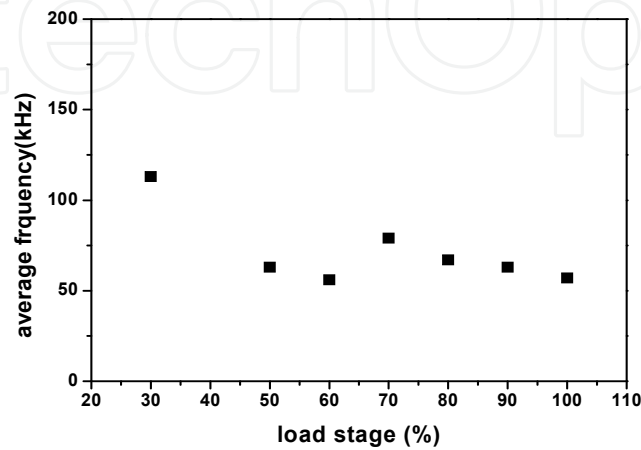
Figure 21. Mean average frequency during each loading stage

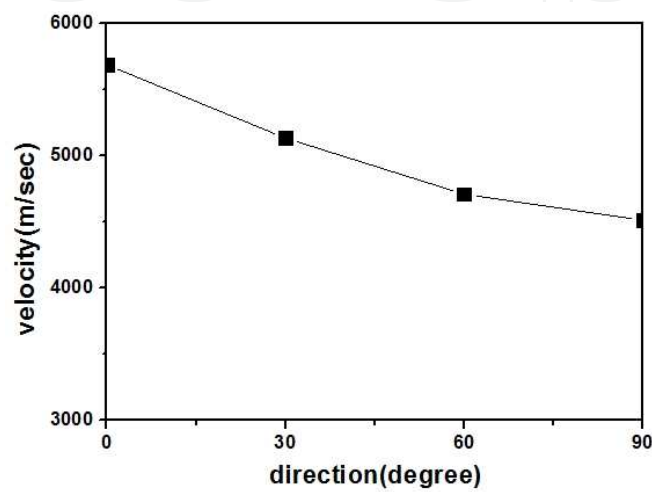
Figure 22. The elastic wave velocity with degree between propagation and wrapping direction

Figure 22 shows the results of measuring the elastic wave speed of the artificial acoustic emission source for the acoustic emission location on the fiber-wrapped composite material. As shown on the picture, the speed of longitudinal elastic wave was 4512 m/sec and the elastic wave speed of the wrapped direction was 5689 m/sec showing the characteristic of anisotropy. Thus, the location was identified using anisotropic vessel source location that uses the difference of time for the acoustic emission signal is to be reached.

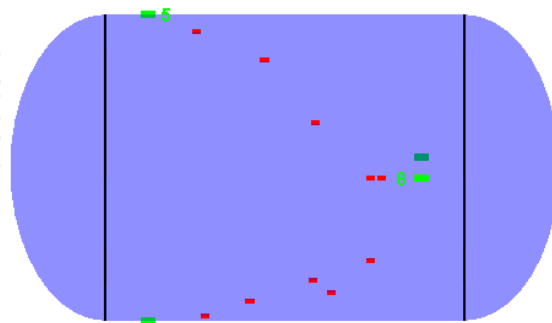
Figure 23. Confirm of Source location

Figure 23 is the location of the sensor and the result of the identification test of the location using the artificial acoustic emission source. The four sensors were attached in staggered locations in channel 5, 6, 7, 8 and channel 7 refers to the backside of 8. The acoustic emission source is located diagonally in equal intervals between channel 5 and 8 and between channel 6 and 8.

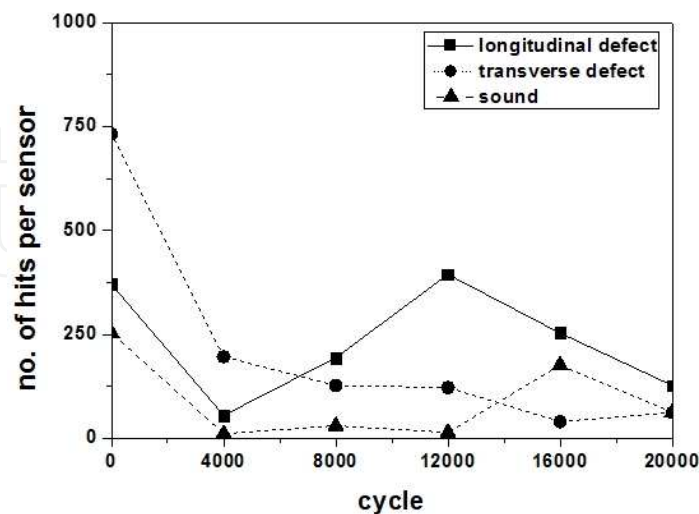
Figure 25. The number of hits per channel during fatigue test for artificial defect and sound vessel

Figure 25 shows the average number of hit per sensor during the fatigue test of vessel. The vessel with the artificial defect has more number of hits compared to the sound vessel and when you see the tendency in increase and decrease, the number of hits for transverse defect vessel and sound vessel decreases as the number of cycle increases; however, the number of hits for longitudinal defect vessel decreases in 4000 cycle and then increases and then decreases in 8000 and 12000 cycles.

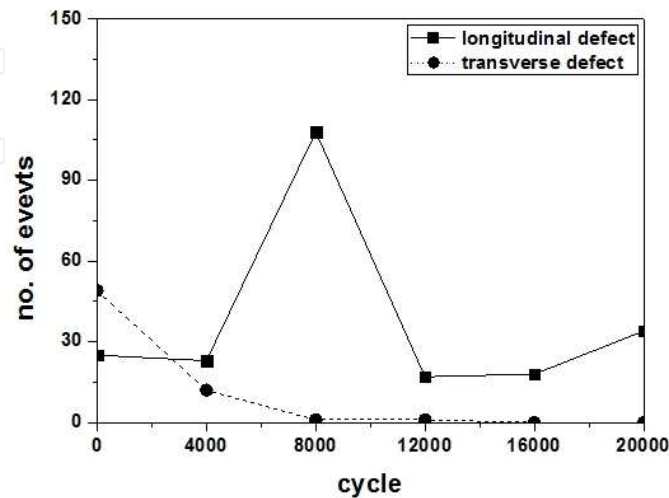
Figure 26. The number of events during fatigue test for artificial defect vessel

Figure 26 shows the number of events extracted during the fatigue test on longitudinal defect and transverse defect vessel. An event shows the number of sources calculating the

location of the acoustic emission source within vessel using the acoustic emission signal that hit the sensor and in the case transverse defect vessel which includes a transverse defect, the number of events is noticeably decreased as the number of cycle increases, but in the case of longitudinal defect vessel which has longitudinal defect, the number of events increases a lot in 8000th cycle and does not change much as the number of cycle increases.

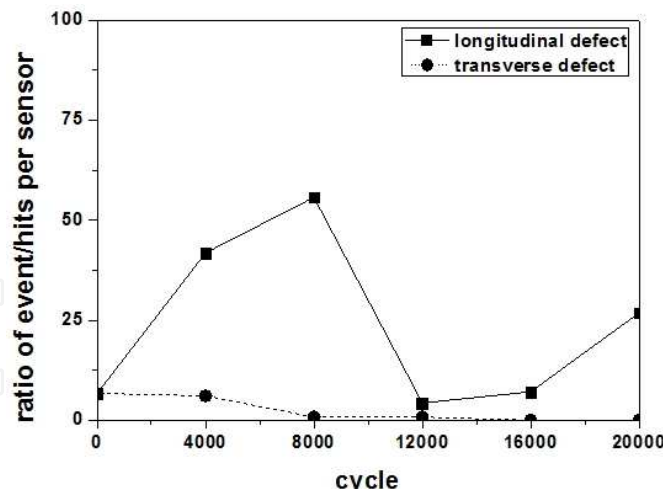
Figure 27. The ratio of events/ hits per sensor during fatigue test for artificial defect vessel

Figure 27 compares the number of hit per sensor and the number of events using Figure 25 and 26 and shows the event/hit ratio according to the increase in the number of cycle. This is a figure that shows the % of the number of hits that can precisely show the source among the total number of hits. In the case of longitudinal defect vessel, it was 41.8 % in the 4000th cycle, 55.7 % in the 8000th cycle. An event can be calculated using the difference in time that the resilience from the source (acoustic emission signal) sent through the walls of the vessel reaches the sensor and has to be extracted from at least 3 sensors. Hits that do not go by such standards cannot be used to calculate events and if the location was identified by simulation or if the signal is weak or is static, it cannot be recorded as an event. In the case of longitudinal defect vessel, the number of hits is small in the 4000th and 8000th cycle but the growth of the rupture is relatively easy and it sends hits to at least 3 sensors with signals with sufficient amplitude so the number of event/hit rate increases.

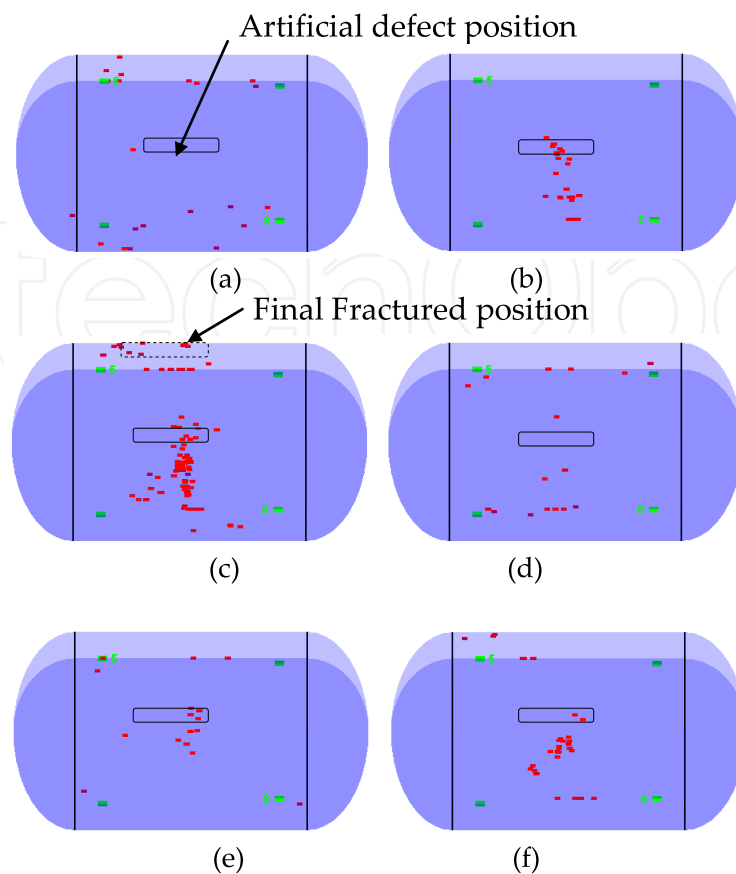
Figure 28. The result of source location with cycle for longitudinal defect : a)0, b)4000, c)8000, d)12000, e)16000, f)20000

Figure 28 is the result of the location due to the acoustic emission test performed during the fatigue test on longitudinal defect vessel. Figure 28 (a) shows the location of 25 events during the first 3 fatigue test cycles. It does not show the location of artificial defects but shows the overall looks on the whole vessel. Such results are not shown in pictures but also in transverse defects vessel, 49 events in Figure 26 shows looks like a) on the whole vessel and it seems that signals were created on the weakest areas of the whole vessel when the first pressure was put. In the case of b), after the 4,000th cycle, in the 3rd fatigue test, 23 events were shown to be clustered around the artificial defect. As for the vessel with transverse defects, after the 4,000th fatigue test cycle, in the 3rd fatigue test, 12 events were created but they were all over the whole vessel so we could not show the location of the artificial defect.

In the case of c), in the 8000th fatigue cycle, 108 events were clustered around the artificial defect and as mentioned in the explanation in Figure 27 more than 50% of the occurred hits were signals related to the artificial defect. Afterwards, events that occurred in d) ~f) were those that mostly occurred near the artificial defect so we can acknowledge that the damage on the composite material is progressed around the artificial defect. Figure 29 shows the surroundings of the longitudinal artificial defect after the 20000th cycle and shows that at the end of the defect, there is a matrix rupture progressing in a hoop-direction and although not clear in the picture, at the end of the depth in the artificial defect, delaminating was observed on the overall defect. In the case of vessel with transverse defects, after the 8,000th fatigue test, less than 1 event was created and the location of the artificial defect could not be shown clearly.

On the other hand, after the 20000th fatigue test, in the burst test, the location of the burst is marked in c) of Figure 28 and events are also observed in a), d), e), and f). The source of the acoustic emission signal is assumed to be the fatigue rupture in the weak areas of the steel liner rather than in the composite material. The final burst in the case of the longitudinal defect accompanies matrix rupture and delaminating as mentioned above during the fatigue test and burst test so the whole vessel area, which is the length of the defect, is thinner in terms of thickness like the depth of the defect and thus is weaker than other areas and it is thought that it burst at the final burst location in which the fatigue rupture occurred in the steel liner.

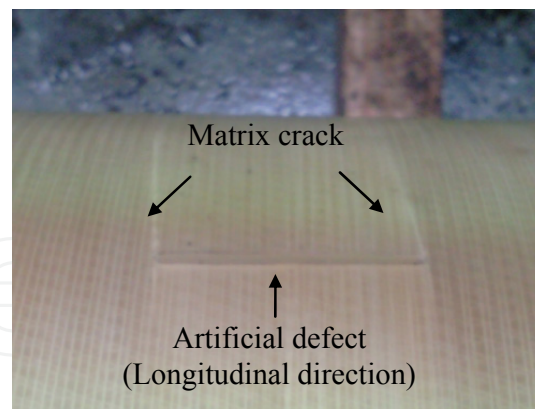
Figure 29. Longitudinal defect and matrix crack after 20000 cycle fatigue test

In order to analyze the characteristics of acoustic emission signals that occurred in the final burst position, event signals observed around the final burst location within 200 mm hoop direction in terms of length as marked in Figure 29 were analyzed. 18 events were occurred during the 20000th fatigue cycle and the number of related hits was 59. Figure 35 shows accumulated amplitude distribution and there are only 3 that are over 60 dB and 49 of them are below 50 dB. You can see the slope as ③ but if you observe closely, it is possible to observe that the same slope exists as ① in Figure 34 and also that it include the initiation of matrix crack. Seeing it as showing the slope of ③, as a signal according to a sole damage mechanism, it is estimated to be related to liner damage and the size is 0.06

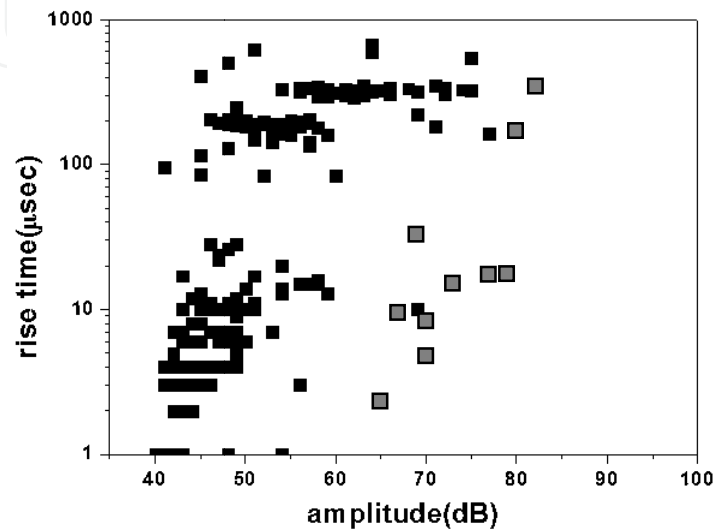
Figure 30. The rise time distribution during initial 3 cycles for sound vessel

Figure 30 shows the relationship between the amplitude of the signal occurring during the early three cycles and the rise time, and can be clearly distinguished as around 10 μ s and over 100 μ s and the grey mark shows the rise time while holding the load during the three cycles and also at 90 %, which is the highest, has a rise time of about 10 μ s. Generally while load holding, it can be inferred that there is likely to be growth of an existent crack rather
