Acoustic Emission of Composite Vessel

Hyun-Sup Jee and Jong-O Lee

1. Introduction

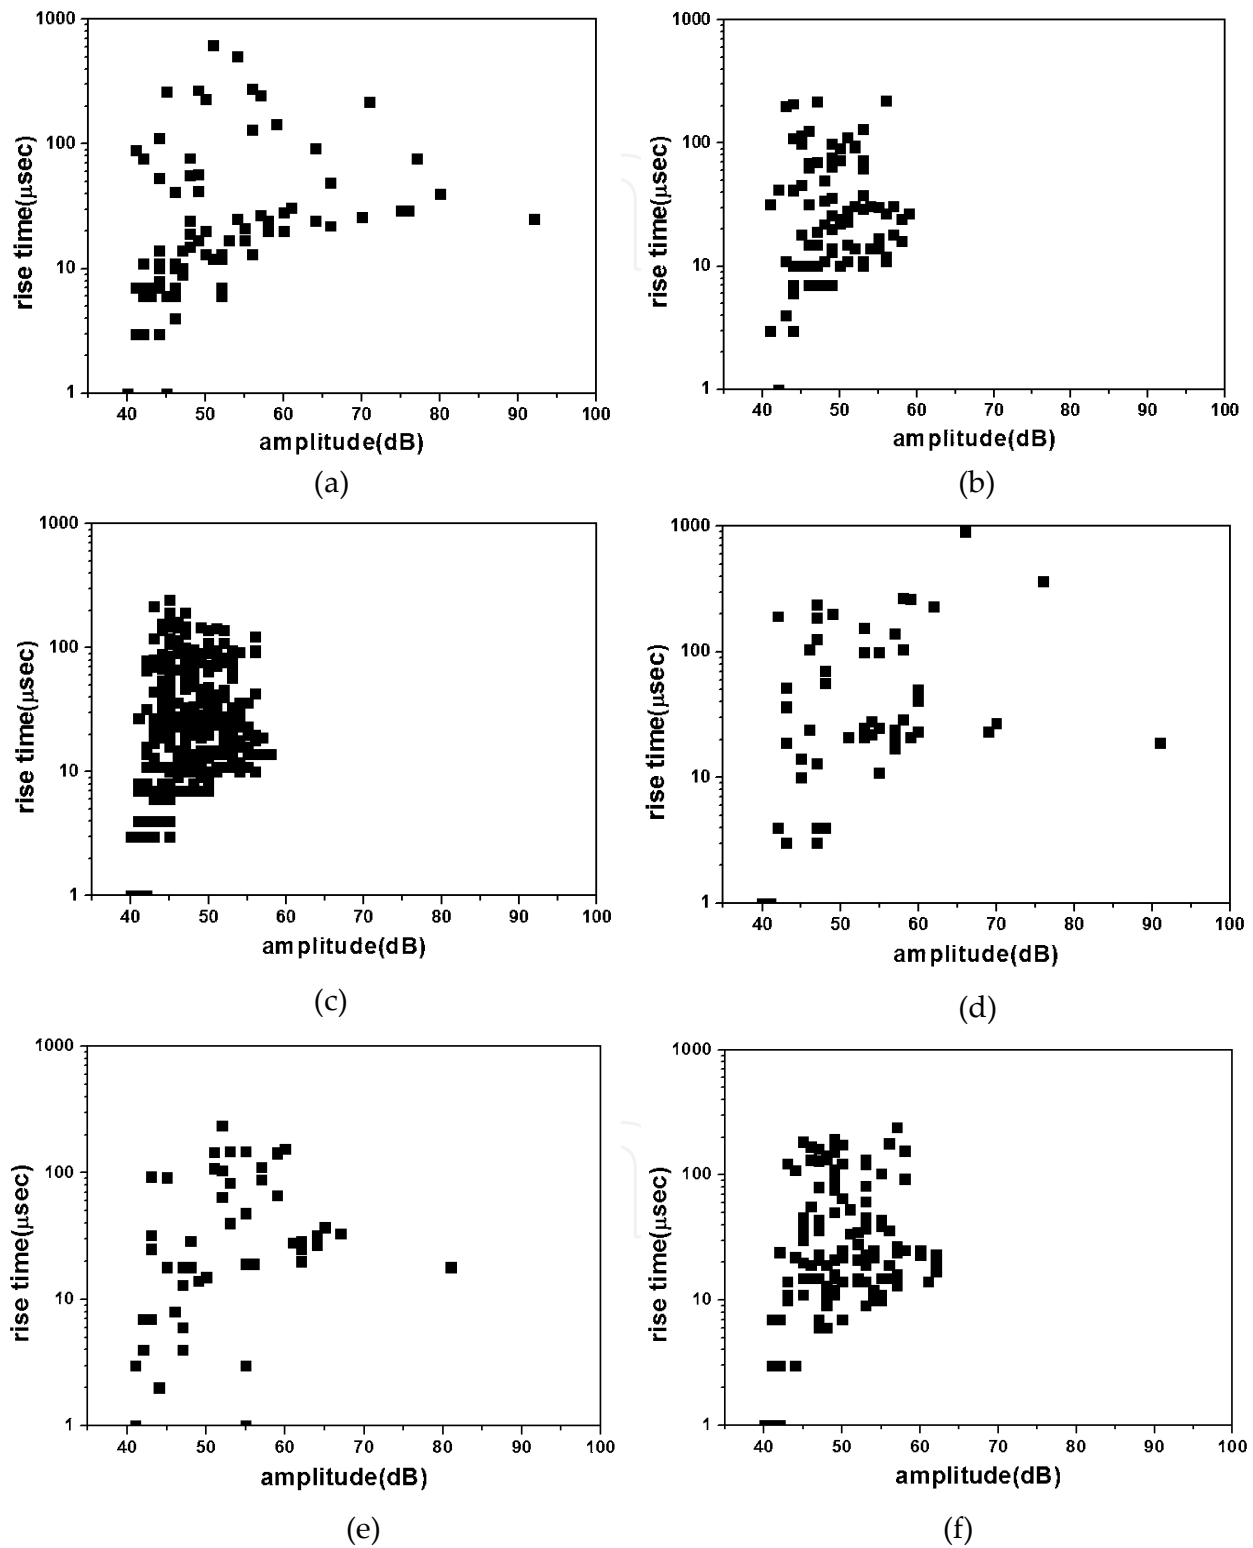
Figure 31. The rise time distribution of hits connected with event during fatigue cycle for longitudinal defect vessel: a) 0, b) 4000, c) 8000, d) 12000, e) 16000, f) 20000 cycles

Figure 31 a) shows the relationship between the amplitude of the signals of events occurring during the first three cycles of the vessel and related hits and rise time and is clustered around 10 μs in the figure and is also scattered around 100-800 μs . It is judged that the initiation and growth of matrix crack will happen in weak areas of the overall vessel. Especially, a higher rise time can be observed when the source forms a cluster around the defect as shown in b), c), e), f) of Figure 31 than when the source is scattered overall on the vessel like a) or d) so the growth of cracks around the defect has a lower rise time than the initiation of cracks.

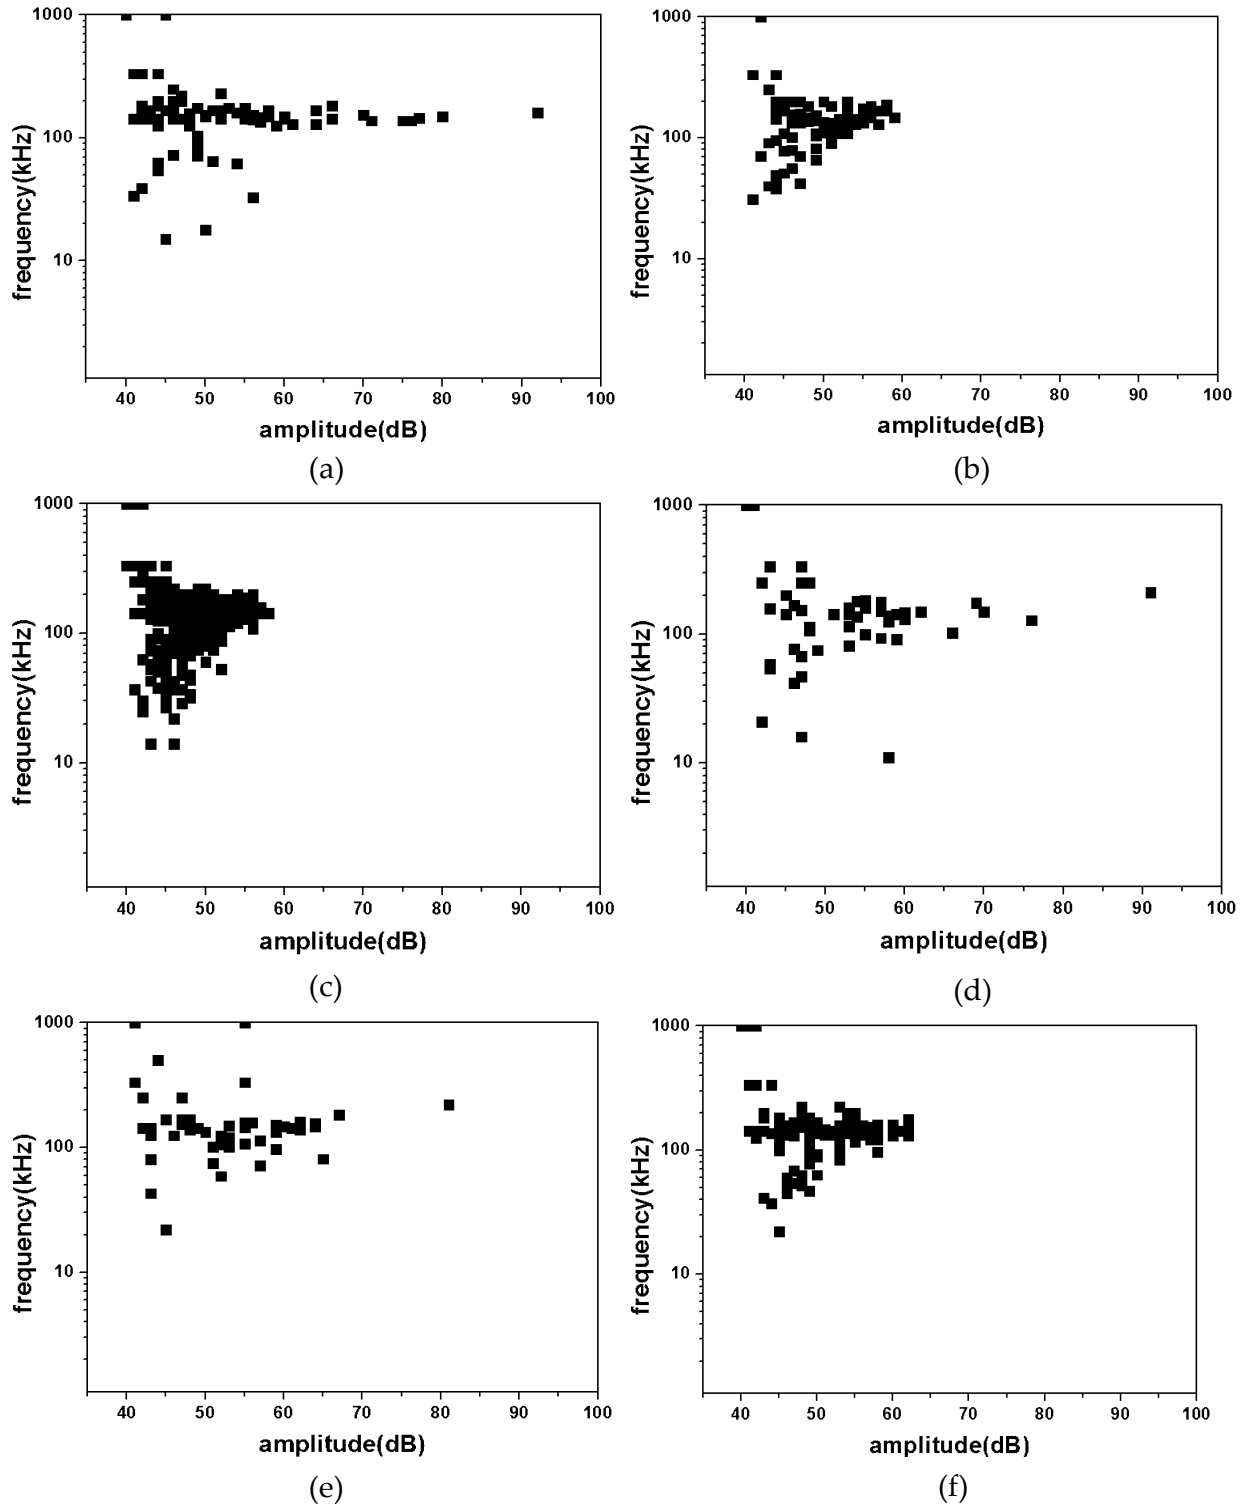
Figure 32. The initial frequency distribution of hits connected with event during fatigue cycle for longitudinal defect vessel: a) 0, b) 4000, c) 8000, d) 12000, e) 16000, f) 20000 cycles

Figure 32 shows the distribution of initial frequency versus the amplitude with fatigue cycle but it is dispersed around 100-200 kHz, which is unrelated to the fatigue cycle. It is in accord with the result that the average frequency of signal which is generated due to initiation and growth of matrix crack is around 100 kHz in the burst test using resonant type sensors [7].

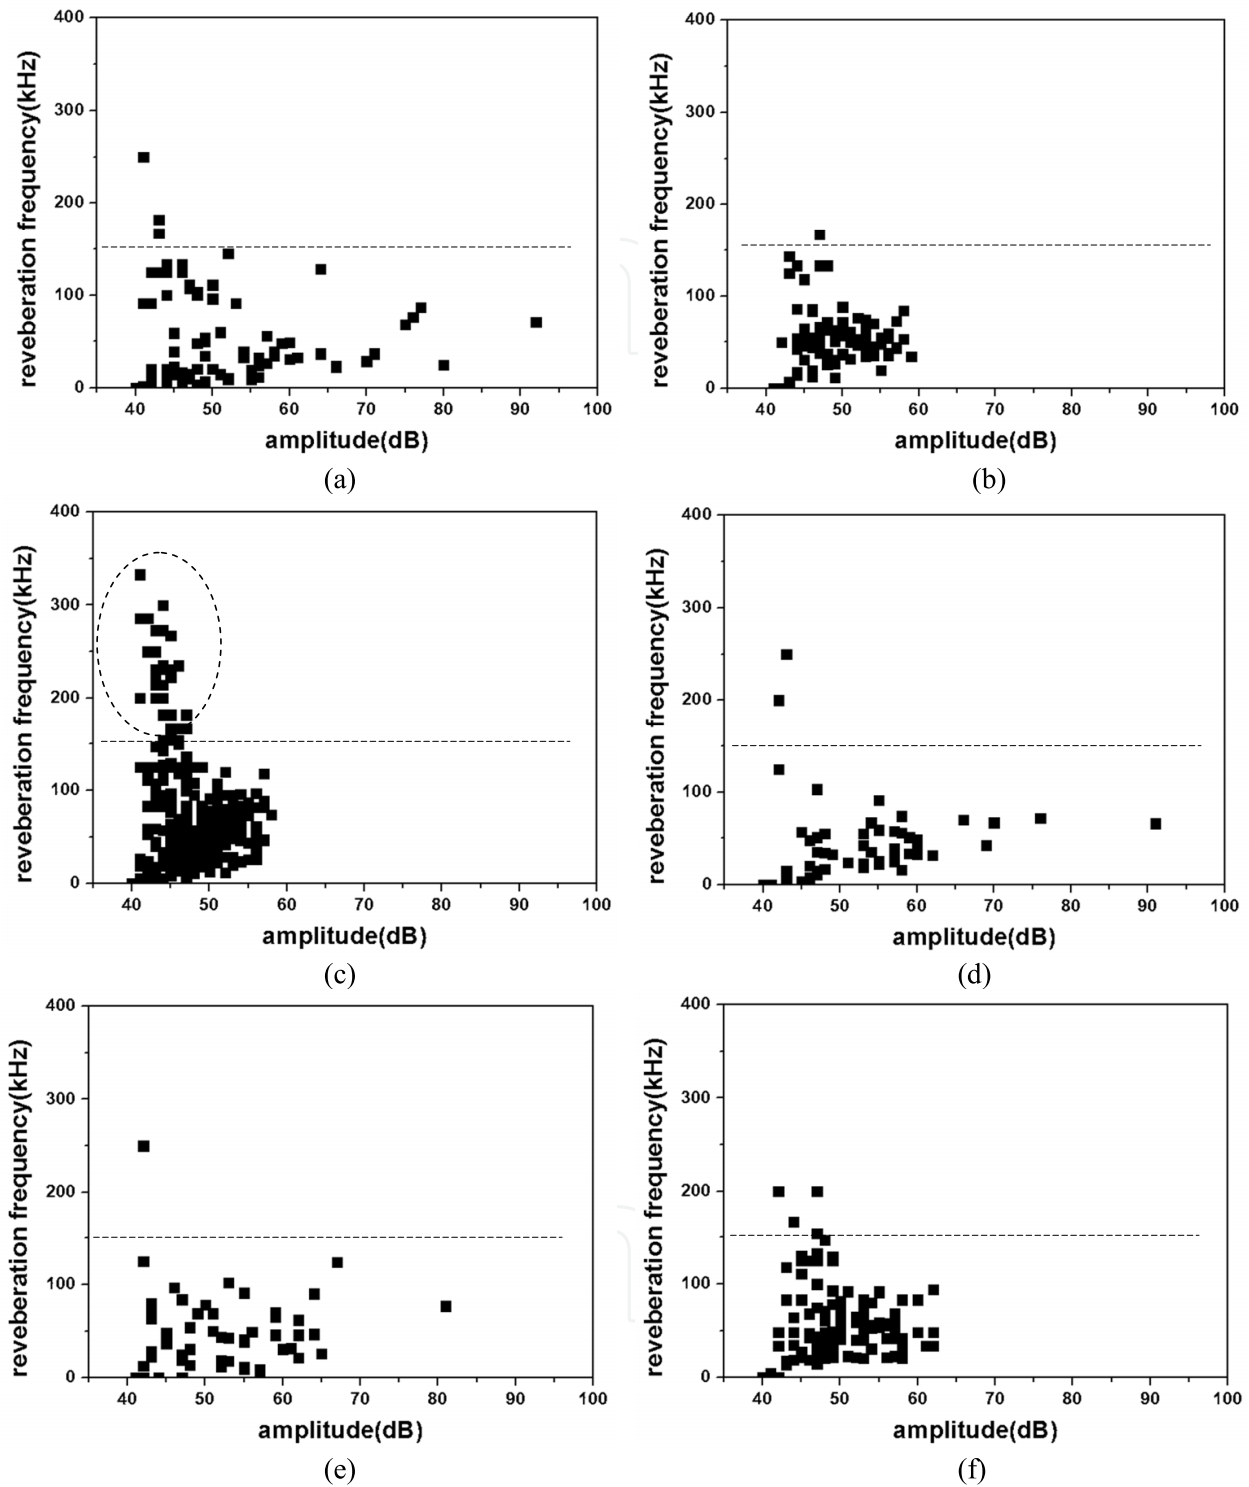
Figure 33. The reverberation frequency distribution of hits connected with event during fatigue cycle for longitudinal defect vessel: a) 0, b) 4000, c) 8000, d) 12000, e) 16000, f) 20000 cycles

Figure 33 shows the distribution of reverberation frequency on amplitude according to the number of fatigue tests but besides the oval area in Figure 33 c) which is the result of the 8000th fatigue test, most are dispersed below 150 kHz. The average reverberation frequency

on signals relating to all events of Figure 33 c) was 73 kHz and these accords to the fact that the average reverberation frequency is between 50 - 75 kHz in all stage of burst which includes the damage mechanism of composite materials in the cast of burst test.[7] On the other hand, the reverberation frequency during the burst test of the same vessel was known to occur in all stage of the burst test in the range of 150 - 350 kHz[8], and in such case, because it includes the mechanism of all damage, it is hard to differentiate damage mechanism as a frequency. There were 23 event signals that had a reverberation frequency in the 150 - 350 kHz area in Figure 33 c) and 16 of them, which are 70 %, occurred in the matrix crack area of Figure 29, which is an observation of artificial defects after the 20000th fatigue test. More than 90 % of the related 44 hits(150 - 350 kHz) were signals with rise time lower than 100 μ s and average rise time of 31 μ s. As mentioned in 3.2.1, it is assumed that it is due to the growth of matrix crack.

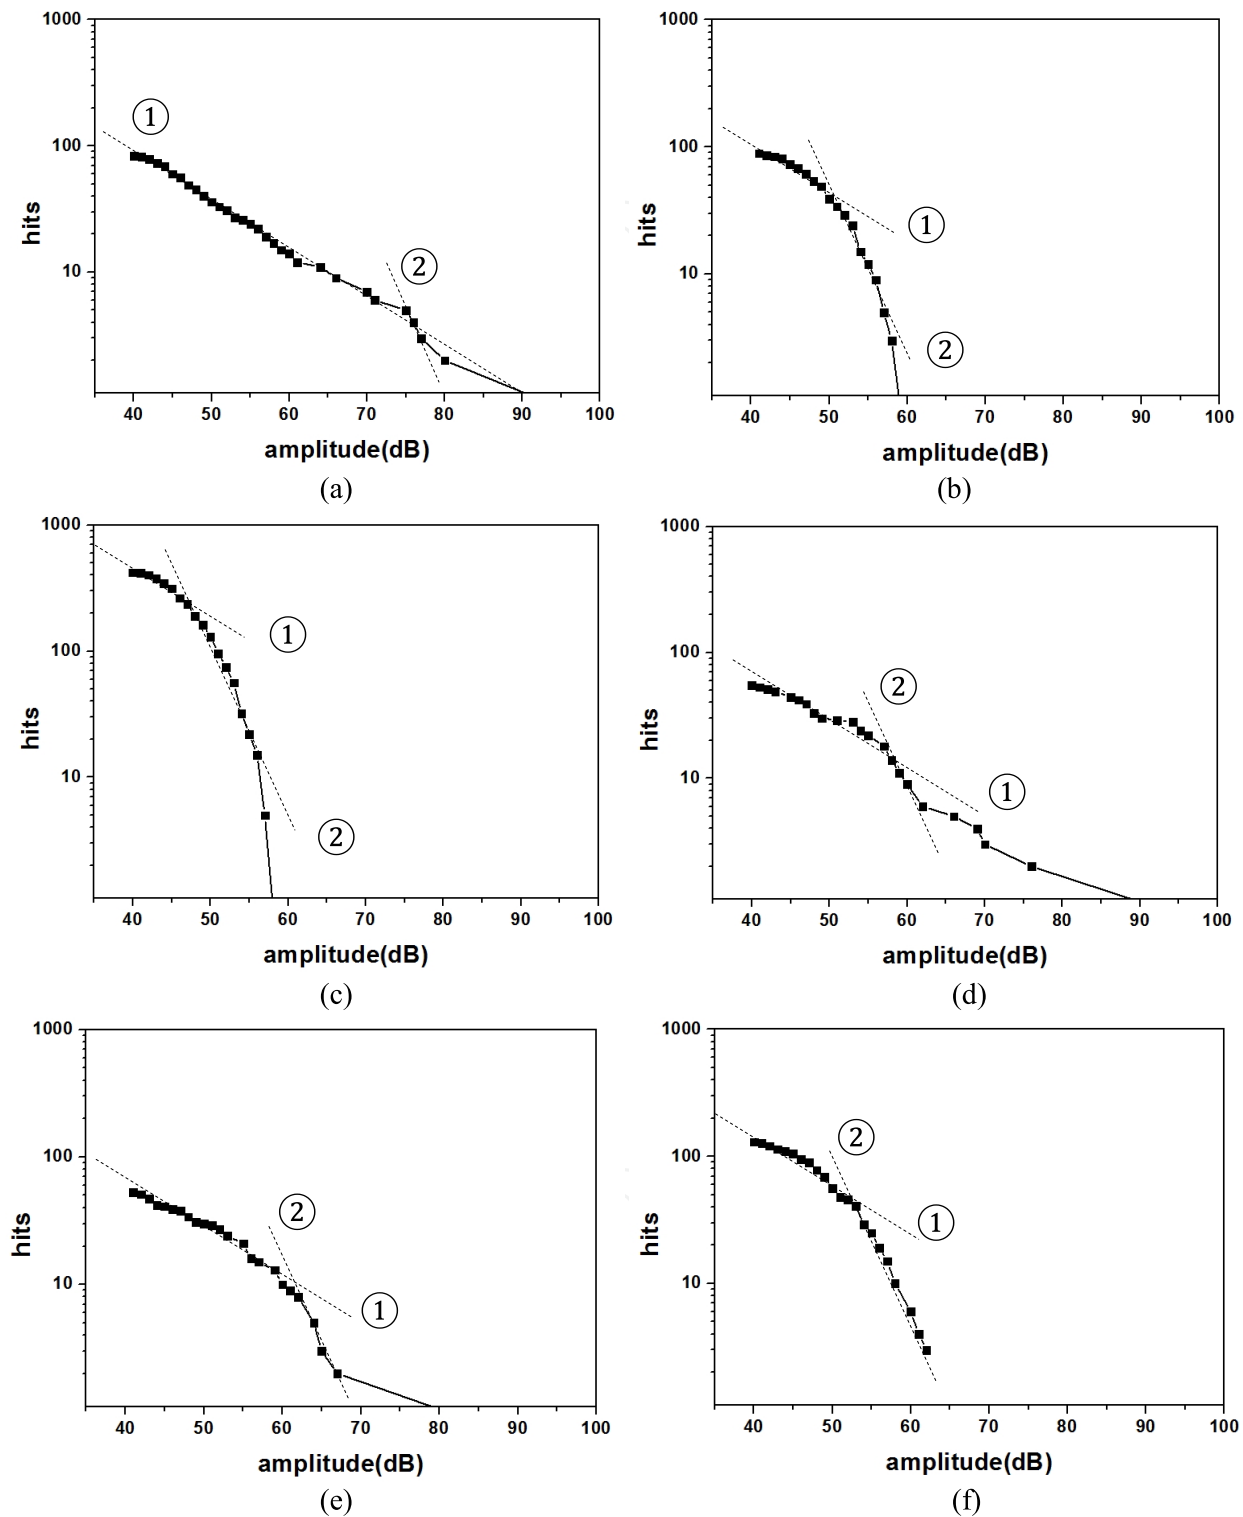
Figure 34. The amplitude distribution of accumulated hits connected with event during fatigue cycle for longitudinal defect vessel: a) 0, b) 4000, c) 8000, d) 12000, e) 16000, f) 20000 cycles

Figure 34 shows the amplitude distribution of accumulated hits according to the number of fatigue test and its slope has two types of shapes. Generally, the slope in the amplitude distribution of accumulated hit is known to be related to the mechanism of the source [8] and in vessel with defects as used in the experiment, as mentioned in the previous chapter, it includes mechanisms such as the initiation of matrix crack, growth of the created cracks (including delaminating), and the initiation and growth of liner fatigue cracks.

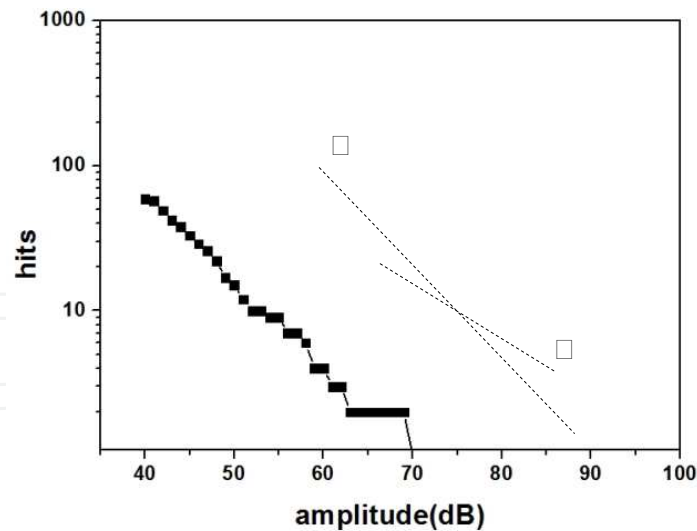
Figure 35. The amplitude distribution of accumulated hits connected with event during fatigue cycle for longitudinal defect vessel

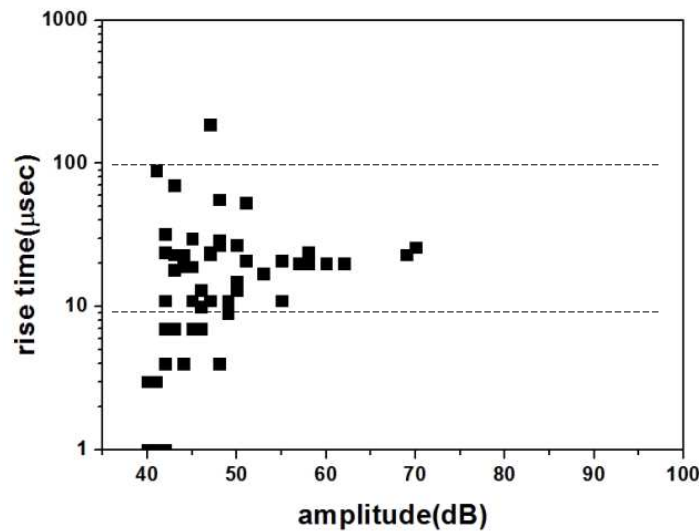
Figure 36. Distribution of rise time on the amplitude of the signals

Figure 36 shows the distribution of rise time on the amplitude of the signals occurred in the final burst location. There is almost no rise time above 100 μ s and is dispersed around 10 μ s. It can be thought that the rise time which occurs during the growth of steel liner fatigue crack is similar to that during the growth of matrix crack.

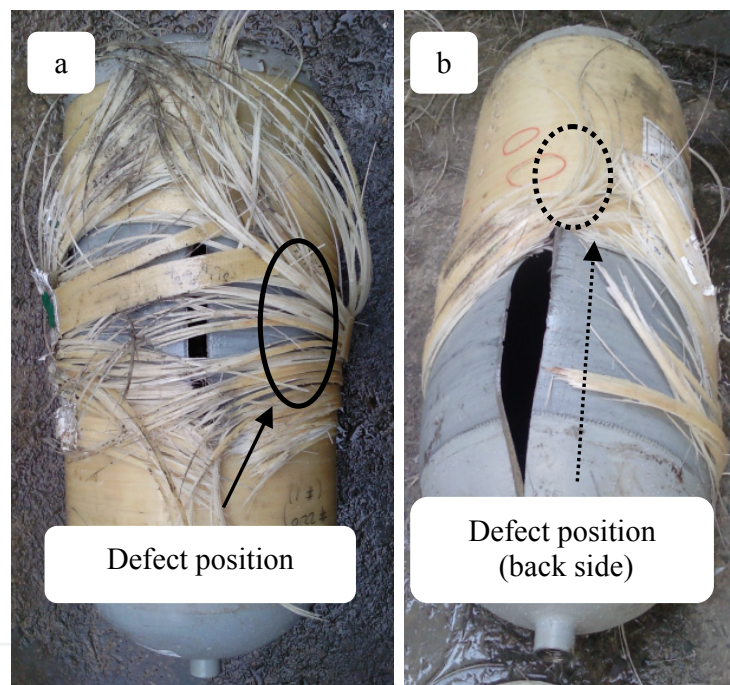
Figure 37. Position of artificial defect and burst location : a) longitudinal, b) transverse

Figure 37 is a picture that shows the burst location in the vessel with the artificial defect. As shown in the picture, we can see that in the case of a vessel with a transverse defect, the final burst location is in the general burst location (cylinder and head area) for a well-constructed type II vessel. However, in the case of a vessel with a longitudinal defect, in both vessels, the final burst location was within the transverse vessel in which the defect was located. We think that this is because in the case of the longitudinal defect, the wrapped fiber is cut in 3 mm depth and in 50 mm length so the effect in which the thickness of the composite material is big, but in the case of the transverse defect, the fiber is cut only in 3 mm depth and in 3 mm length so the effect is small.
