Land Use Changes and Environmental Problems Caused by Bank Erosion: A Case Study of the Kolubara River Basin in Serbia

Slavoljub Dragicevic, Nenad Zivkovic, Mirjana Roksandic,
Stanimir Kostadinov, Ivan Novkovic, Radislav Tomic, Milomir Stepic,
Marija Dragicevic and Borislava Blagojevic

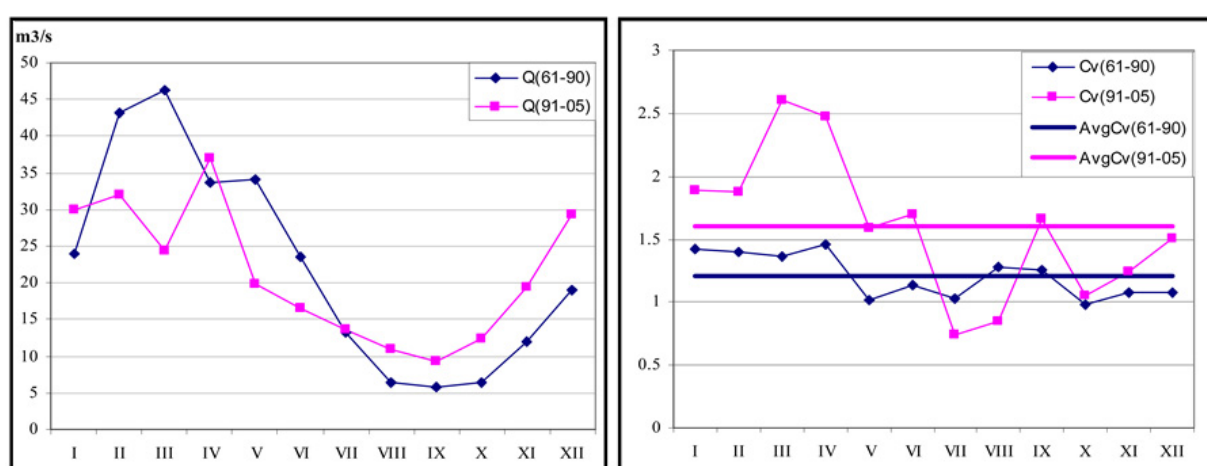
Figure 2. Mean monthly discharges (Q) and coefficients of variation (Cv) of the Kolubara River measured in Drazevac gauging station for the both periods of observation

To study water balance of the Donjokolubarski basin we used the following periods: 1925-1960, 1961-1990 and 1991-2005. With this approach it was possible to determine the changes that may be occurred after diverting the Kolubara River into the Pestan's riverbed in 1959. Briefly, precipitation analysis showed that the second period was a bit wetter than the first, actually about 60 mm in the Pestan River basin and 80 mm in the Turija River basin and the Tamnava River basin. Meanwhile, higher air temperatures and higher evaporation caused almost the same specific discharges of these rivers. The last period was in mean values similar to the second, apart from intensified variation of extreme values of all climatic elements. The discharges were influenced by more frequent alternation of wet and dry periods, which could be seen on figure 2.

Preliminary results of the Donjokolubarski basin annual flow variation show discrepancy in spring and summer monthly flow among two studied periods (Figure 2 - right). Further research should examine correlation of monthly flow and bank erosion intensity.

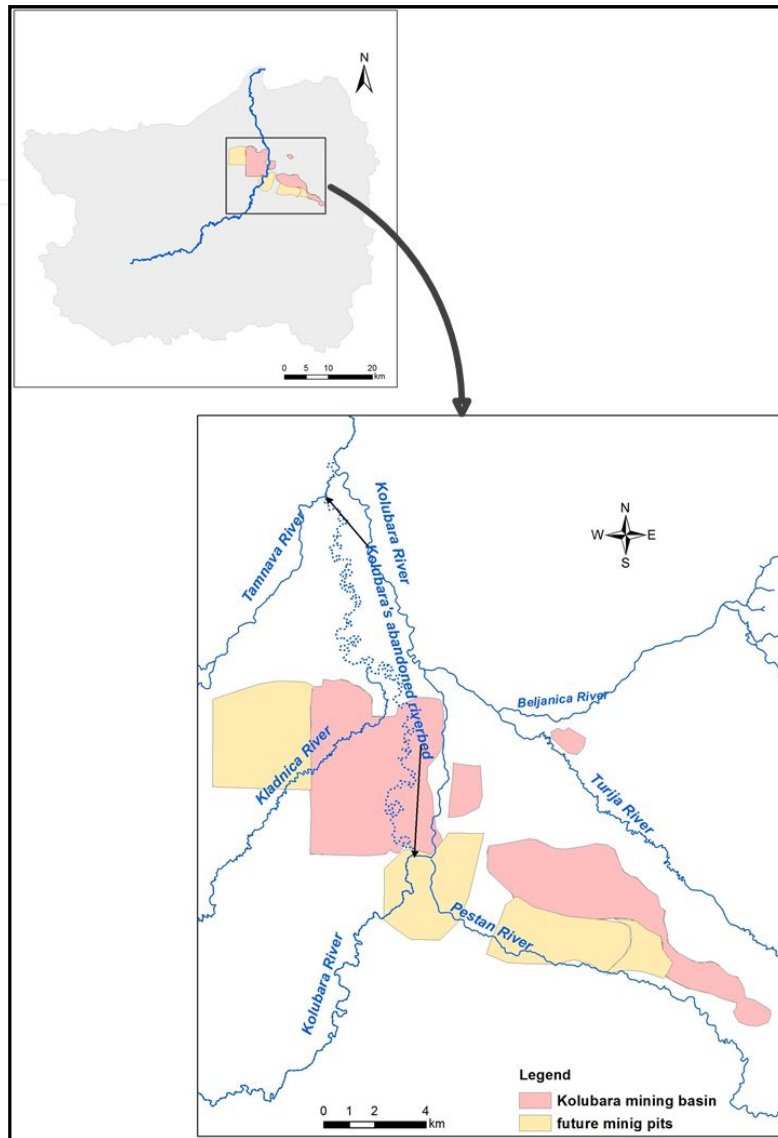
Figure 3. Plan of the mining fields in Kolubara mining basin [28]

Opencast lignite exploitation in Kolubara mining basin started in 1952 when the mining field "A" was open (it was exploited till 1966). Mining field "B" was opened in 1952, mining

field “D” in 1961, “Tamnava-East Mining Field” in 1979, “Tamnava-West Mining Field” in 1994 and mining field “Veliki Crljeni” in 2008 [28].

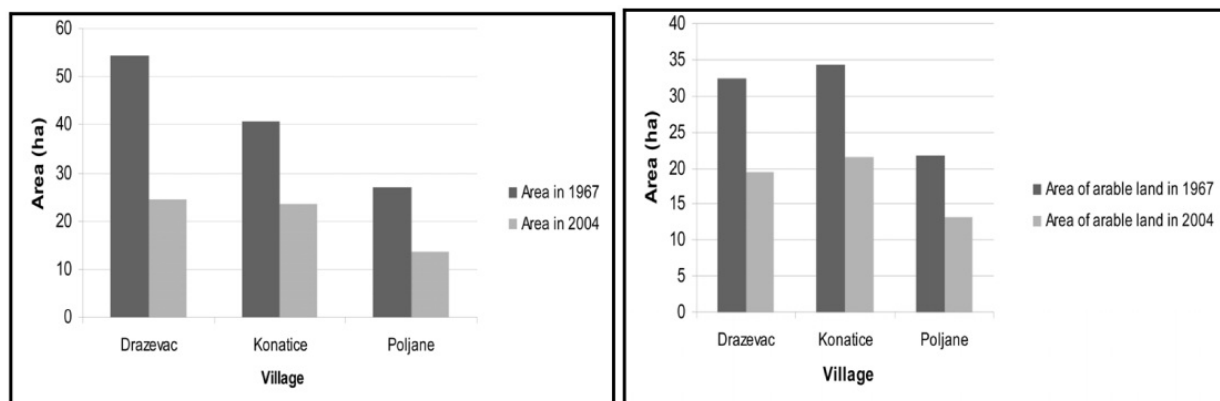
Figure 4. Land use changes in total area (left) and area of arable land (right) in Drazevac, Konatice and Poljane between 1967 and 2004

From 247 endangered land parcels, 136 are arable land with the area of 111.6 ha in 1967, and 76.48 ha in 2004, which means that within 37 years 35.12 ha of arable land was lost for farming, and it is 31.5 % of the initial area (in 1967). The woods comprise 21 of all endangered land parcels with area of 6.87 ha in 1967, and 3.01 ha in 2004, which means that it has been lost 3.86 ha of woods. There are only the three endangered land parcels with pastures, and their area was 1.27 ha in 1967, and 0.57 ha in 2004. All five endangered land parcels with meadows are in the area of Drazevac village.

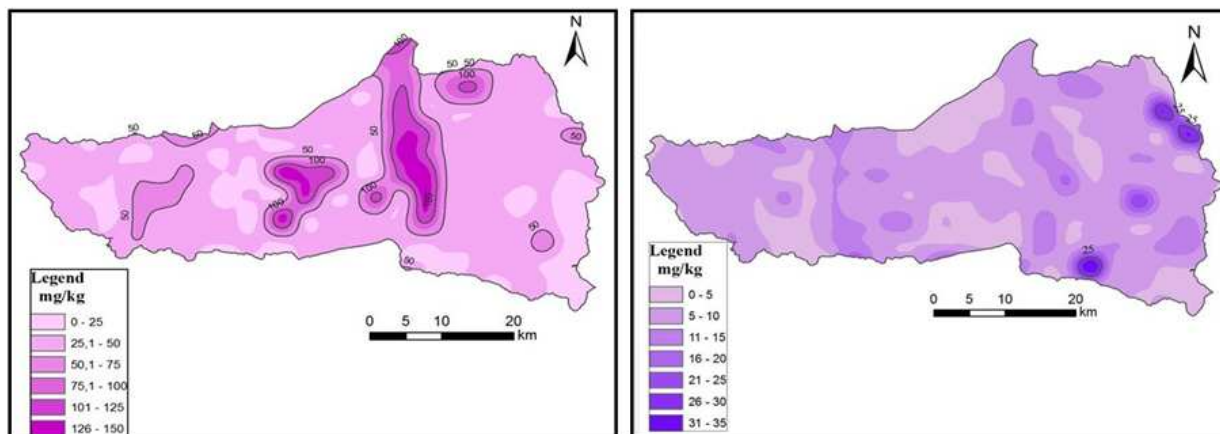
Figure 6. Distribution of Ni (left) and As (right) in the soil of the Donjokolubarski basin [18].

nutrients found in the soil as well as chemical pollution of water and sediment by pesticides and heavy metals are very important ecological problem in the study area. On two locations we have sampled the accumulated material from the Kolubara's riverbed to examine the transport of contamination and accumulation of contaminated sediments due to bank erosion processes.

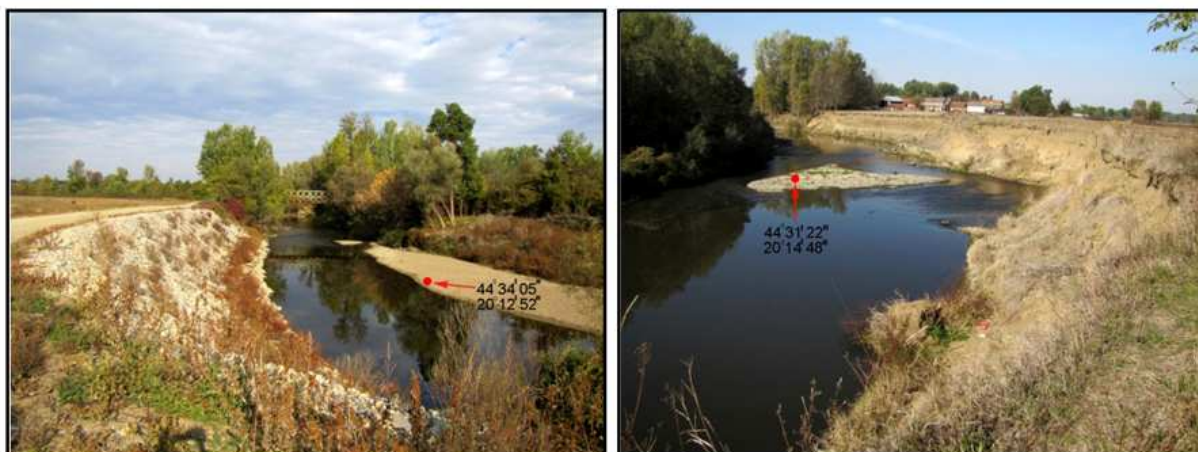
Figure 7. Sampling of deposited sediments on location 1 (left) and 2 (right)

The sediment samples were taken on two locations in the Kolubara's riverbed. For heavy metals and carbon analysis the soil was milled to a fine powder. Heavy metals were determined by AAS method.

The deposited sediments have sandy-clay texture. Chemical characteristics of deposited sediments from Kolubara's riverbed are: mildly alkaline reaction, high bases saturation degree and low humus content. The average heavy metal concentration in sediments decreased in the order: $\text{Ni} > \text{Cr} > \text{Zn} > \text{Pb} > \text{Cu} > \text{Cd}$.
