Imaging Patellar Complications After Knee Arthroplasty

Pietro Melloni, Maite Veintemillas, Anna Marin and
Rafael Valls

<http://dx.doi.org/10.5772/53666>

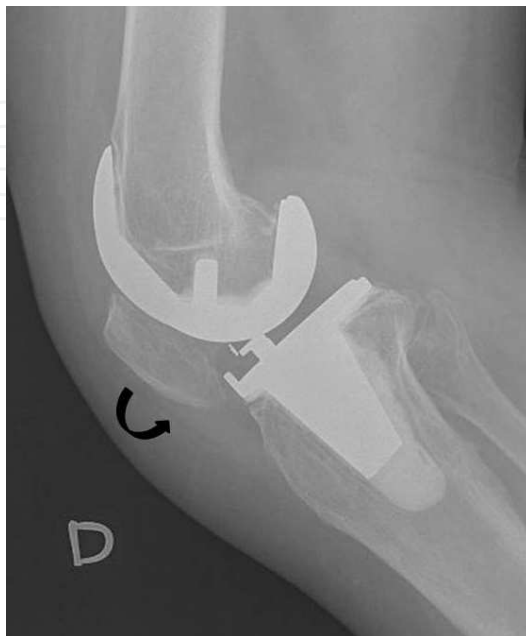
Figure 1. Patellar Instability. A 60-year-old man, five years after total knee replacement. Lateral radiograph reveals caudal displacement of the patella (curved arrow).

Careful radiographic follow-up should be considered when deep flexion is achieved in a knee with a patella baja after total knee arthroplasty (Figure 1). Patellar dislocation (n=6) is mainly due to direct trauma to the patella or to extensor mechanism rupture [20] (Figure 2).

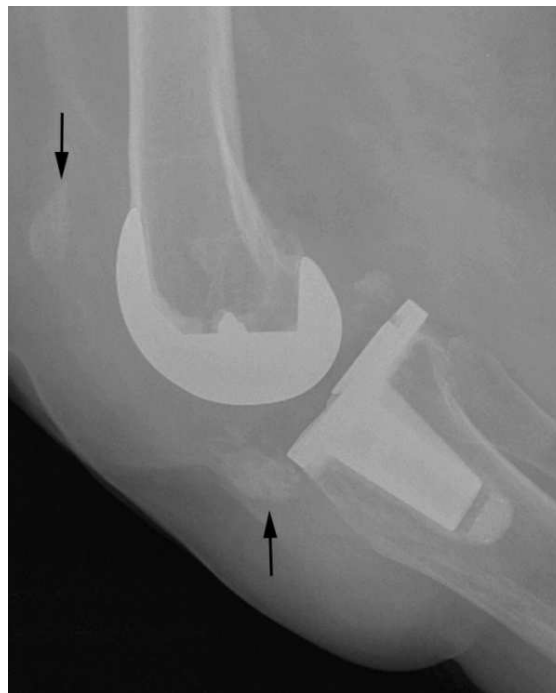
Figure 4. Patellar Avulsion Fracture. A 73-year-old woman, seven years after total knee replacement. Lateral radiograph shows a transverse avulsion fracture in the mid-portion of the patella with displacement of its poles in the cranial-caudal direction (arrows).

Trauma to the patella, either direct or indirect, and increased patellofemoral stress are other causes of fracture. Indirect causes might include an eccentric quadriceps muscle contraction associated with a stumble, resulting in an avulsion fracture (Figure 4).

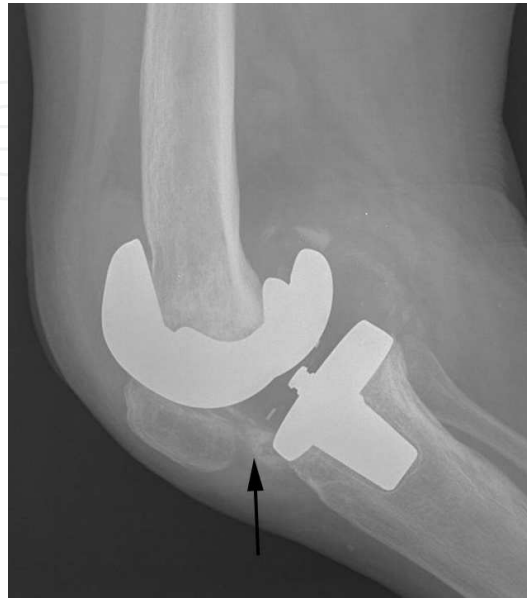
Figure 9. Prosthetic Button Rupture. A 68-year-old woman, four years after total knee replacement. Lateral radiograph shows a rupture of the patellar prosthetic button (arrow) with caudal displacement.

Rupture of the patellar prosthetic button (Figure 9) is rare but can occur due to polyethylene wear, fusion defects in the polyethylene structure [31], or trauma to the patella. [32] The incidence of wear in patients with all-polyethylene and metal-backed components ranges from 5% to 11%. Congruity, maltracking, and contact force are associated with polyethylene wear. Decreased polyethylene thickness in metal-backed designs is the determining factor for mechanism failure.

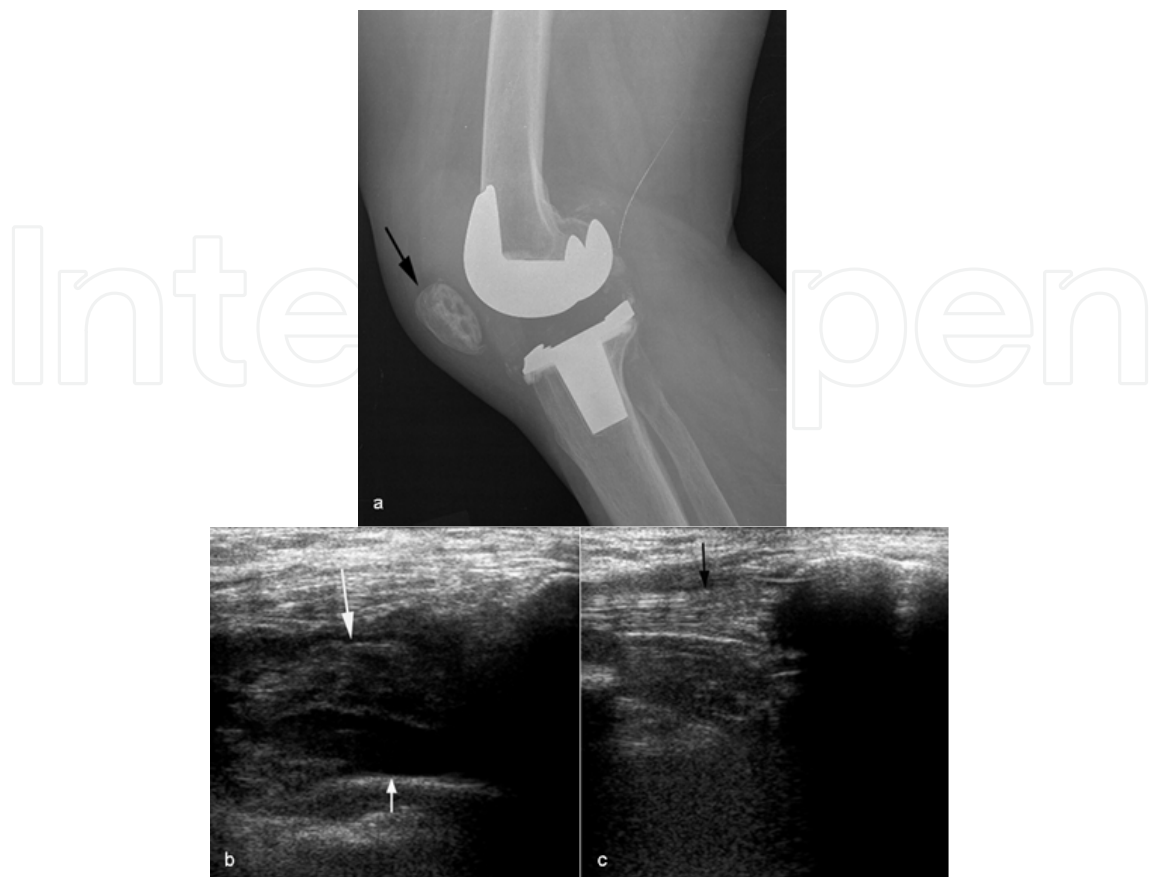
Figure 10. a-c).- Quadriceps Tendon Rupture. A 73-year-old woman, ten years after total knee replacement. Lateral radiograph (a) shows patellar displacement and rotation with clinical suspicion of quadriceps tendon tear (black arrow). US (b) confirms a disrupted quadriceps tendon (long white arrow) with a suprapatellar fluid collection (short white arrow) and a 5 cm gap between the end of the tendon and the patella. Compare with the sonogram of the contralateral knee showing a normal quadriceps tendon (fine black arrow) with total knee replacement (c) in the same patient, who had rheumatoid arthritis.

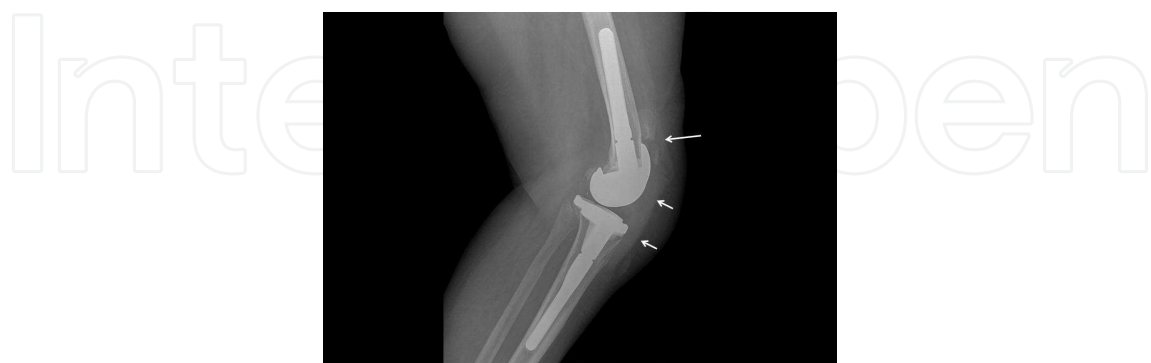
Figure 11. Patellar Tendon Rupture with Patellar Avulsion Fracture. A 69-year-old woman, twelve years after total knee replacement and two years after revision knee replacement with long femoral and tibial stems. Lateral radiograph shows cranial displacement with transverse avulsion fracture in the mid-portion of the patella (long arrow). Note the extensive soft-tissue edema in the patellar area (short arrows), leading to suspected patellar tendon rupture, which was confirmed at ultrasonography (not shown).
