Application of Acoustic Emission Technique in the Monitoring of Masonry Structures

Jie Xu, Qinghua Han and Ying Xu

Abstract

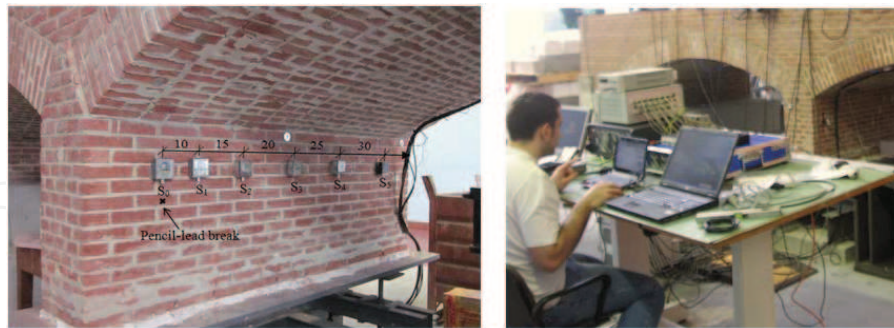
Figure 6. Wave velocity test: (left) the sketch of the pencil-lead break point and the sensor distribution and (right) scenario of the velocity test.

As shown in **Figure 6**, sensors (S_0 - S_5) are adopted to monitor acoustic data, and the distance between two neighbored sensors increases from S_0 - S_1 to S_4 - S_5 with an increment value of 5 cm. During the test, the pencil was broken beneath the S_0 sensor, 5 cm away from the same surface, to analyze velocity propagation in the surface, as shown in **Figure 6**. At the same time, AE wave propagation inside the masonry bridge was also investigated through the same sensor array shown in **Figure 6**, and the pencil was broken on the opposite surface of the central pier but at the same corresponding position of sensor S_0 .

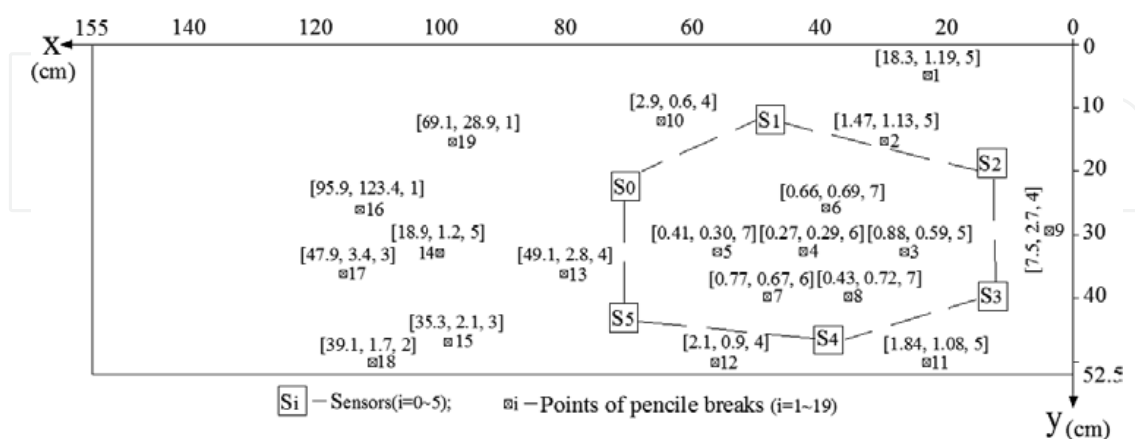
Pencil-lead break tests are conducted to produce AE source on the right-side surface of the masonry bridge. As shown in **Figure 10**, six sensors described in Section 2.3.1 are attached to the surfaces. Nineteen different points were selected to make a pencil-lead break (artificial

Figure 10. Crack source localization results from the traditional and the proposed modified methods. For $[a, b, c]$, a is the average error from the traditional method, b is the average error from the modified method, and c is the source breaks used for each point.

The localization results are shown in **Figure 10** for both the proposed modified and traditional methods. It is clearly shown that the location accuracy changes with the source break position. According to the accuracy, we divided the break points into three groups. As the dashed line shown in **Figure 10**, points 3 to 8 inside the central area of the sensor network have the best accuracy for localization for both methods. In the second group, points 2, 9, 10, 11, and 12, distributed on the nearby region of the sensor network, comprise the second group. Points in the third group are the rest of the points, far from the sensor network.

In the first group, the two methods both get the ideal result, the errors are all smaller than 6 mm, and most crack sources can be detected. In the second group, the proposed modified model gives better localized results than the traditional method. The errors value (*a* in **Figure 10**) in the traditional method is 15 to 75 mm, whereas the errors value (*b* in **Figure 10**) can be reduced to 6 to 27 mm in the proposed modified method. In this group, about half of the break sources can be monitored based on the value *c* in **Figure 10**. The result from the traditional method for the third group is hardly acceptable for its huge errors, but the proposed modified method can be still in good results. Although the errors are 3 or 4 cm, which are slightly large, the localized results are still acceptable if compared to the total size scale of the surface.

From the test results, compared to the traditional method, the proposed modified method can give better source localization results for the masonry structure in all the three group conditions.

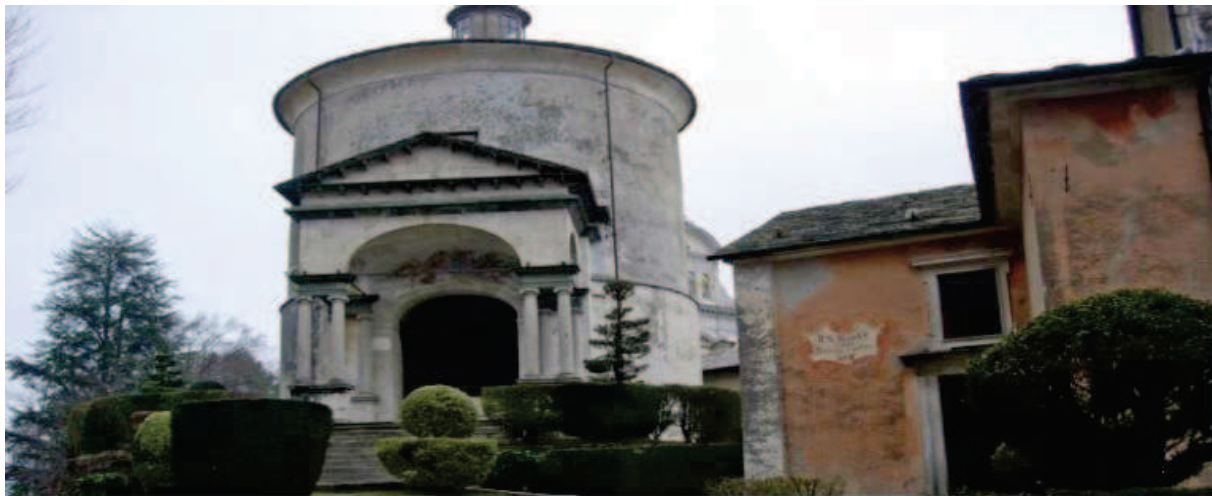
Figure 12. Out view of the Chapel XVII.

The first monitored structure by AE technique was chosen as the Chapel XVII, which tells the story of the transfiguration of Christ on Mount Tabor, as shown in **Figure 12**. Chapel XVII was constructed starting from the foundations in 1572 but was finished only in the 1760s.

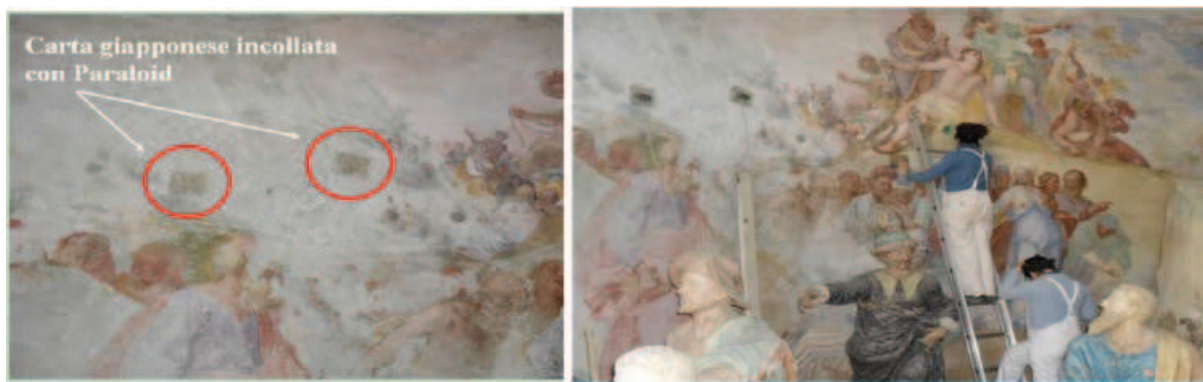
Some necessary previous operations were carried out by professional restorers for attaching the AE sensors on the wall. First, areas were selected and prepared for monitoring with the films of Japanese paper, of which the surface was then stretched out a hand of light “Paraloid”, as shown in **Figure 15a**. This is one kind of acrylic resin that is used in restoration as a consolidation at low concentrations (2–4%) or glue at higher concentrations. As shown in **Figure 15b**, the “Paraloid” here provides a good basis for the bonding of the AE sensors.

Figure 15. (a) "Paraloid" position with Japanese films and (b) bonding of the sensors.

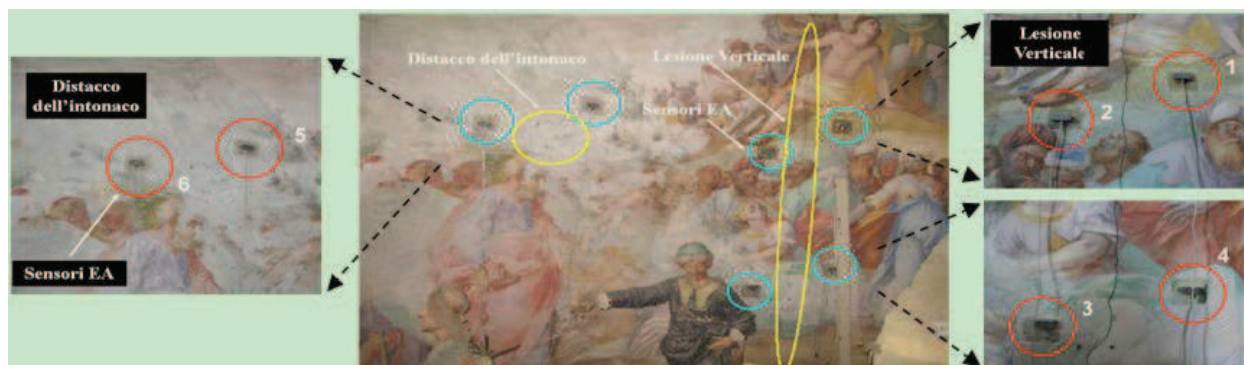
The sensors have been arranged in positions useful to monitor simultaneously both the progress of the lesion and the detachment of the plaster. The detailed locations of the sensors are shown in **Figure 16**.

Figure 16. Detailed sensor positions.
