Human-Induced Geo-Hazards in the Kingdom of Saudi Arabia: Distribution, Investigation, Causes and Impacts

Ahmed M. Youssef, Hasan M. Al-Harbi,
Yasser A. Zabramwi and Bosy A. El-Haddad

Keywords: earth fissures, sinkholes, human induced, KSA

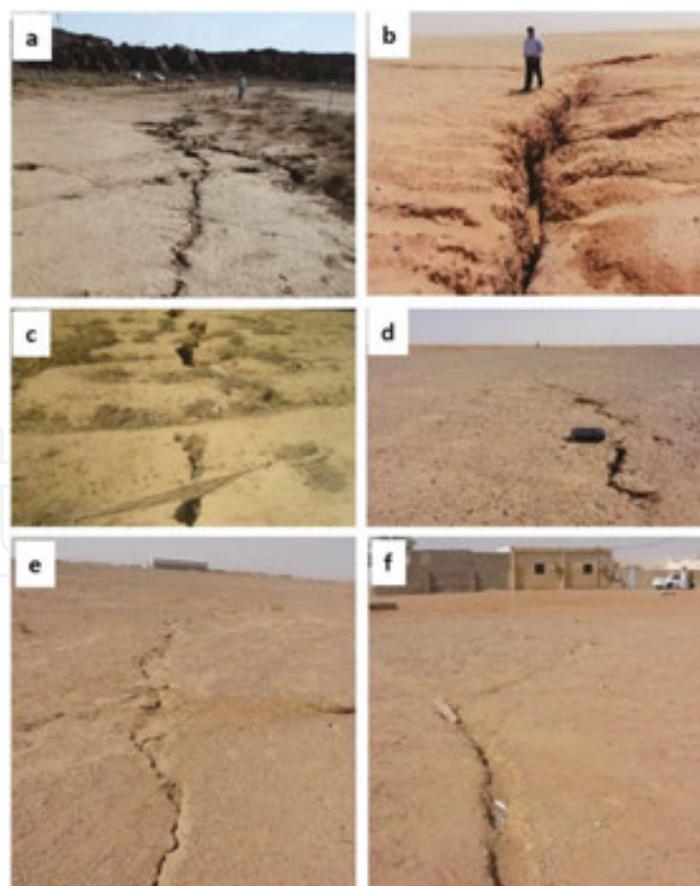
Figure 1. Earth fissures distributed in different areas in the KSA.

Earth fissures can be formed in loess soil due to water effect (rain, storms, floods, or leakage from agricultural irrigation channels and/or from neighboring houses). Earth-fissure and land-subsidence problems were reported in several areas in the Kingdom of Saudi Arabia causing damage to infrastructures, buildings, and agricultural areas (**Figure 1**). There are many examples of loess-related failures (earth fissures and subsidence) in the KSA such as the areas north of Jizan city, El-Darb Area, and North of Al-Nai village of Hail Region [1]. Many areas in the KSA are suffering from excessive groundwater extraction and are consequently subjected to land subsidence and earth fissures [1, 36–43]. Different types of earth fissures were detected in the KSA according to various reasons, among them are (a) earth fissures associated with groundwater extraction for agricultural development such as in Wadi Najran, Wadi El Dawather, Hail Region, Qasim Region, and Al Jouf Region; (b) earth fissures that are related to clay deposits (swelling and compressed clay deposits) such as in Hail, Al Qasim, and Al Jouf Regions; (c) earth fissures due to the Khabra deposits, which appear due to the drying effect such as in Al Jouf, Hail, and Al Qasim Regions; (d) earth fissures that are related to geological structures and groundwater withdrawal; and (e) earth fissures that are due to earthquake effects (El Shaqa area, northwest of El Madinah).

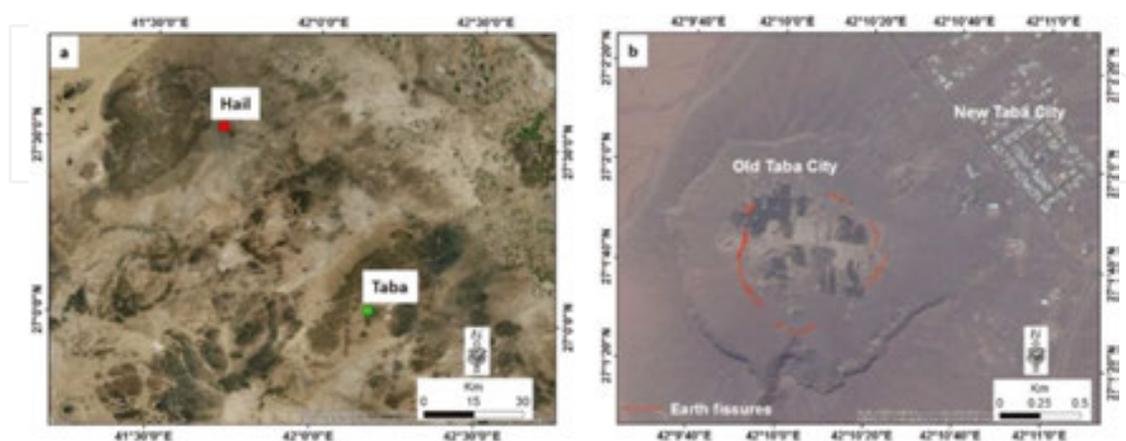
Figure 2. (a) Location of Tabah village related to the Hail city; (b) Location of earth fissures in the old Tabah village in relation to the New Tabah village.

The old village of Tabah is located ~70 km southeast of the Hail city at a latitude of 27° 02'N and a longitude of 42° 10'E (**Figure 2a**). It is laid on Harrat Hutaymah in an ancient volcanic crater (**Figure 2b**). This crater has dimensions of ~1.7 km by ~1.5 km and is filled with fine sediments and gravel (eroded from the surrounding volcanic tuffs), subsequently, filled with water forming a groundwater aquifer. The aquifer has been used since few decades until now by the village for drinking and irrigation. The crater has a low rim where weakly lithified tuff is exposed. Some Precambrian rocks and dikes are exposed inside the crater due to the erosion of tuff materials to fill the volcanic vent. The earth fissures are located in the old village of Tabah, which lies about 1 km southwest of the new Tabah village (**Figure 2b**). These earth fissures have been recognized and recorded since 1984. Extensive field investigations have shown the presence of earth fissures in different types, lengths, shapes, and directions (**Figure 3a**). Most of them are shown as ring shapes, forming a concentric zone along the margins of the volcanic vent (with a dimension of ~0.9 by ~0.7 km). They are deep, wide-open, and long fissures (more than 4 m deep, 3 m wide, and 600 m long). They spread in the floor of the village, agricultural areas, and cut through buildings (**Figure 3b**). Most nearby buildings and agricultural areas were damaged by these earth fissures. The presence of the earth fissures in the area leads to migration of most of the population to other areas (New Tabah village). There are some previous studies conducted in this area such as detailed in Refs. [24] and [36]. These studies indicated that the first earth fissures that were 120 m long were observed in 1981. Roobol et al. [24] mentioned that extensive earth fissures (as long as 500 m long) happened in 1984, causing damage to buildings. The present typical situation of these earth fissures is shown in (**Figure 2b**). The earth fissures in the area are shown as concentric rings (zone). Along this zone, most of the agricultural areas, village buildings, and concrete walls of the village cemetery were damaged. These earth fissures are associated with ground subsidence in some

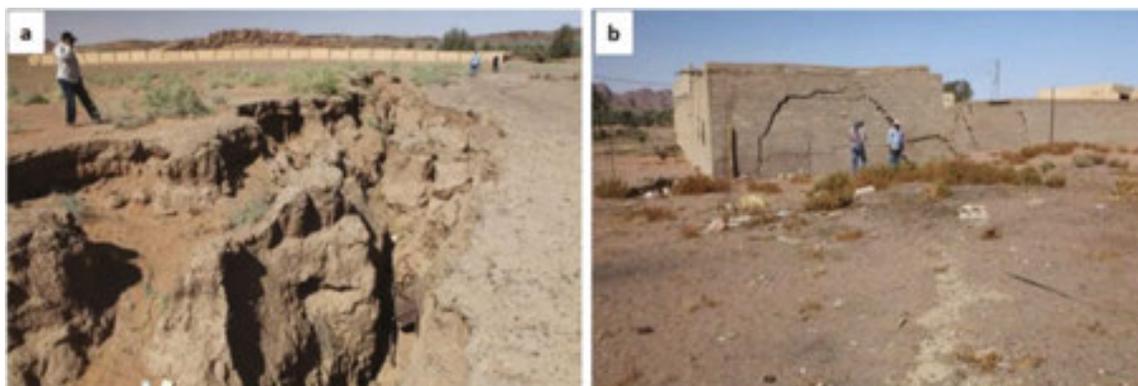
Figure 3. Photographic pictures showing (a) Earth fissures' distribution, (b) Impact of earth fissures on buildings.

parts, showing a vertical displacement (up to 1.5 m). We believe that these earth fissures and ground subsidence are not yet completed and will continue in the future.

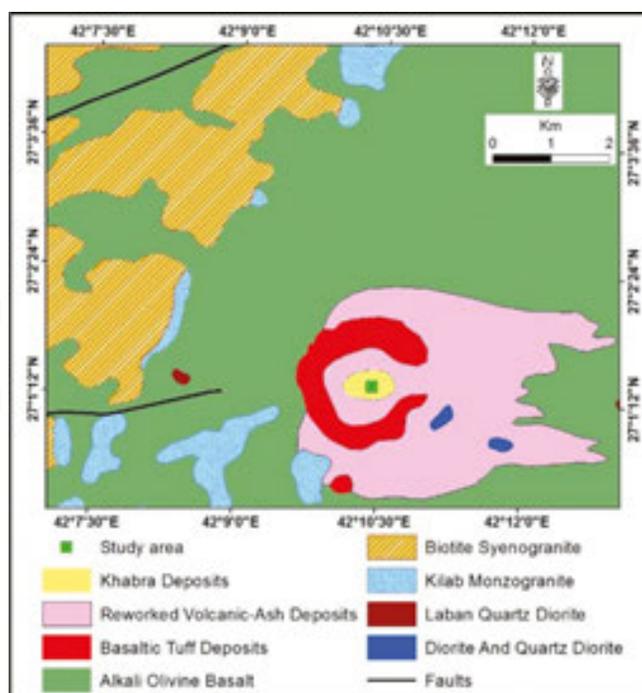
Figure 4. Surface geological map of the study area and its surrounding.

(3) Basaltic tuff deposit (Qt); (4) Alkali olivine basaltic rocks (Qb); (5) Biotite syenogranite rocks (sgb); (6) Kilab mozogranite rocks (kmg); (7) Laban quartz diorite rocks (lqd); and (8) Diorite and quartz diorite rocks (di).

Analysis of satellite image and topographic map of the study area indicated that the earth fissures are located between elevations of 1020 m and 1030 m from the mean sea level. Geologically, the study area consists of the following geological units from the youngest to the oldest as follows (**Figure 4**): (1) Khabra deposits (Qk), including silt, clay, and some sand; (2) Reworked volcanic ash deposit (Qa) consisting of a redeposition of ancient volcanic deposits;

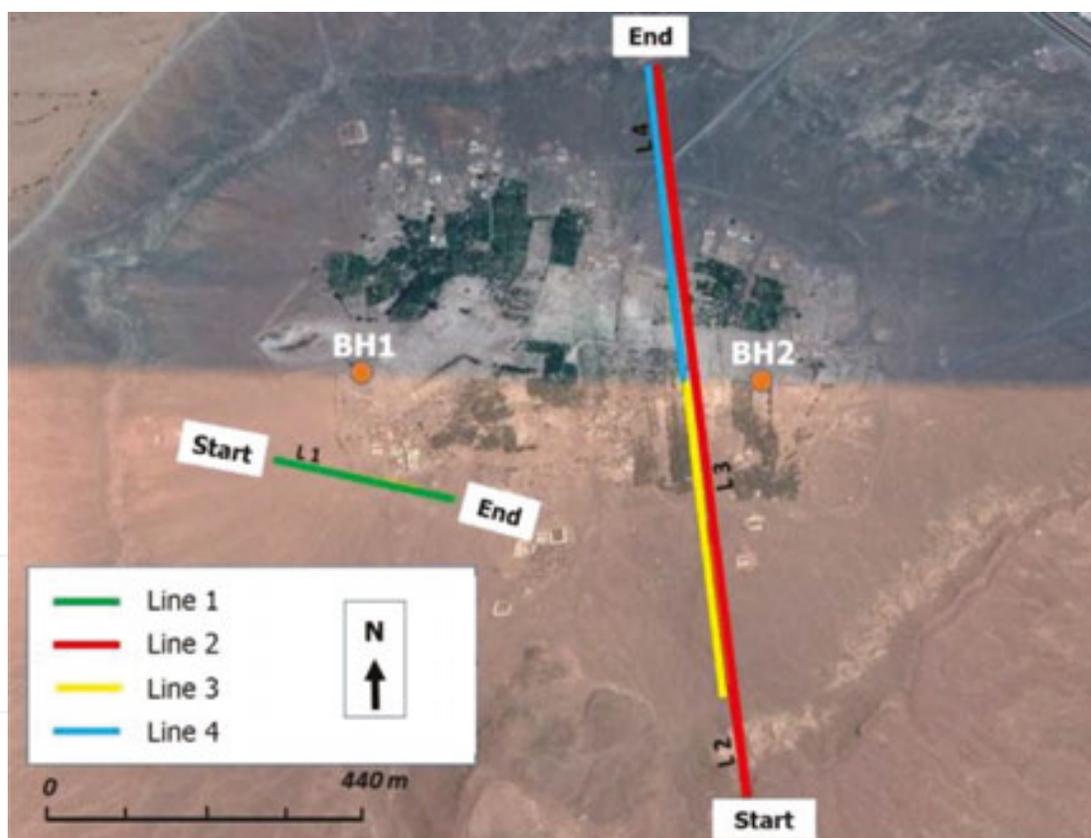
Figure 5. Distribution of geophysical lines and boreholes in the study area.

Geophysical investigation using the electrical-resistivity method was performed and is presented in this chapter. Electrical-resistivity tomography (ERT) represents commonly used geophysical techniques for the detection of earth fissures, which has been widely used in the KSA, producing satisfactory results. ERT is particularly useful in areas with significant resistivity contrasts. For measurements, four electrical-resistivity lines were performed in the old Tabah village (**Figure 5**). The first electrical line has a west-to-east direction with a total length of 285 m and spacing of 1 m and 3 m between electrodes, while the remaining three lines have south-to-north direction and lengths of 960 m, 470 m, and 470 m for the second, third, and fourth lines, respectively. The spacing between the electrical poles is 10 m each.

Two boreholes were drilled in the study area to investigate the subsurface soils and rocks (**Figure 5**). Analysis of the boreholes indicated that the sediment layer is characterized by alternation of sand with silt, clay with silt, sand with clay, and silt and some gravels and different rocks (**Figure 7**). These deposits have color ranging from light brown to brown and a thickness of 19 m (BH 1) to 144 m (BH 2). According to the unified soil classification system (USCS), these sediments include (a) clay with silt (CL–ML), which are characterized by liquidity-limit values ranging 18–28, plastic-limit values ranging 12–21, and plastic-index values ranging 5–7; (b) sand with silt (SM) and sand with silt and clay (SC–SM), which are characterized by a liquidity-limit value of 13, plastic-limit value of 9, and a plastic index value of 4.

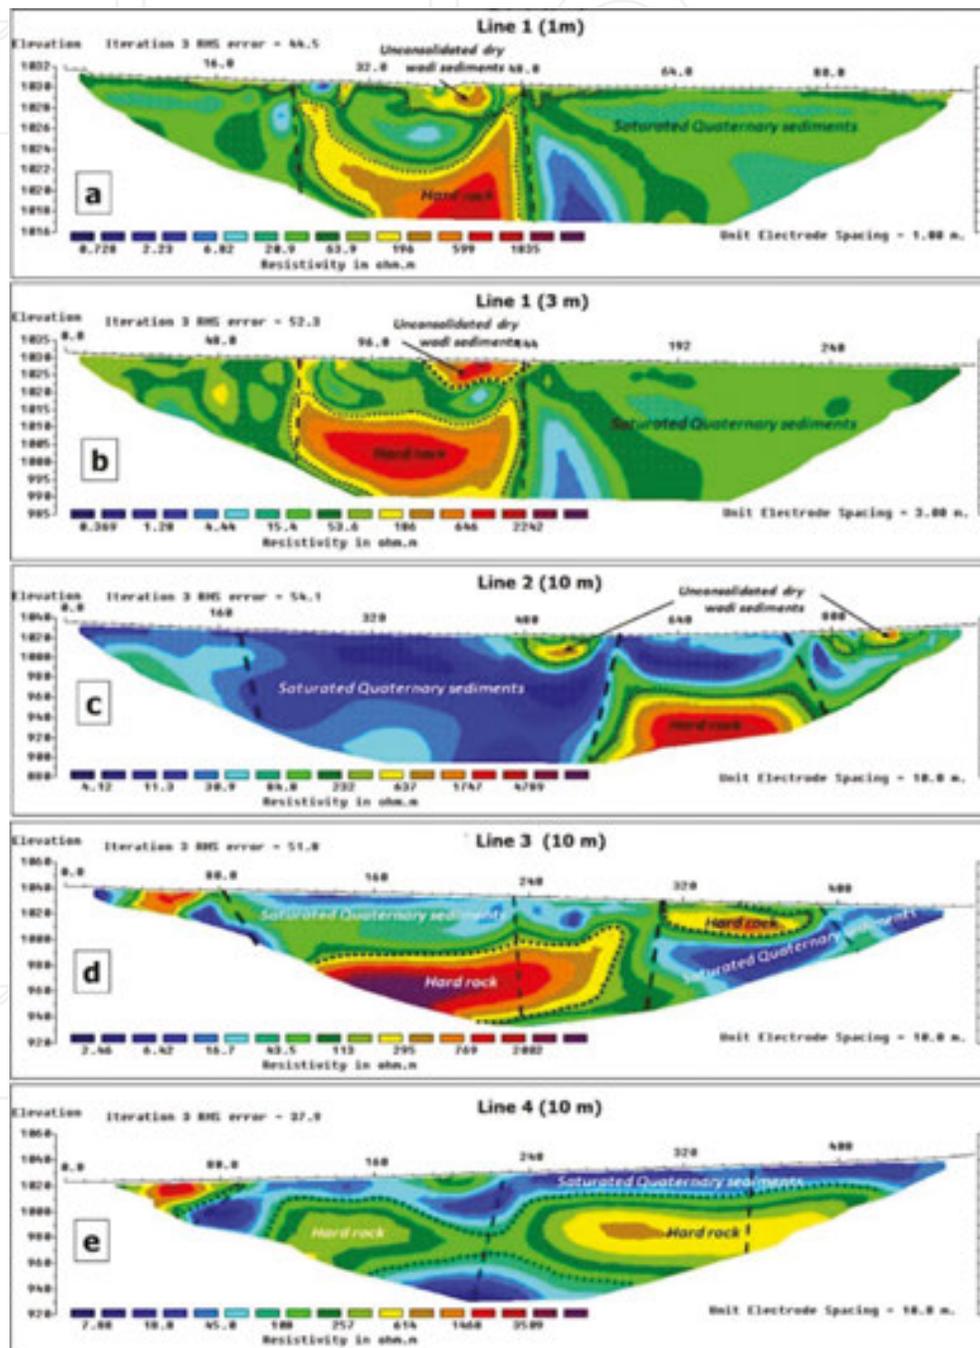
Figure 6. Electrical-resistivity profiles of different lines:(a) Line 1 with 1 m electrode spacing; (b) Line 1 with 3 m electrode spacing; (c) Line 2 with 10 m electrode spacing; (d) Line 3 with 10 m electrode spacing; and (e) Line 4 with 10 m electrode spacing. Note: horizontal axes do not have the same scale.

Line 1 (L1) moves across the earth fissures with a west-to-east direction. It applied with 1 m electrode spacing (**Figure 6a**) and 3 m spacing (**Figure 6b**). Information collected using this line shows that the soil in the region, which consists of Quaternary and volcanic ash sediments, has low electrical resistance up to the maximum depth of the profile (40 m). The decrease in

the electrical resistance values is related to the water-saturation effect. It reveals the presence of vertical fissures in the middle part of the electric line (L1) (**Figures 6a, b**), which represents the contact line between the water-saturated soil and the Precambrian complex rocks, which has high electrical resistance. These hard rocks begin from 5 m under the surface and extending up to 40 m deep.

Line 2 (L2) moves across the earth fissures with a south-to-north direction with a total length of 950 m, 10 m electrode spacing, and reaches up to 130 m depth (**Figure 6c**). It is clear that there is a large underground reservoir with a large thickness as the electrical resistance values are low. The end of the profile shows the presence of high-resistance materials (solid rocks) at a depth of 50 m, extending beyond the total depth of the profile (130 m deep). Different deep earth fissures were detected along the profile and appeared at the contact between sediments and hard rocks (**Figure 6c**).

Line 3 (L3) moves across the earth fissures with a south-to-north direction with a total length of 470 m, and 10 m electrode spacing (**Figure 6d**). It was found that this profile reflects the same phenomena that have been monitored in Lines 1 and 2 where there is a large zone of water-saturated sediments (with low electric resistance), which intruded with hard rocks (with high electric resistance). The hard rocks appear at a depth between 30 m and 50 m in the middle of the profile. Various deep earth fissures were detected along the profile at distances of 80 m, 230 m, 310 m, and 390 m from the start point of the line (**Figure 6d**). These earth fissures mostly appear along the contact between soil and rocks.

Line 4 (L4) moves across the earth fissures with a south-to-north direction with a total length of 470 m and 10 m electrode spacing (**Figure 6e**). It was found that this profile reflects the same phenomena that have been monitored in Lines 1, 2, and 3 where there is a large zone of water-saturated sediments (with a low electric resistance), which intruded with hard rocks (with high electric resistance). Hard rocks appear as a horizontal layer at a depth of 10 m from the surface. Various deep earth fissures were detected along this profile (L4) at distances of 100 m, 210 m, and 345 m from the start point (**Figure 6e**). These earth fissures mostly appear along the contact between soil and rocks.

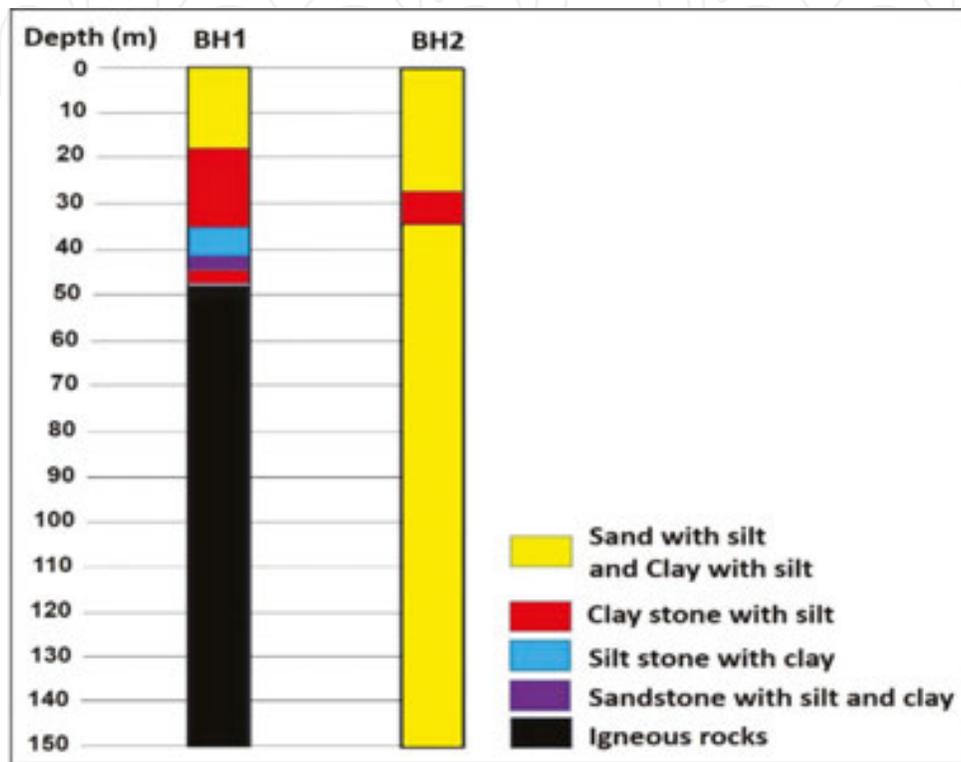
Figure 7. Lithology of boreholes.

Rocks are characterized by the following: (a) clay stone is characterized by gray to white color, includes some clay and silt, highly fractured, the rock-quality designation (RQD) ranging from very poor to poor (0–40) percent of the recovery ranging from 40 to 100%, and the uniaxial compressive strength ranging from 0 MPa to 4.3 MPa; (b) sandstone is characterized by brown color, highly fractured, the rock-quality designation (RQD) ranging from very poor to fair (20–66), the recovery percent of 100%, and the uniaxial compressive strength ranging from 4.6 MPa to 7.4 MPa; (c) siltstone is characterized by brown color, moderately to highly fractured, the

rock-quality designation (RQD) ranging from very poor to fair (0–40), the recovery percent ranging from 90 to 100%, and the uniaxial compressive strength ranges from 1.4 MPa to 7.2 MPa; (d) igneous rock is characterized by brown color, fine grained, slightly to highly fractured, the rock-quality designation (RQD) ranging from very poor to fair (0–74), the recovery percent of 100%, and the uniaxial compressive strength ranging from 1.1 MPa to 15.3 MPa.

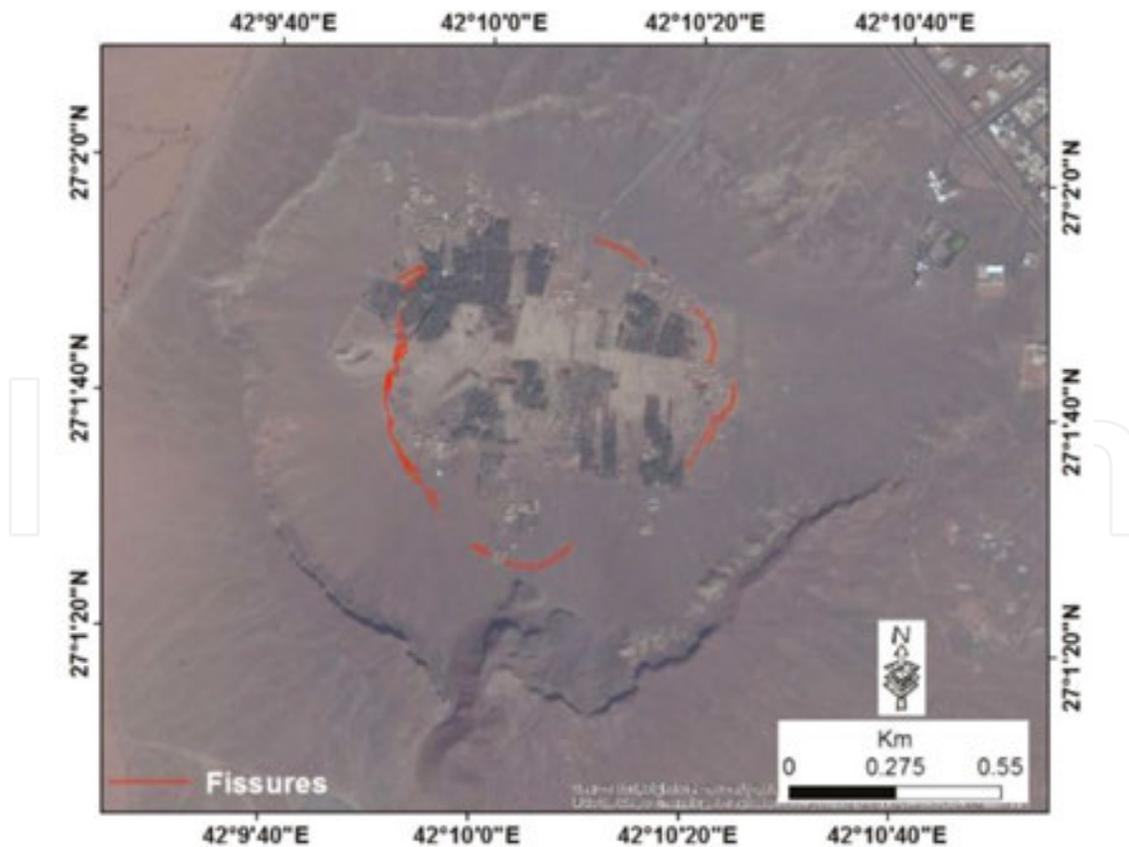
Figure 8. An example of agricultural activities in Tabah area.

- a. The area is characterized by the presence of agricultural areas since few decades ago, which mainly depend on the groundwater aquifer in the area (Figure 8). According to the information obtained from residents of the area, the groundwater level was near the earth's surface (<50 m below the surface) 30 years ago. As a result of drilling of a large number

of groundwater wells (for domestic use, irrigation, and road building, which in turn led to extensive withdrawal of huge amounts of groundwater), the water level declined to the level of 120 m in 1985 and now lower than 160 m below the earth's surface.

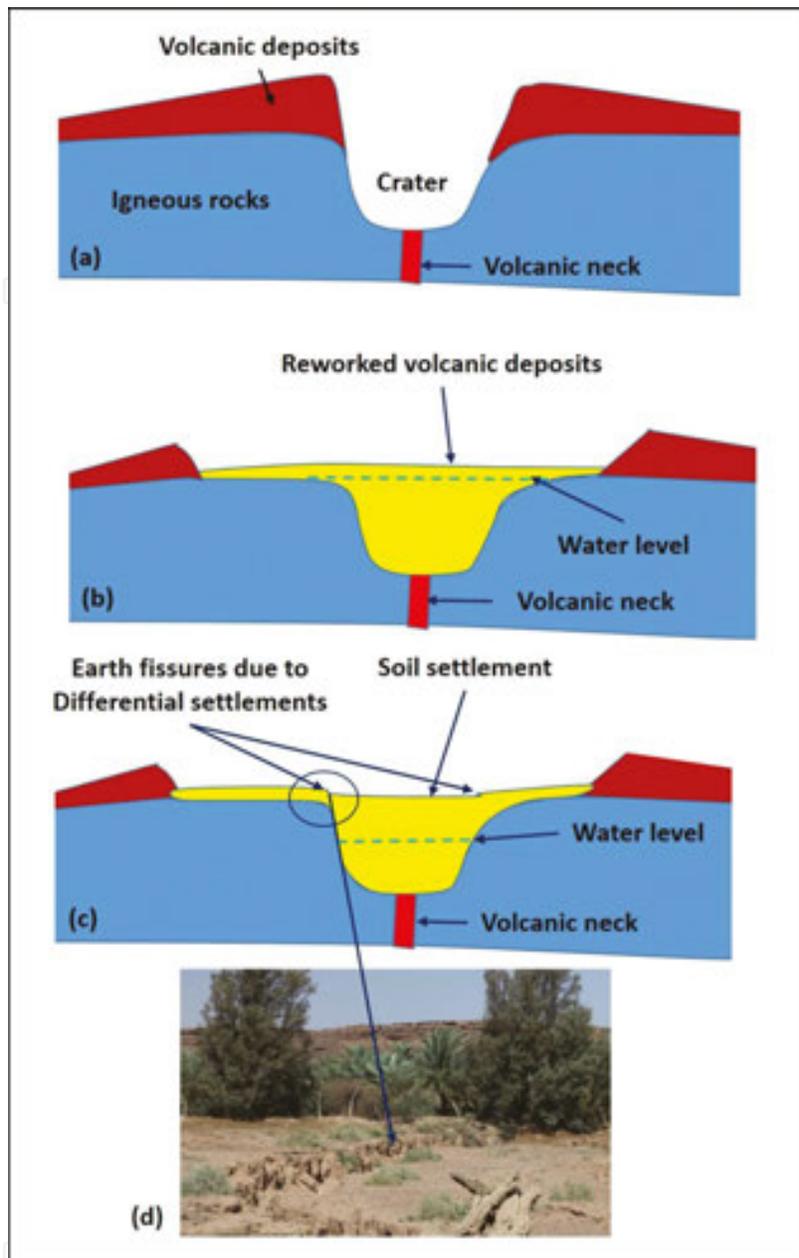
Figure 9. Earth fissure development model in Tabah area (modified after Roobol et al. [24]): (a) Before erosion of volcanic deposits; (b) After erosion of volcanic deposits and refill, the vent, water table is very shallow; (c) Current condition, water table ~160 m deep and earth fissures occurred; and (d) Photograph showing current earth fissures.

- c. As a result of the topography irregularity, the thickness of the sediments increased toward the centre of the area and decreased outwards where the solid rocks become near the surface especially on the sides of the area. As a result of the groundwater withdrawal, the water level significantly declined, leading to the compression of the sediments. According to the differential settlement of these sediments, along the edges, the amount of settlement is small and increases toward the centre of the area. This leads to the appearance of earth fissures at the contact surface between hard rocks and deep sediments. Some of these fissures have vertical displacement. **Figure 9** shows a model for the earth-fissure development. The geophysical and geotechnical investigations confirmed this theory as the cause of earth fissures.

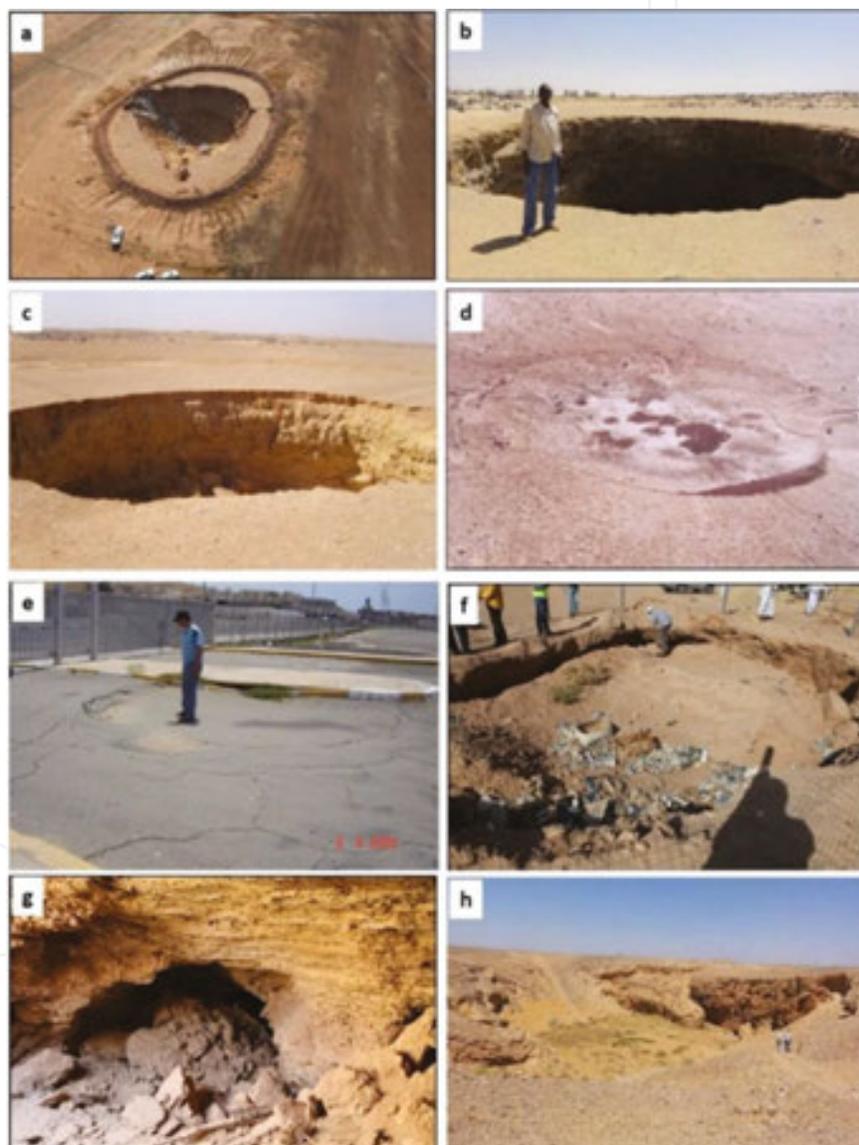
Figure 10. (a) Cover-collapse sinkhole in Al Jouf farm company area; (b) Caprock-collapse sinkhole in Al Issawiah area; (c) Caprock-collapse sinkhole in Al Issawiah area; (d) cover-suffosion sinkhole in Al Khafji area; (e) sagging sinkhole in Jizan area; (f) Bedrock-collapse and sagging sinkhole in Aba Alwrood area, Al Qasim region; (g) Bedrock-collapse and sagging sinkhole in Turaif area, Al Qasim Region; and (h) Bedrock sagging and collapse sinkhole at Bsita, Al Jouf Region.

1. Cover-collapse sinkholes case study, Al Jouf farm sinkhole: this type of sinkhole is a cover collapse sinkhole, located at a latitude of $29^{\circ}46'43.68''\text{N}$. and longitude of $38^{\circ}27'37.02''\text{E}$. This sinkhole has 40 m diameter and 15 m depth. It occurred in 2006 within a farm circle (**Figure 10a**). Geologically, the limestone bedrock of the Sirhan formation is overlain by a thick Quaternary cover (Aeolian sands capped by a quartz-rich gravel sediments). This sinkhole is formed due to excessive groundwater extraction, which started in 1989. Recent measurements of the water table indicated that the water level is at about 205 m deep from the ground surface. The drawdown of the water table has reached ~100 m.

2. Caprock-collapse sinkhole case study, Al Issawiah sinkholes: four sinkholes were recognized in Al Issawiah area, and some of them are caprock-collapse sinkholes. One of them is located at a latitude of $30^{\circ}43'30.5''\text{N}$. and longitude of $38^{\circ}06'01''\text{E}$. It is a subcircular collapse sinkhole with a diameter of 27 m and a depth of 23 m. It is opened on a basaltic caprock (**Figure 10b**). Geologically, the Sirhan formation in this area consists of friable calcareous sandstone, limestone, and shale, unconformably overlain in some areas by basalt of the Harrat Al Harrah lava field [54]. The basalt is covered by a thin silty soil plus discontinuous sand dunes and residual basalt boulders. In other areas, the basaltic layer disappears (**Figure 10c**). Field investigations indicated that the water table was exposed at the bottom of the sinkhole; with increasing groundwater exploitation because of increasing irrigation crops, the depression became dry and the water table declined.

4. Sagging sinkholes: sagging sinkholes involve the progressive passive bending of sediments related to dissolution of underlying soluble material. This type of sinkholes appears in many areas in the KSA, which are underlain by various formations such as Jilh, Arab, Zallum, Badanah, and Umm er Radhuma formations. Most of these areas are characterized by khabras deposits, which are filled by Quaternary fine-grained deposits. Many authors indicated that these khabras correspond to large sagging sinkholes relating to differential, interstratal karstification of the gypsum beds and the progressive ductile bending of the overlying rock strata [47, 49, 50, 55]. Another example of sagging sinkholes was documented in the sabkha environment in Jizan area where there was subsurface dissolution of evaporites, frequently induced by artificial water input into the ground and caused ground settlement (**Figure 10e**) [1].

- a. Aba Alwrood sinkhole located in Al Qasim Region at the latitude of $26^{\circ}25'52.16''\text{N}$. and longitude of $44^{\circ}03'10.69''\text{E}$. This sinkhole is a sagging and collapsing sinkhole which is 10.5 m long and 7.5 m wide that occurred in 2010 (**Figure 10f**). Geologically, the gypsum bedrock is of Jilh Formation of Triassic-age [56].

- b. Turaif sinkhole is located in Al Qasim Region, at the latitude of $26^{\circ}49'26.65''\text{N}$. and longitude of $44^{\circ}09'46.83''\text{E}$. Geologically, this sinkhole area consists of thinly bedded gypsum, limestone, and shale of the Triassic Jilh Formation [56]. The layers in the sinkhole

display downward bending, indicating two mechanisms of subsidence, including sagging and collapsing (**Figure 10g**).

- c. Bsita sinkhole is located in Al Jouf Region, at the latitude of $30^{\circ}11'16.8''\text{N}$. and longitude of $37^{\circ}51'1.88''\text{E}$. This sinkhole has an oval shape with a length of 100 m and width of 60 m (**Figure 10h**). Geologically, Palaeocene- and Eocene-age rocks of Mira formation are exposed in the area. These rocks consist of a thinly bedded silicified limestone and banded chert [54]. The studied evidence of this sinkhole indicates that the depression corresponds to a sagging-collapse sinkhole [10].

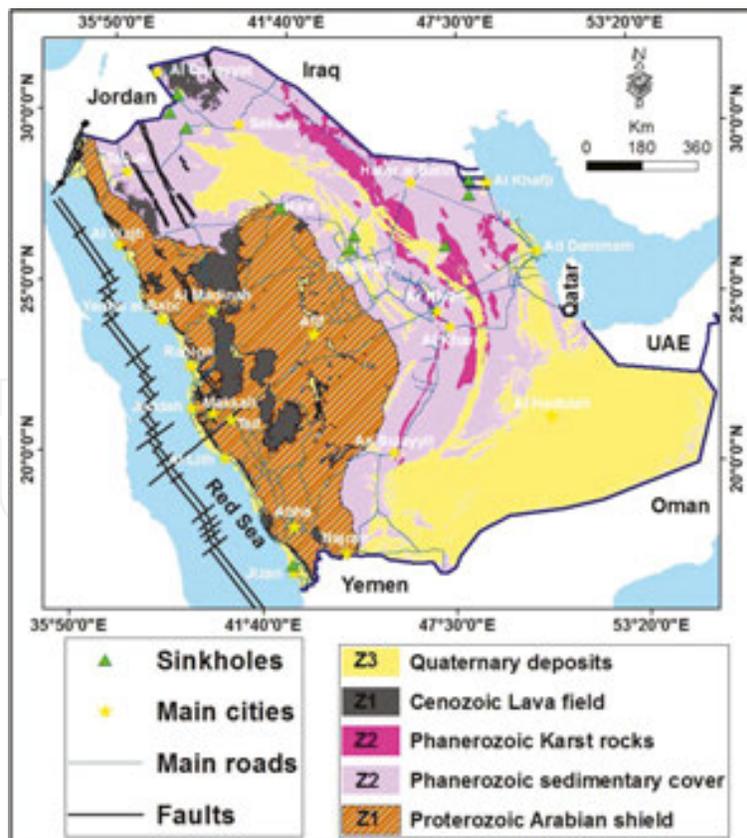
Figure 11. Geological map of the KSA showing areas of earth fissures and sinkholes.

The Kingdom of Saudi Arabia is located on the southern part of the Arabian Plate. According to the geological maps of 1:250,000 scale, which covers the KSA, an important information on the distribution of different rock units can be obtained as shown in (Figure 11). The KSA consists of three main geological zones:

Zone 1: The Arabian Shield, situated on the western part of the KSA. It consists of Precambrian rocks, locally covered by Cenozoic lava flows [57].

Zone 2: The Arabian Platform, situated on the eastern and northern part of the KSA. It is characterized by a Phanerozoic sedimentary succession [58]. It includes a significant proportion of carbonate and evaporite karst formations.

Zone 3: The Quaternary sediments cover a narrow coastal strip along the margin of the Red Sea and the east margin of the KSA. It also covers some areas of Zone 2. According to this map, it was found that the carbonate and evaporate rocks cover a significant portion of the KSA, which is exposed on the surface and sometimes covered by other rock formations. Different types of sinkholes were documented and mapped along Zone 2 [41–43, 46, 49, 59–62].

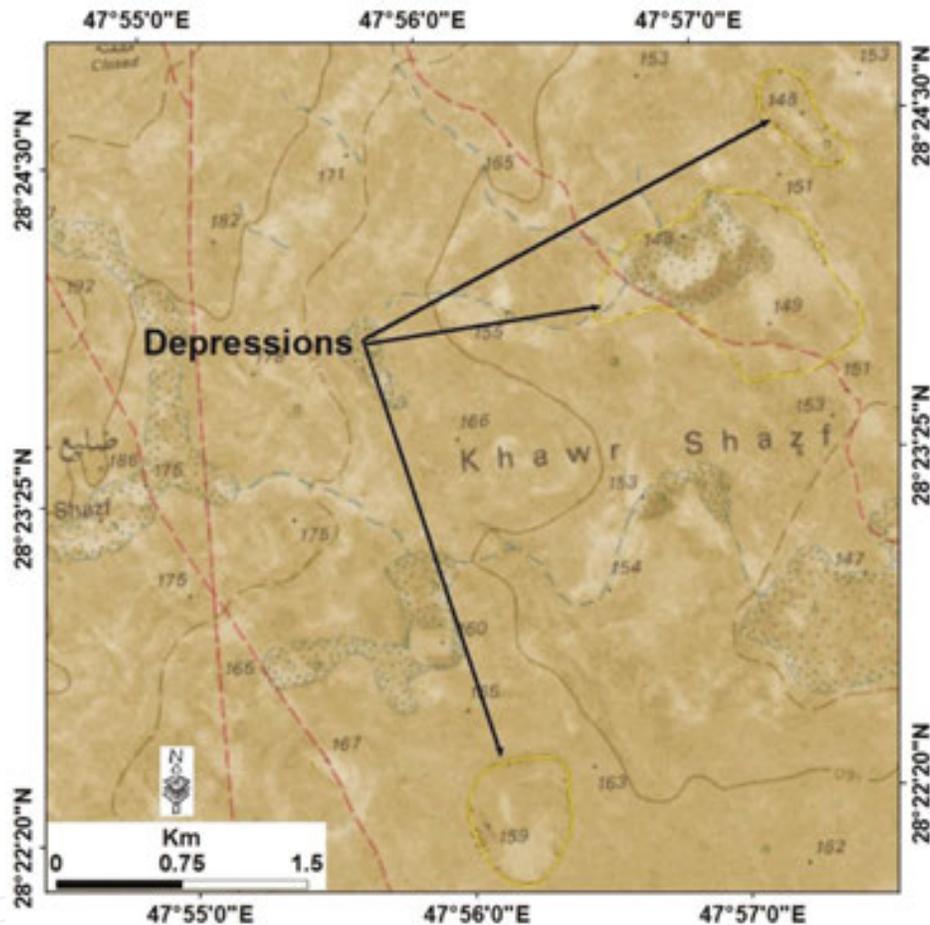
Figure 12. Topographic map of a small part of An Nu'ayriyah area showing dahls (potentially sinkhole areas).

According to topographic maps of 1:50,000 scale, different types of depressions related to dissolutions were detected and mapped. These depressions have local names (Dahls). The presence of these depressions can give a good indication of the presence of sinkholes and dissolution-induced subsidence depressions. Many studies were conducted on these depressions that are mapped in the topographic maps, and they verified that these depressions are related to dissolution and collapse sinkholes [10]. Some of these depressions (Dahls) on a topographic map of An Nu'ayriyah area is shown in **Figure 12**.

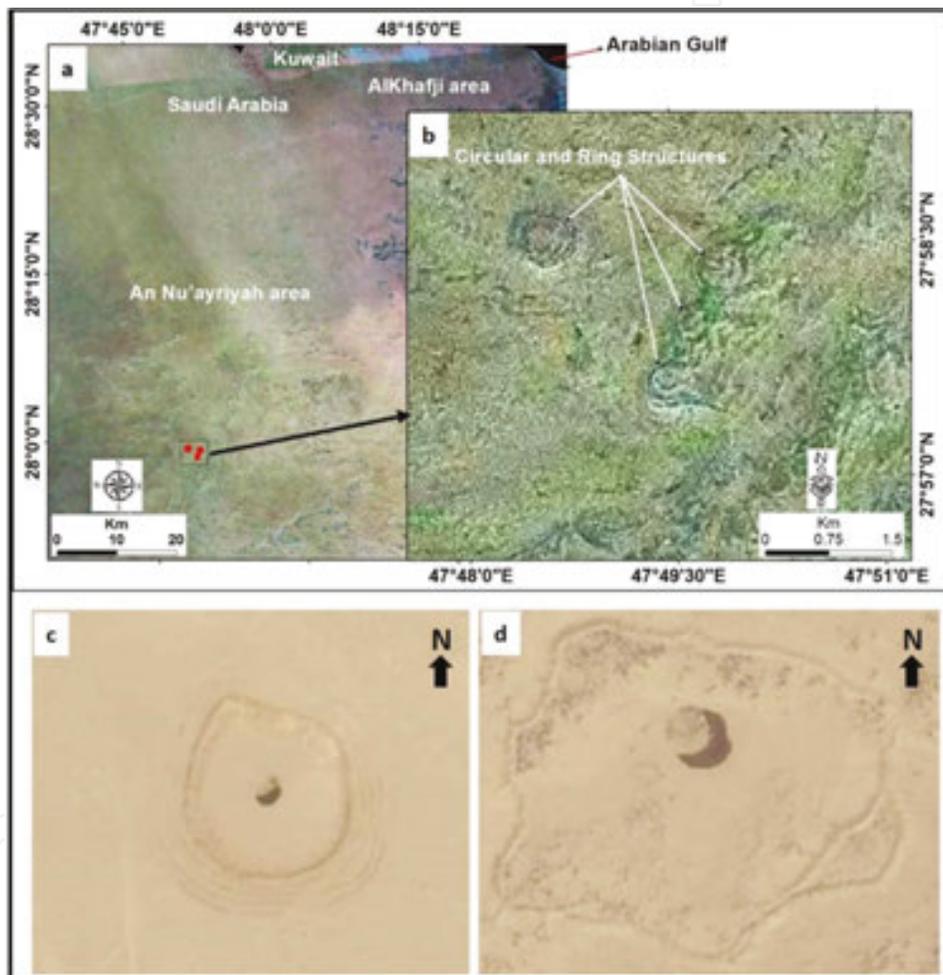
Figure 13. (a) Circular and ring structure features at An Nu'ayriyah area;(b) Circular and ring structure features at An Nu'ayriyah area; (c) Google-earth map of sinkholes at Al Issawiah area; (d) Google-earth map of sinkholes at Al Issawiah area.

One of the popular, nondestructive methods for detecting karst-related features and sinkholes is the use of remote-sensing data. These remote-sensing data can be used for recognizing different surface features that are related to karst phenomena using visual inspection. Different types of remote-sensing data have previously been used for distribution and recognition of sinkholes and karst-surface features such as aerial photographs [63, 64] and satellite images [10, 17]. In the KSA, aerial photographs are very rarely and in a limited manner used for detecting karst related features. However, Landsat images of 15 m resolution can easily be

prepared using the fusing technique to sharpen the resolution of 30 m bands 1, 2, 3, 4, 5, and 7 to enhance the resolution to 15 m resolution using panchromatic band 8. These data were used before to detect surface features (circular features, depressions, and ring structures) that are related to karstification at An Nu'ayriyah area (**Figures 13a, b**). Another set of remote-sensing data was used to detect sinkholes, including the imagery of professional Google Earth. These high-resolution images were used in different projects in the KSA and give valuable information about the presence of sinkholes and their time of occurrence. **Figures 13c, d** shows some examples of Google Earth high-resolution images with different sinkholes at Al Issawiah area.
