Assessment of the Riparian Vegetation Changes Downstream of Selected Dams in Vhembe District, Limpopo Province on Based on Historical Aerial Photography

John M. Mokgoebo, Tibangayuka A. Kabanda and
Jabulani R. Gumbo

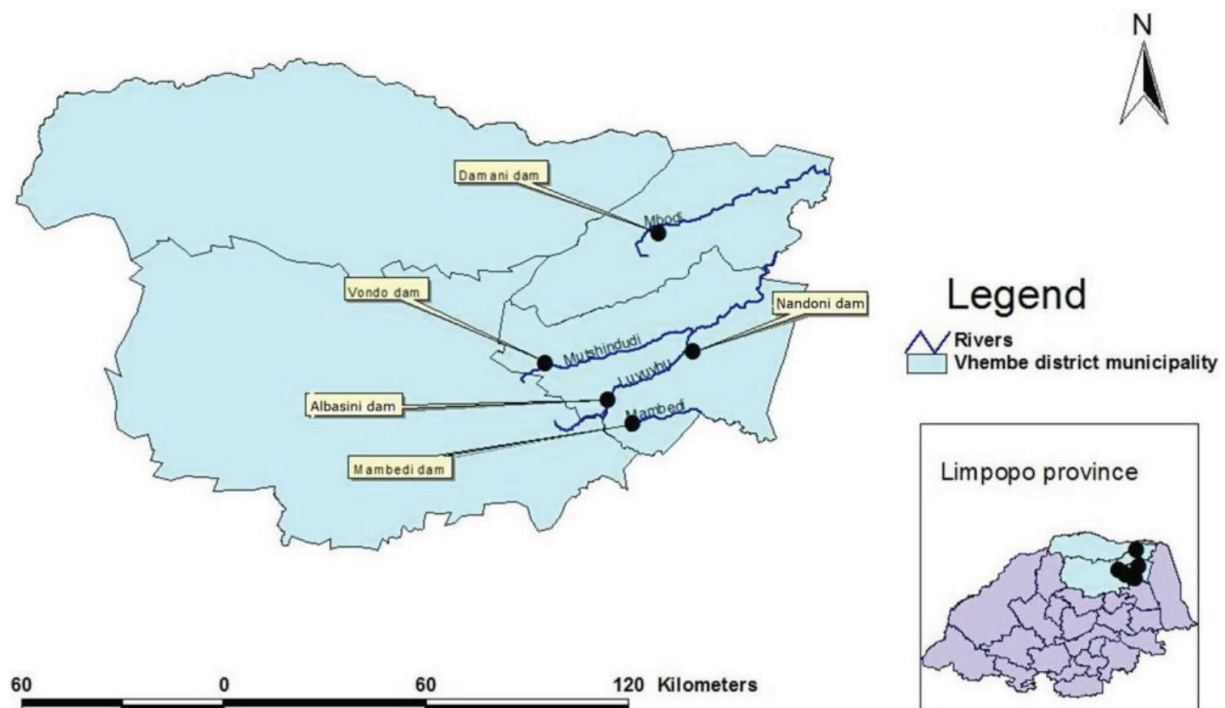
Figure 1. The locations of selected dams in the study area.

The Damani dam is on the Mbewi River and was established in 1991 (**Figures 1 and 2**). The dam is situated at 22°50'07"S and 30°31'22"E and was built to supply water to the former Damani Coffee Estate which required $4.08 \times 10^6 \text{ m}^3$ per annum. It supplies irrigation water to the surrounding commercial farms owned by local community members. Its maximum water carrying capacity is $12.4 \times 10^6 \text{ m}^3$ and it has a surface area of 130 ha [6].

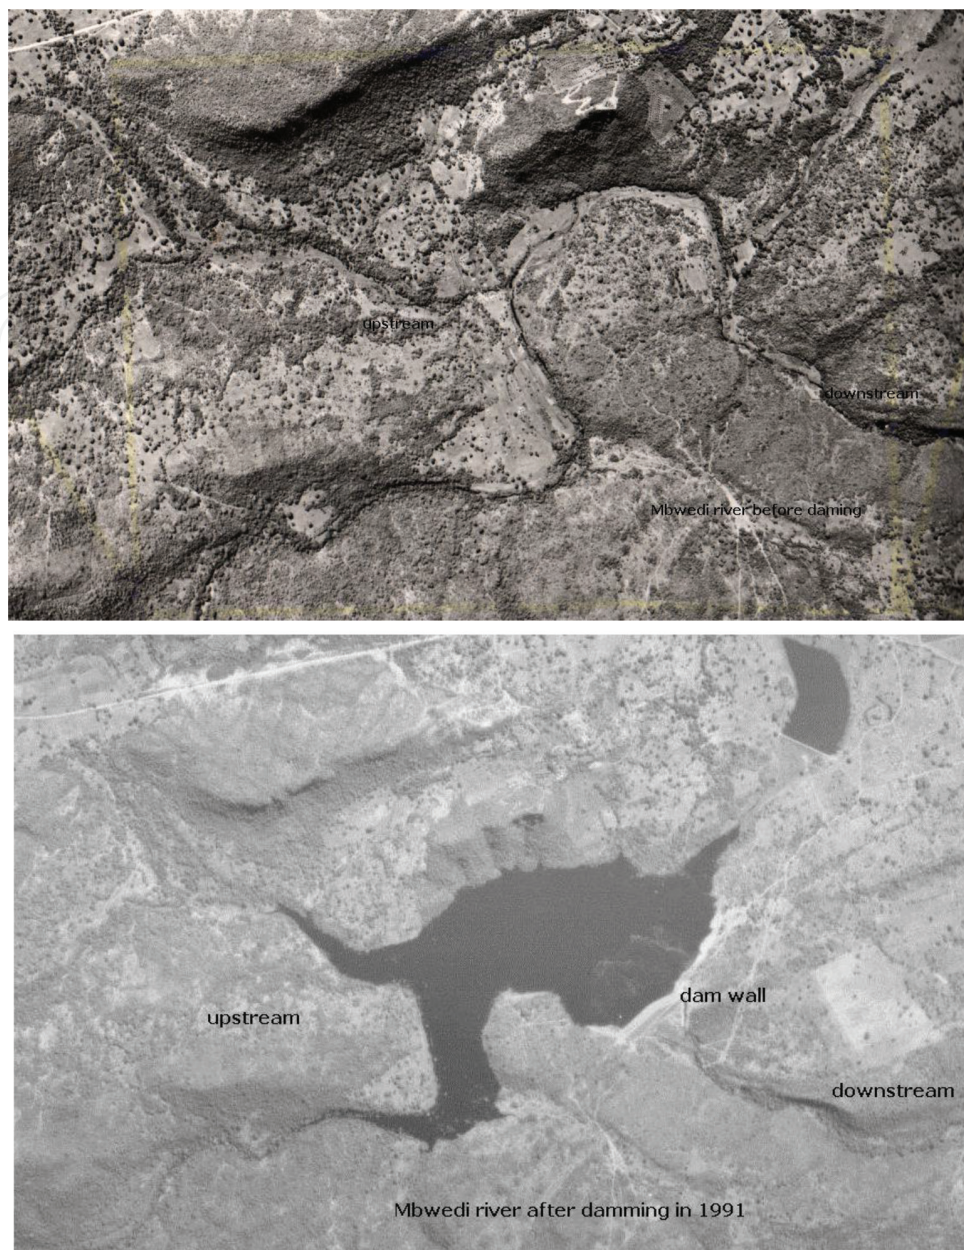
Figure 2. The riverine vegetation along Mbweni River before the damming (top) and after construction of the Damani dam (bottom).

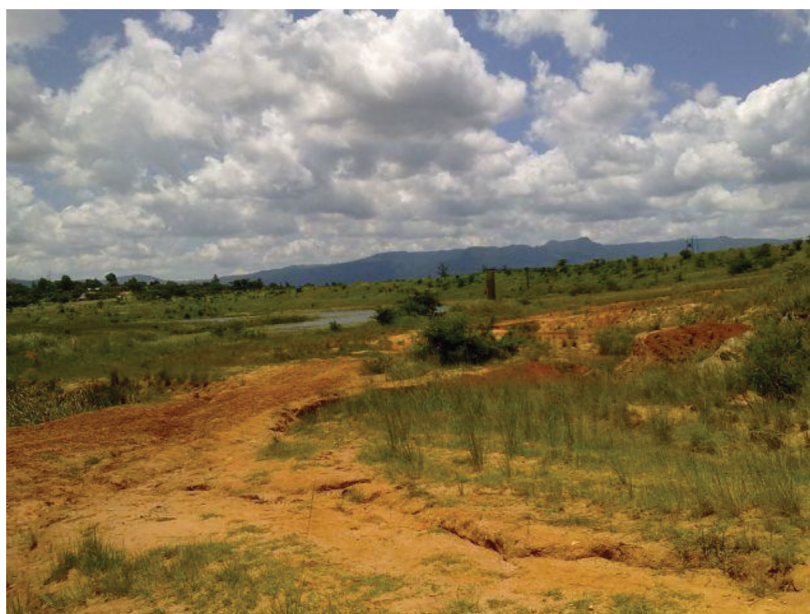
Plate 1. The defunct Mambedi dam after the 2000 floods (December 2008).

From **Plate 1** it can be seen in the background, where less water accumulates, that the area is characterised by fine thatching grass (*Hyparrhenia filipendula*) with a few unevenly scattered *Acacia ataxacantha* trees. Vegetation is still in its primary stage of succession and the stagnant water body that can be seen in the background has shown deterioration in water quality. From the photograph, it is evident that the failure of the dam reduced the aquatic environment and riparian and aquatic biota suffered from the failed water management project. The aquatic and riparian zones were colonised by terrestrial grass and woody plants. Orr [17] has stated that plant composition differs among recent and older sites as newer sites are dominated by a combination of grasses and early successional forbs. The same is true with the Mambedi dam. Again, the presence of low grass density on the banks will make the river banks more unstable and result in calving. Once this occurs, erosion of banks will increase and sedimentation will

also increase. Simon and Collison [18] have noted that if vegetation development progresses to trees banks are expected to be more stable than if banks are dominated by grass communities. This is why Russell et al. [19] have argued that without riparian vegetation, erosion and sedimentation will increase in dams. Channels that are characterised by low grass densities are more likely to lead to channel straightening [20, 21].

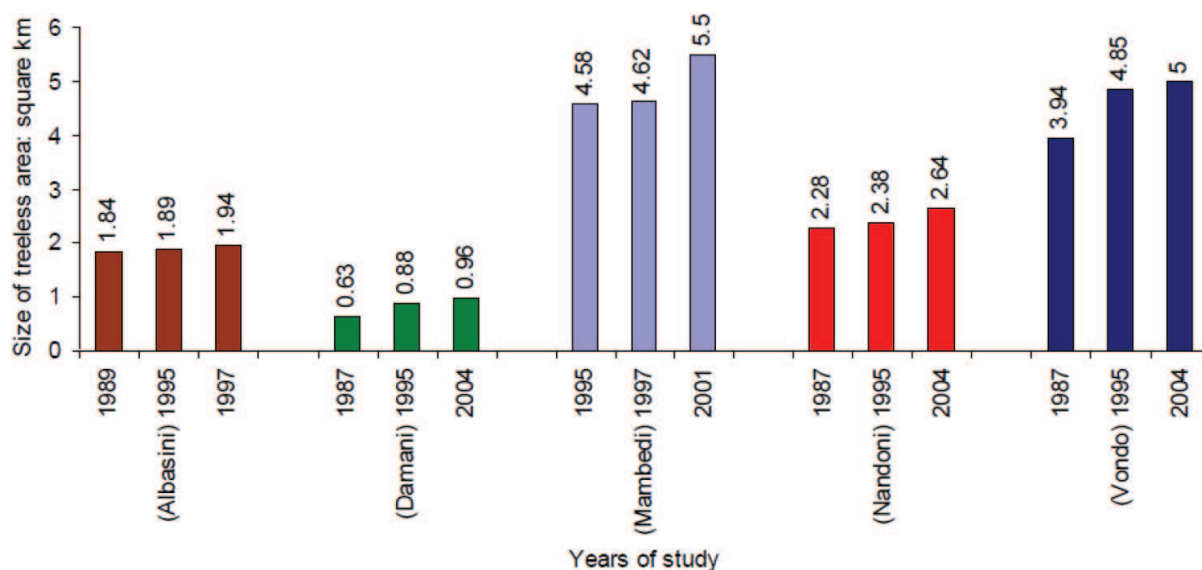
Figure 3. Total surface areas upstream and downstream of dams devoid of trees.

However, the Vondo dam area is characterised by commercial agriculture and human settlement along the Mutshindudi River. Therefore, the extent of the impact of the dam downstream is complicated by the existence of settlements and intense commercial farming (tea plantations). The field data and photo data do not correspond in all cases but this happen to agree in this particular case because of the human settlements and tea plantations. For example, Kellog and Zhu [26] noted that during the construction of the Three Gorges Dam (China) clearing of vegetation for agriculture the average width of the upstream waterway increased from 0.6 to 1.6 km. This shows how dams negatively impact on their immediate environments. The same is true with the area in the vicinity of the Vondo dam. Therefore, the lower tree density downstream of the Vondo dam corresponds with the size of the treeless area (1.06 km^2) calculated from remotely sensed images. Results in **Table 6** and **Figure 3** also show that upstream tree

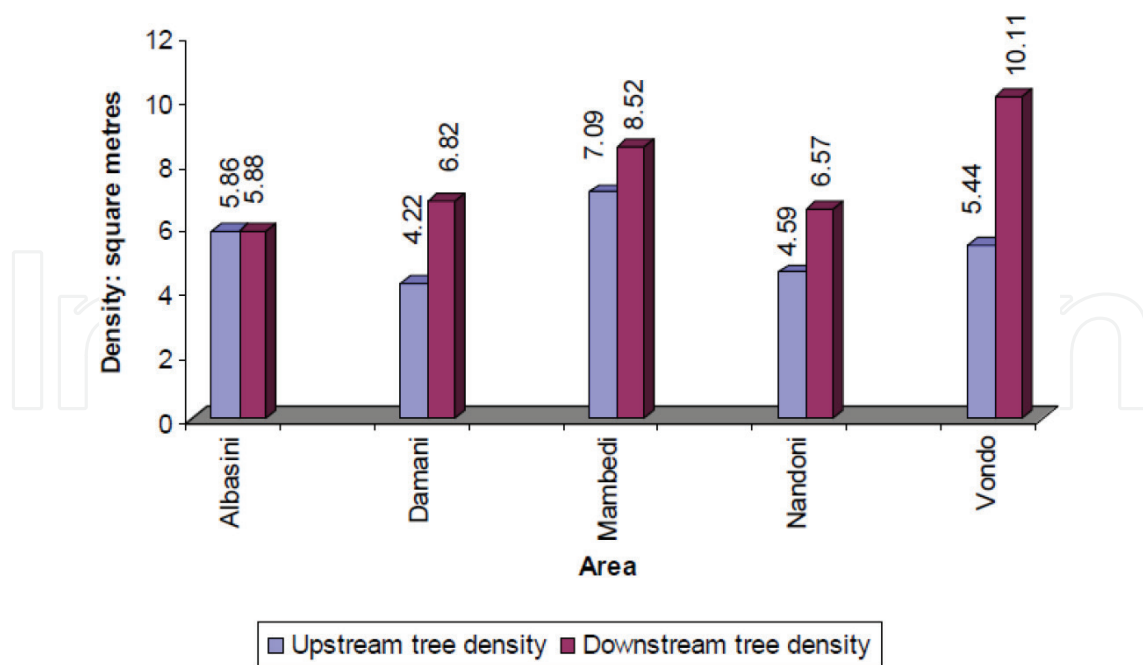
Figure 4. Tree densities downstream and upstream of the dams.

From **Figure 4** Vondo shows slightly higher upstream density and much lower downstream density. Vondo shows lower downstream density than all studied dam areas. Downstream of Vondo dam area, is less dense (10.11 m^2) than in all studied dam areas while Albasini dam area is denser.

density is highest at Damani dam (4.22m^2) on the Mbwedi River and lowest at Mambedi dam (7.09m^2) on the Mambedi River. Downstream tree density is highest on the Albasini dam and lowest in all other dams. Downstream tree density is highest on the Albasini dam (5.88m^2) and lowest on the Vondo dam (10.11m^2). Tree density upstream of Nandoni dam is higher (4.59m^2) than downstream of the dam (6.57m^2). Thus, the growth in treeless area downstream of all studied dams occurs as a result of low flows which are available for riparian irrigation. This is caused by the upstream presence of the dams. This, according to Lees et al. [27] and Sutherland et al. [28], occurs because construction of dams leads to fragmentation and degradation of riparian zones which also leads to loss of ephemeral habitats.
